Daily Report

Project:	Durham Meadows Pipeline Installation	Date:	August 27, 2021
Location:	Maple Avenue, Durham; Long Hill Road and the Shared Access Driveway, Middletown	Day of Week:	Friday
Project #:	AECOM: 6061487	Report No:	312
Contractor:	Ludlow Construction	Page:	1 of 17

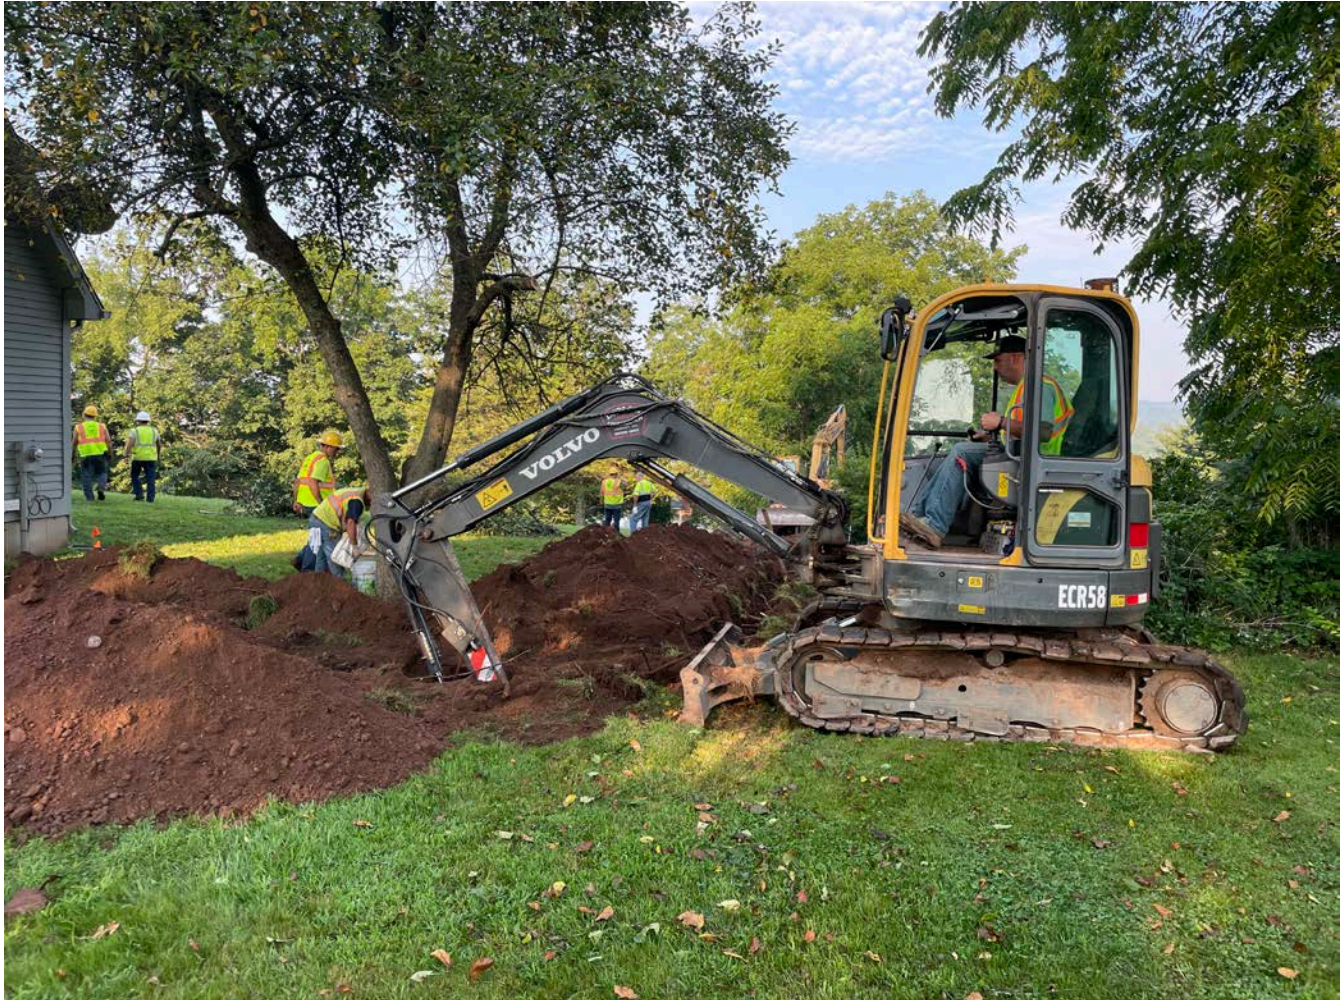
Picture 1: Ludlow excavating at the 109 Maple Avenue property as they install a 2" copper water service line. View to the southwest.

0729: Ludlow continues trenching at the 109 Maple Avenue property for the installation of a 2" copper water service line.

0752: Ludlow has daylighted the concrete foundation on the north side of the 109 Maple Avenue residence. Ludlow has almost finished excavating the trench for the installation of the 2" copper water service line.

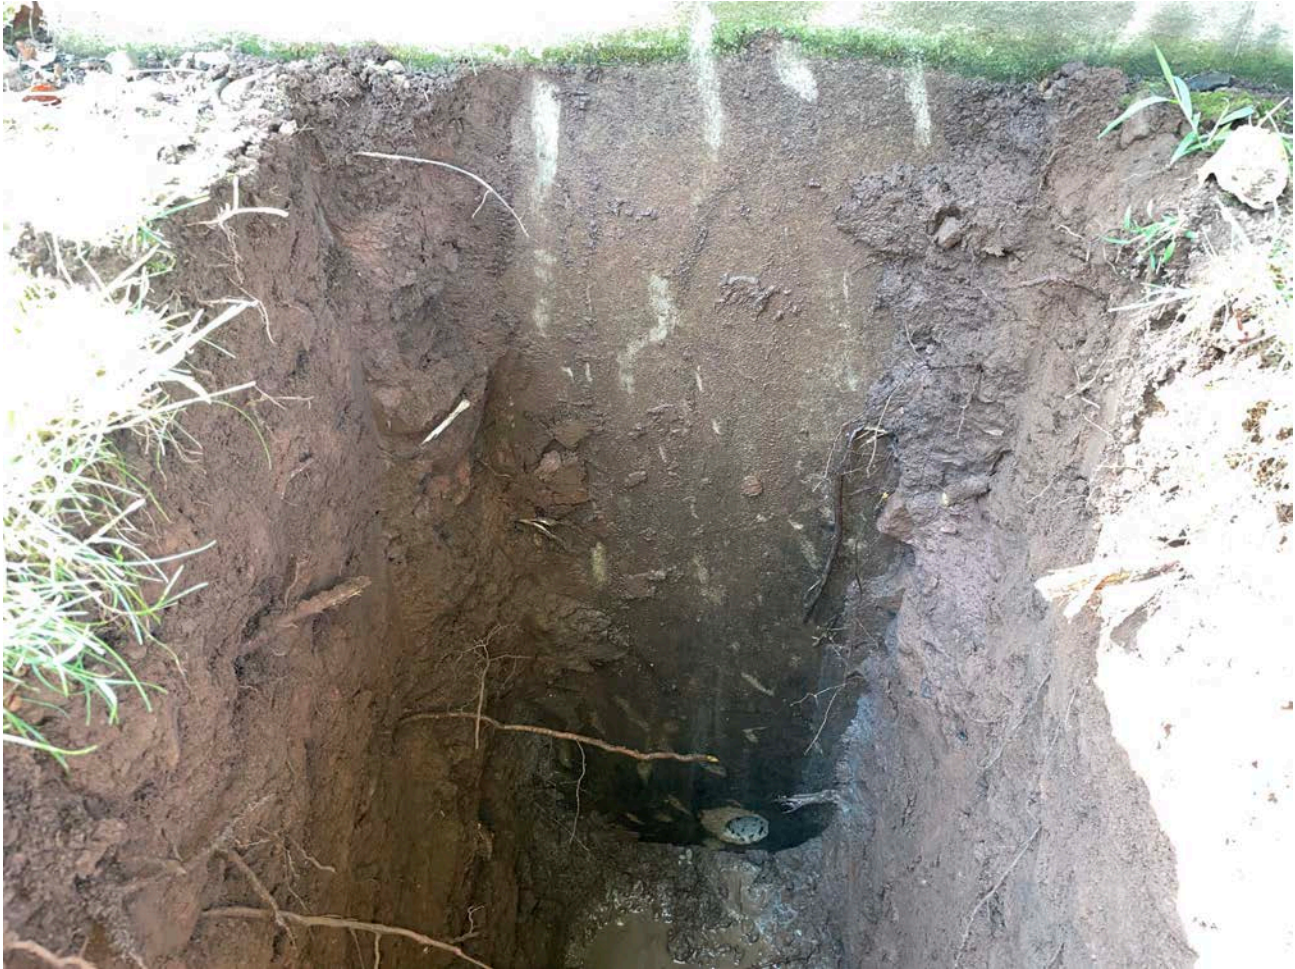
Picture 2: Hole that Ludlow cored through the northern foundation for the 109 Maple Avenue residence for the installation of a 2" copper water service line. View to the south.

0836: Ludlow has cored through the concrete foundation on the north side of the 109 Maple Avenue residence for the installation of a 2" copper water service line.

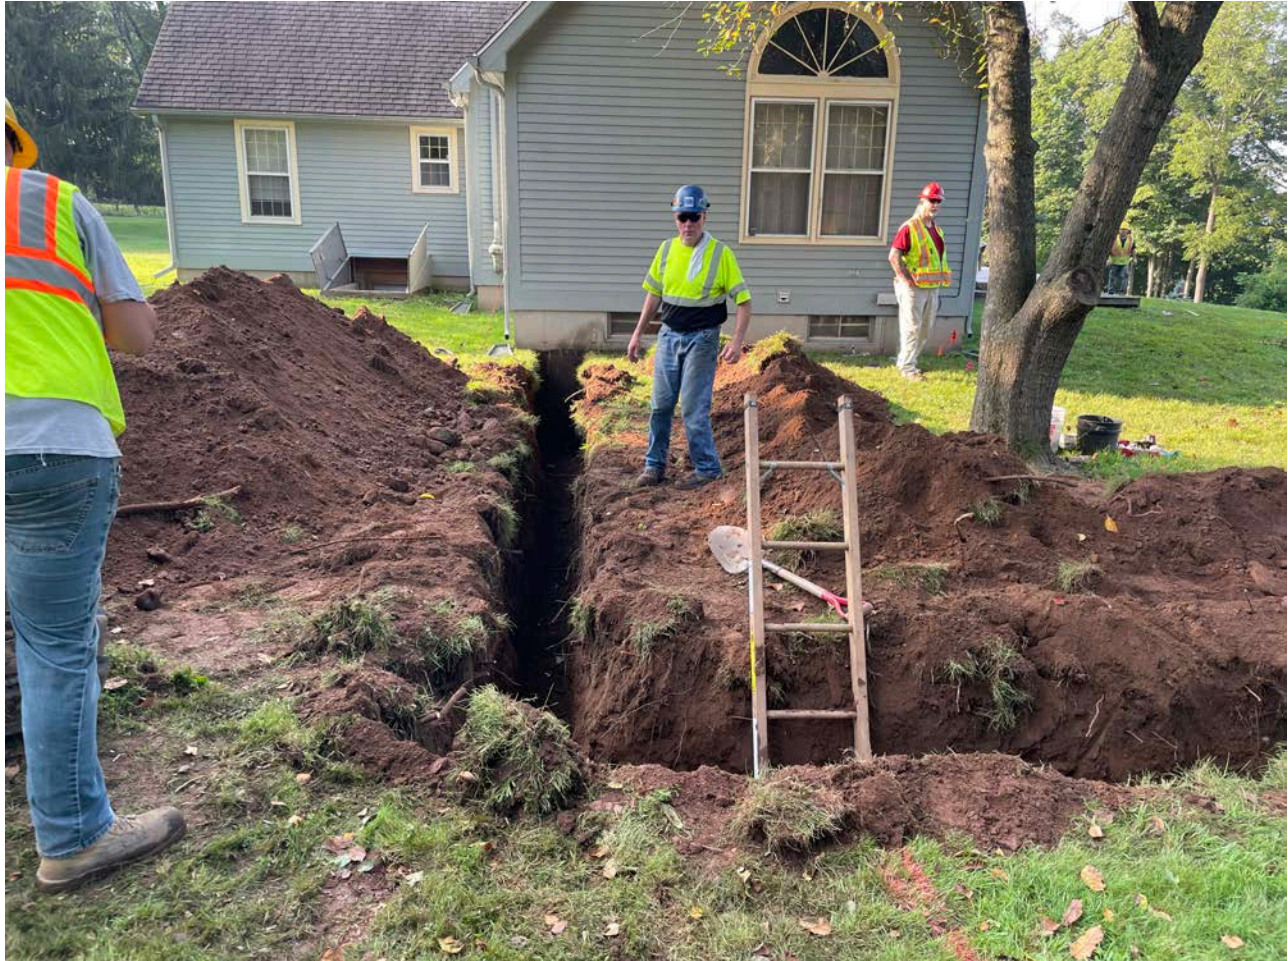
Picture 3: Trench that Ludlow has excavated for the installation of a 2" copper water service line at the 109 Maple Avenue property. View to the south.

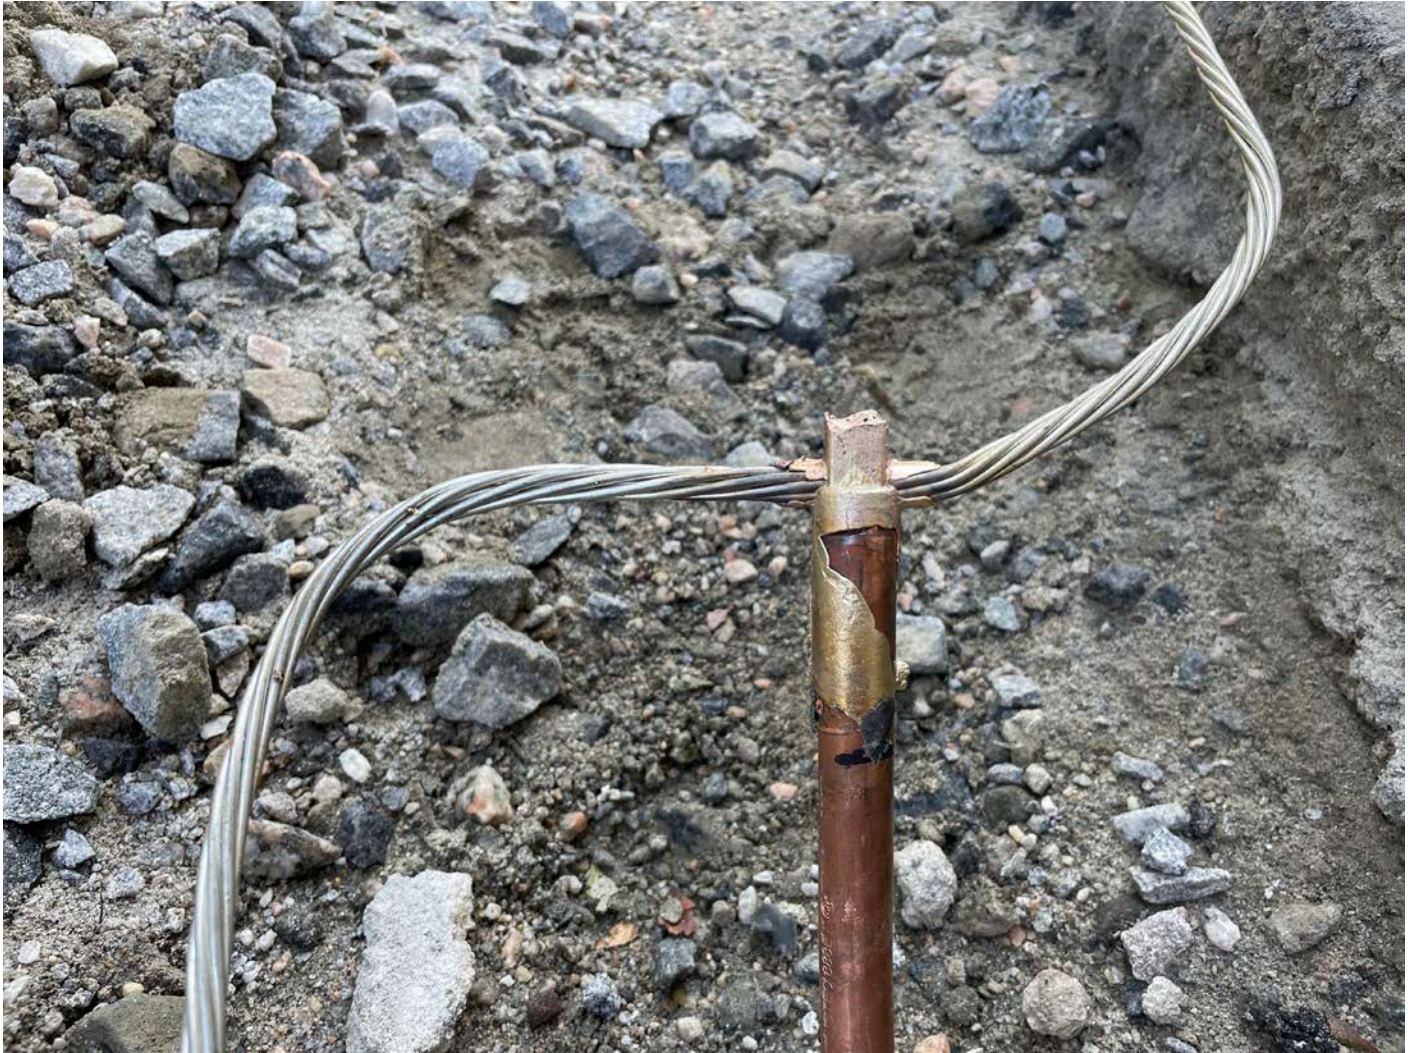
Picture 4: Grounding line that was cad welded to a grounding rod at the water tank work zone located east of the Shared Access Driveway in Middletown.

0911: A&R Electrical is working at the water tank installing conduits on the northeast side of the water tank next to the blower pad. A&R Electrical has cad welded six of the eight sections of grounding wire that need to be cad welded to either a grounding rod or to itself. A&R Electrical will bring a mold to the site on Monday to weld two areas where the ground wire overlaps itself.

1126: A&R Electrical continues to work at the water tank work zone. All the areas where grounding lines are connected to grounding rods have been cad welded.

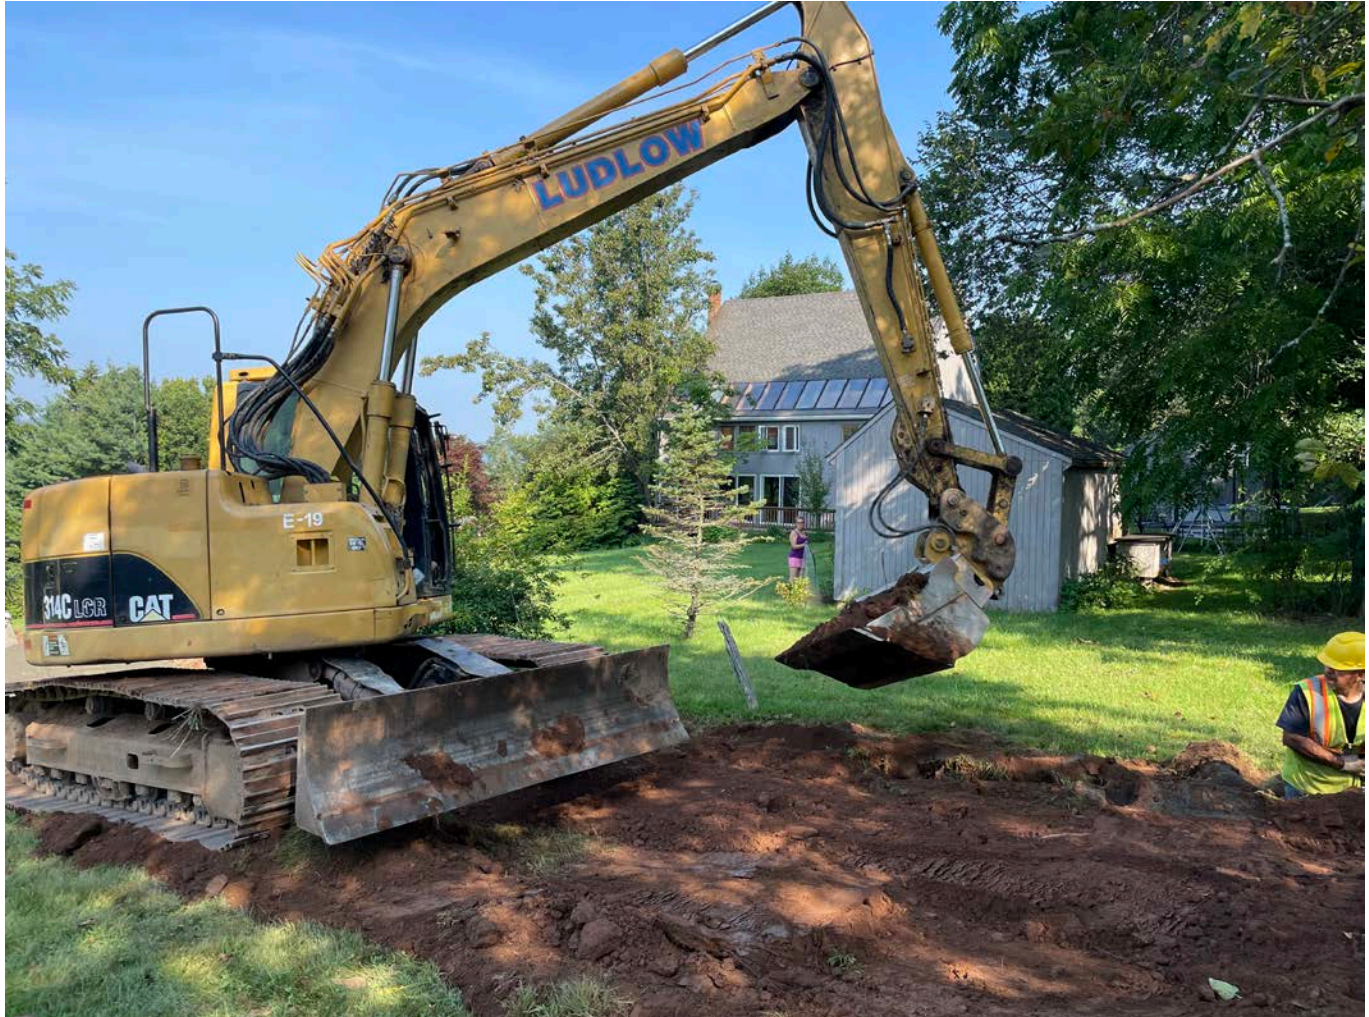
Picture 5: Ludlow backfilling the trench they excavated at the 109 Maple Avenue property for the installation of a 2" copper water service line. View to the north.

1018: Ludlow is finishing up with backfilling the water line trench at 109 Maple Avenue, Durham, property.

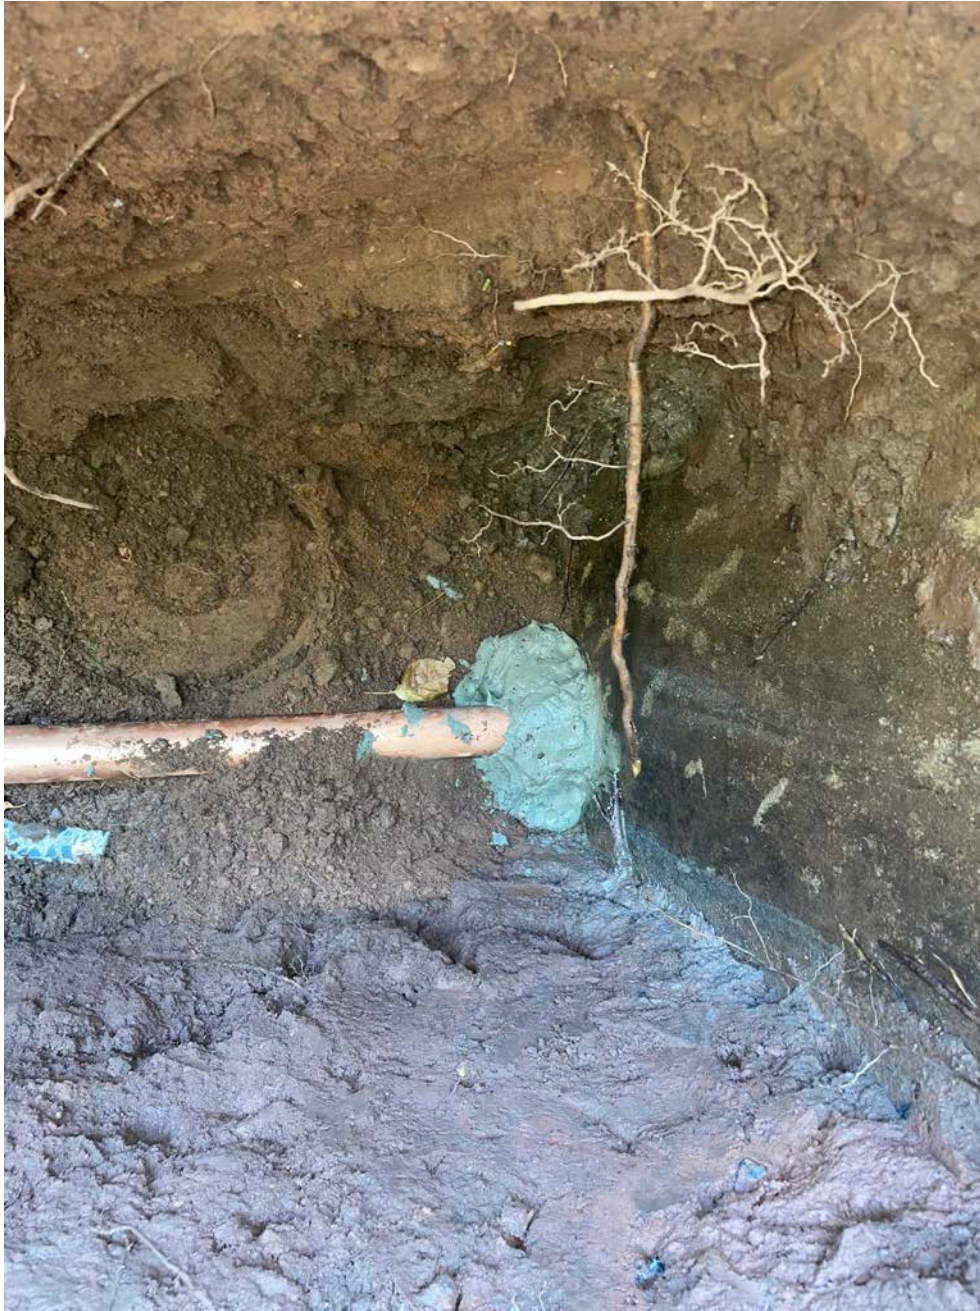
Picture 6: 2" copper water service pipe that has been cemented into place with non-shrink grout on the northern foundation of the 109 Maple Avenue residence. View to south.

0935: Ludlow has inserted 2" copper water service line through the north side of the 109 Maple Avenue residence foundation. The 2" copper line has been secured on both sides of the foundation with non-shrink grout.

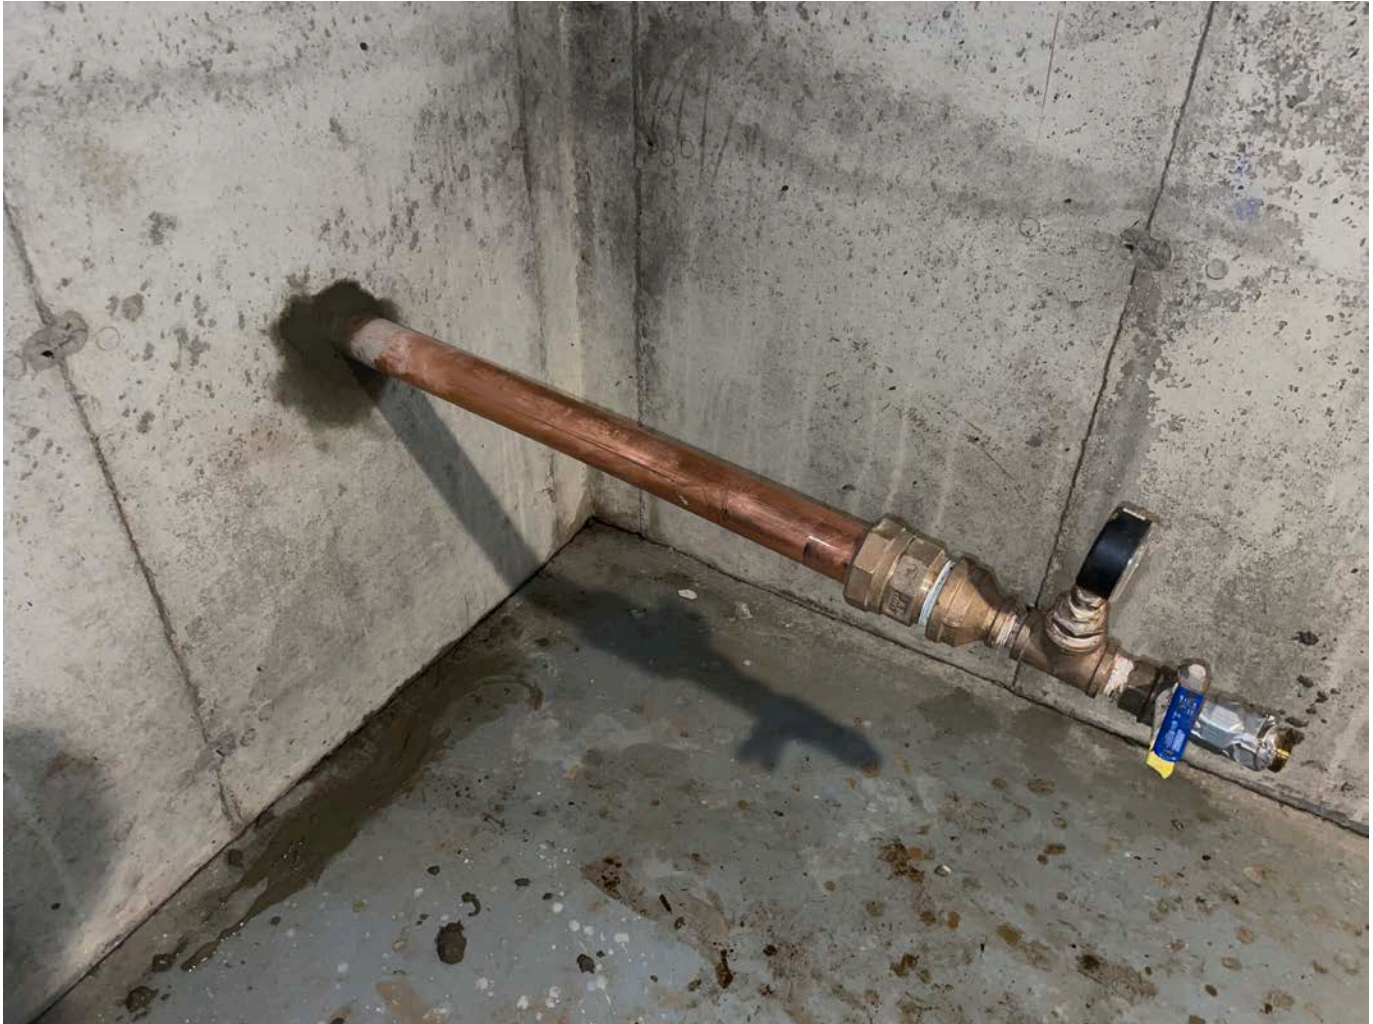
Picture 7: 2" copper water service pipe that has been cemented into place with non-shrink grout on the northern foundation of the 109 Maple Avenue residence. View to northeast.

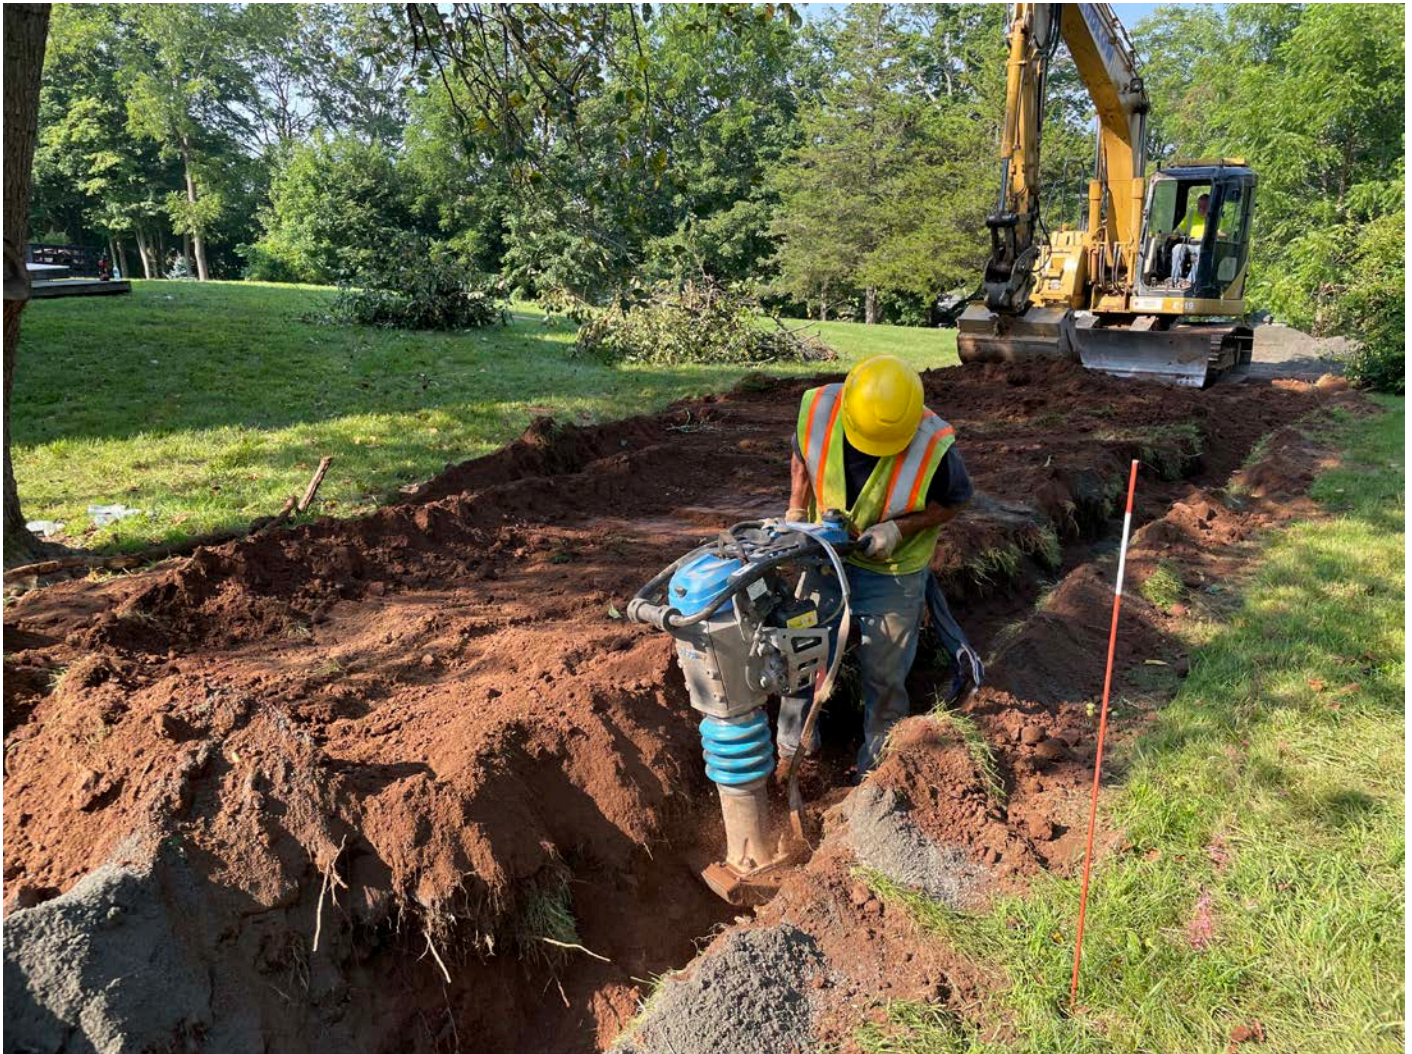
Picture 8: Ludlow using a jumping jack to compact native fill that was backfilled in 1' lifts at the 109 Maple Avenue residence in Durham. View to the southwest.

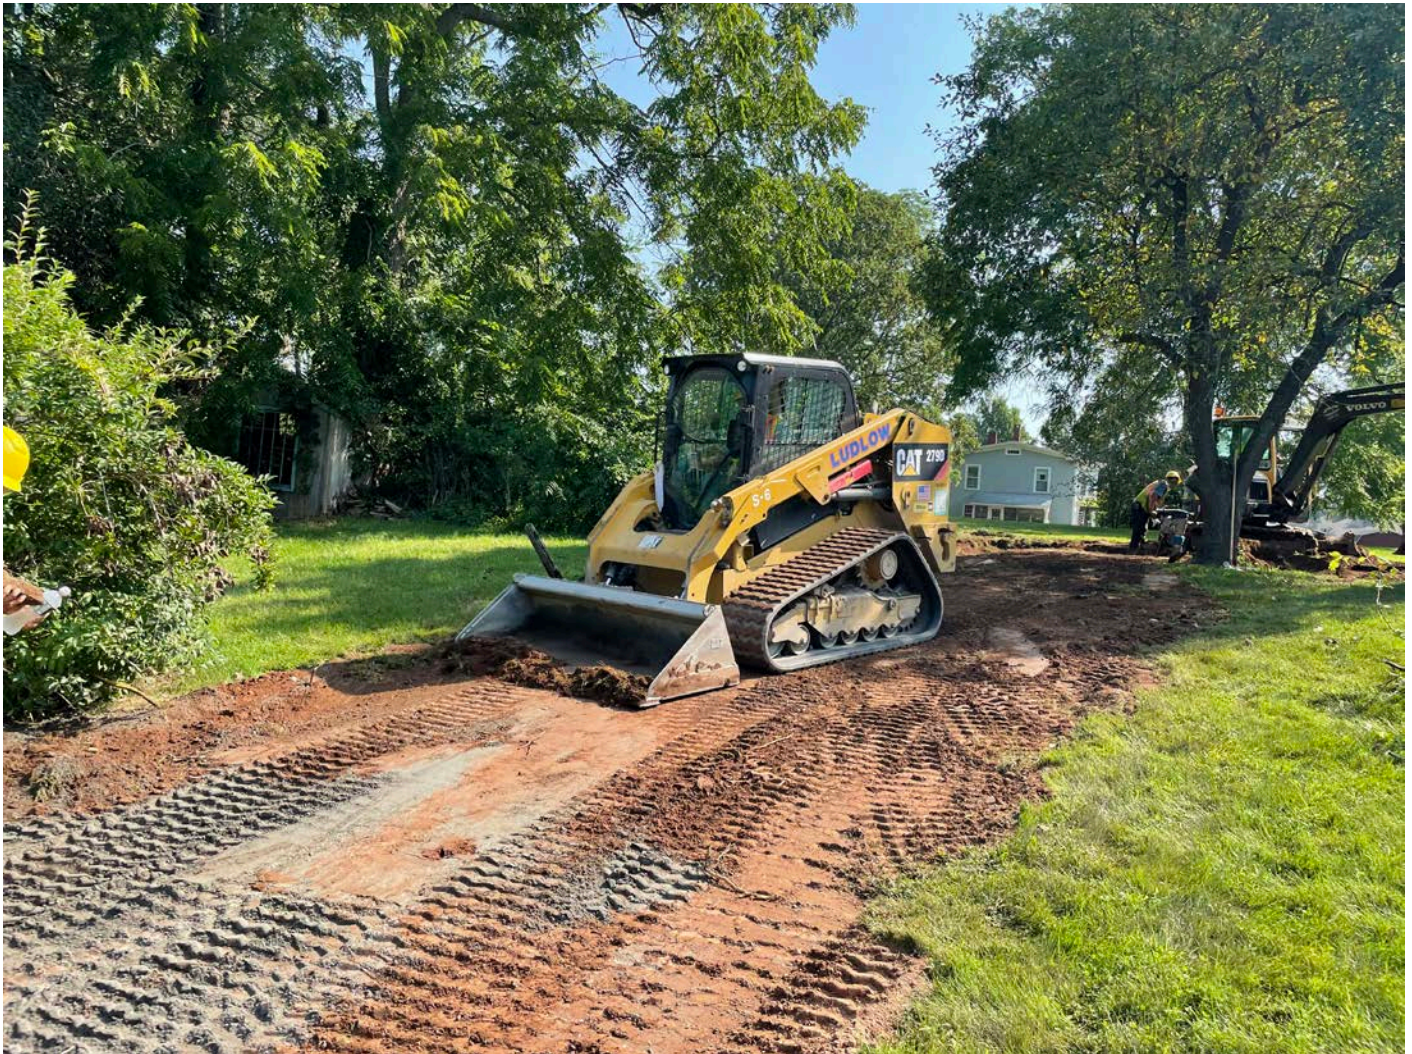
Picture 9: Ludlow grading loam as they restore the sections of the lawn at the 109 Maple Avenue residence that were disturbed during the Installation of a 2" copper water service line. View to the northeast.

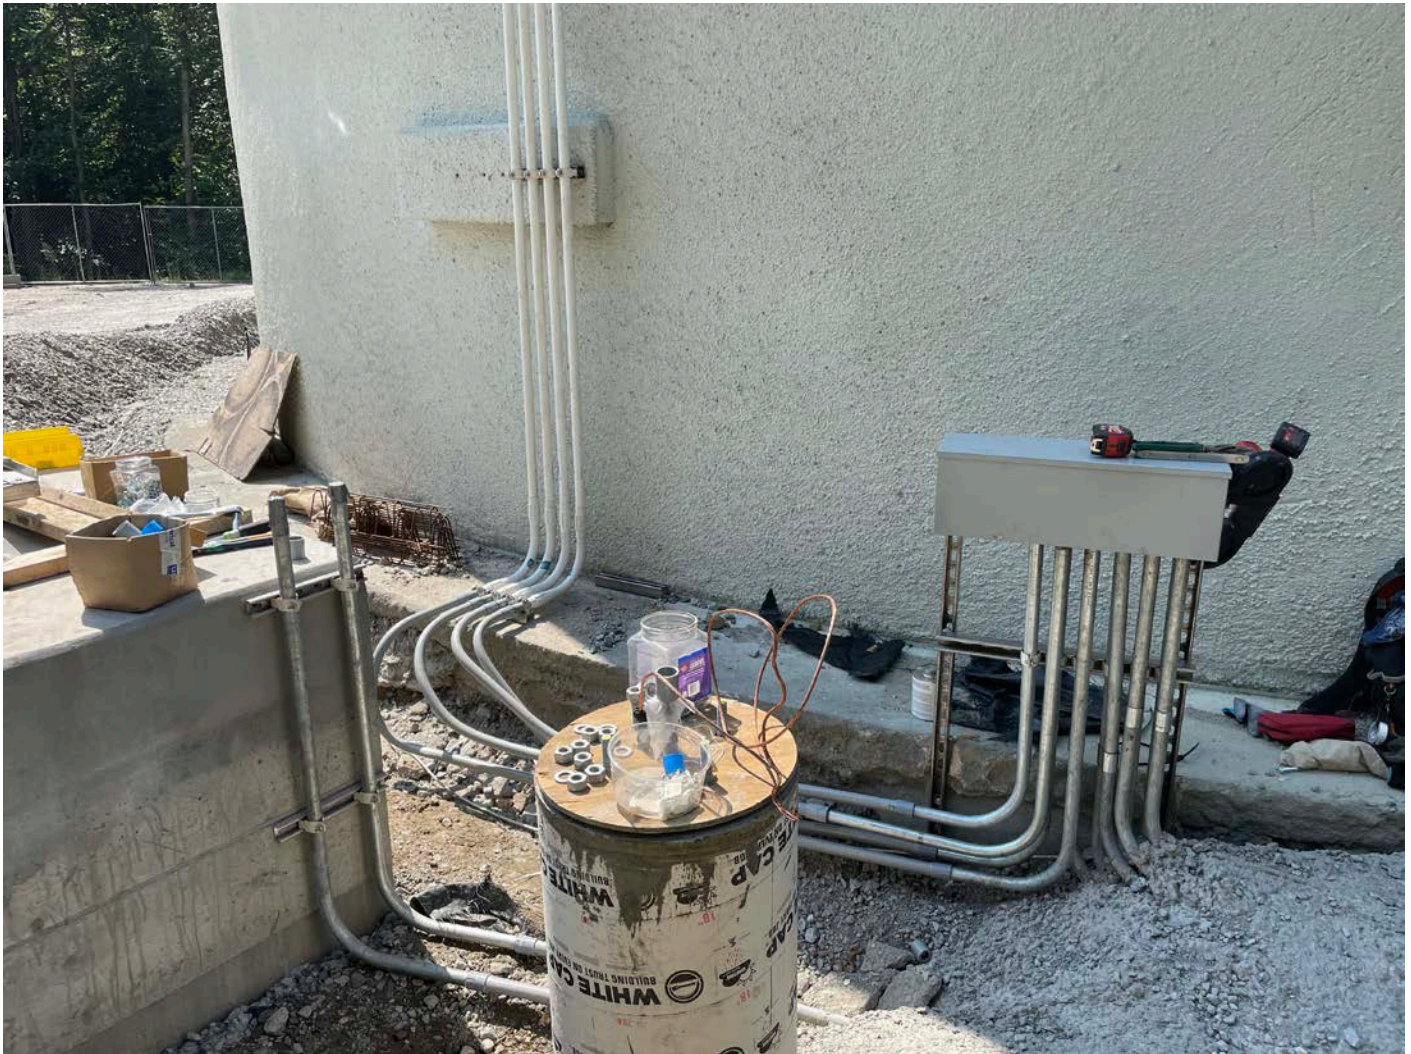
Picture 10: Conduits that A&R Electrical installed today on the pull box located on the northeast side of the water tank located east of the Shared Access Driveway in Middletown. View to the south.

1416: A&R Electrical continue to work at the water tank installing conduits associated with the blower located on the north east side of the water tank.

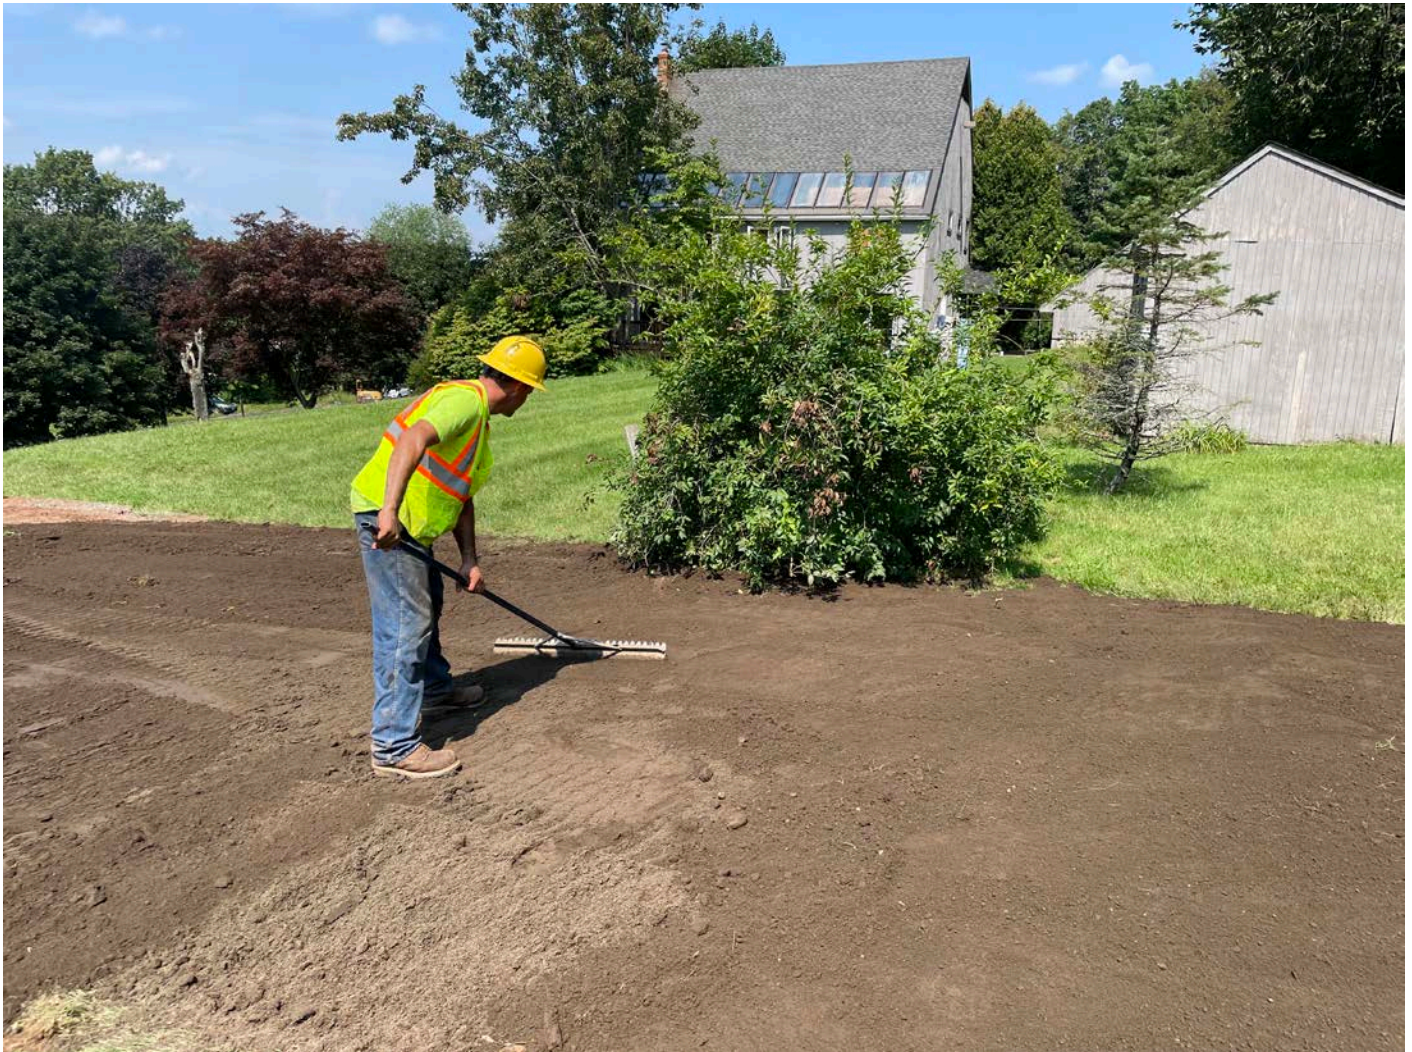
Picture 11: Ludlow raking out loam at the 109 Maple Avenue property, Durham, as part of restoration efforts following the installation of a 2" copper water service line. View to the northwest.

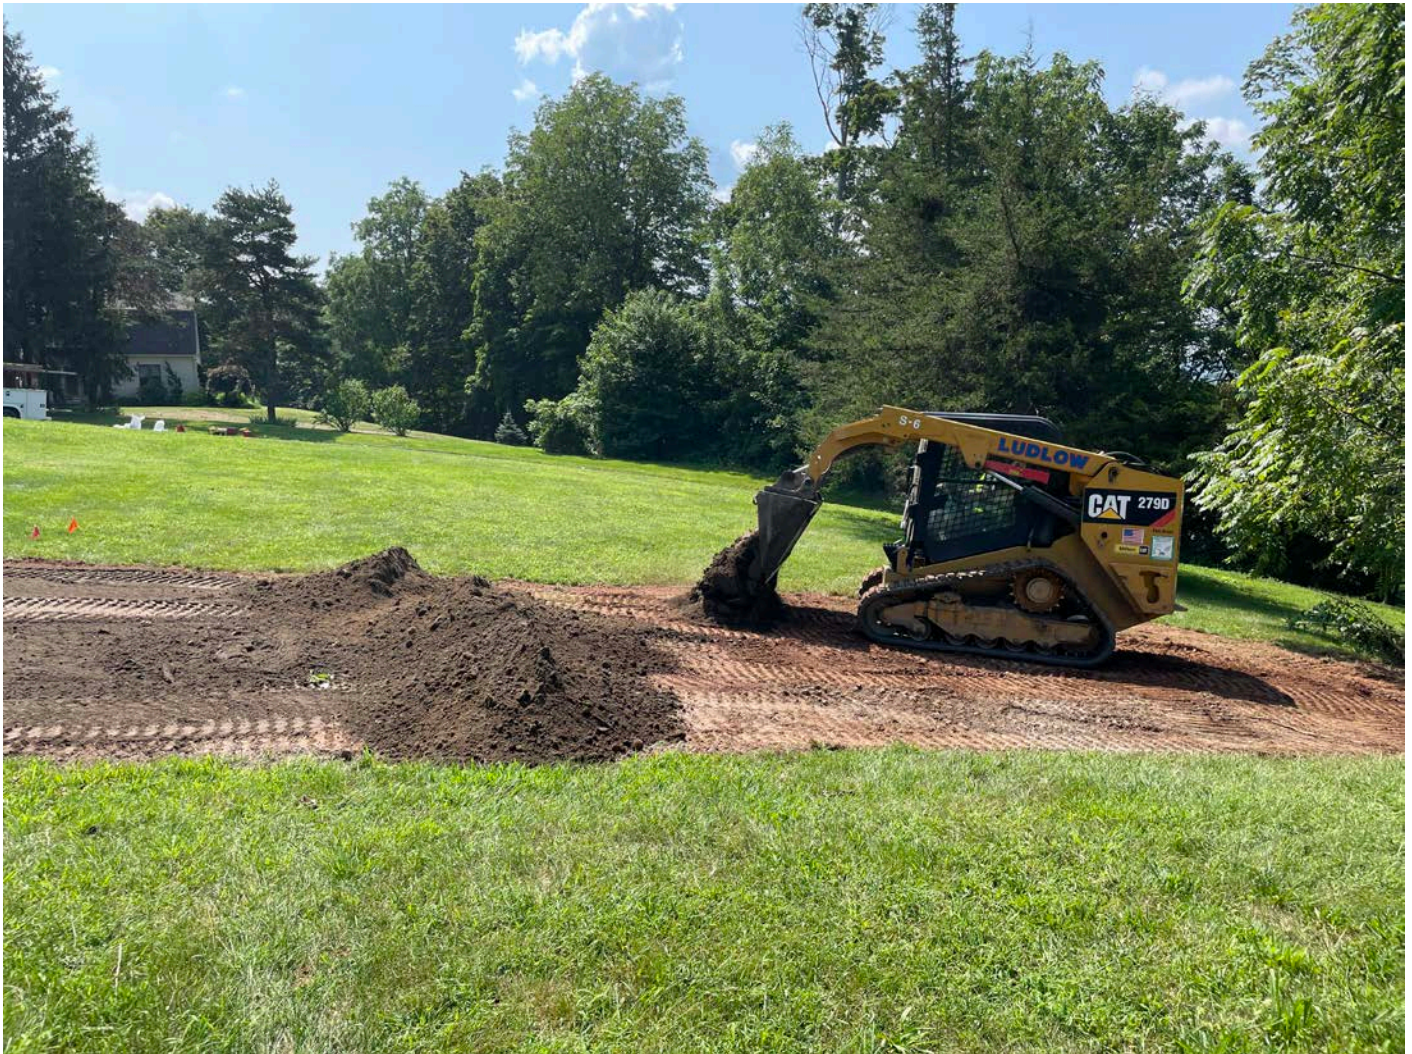
Picture 12: Ludlow grading loam at the 109 Maple Avenue property, Durham, as part of restoration efforts following the installation of a 2" copper water service line. View to the southwest.

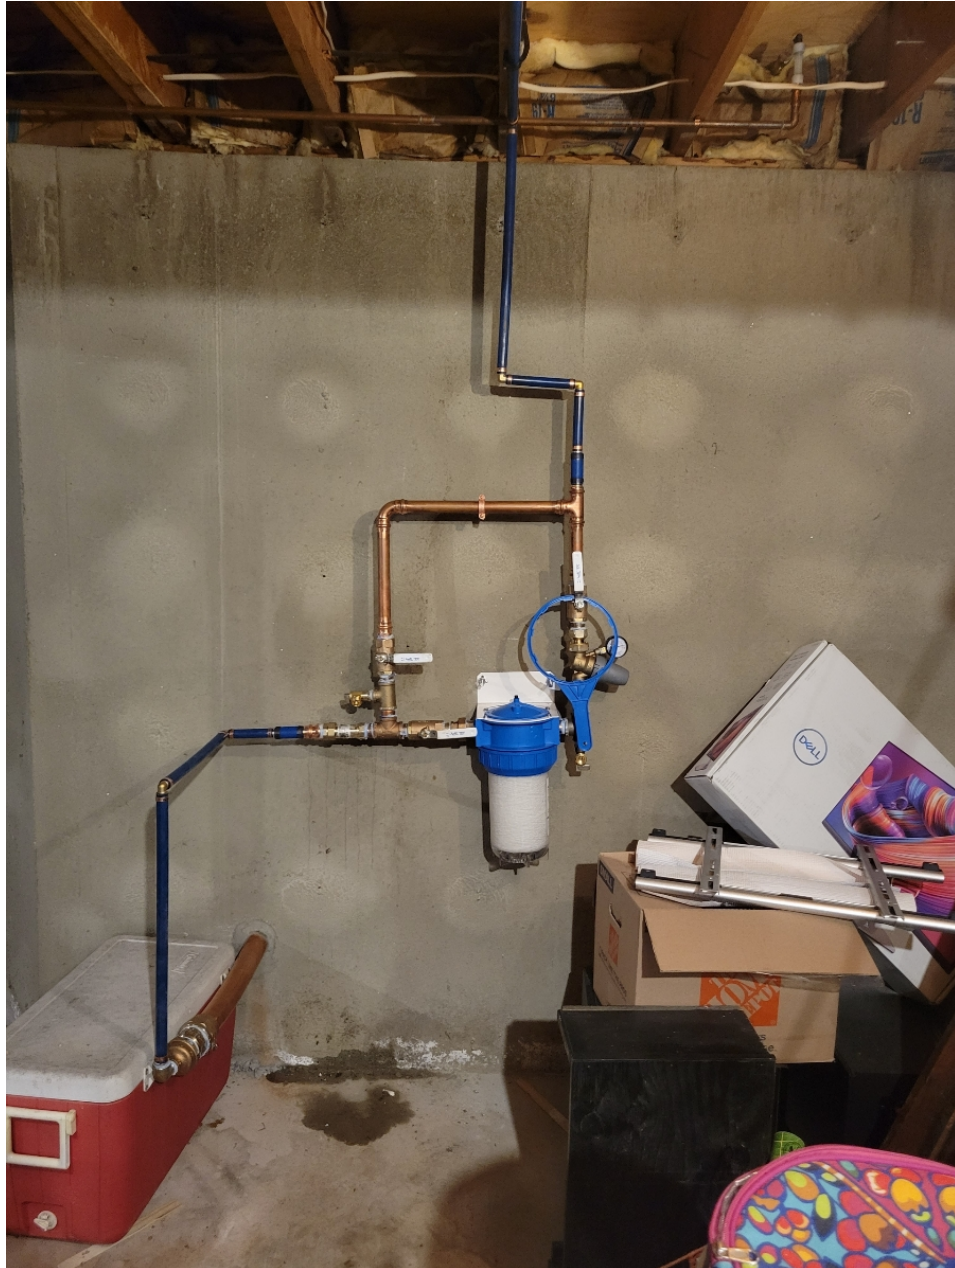
Picture 13: View of final water service components installed at the 95R Maple Avenue property by Fazzino Plumbing.

Fazzino Plumbing and Heating, Inc. installed final water service components for the 97 and 95R Maple Avenue, Durham, residences.

0948: Connecticut Water is installing a water meter in the meter pit for 95R Maple Avenue. Connecticut Water just finished installing a water meter at 97 Maple Avenue.

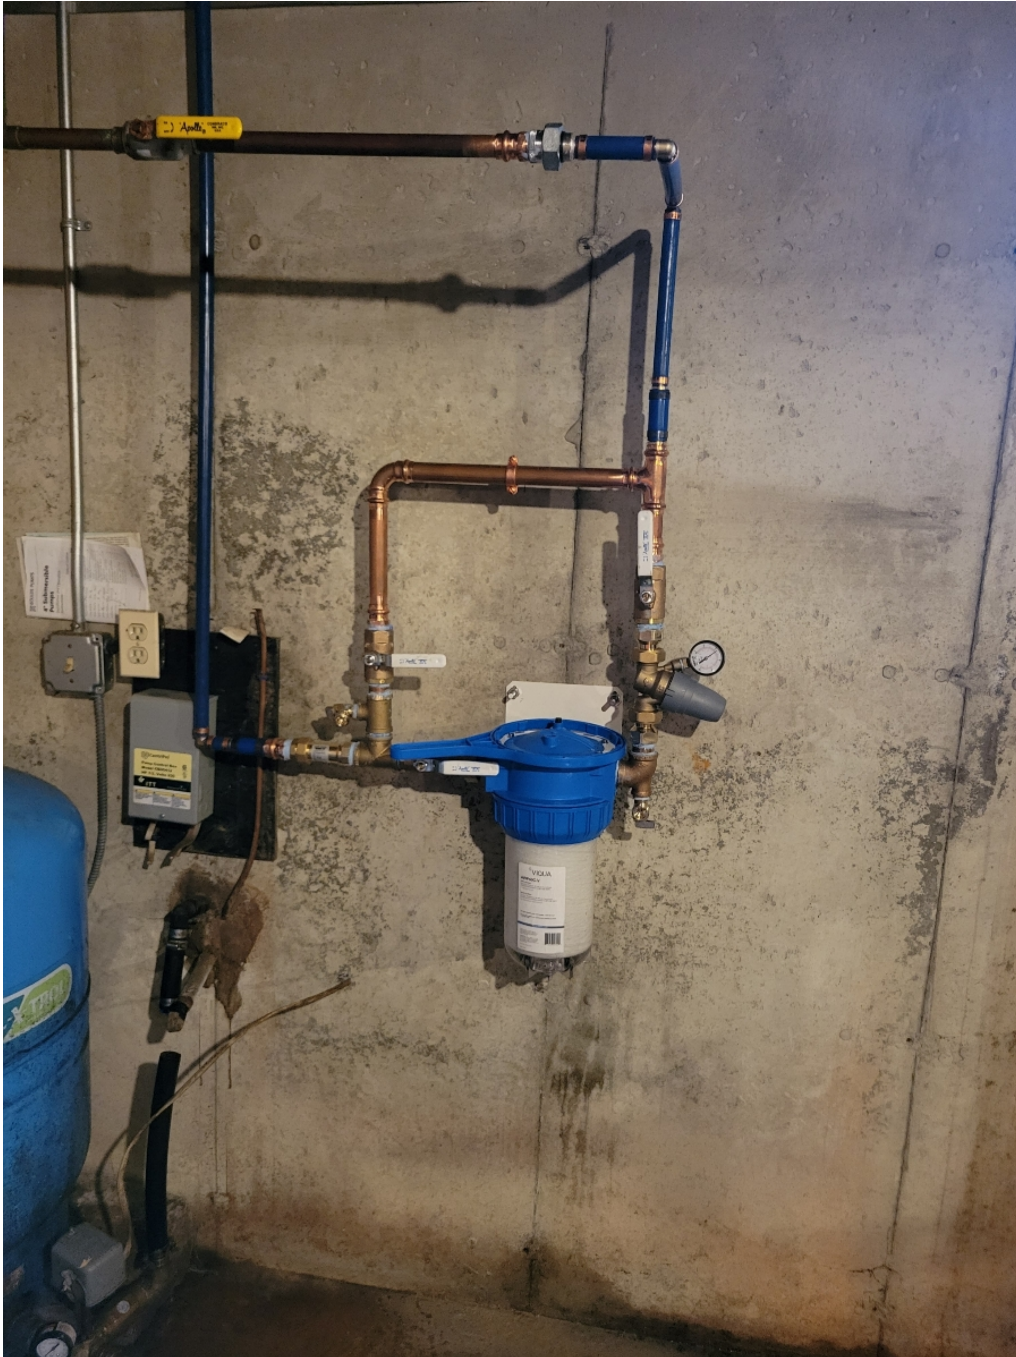
Picture 14: View of final water service components installed at the 997 Maple Avenue property by Fazzino Plumbing.
