Daily Report

Project:	Durham Meadows Pipeline Installation	Date:	September 08, 2021
Location:	Maple Avenue, Durham; S. Main Street, Middletown	Day of Week:	Wednesday
Project #:	AECOM: 6061487	Report No:	318
Contractor:	Ludlow Construction	Page:	1 of 16

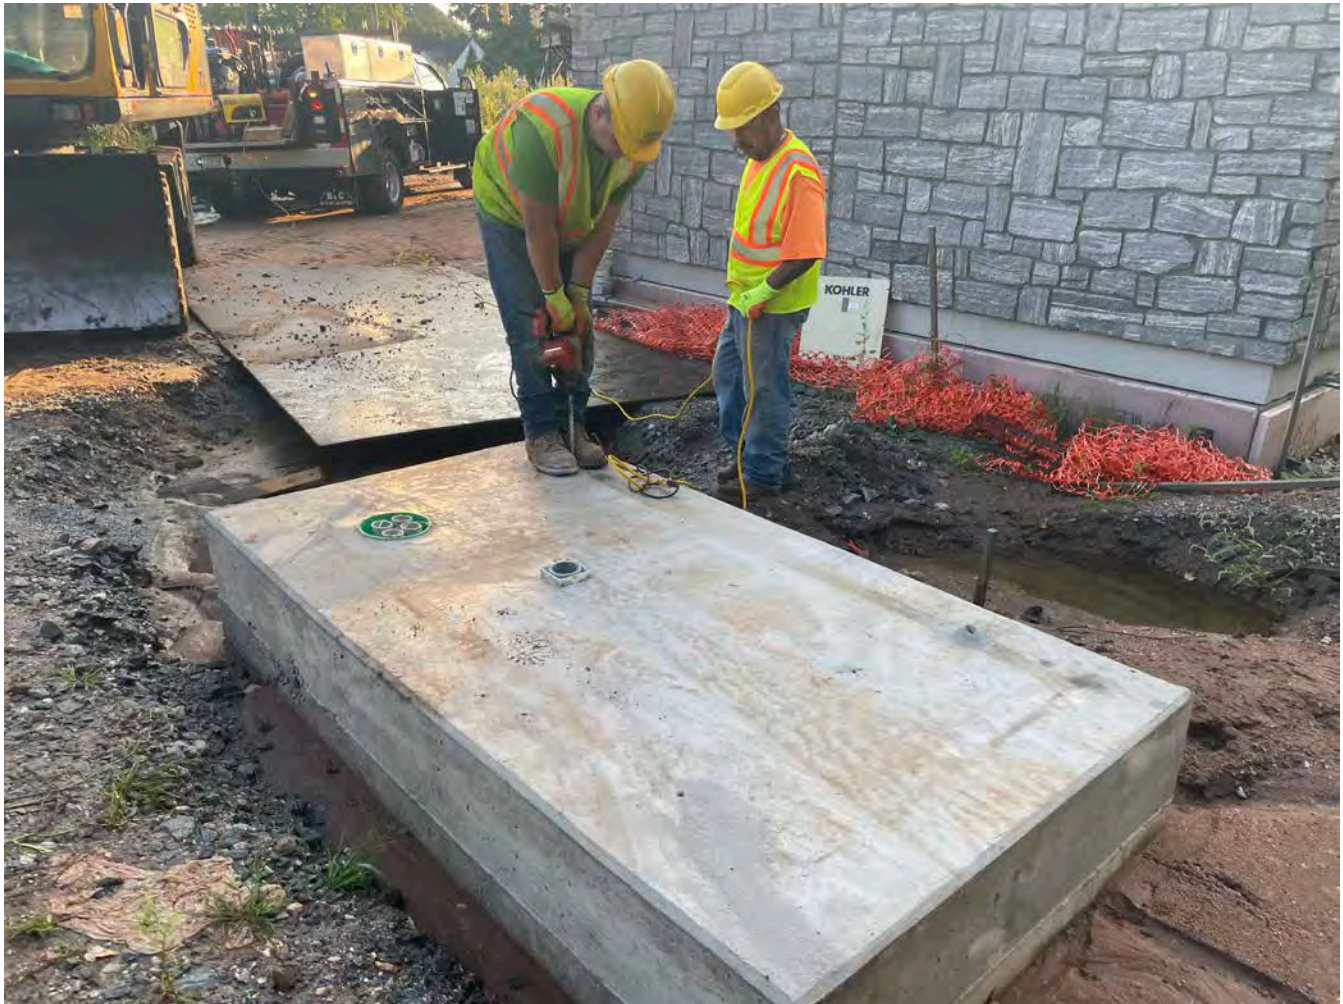
0721: Ludlow has lifted the generator off of its pad and has begun to drill holes into the concrete to set bolts that will secure the generator in place.

Picture 1: Ludlow drilling into the concrete pad for the generator located on the west side of the booster station at Station 750+63. View to the northeast.

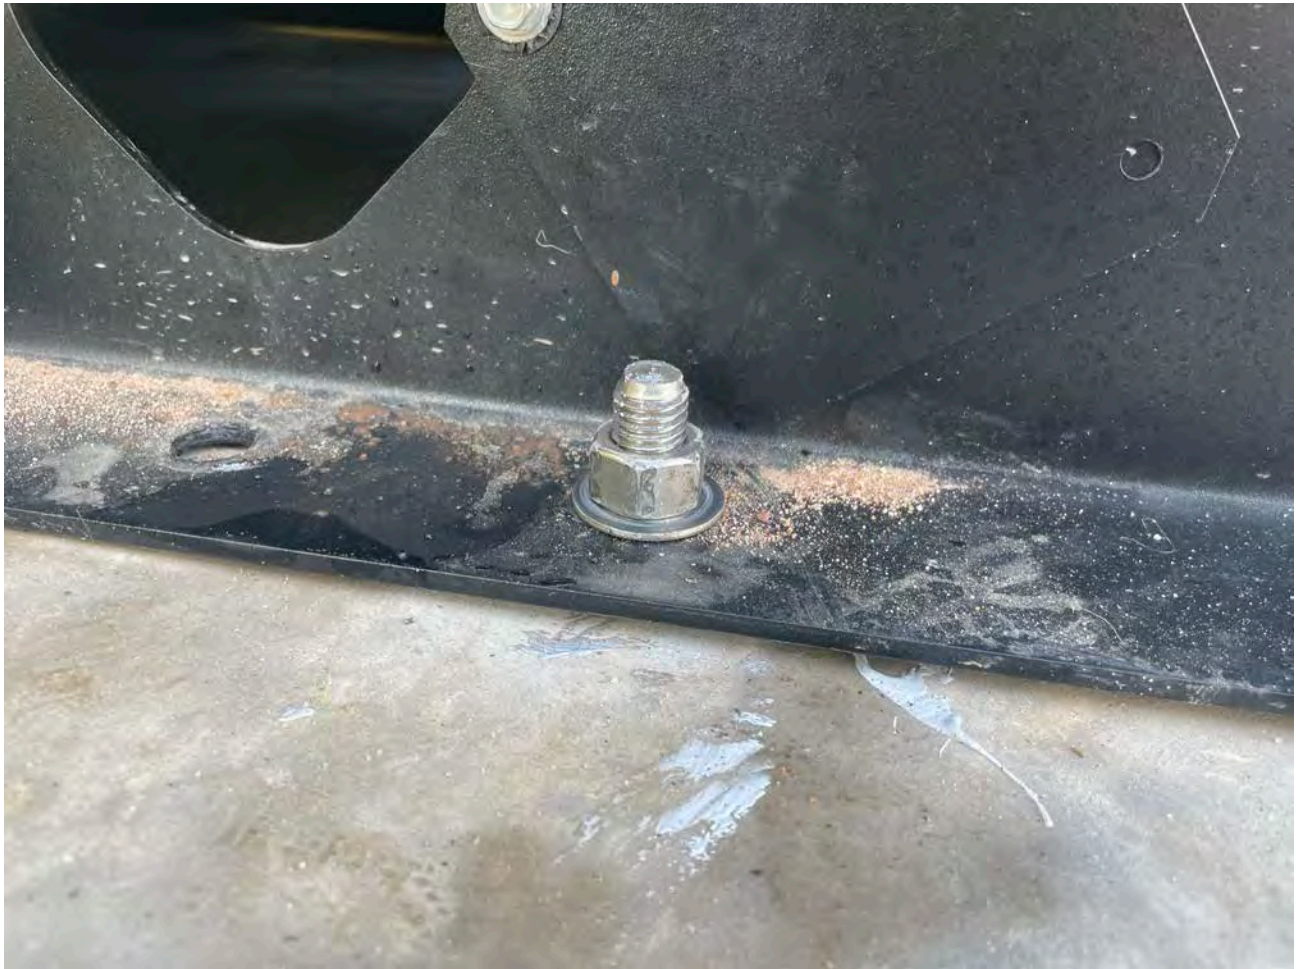
0744: Ludlow has finished setting bolts into the generator pad at the booster station and has bolted the generator to the pad.

Picture 2: Closeup of one of the bolts used to anchor the booster station generator to its concrete pad. View to the southwest.

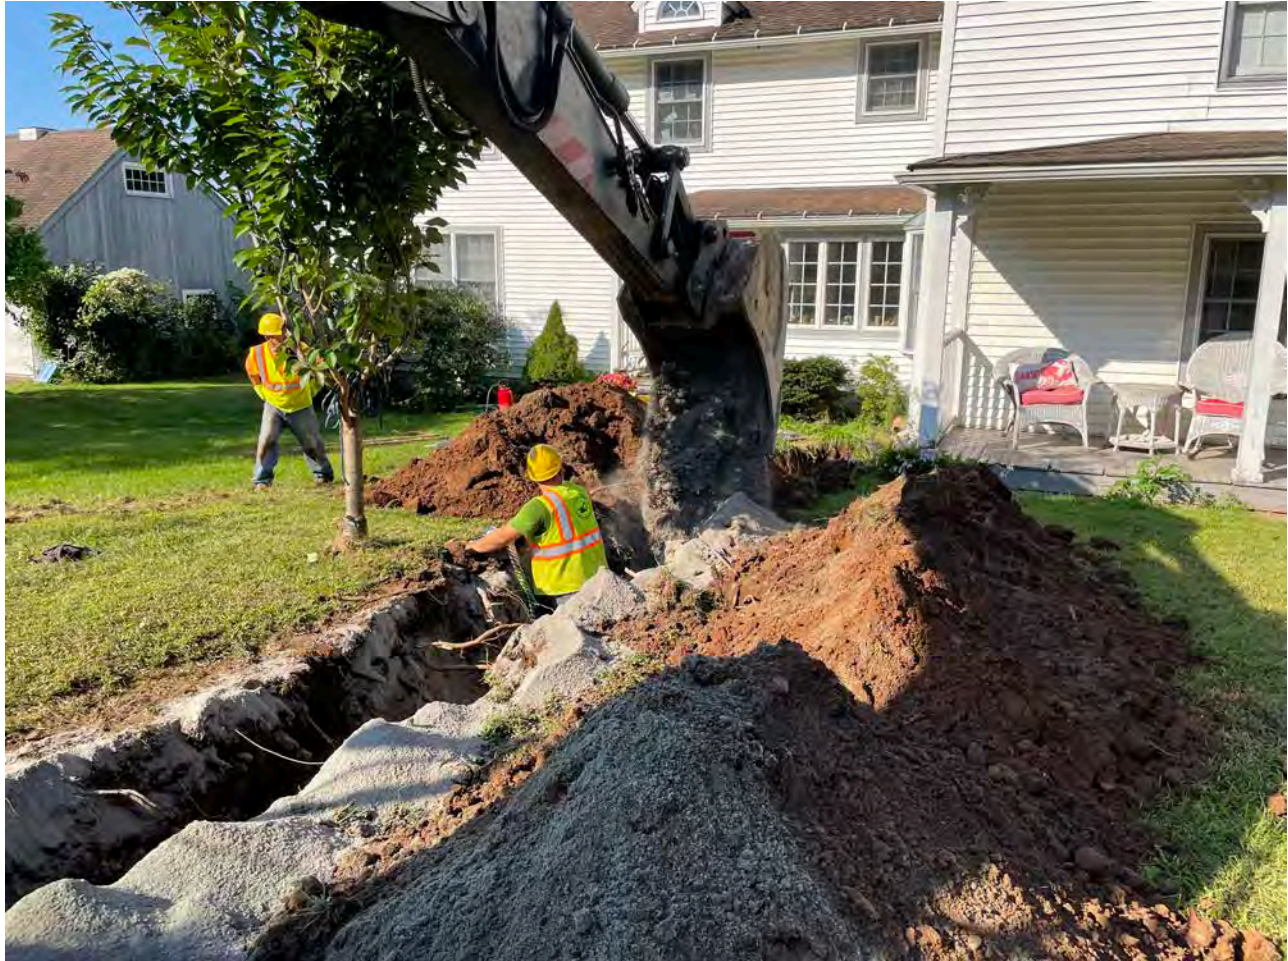
0924: Ludlow is placing sand followed by caution tape over the 1" copper water service line they have placed in the trench they excavated at the 146 Maple Avenue residence.

Picture 3: Ludlow placing sand followed by caution tape over the 1” copper water service line they have placed in the trench they excavated at the 146 Maple Avenue residence.

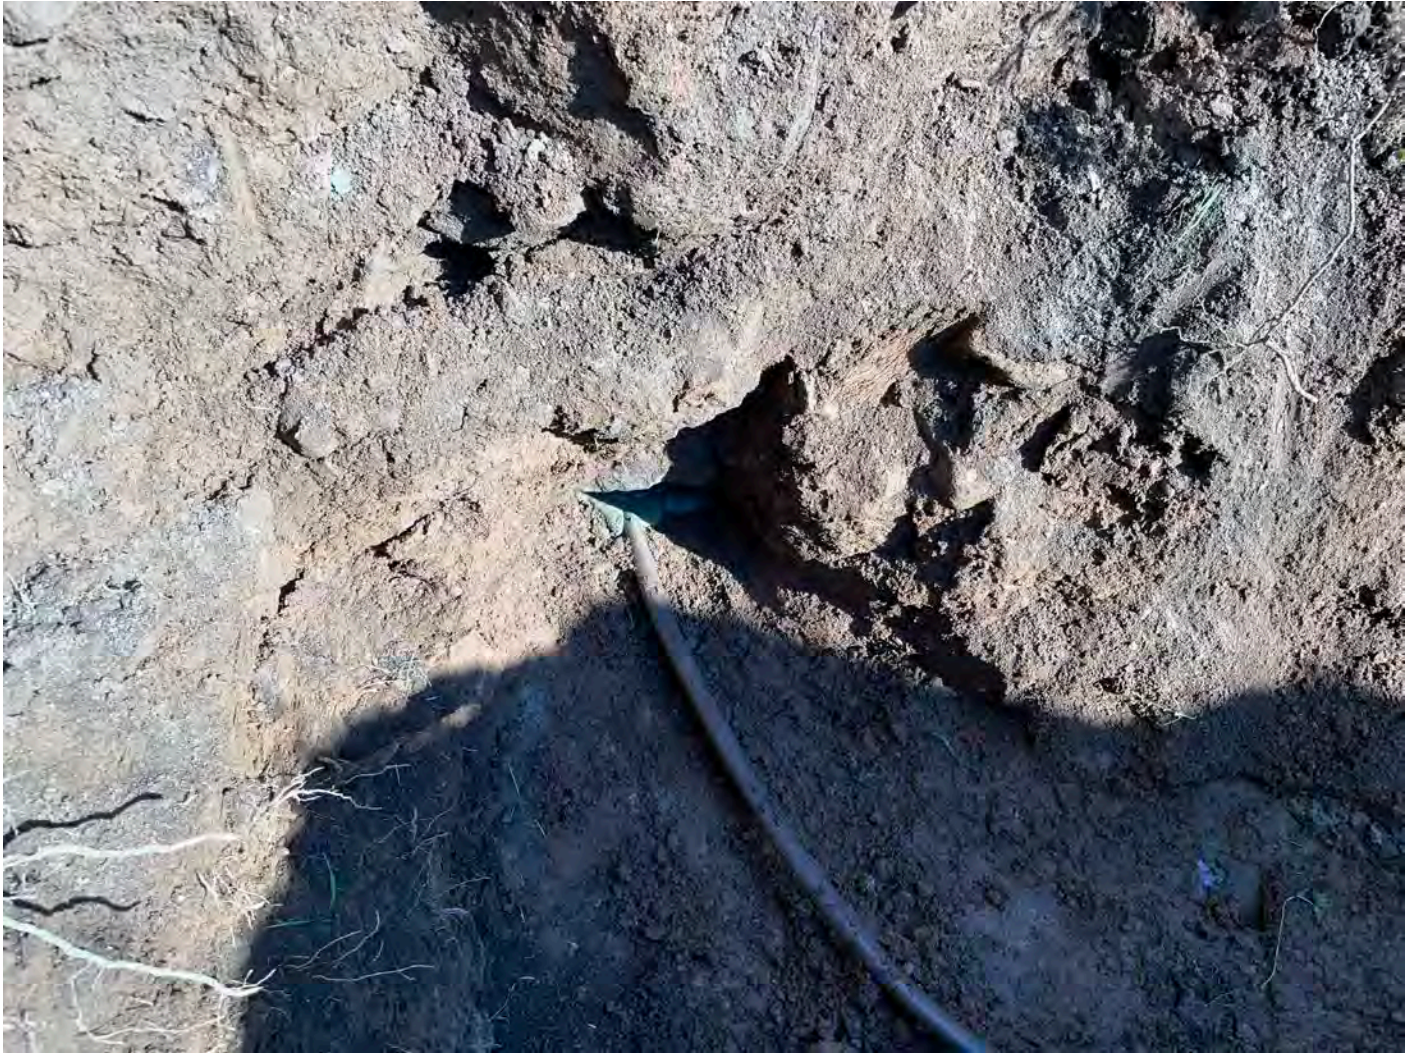
0909: Ludlow has laid out 1" copper water service line at the bottom of the excavation located east of the 146 Maple Avenue residence. The pipe has been inserted into the south side of the home's foundation on the most eastern portion of the house that juts out to the east. The penetration through the field stone foundation was made with a rotary hammer approximately 16" west of the southeast corner of the portion of the house that juts out towards Maple Avenue.

Picture 4: 1" copper water service line penetrating into the south side of the foundation for 146 Maple Avenue, on the most eastern portion of the house that juts out to the east towards Maple Avenue.

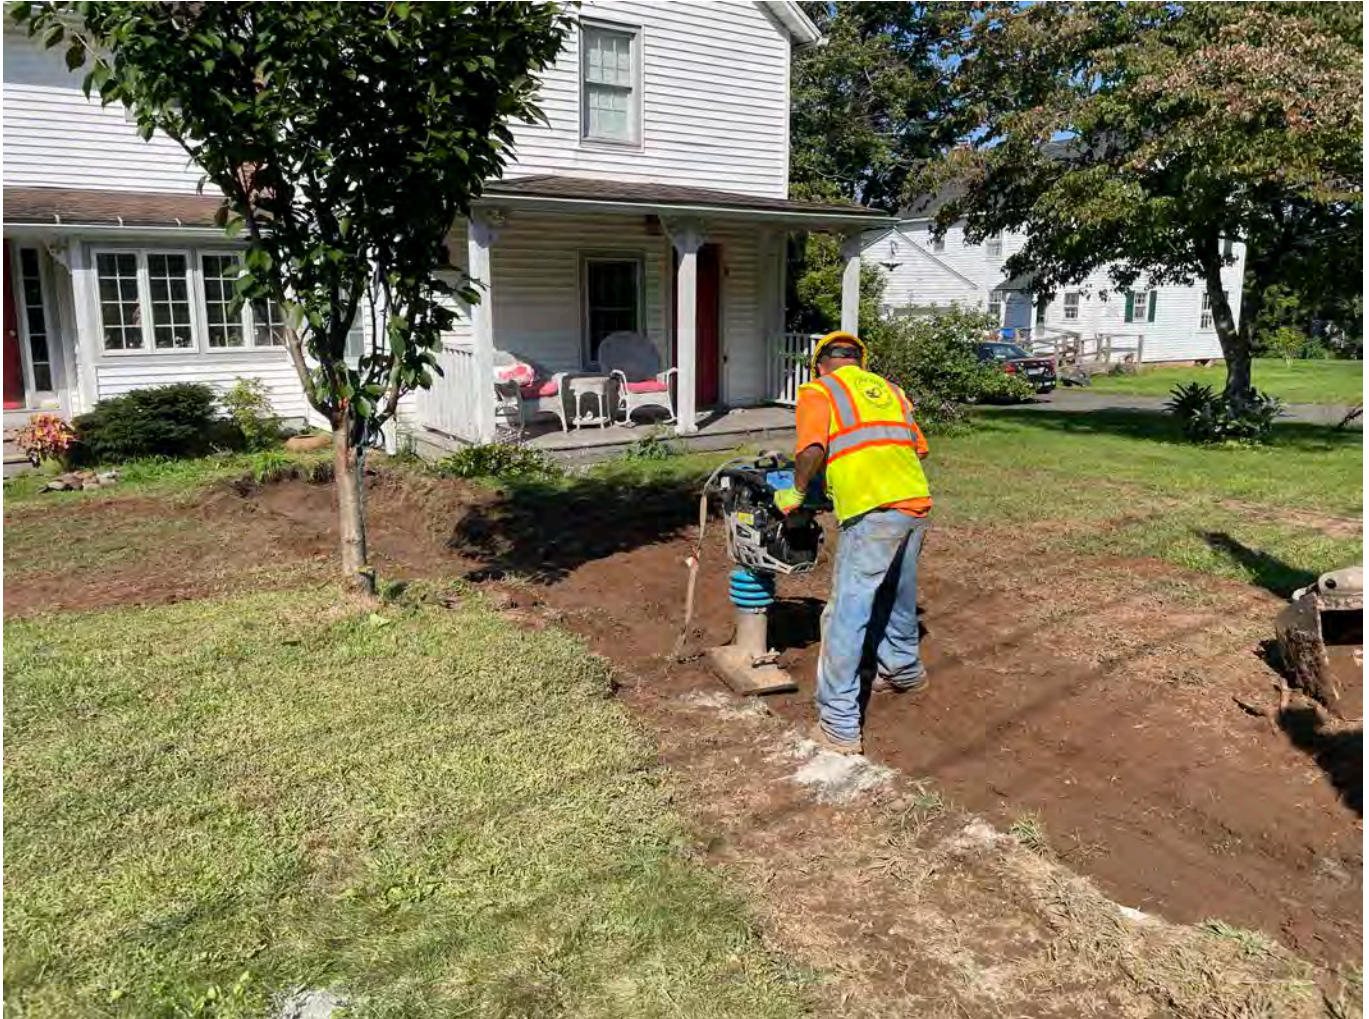
1020: Ludlow continues backfilling the trench they excavated at the 146 Maple Avenue property for the installation of a 1" copper water line .

Picture 5: Ludlow compacting fill that was backfilled over the 1" copper water service line they installed at the 146 Maple Avenue residence. View to the northwest.

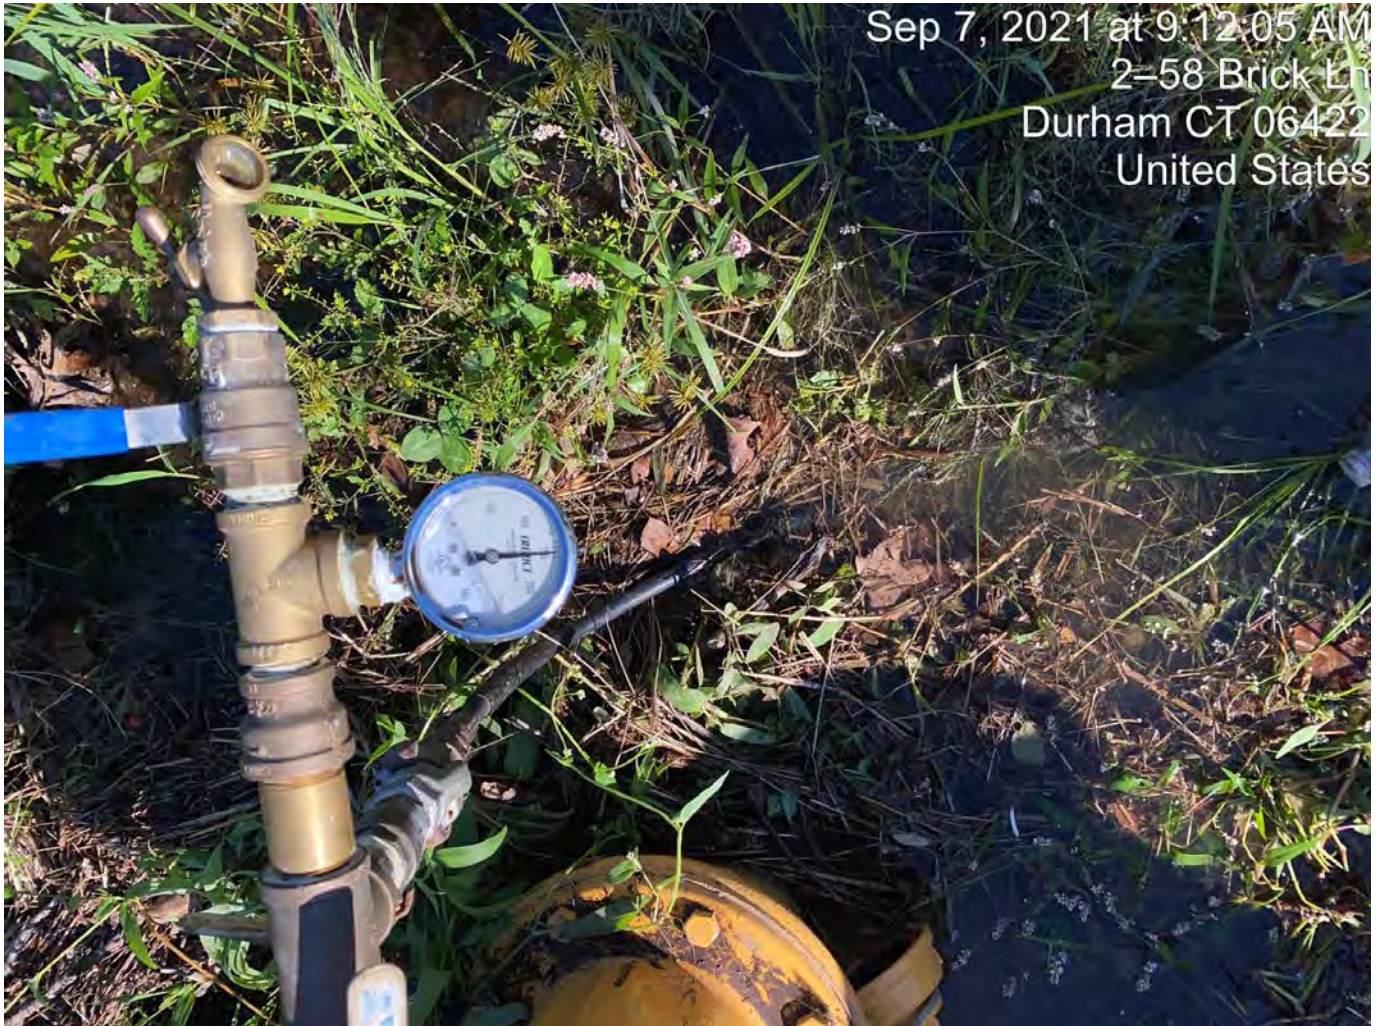
Ludlow pressure tested the 12" DIP they installed as part of the Maiden Lane stream crossing on September 7, 2012. The piping passed the pressure test, which ran from approximately 0910 hours to 1127 hours; during which the piping maintained a pressure of 150 PSI throughout the test.

Picture 6: Starting pressure for the pressure test that Ludlow conducted on September 7, 2012, on the 12" DIP they installed as part of the Maiden Lane stream crossing.

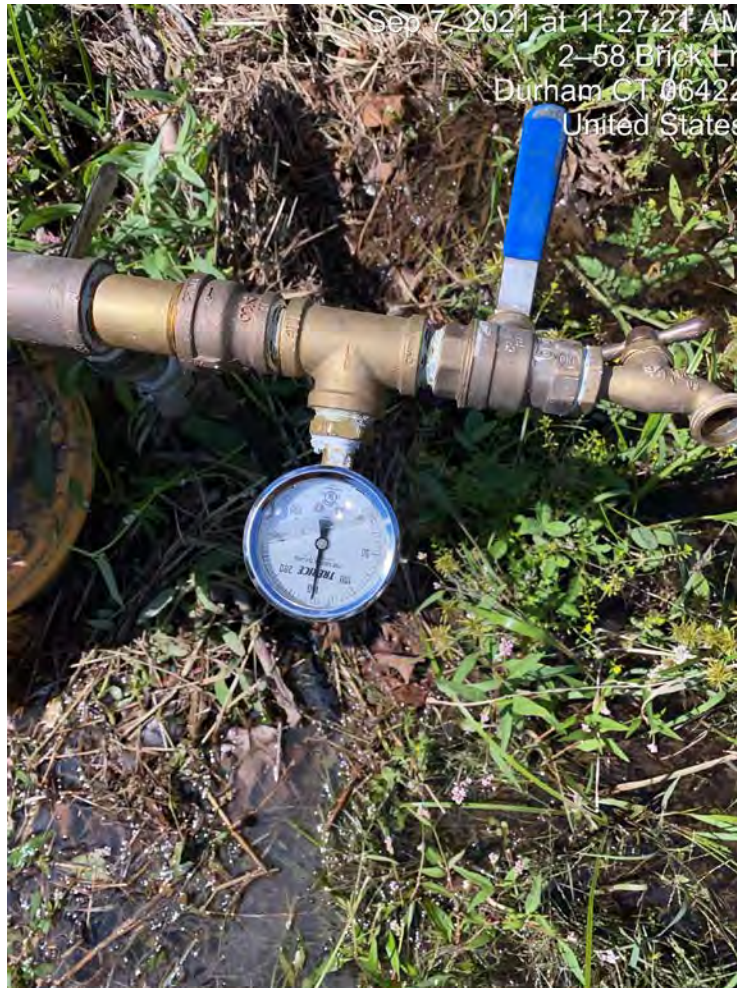
Picture 7: End pressure for the pressure test that Ludlow conducted on September 7, 2012, on the 12" DIP they installed as part of the Maiden Lane stream crossing.

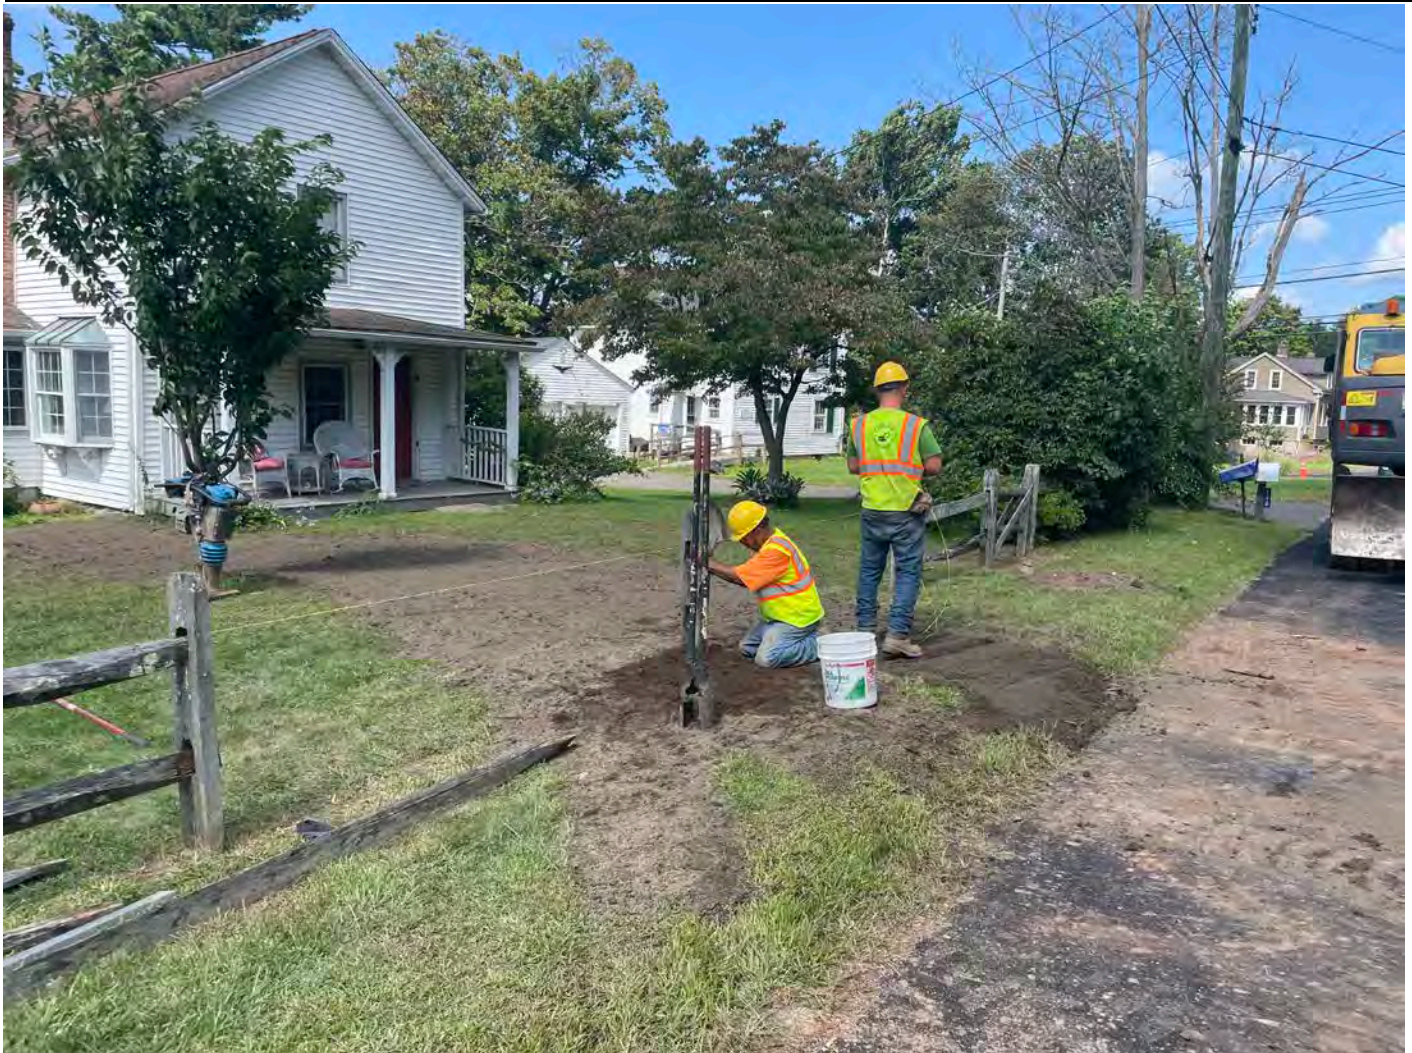
1136: Ludlow is erecting a portion of the split rail fence at the 146 Main Street property after having removed a fence post and the adjoining fence slats when they excavated the trench for the installation of a 1" copper water service line.

Picture 8: Ludlow working on reassembling a portion of the fence they temporarily took down at the 146 Maple Avenue residence after installing a 1" copper water service line. View to the northwest.

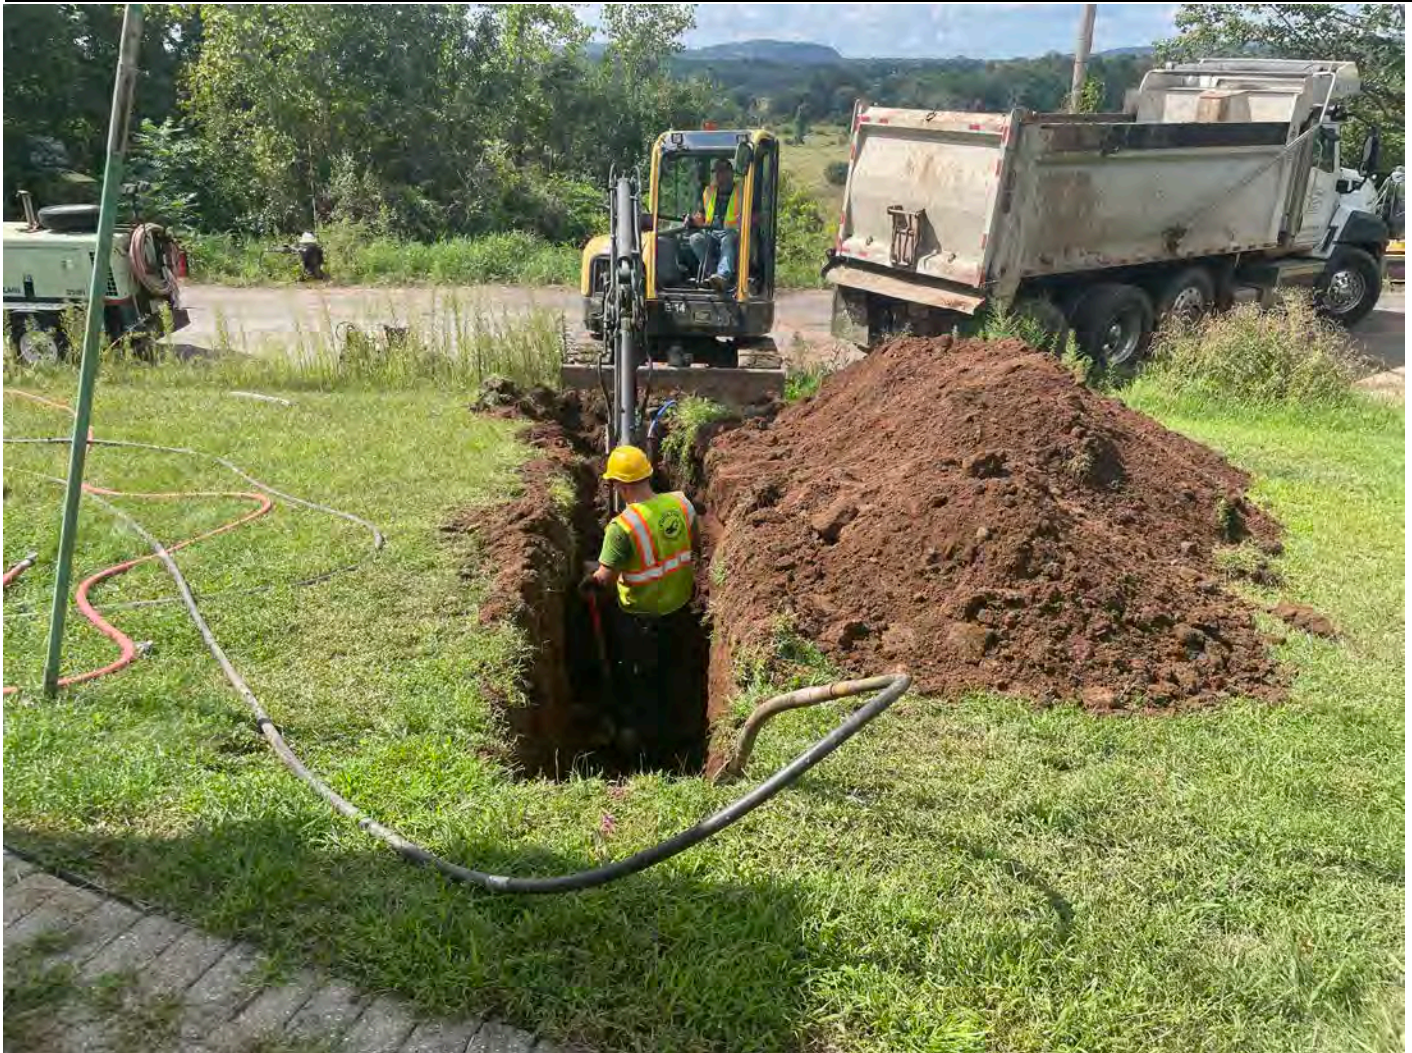
1230: Ludlow has finished the installation of a 1" copper water line at 146 Maple Avenue. Ludlow is currently excavating on the west side of the 133 Maple Avenue residence.

Picture 9: Ludlow excavating at the 133 Maple Avenue property to install a 1" copper water service line. View to the west.

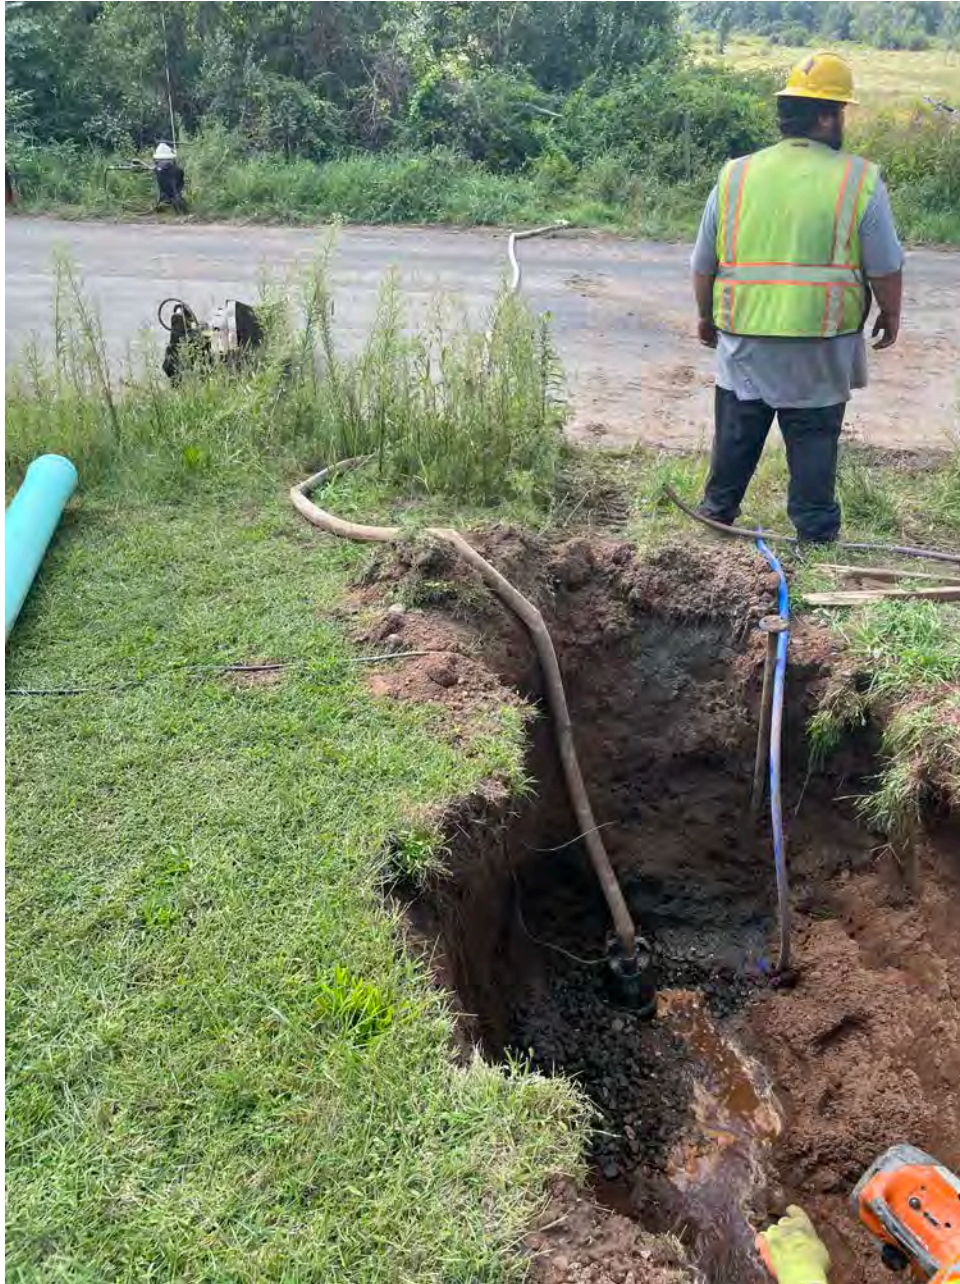
1317: Ludlow is pumping water out of the trench at 133 Maple Avenue. The water is being pumped across the road into the empty lot across the street. Ludlow broke a 6" clay drainage pipe running north west to south east on the west side of the 133 Maple Avenue residence.

Picture 10: Ludlow pumping water from the excavation at the 133 Maple Avenue property as they install a 1" copper water service line. Water is being pumped into the empty lot located across the street to the west of the 133 Maple Avenue property. View to the west.

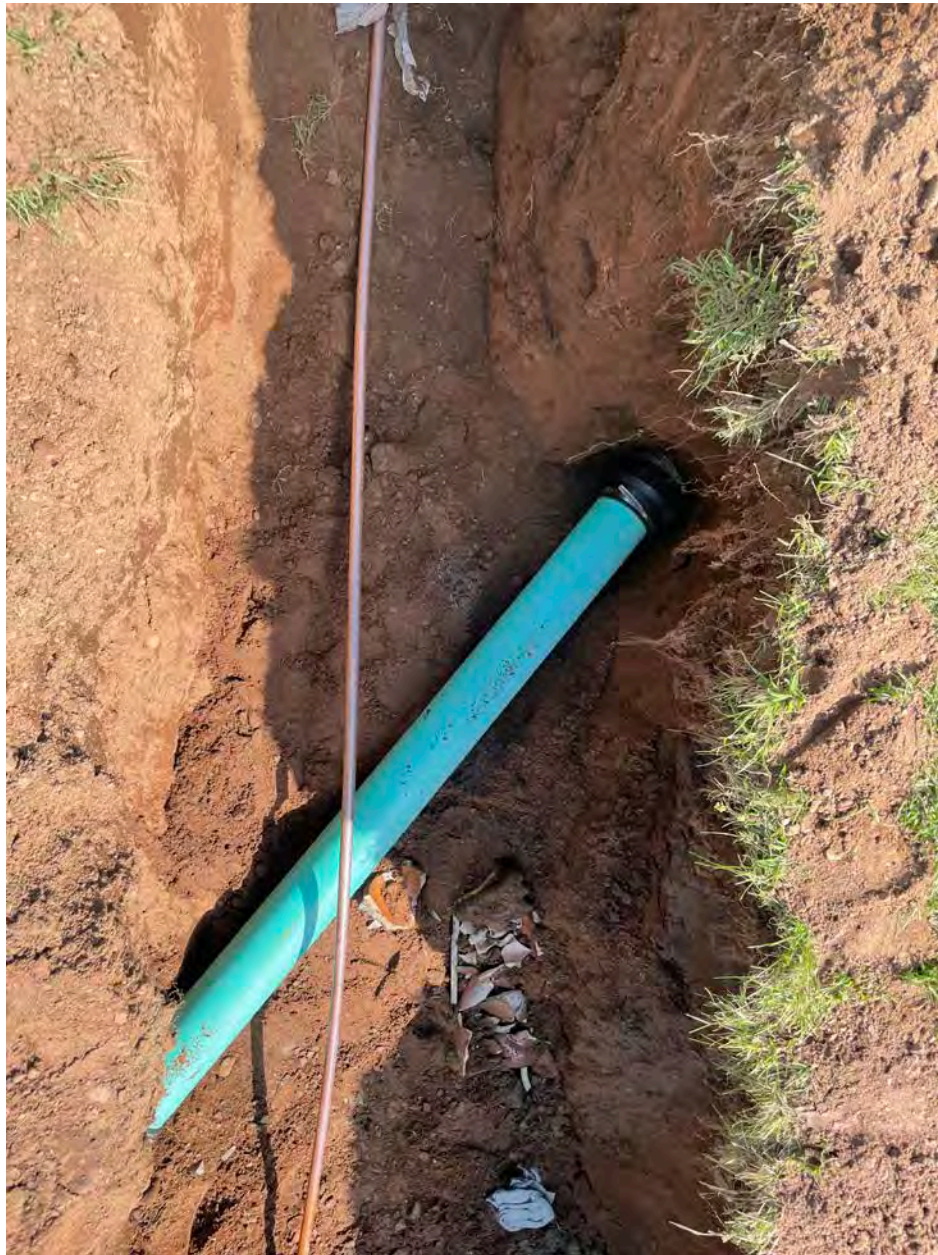
Picture 11: Repair that Ludlow made to a 6" clay drainage line at the 133 Maple Avenue property.

1325: Ludlow is preparing to fix the 6" clay drain they broke on the side of the 133 Maple Avenue residence using 6" PVC and two Fernco boots.

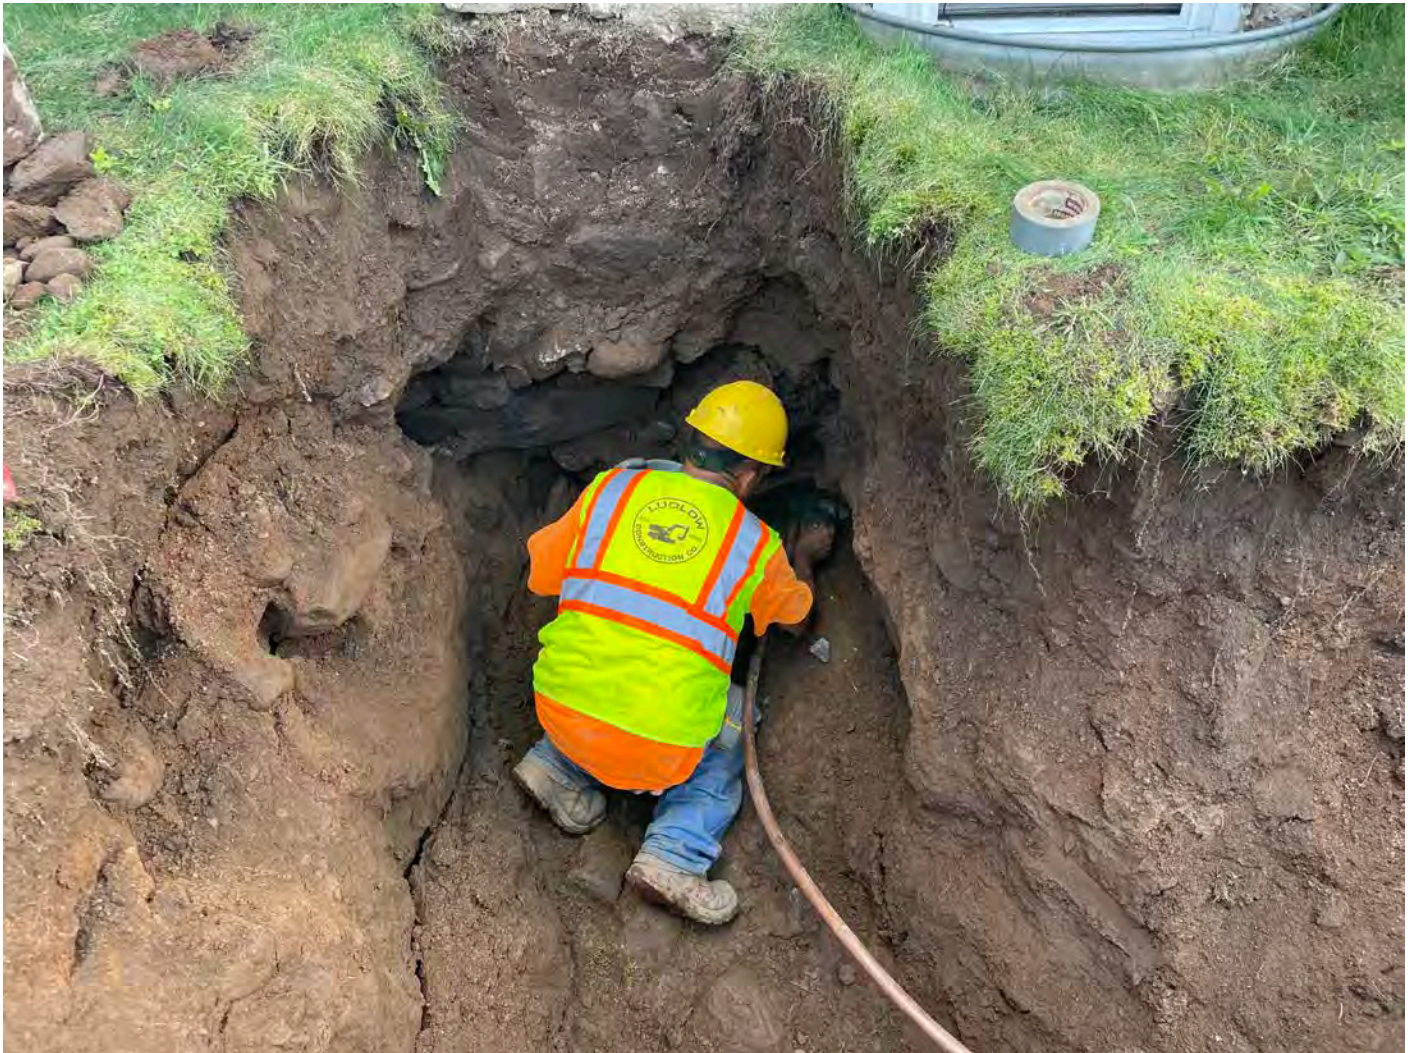
1354: Ludlow has installed 1" copper water service pipe through the penetration they made on the northern foundation of the 133 Maple Avenue residence. Ludlow is currently securing the pipe in place with non-shrink grout.

Picture 12: Ludlow securing 1" copper water service line with non-shrink grout on the north side of the 133 Maple Avenue residence. View to the south.

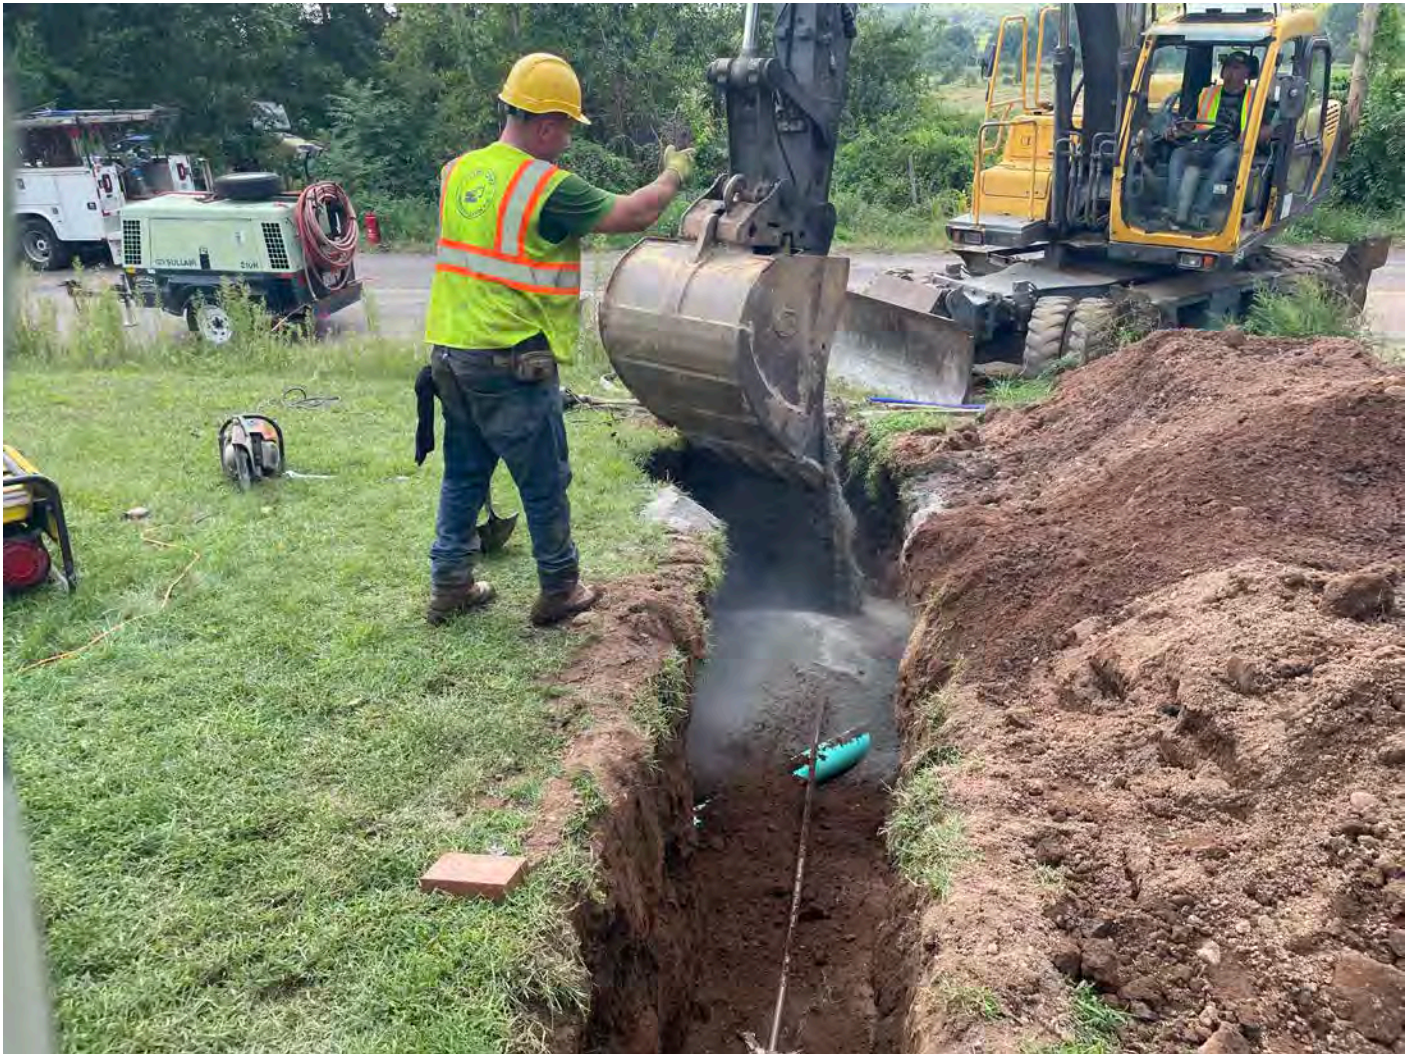
1457: Ludlow begins to place 6" of sand on top of the 1" copper water service line they just installed at 133 Maple Avenue.

Picture 13: Ludlow placing sand over the 1" copper water service line they installed at the 133 Maple Avenue property. View to the west.
