#### **Daily Report**

Project:Durham Meadows Pipeline InstallationDate:September 13, 2021Location:Wallingford Road, DurhamDay of Week:Monday

**Project #:** AECOM: 6061487 **Report No:** 321

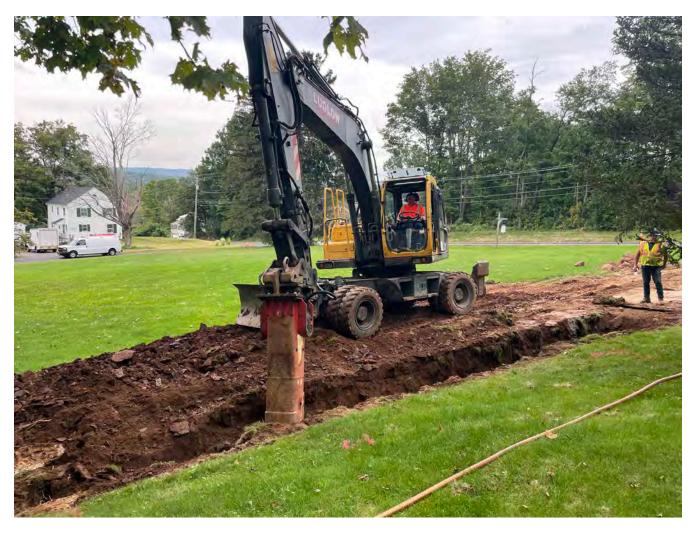
Picture 1: Ludlow breaking up rock as they continue to excavate a trench at the 22 Wallingford Road, Durham, residence for the installation of a 1.5" copper water service line. View to the northwest.

0736: Ludlow is hammering rock in the trench they are excavating at the 22 Wallingford Road property for the installation of a 1.5" copper water service line.

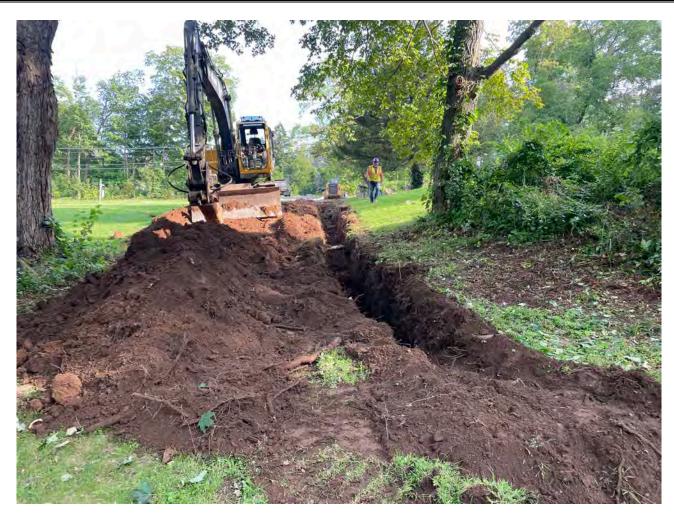
Picture 2: View of the trench that Ludlow is excavating at the 22 Wallingford Road, Durham, residence for the installation of a 1.5" copper water service line. View to the north.

0834: Ludlow continues to excavate a trench at the 22 Wallingford Rod property for the installation of a 1.5" copper water service line.

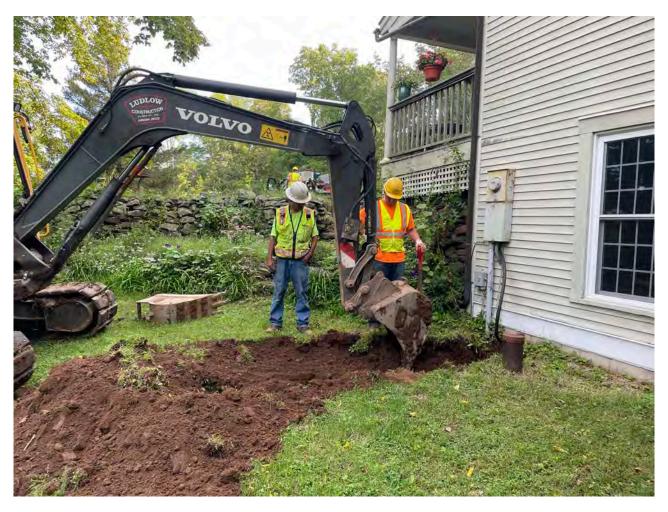
Picture 3: Ludlow excavating a trench on the west side of the residence located at 22 Wallingford Road for the installation of a 1.5" copper water service line. View to the northeast.

0907: Ludlow has begun excavating on the west side of the 22 Wallingford Road residence, immediately north and proximal to the residence's well. While excavating for the placement of 1.5" copper pipe, Ludlow severs three 4" white PVC drain lines. Ludlow will repair the lines with 4" PVC and Fernco boots.

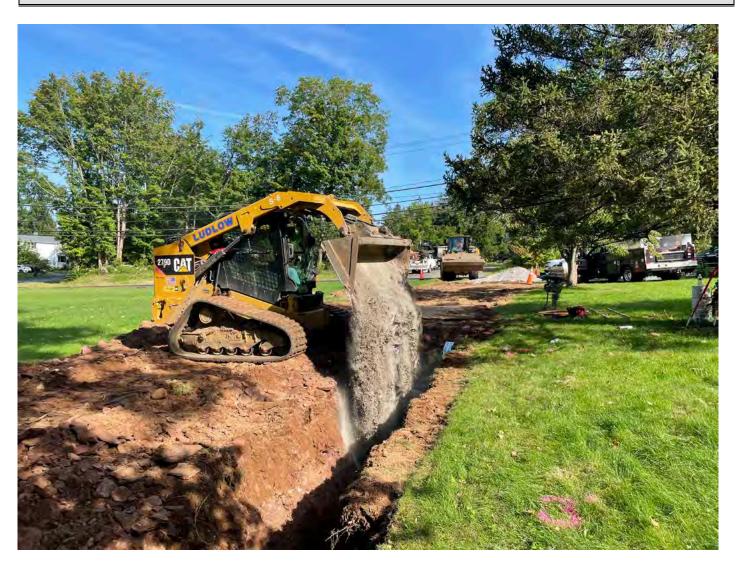
Picture 4: Ludlow placing sand over the 1.5" copper water service line they are installing at the 22 Wallingford Road, Durham, residence. View to the north.

1030: Ludlow continues to backfill over the 1.5" copper water service line they have installed at the 22 Wallingford Road property.

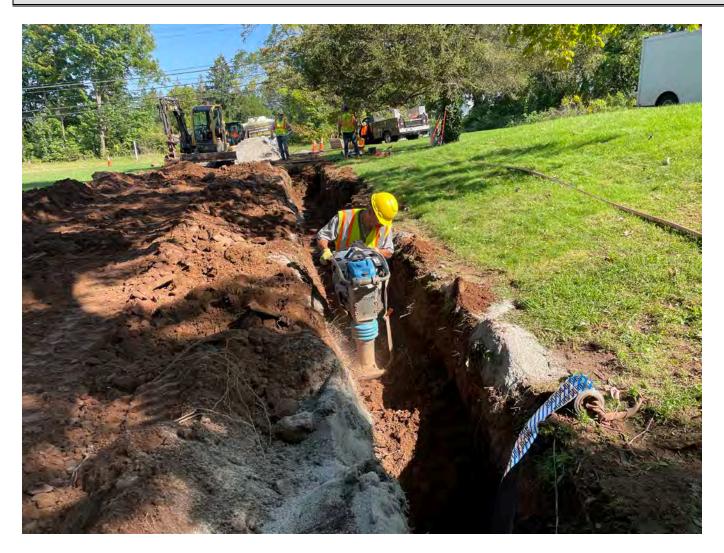
Picture 5: Ludlow compacting native fill that they placed over the sand and caution tape they placed over the 1.5" copper water service line they installed at the 22 Wallingford Road property. View to the north.

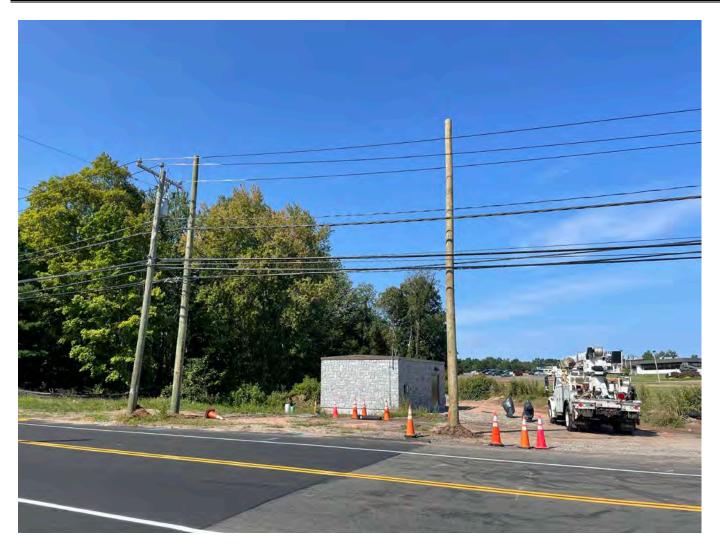
Picture 6: Two poles that Frontier installed today at the booster station. View to the west.

1046: Frontier has installed two telephone poles at the booster station located at Station 750+63 on S. Main Street.

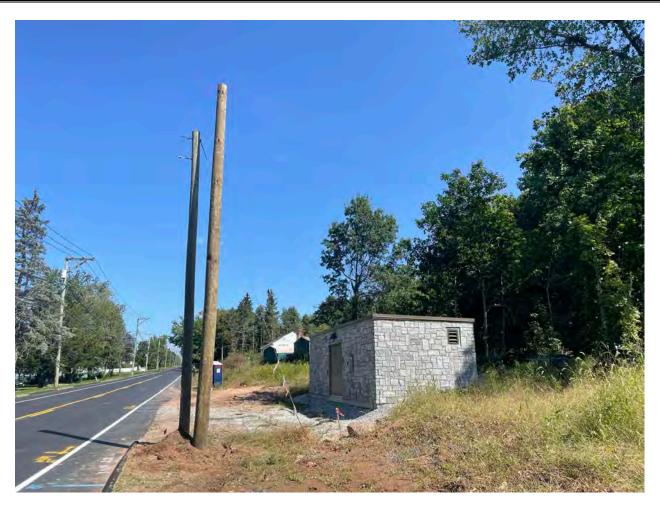
Picture 7: One pole that Frontier installed today at the water meter building. View to the north.

1223: Frontier has installed one telephone pole at the water meter building located at Station ~124+80.

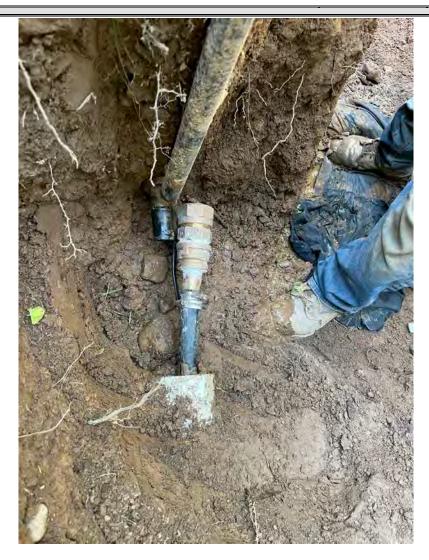
Picture 8: Brass fitting that Ludlow connected to the 1" HDPE well water line that penetrates the western foundation of the 22 Wallingford Road property in Durham. Ludlow ended up connecting the 1.5" copper water service line to the compression fitting located on the opposite end of the brass fitting.

1202: Ludlow has cut the 1" HDPE water line that runs from the drinking water well for the 22 Wallingford Road residence and passes through the west side of the home's foundation. Ludlow is connecting a threaded brass fitting to the section of the 1" HDPE line that penetrates the home's western foundation. The other side of the brass fitting is connected to a compression fitting that will connect to the 1.5" copper waterline that Ludlow is installing.

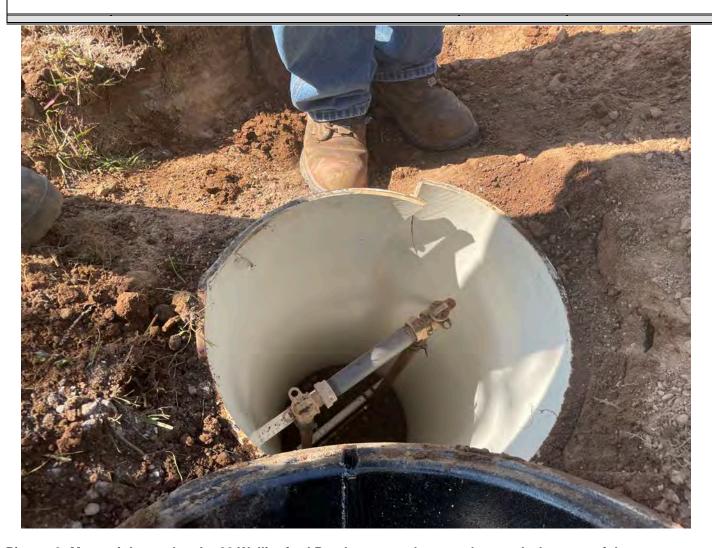
1426: One of Ludlow's dump trucks backs over the meter pit at the 22 Wallingford Road property, cracking the PVC casing. AECOM informs Ludlow's QC officer.

Picture 9: Meter pit located at the 22 Wallingford Road property that was damaged when one of the construction trucks backed over it.

1505: AECOM informs the USACE field representative of the incident at 22 Wallingford Road where Ludlow damaged the meter pit they just installed.

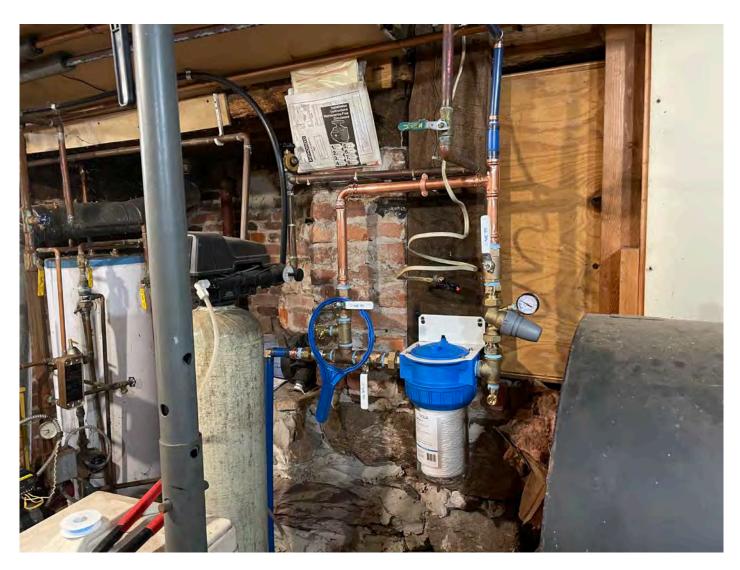
Picture 11: Final water service components that Fazzino Plumbing installed today at the residence located at 22 Wallingford Road, Durham.

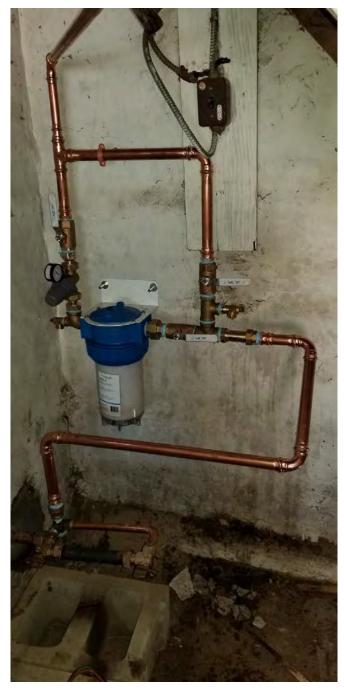
Picture 12: Final water service components that Fazzino Plumbing installed today at the residence located at 47 Wallingford Road, Durham.
