Daily Report

Project:	Durham Meadows Pipeline Installation	Date:	September 21, 2021
Location:	Main Street, Durham; S. Main Street, Middletown	Day of Week:	Tuesday
Project #:	AECOM: 6061487	Report No:	327
Contractor:	Ludlow Construction	Page:	1 of 15

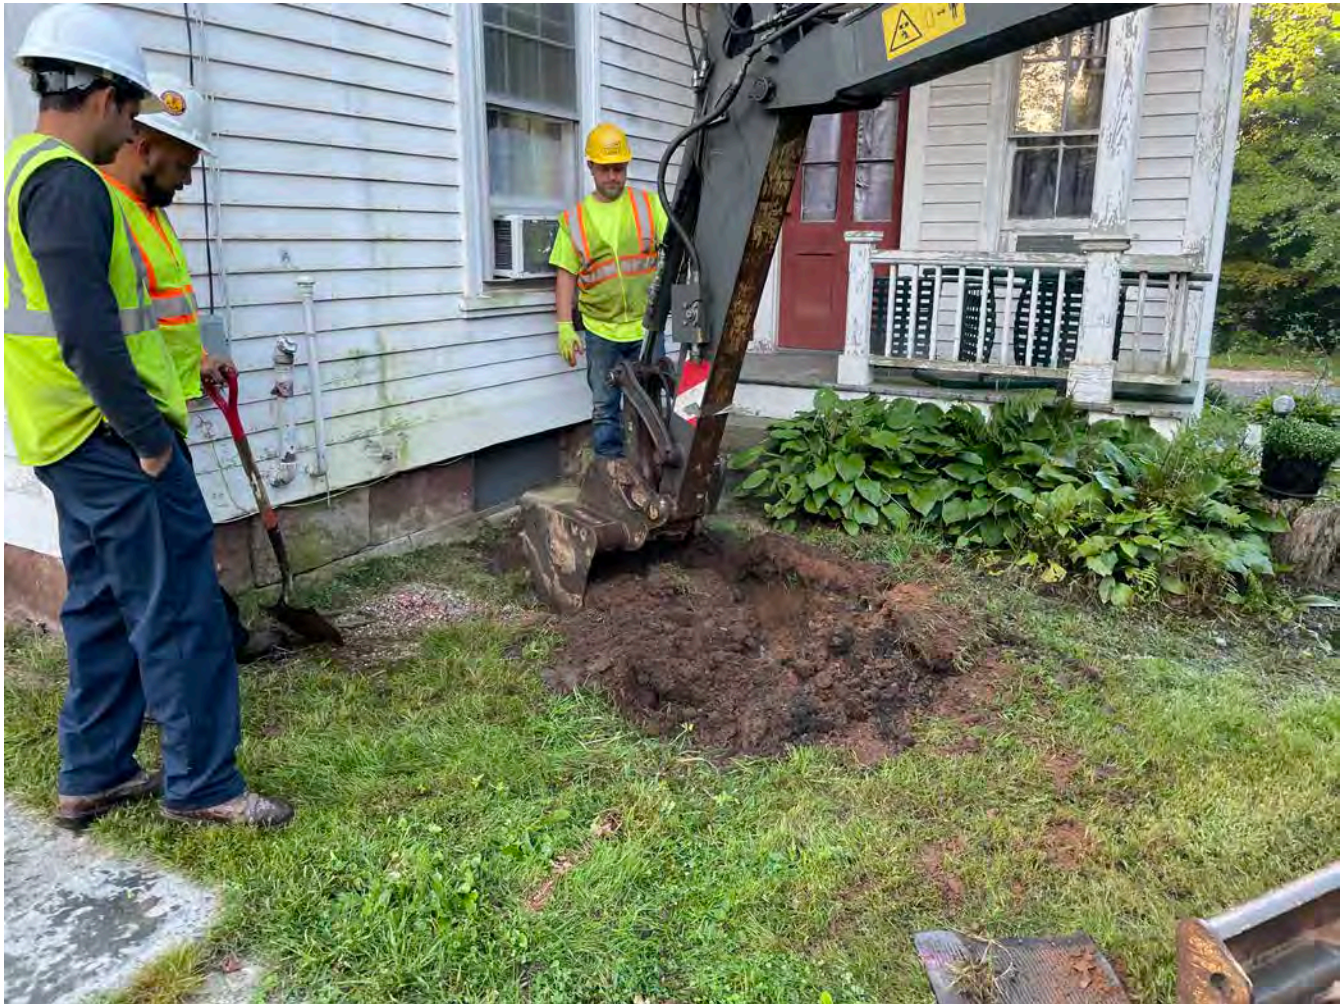
Picture 1: Ludlow beginning to excavate at the northeast corner of the 298 Main Street, Durham, residence on the north side of the home. View to the southwest.

0731: Ludlow begins to excavate on the northeast corner of the 298 Main Street residence for the installation of a 1" copper water service line. Ludlow is currently daylighting the north side of the home's foundation approximately 5' feet west of the northeast corner of the main section of the house (the wing of the house that juts out to the east).

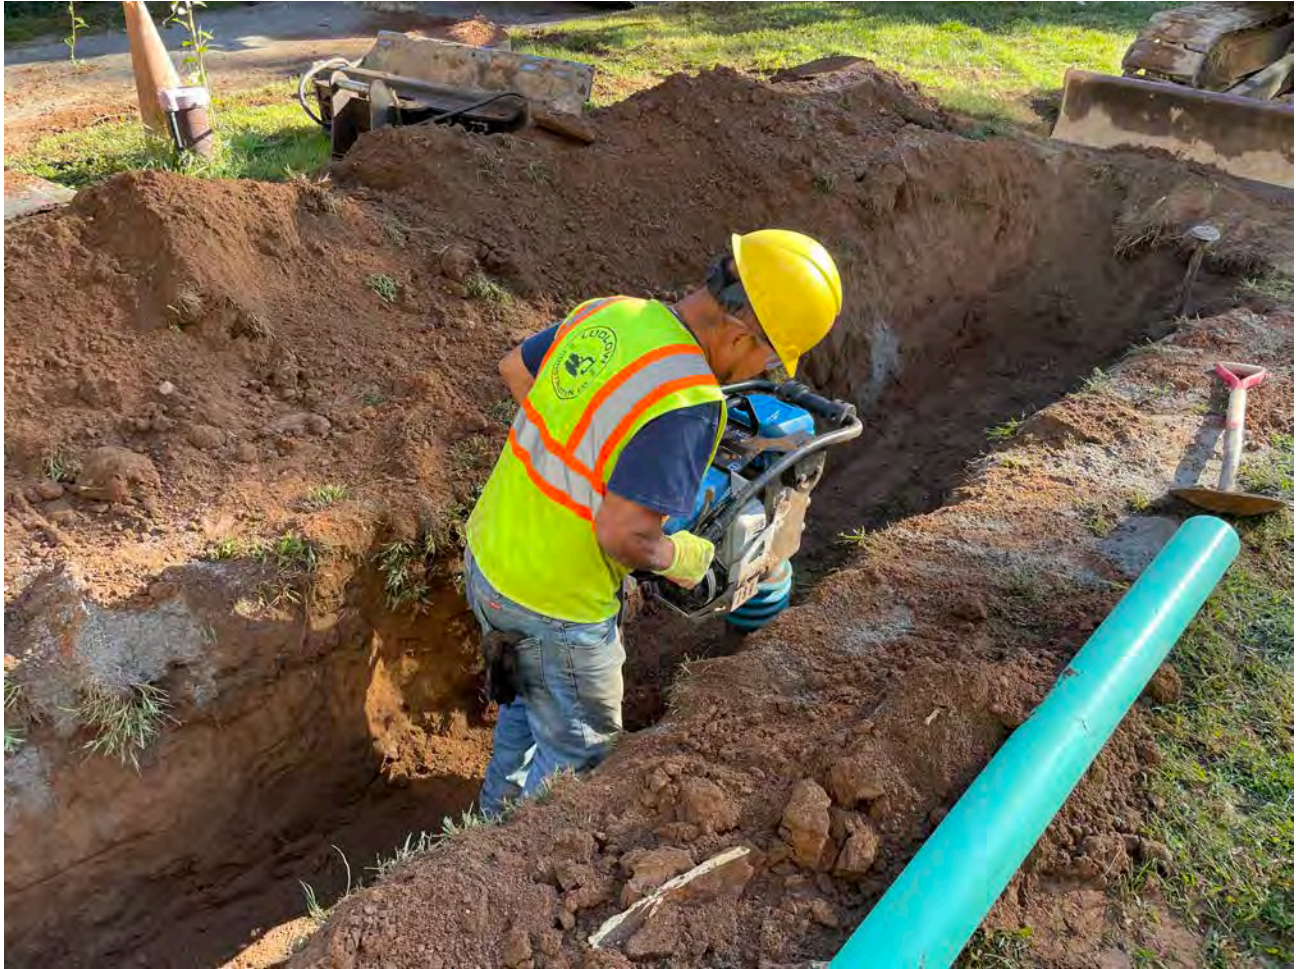
Picture 2: Ludlow compacting backfill with a jumping jack in the trench they excavated for the installation of a 1" copper water service line at the 298 Main Street residence. View to the southwest.

0906: Ludlow is repairing a 4" clay drain line at the 298 Main Street residence that they broke during the installation of a 1" copper water service line. Ludlow is using 4" PVC and two Fernco boots to make the repair. Ludlow is backfilling over the 1" copper water service line, placing fill in 1' lifts and compacting it with a jumping jack.

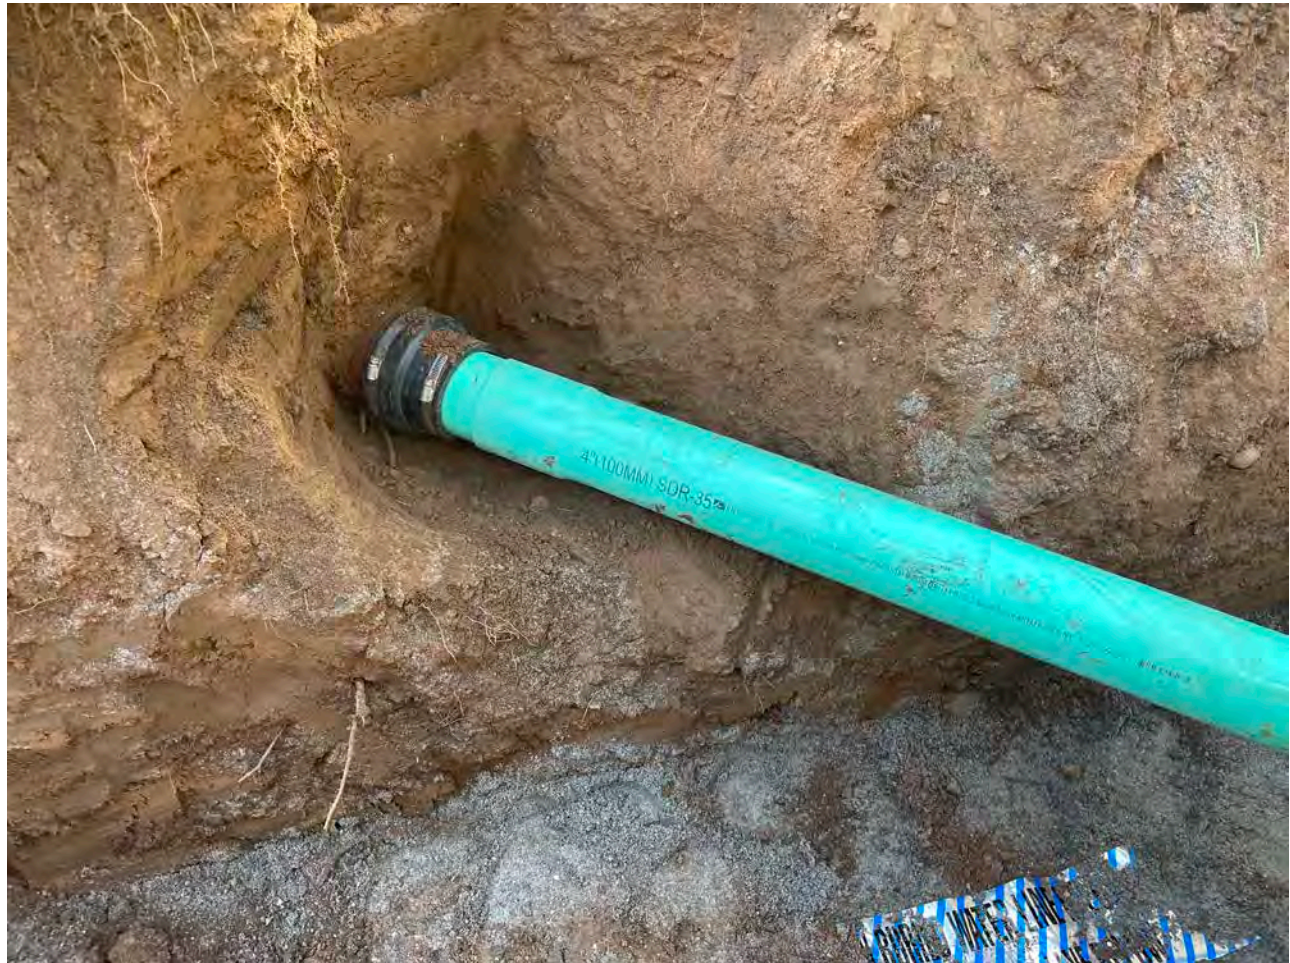
Picture 3: 4" PVC and Fernco boot used to repair a clay drain line that was broken during the installation of a 1" copper water service line at the 298 Main Street residence.

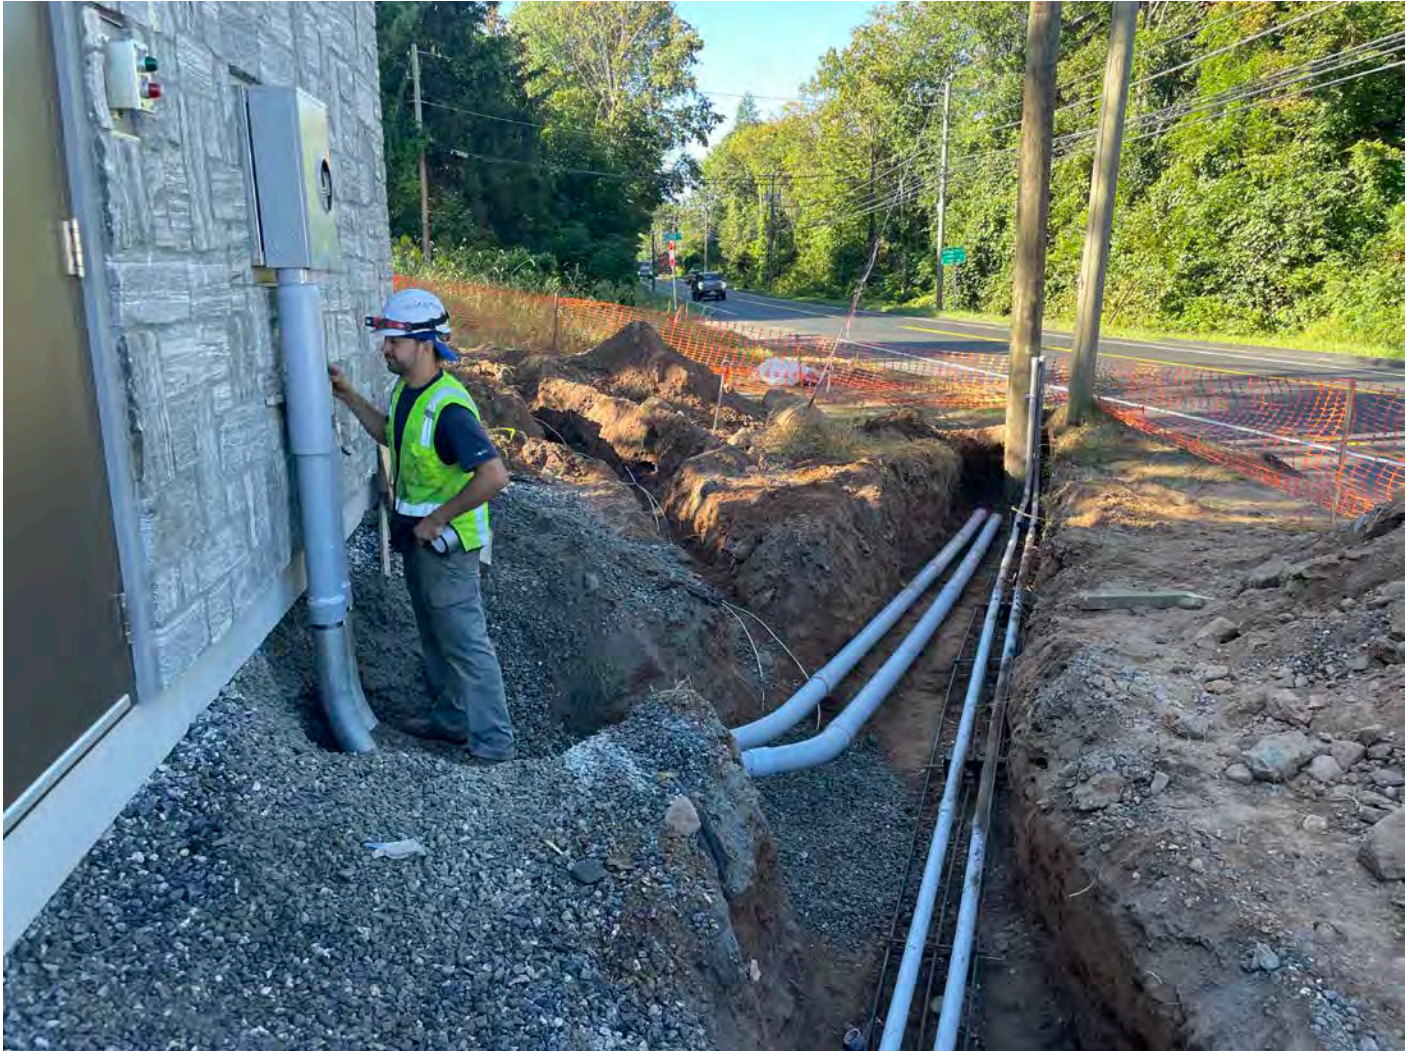
Picture 4: A&R Electrical installing conduits at the meter station building located at Station 124+80 S. Main St. Middletown. View to the southwest.

A&R Electrical installed conduits at the water meter building coming off one of the recently installed poles at the water meter building located at Station 124+80. Ludlow directed the placement of 4000 PSI concrete encasement over the conduits.

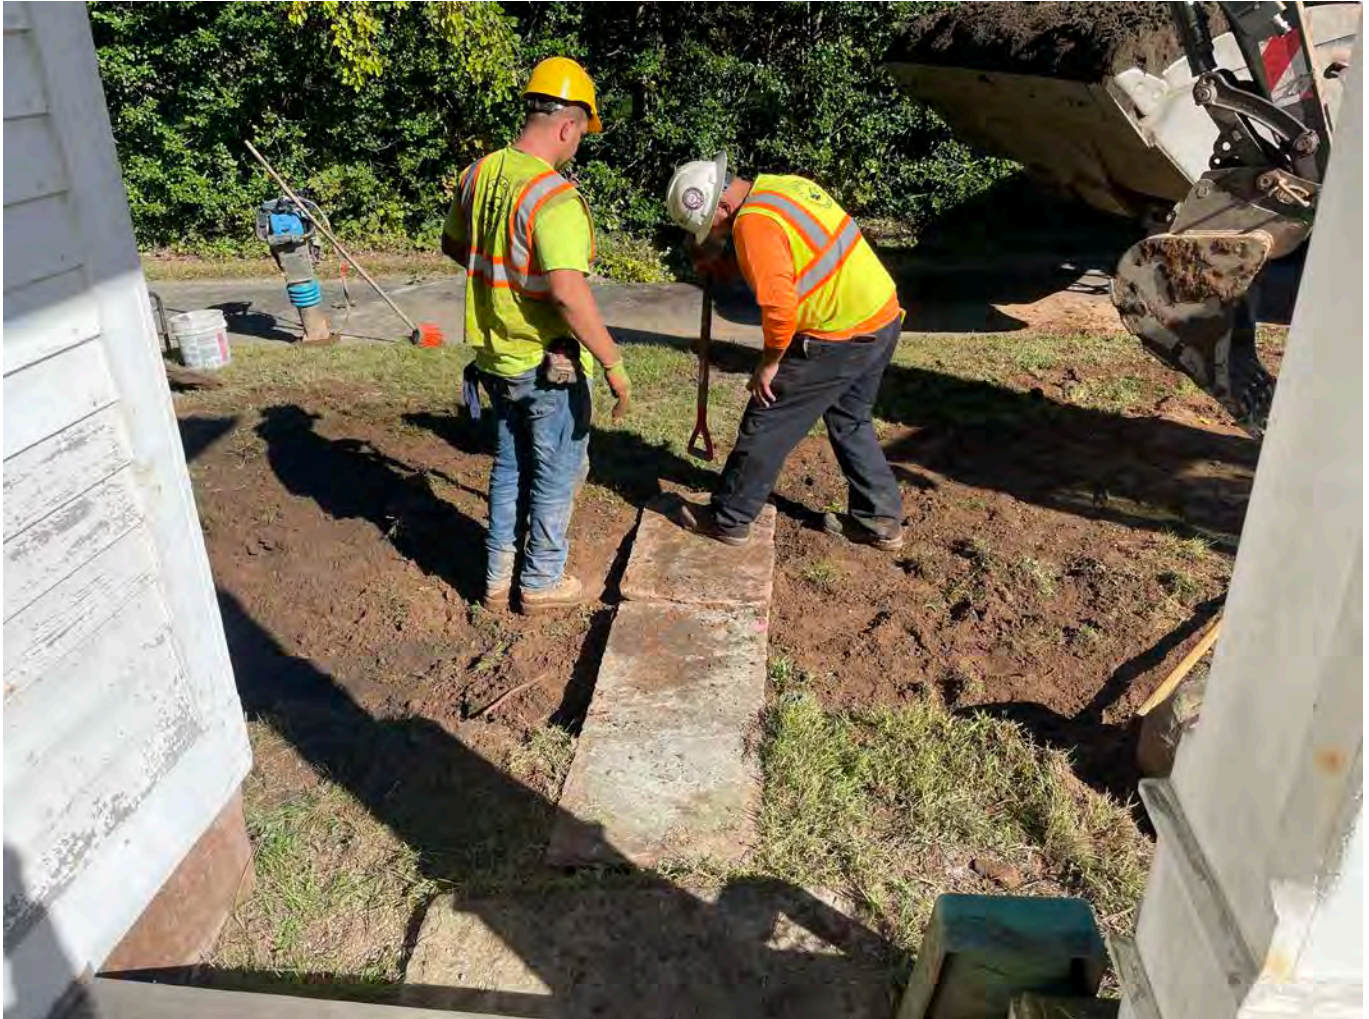
Picture 5: Ludlow replacing pavers for the walkway at the 298 Main Street residence after the installation of a 1" copper water service line. View to the north.

0949: Ludlow is placing pavers at the 298 Main Street residence. Ludlow is also finishing up with backfilling the trench they excavated for the installation of a 1" copper water service line.

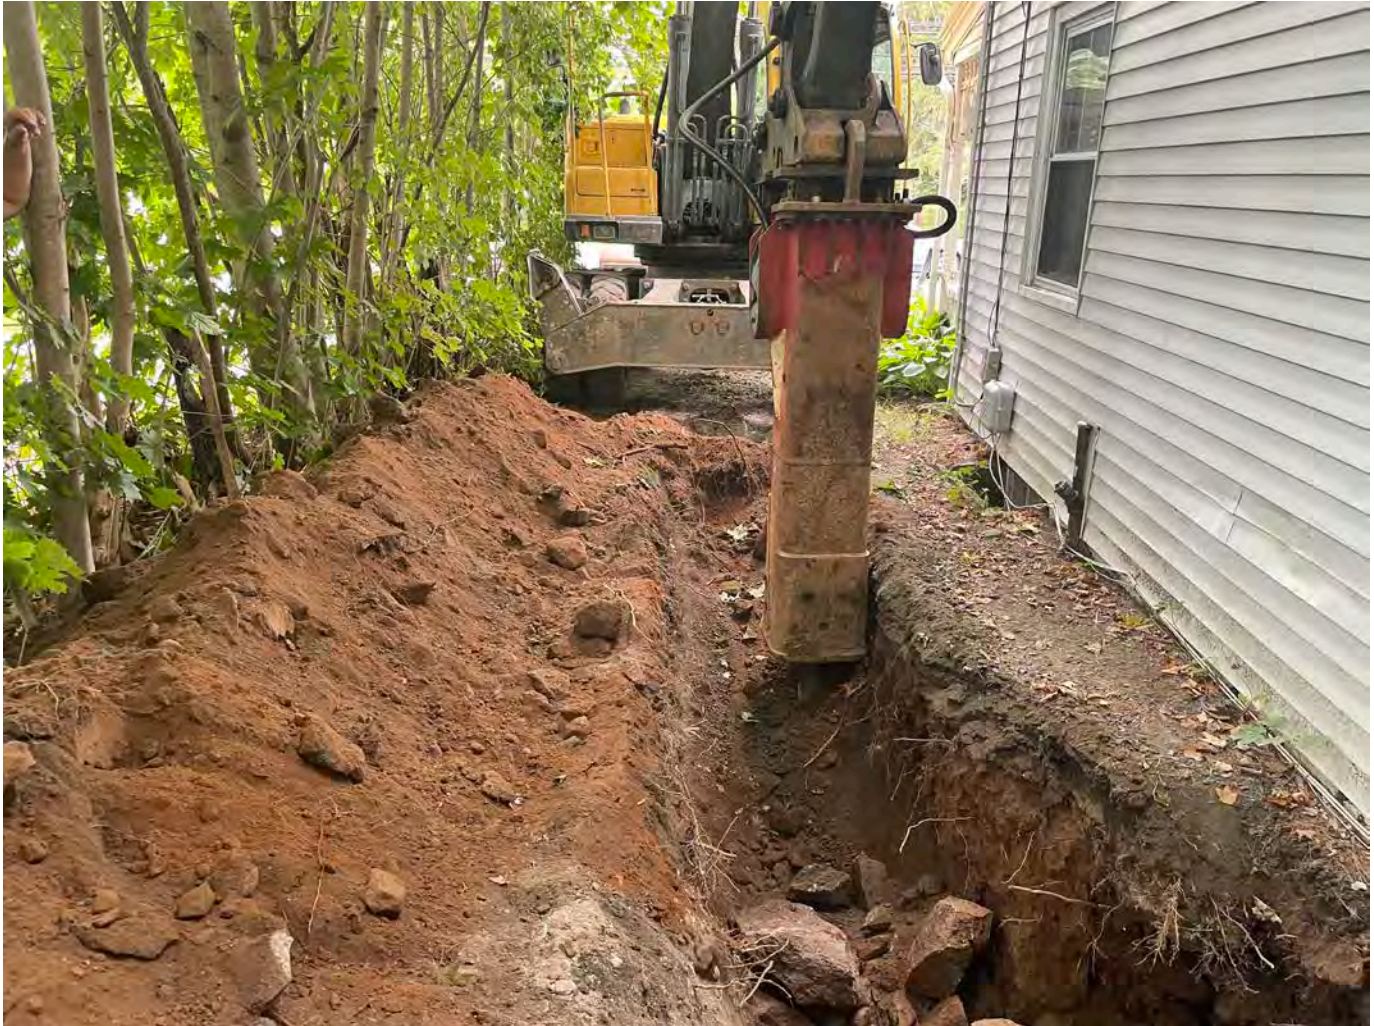
Picture 6: Ludlow using a hammer to break up bedrock they encountered when excavating a trench on the north side of the 312 Main Street residence for the installation of a 1” copper water service line. View to the east.

1154: Ludlow is hammering rock that they've encountered while excavating at the 312 Main Street property for the installation of a 1" copper water service line.

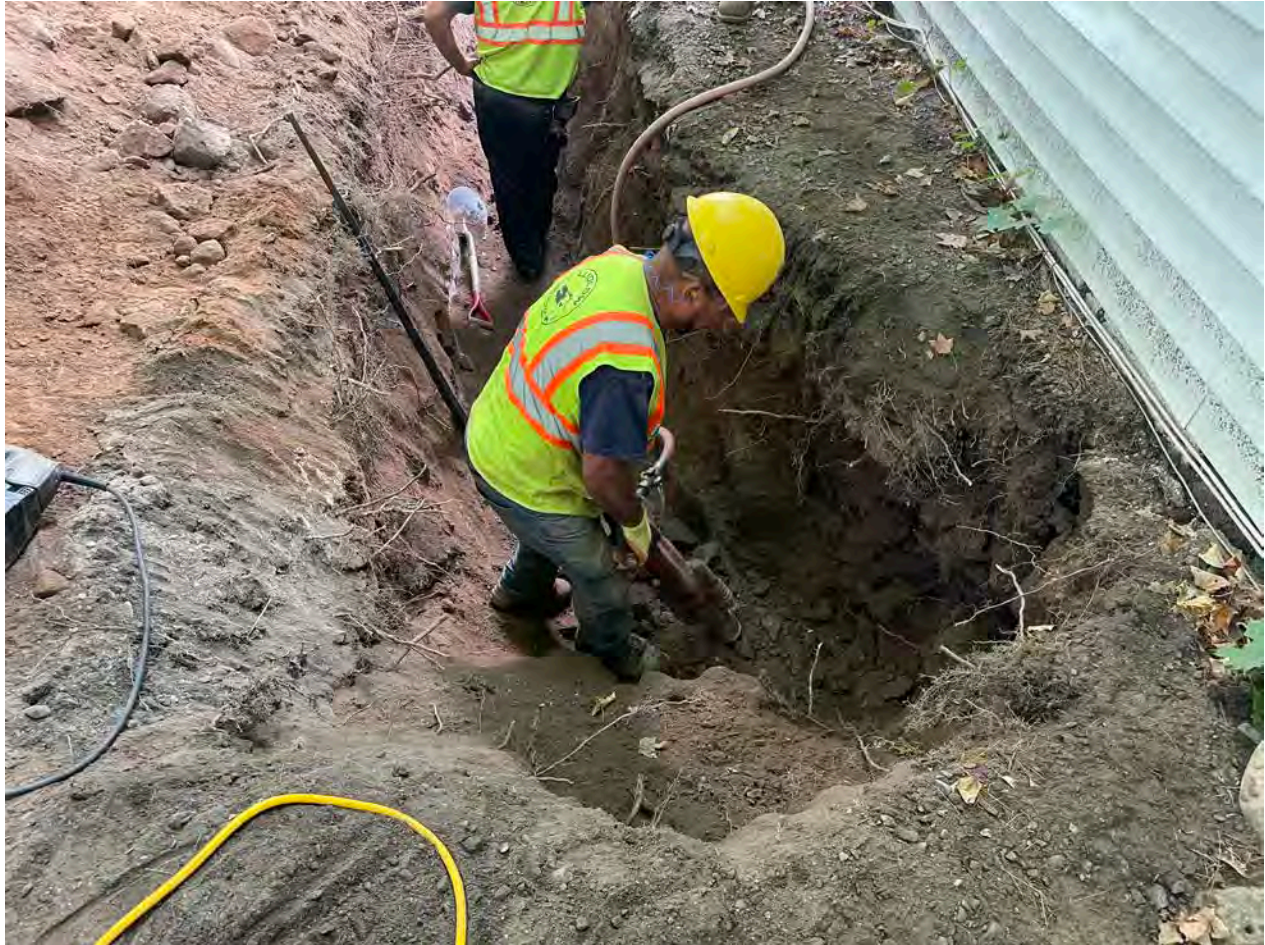
Picture 7: Ludlow using a jackhammer to break up bedrock they encountered when excavating a trench on the north side of the 312 Main Street residence for the installation of a 1" copper water service line. View to the east.

1229: Ludlow continues to break up rock they've encountered in the trench they are excavating at the 312 Main Street property.

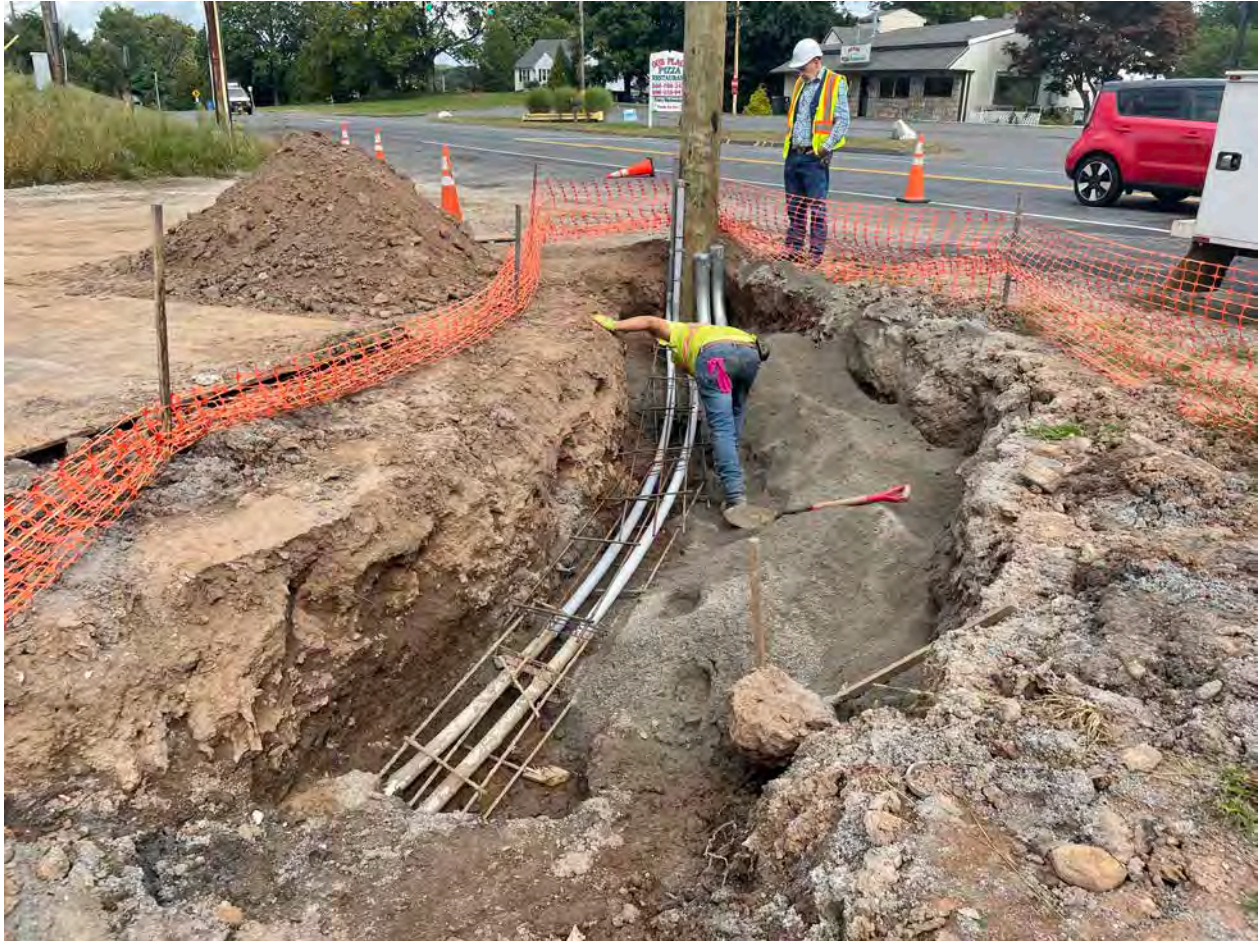
Picture 8: Ludlow placing rebar under and over the 2" PVC conduits coming off one of the recently installed poles at the booster station located at Station 750+63 S. Main St., Middletown. View to the northeast.

1422: Concrete has not yet been delivered to the booster station. Ludlow has placed rebar above and below the 2" PVC conduit that is receiving the concrete placement. The adjoining 4" conduits have been covered with sand.

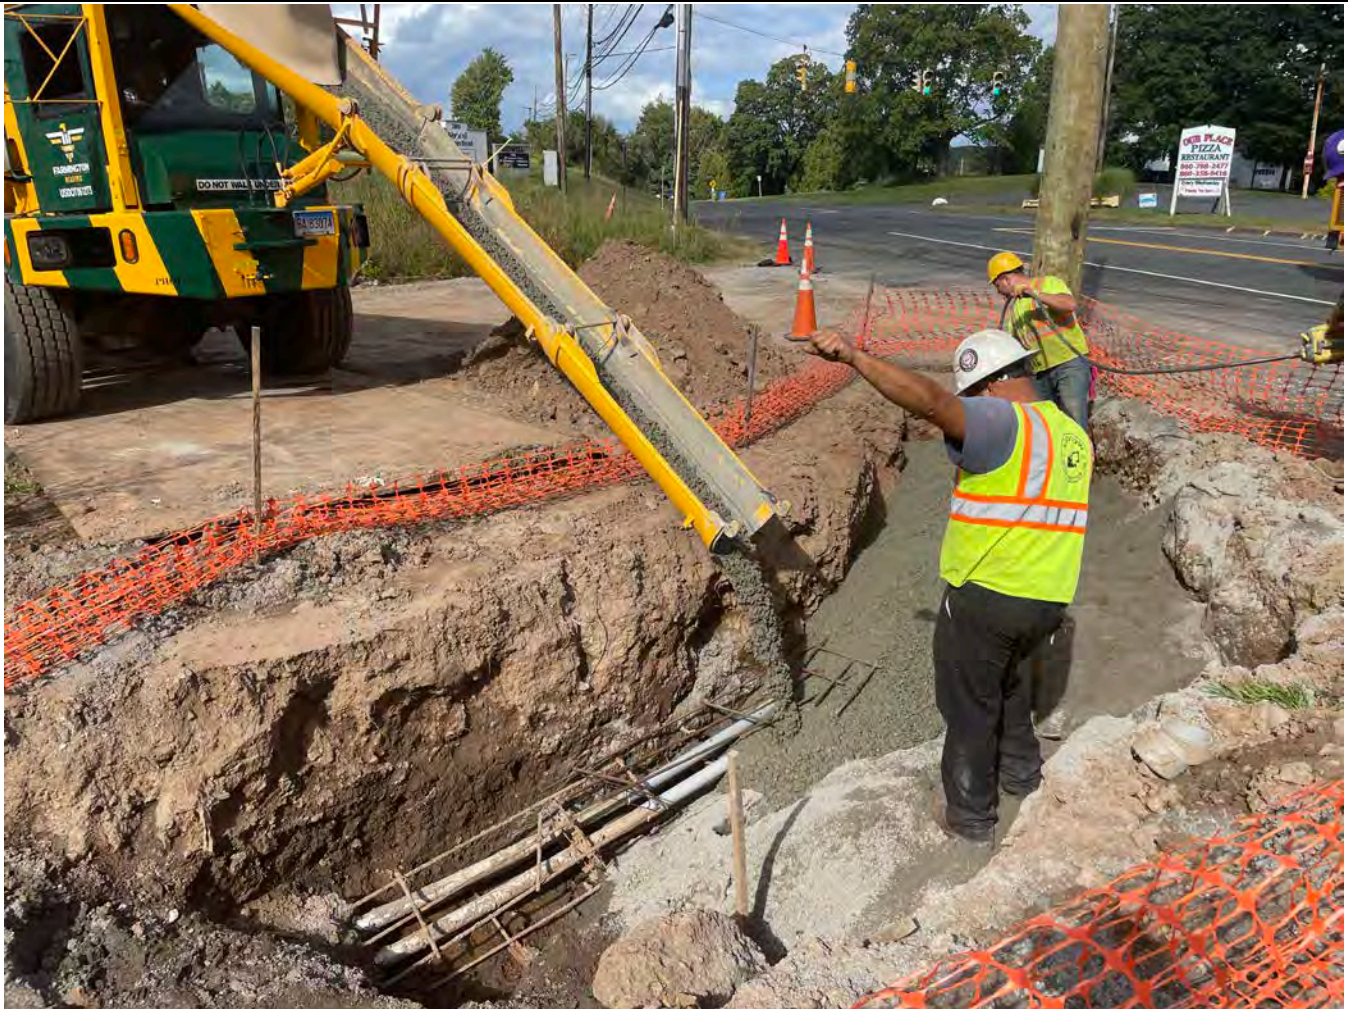
Picture 9: Ludlow directing the placement of 4000 PSI concrete over the 2” PVC conduits coming off one of the recently installed poles at the booster station located at Station 750+63 S. Main St. Middletown. View to the northeast.

1503: Farmington begins to place concrete over the 2" PVC conduits at the booster station located at Station 750+63. JTC reports the following field QC data for the 8-yard load of concrete that was delivered to the booster station:

- slump: 7.0"
- air entrainment: 5.2%
- temperature: 80.0°F

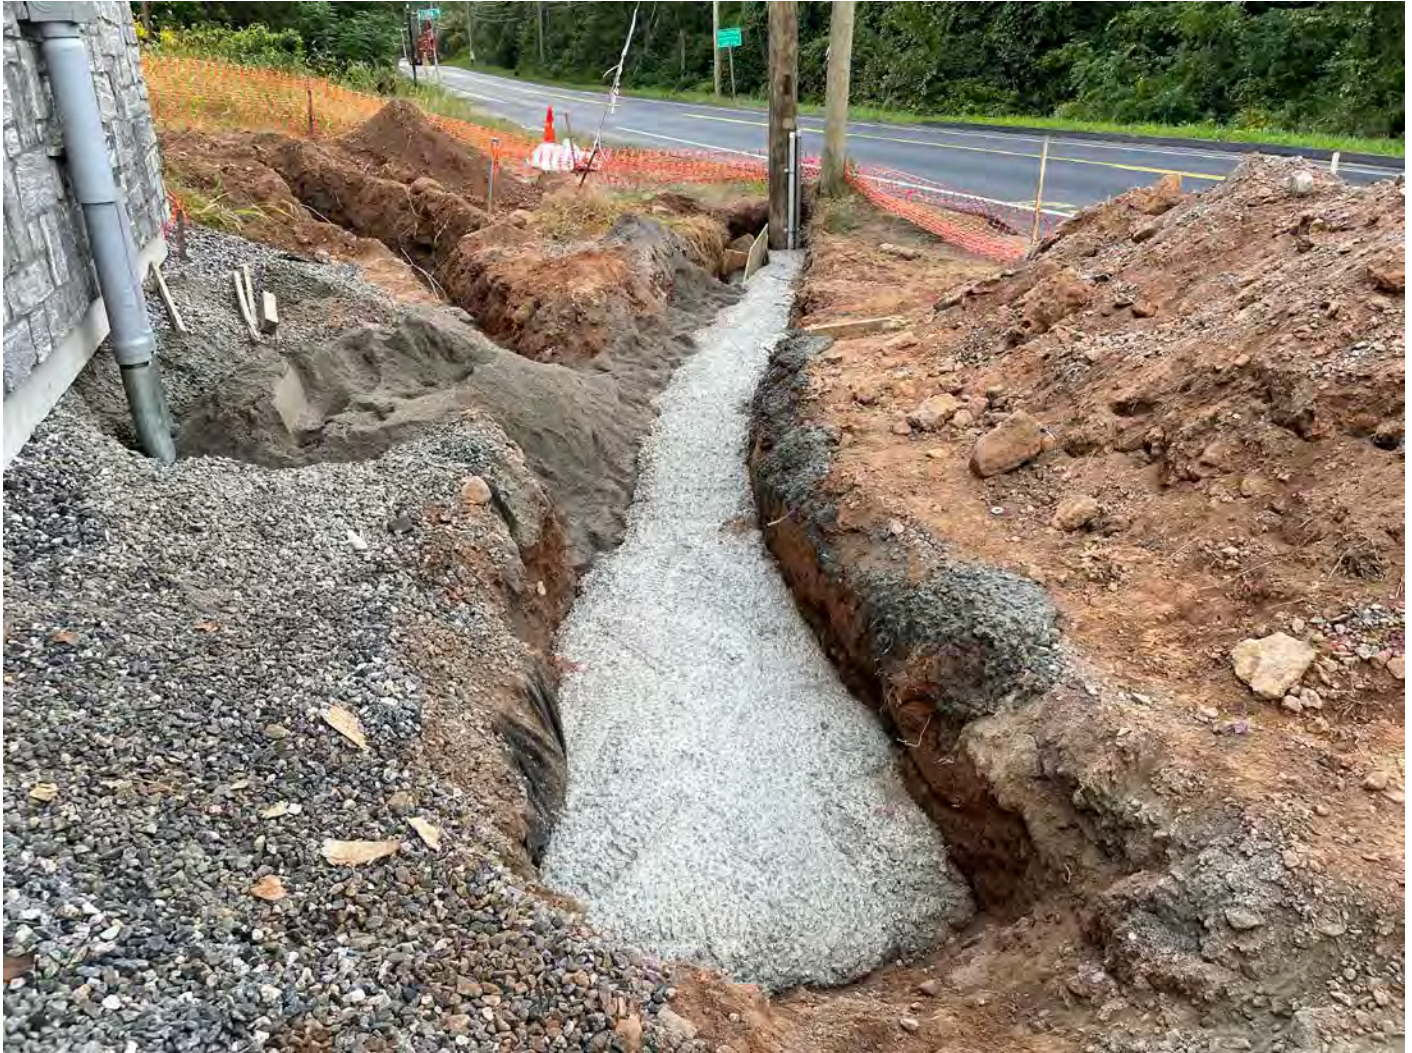
Picture 11: View of the concrete that was placed over PVC conduits at the water meter building located at Station 124+80 S. Main St. Middletown. View to the south.

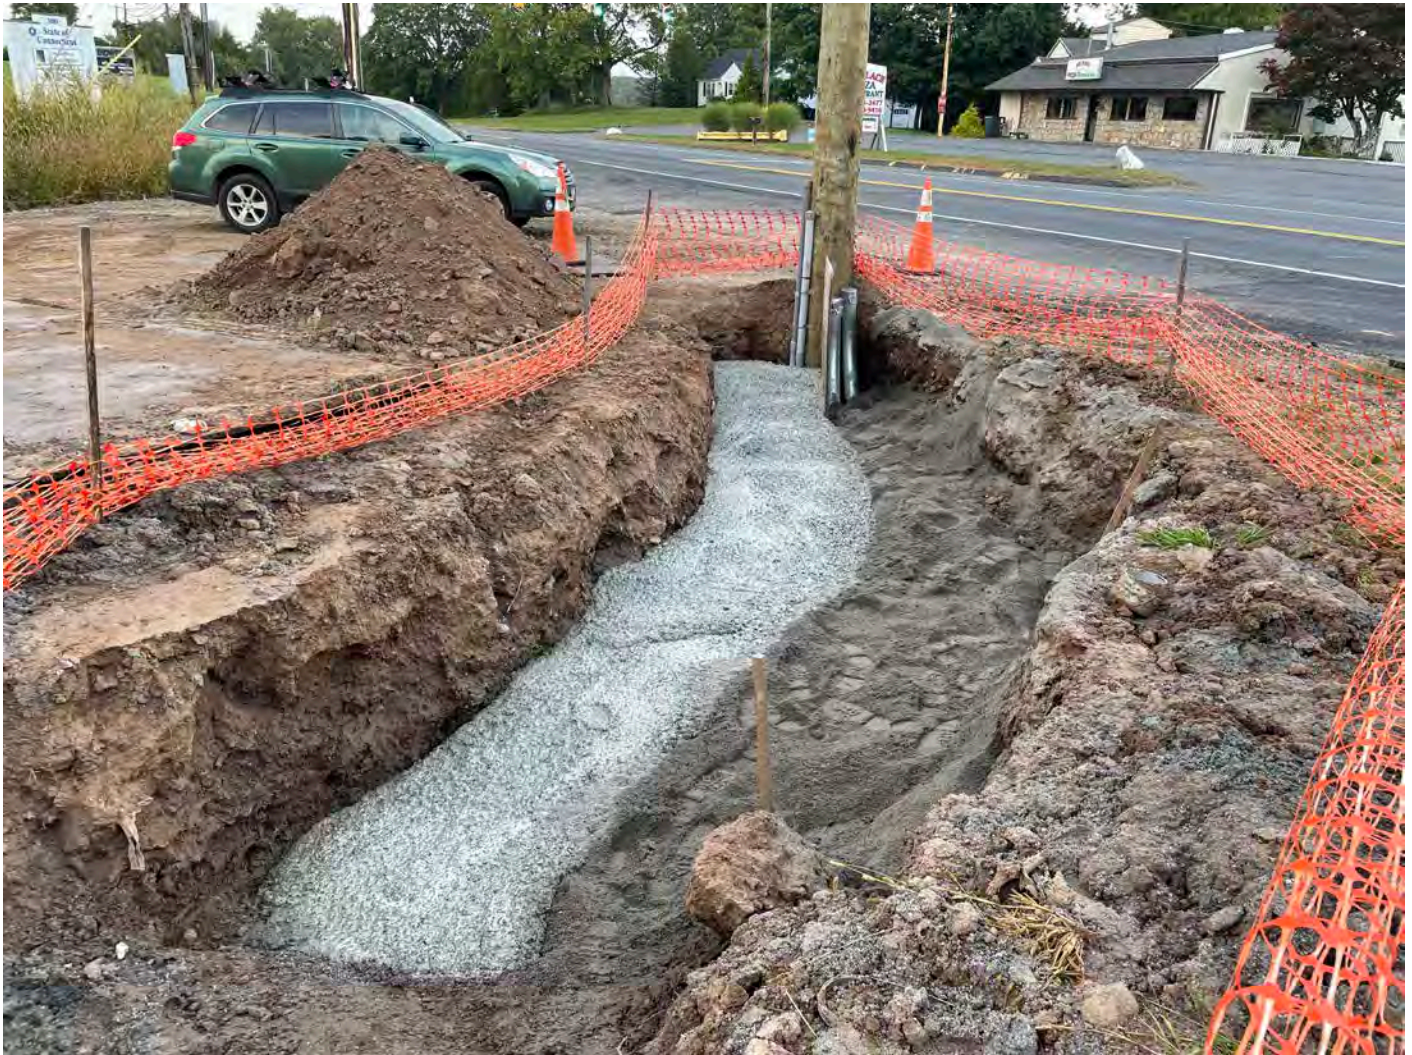
Picture 12: View of the concrete that was placed over PVC conduits at the booster station located at Station 750+63 S. Main St. Middletown. View to the northeast.

Ludlow directed the placement of 4000 PSI concrete over the 2" PVC conduits coming off one of the recently installed poles at the booster station located at Station 750+63.
