Daily Report

Project:	Durham Meadows Pipeline Installation	Date:	September 22, 2021
Location:	Main Street, Durham	Day of Week:	Wednesday
Project #:	AECOM: 6061487	Report No:	328
Contractor:	Ludlow Construction	Page:	1 of 13

Daily Activities – Installation of water lines, Main Street, Durham

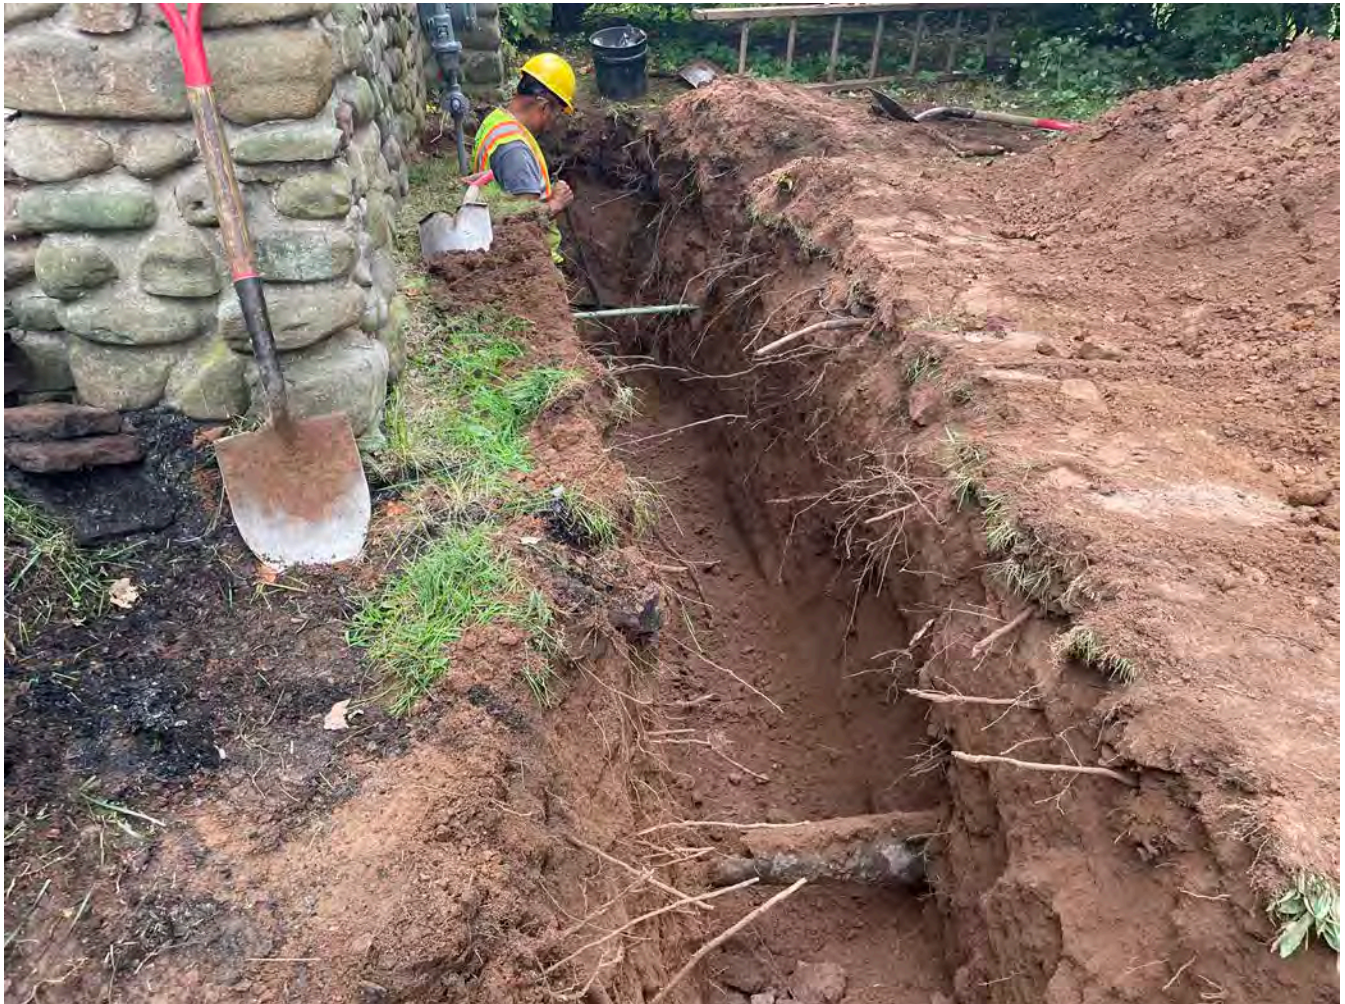
Picture 1: Trench that Ludlow excavated on the north side of the 316 Main Street, Durham, residence for the installation of a 1" copper water service line. View to the west.

0741 Ludlow begins to excavate on the north side of the 316 Main Street residence next to the northeast corner of the house for the installation of a 1" copper water service line.

0812: Ludlow continues to excavate on the north side of the 316 Main Street residence.

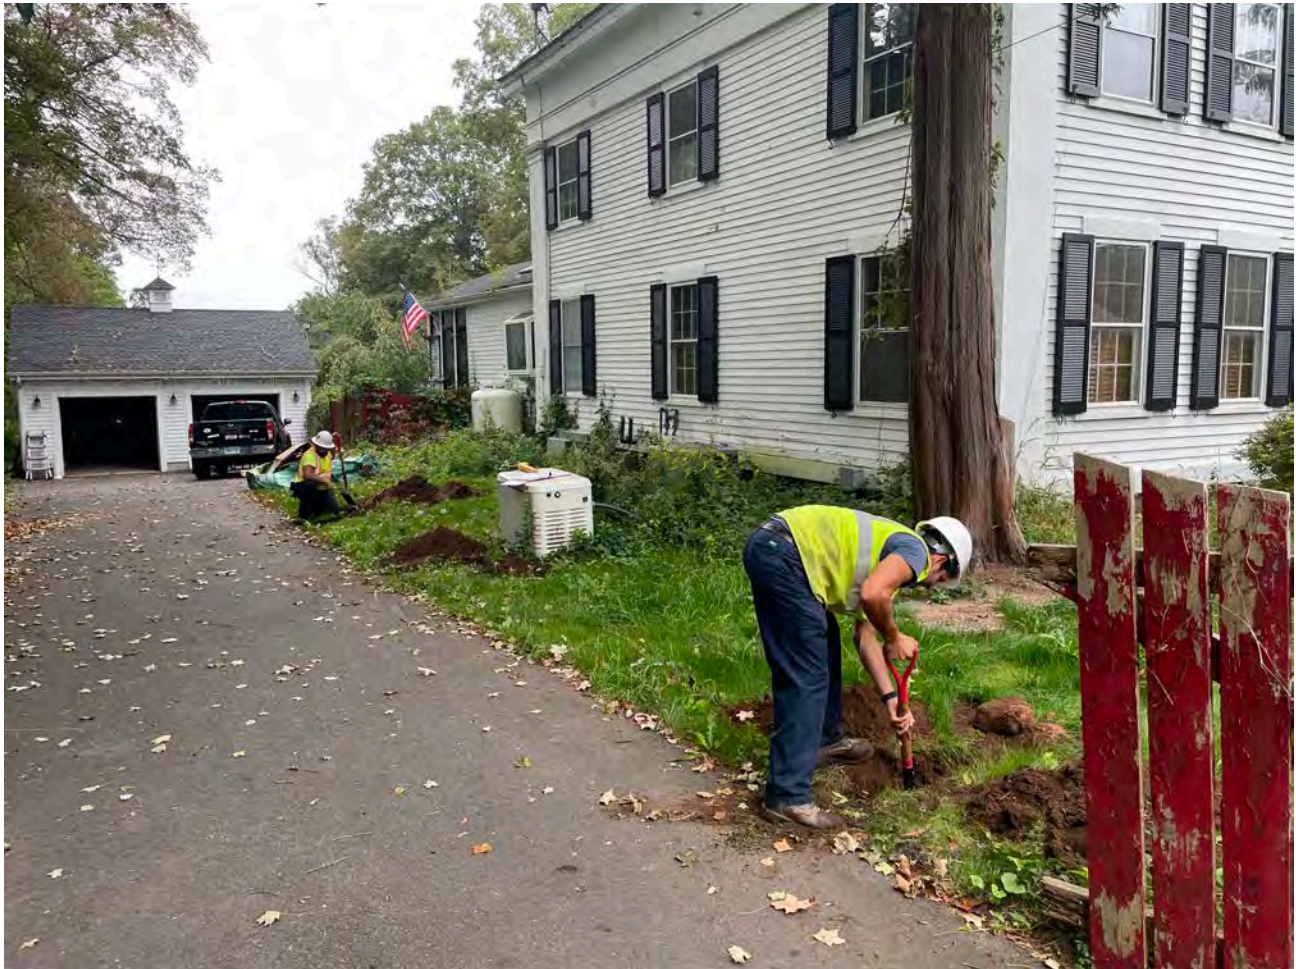
Picture 2: Ludlow hand excavating at the 313 Main Street, Durham, property to locate a recently-installed gas line that conflicts with the planned route that Ludlow had planned to run a 1" copper water service line to the residence. View to the east.

0829: Ludlow is excavating by hand at the 313 Main Street property to locate a recently installed gas line. The location of the gas line necessitates a change in the placement of a 1" copper water service line for the residence. Ludlow will move the line several feet to the north, which will require that they remove a section of the property's driveway.

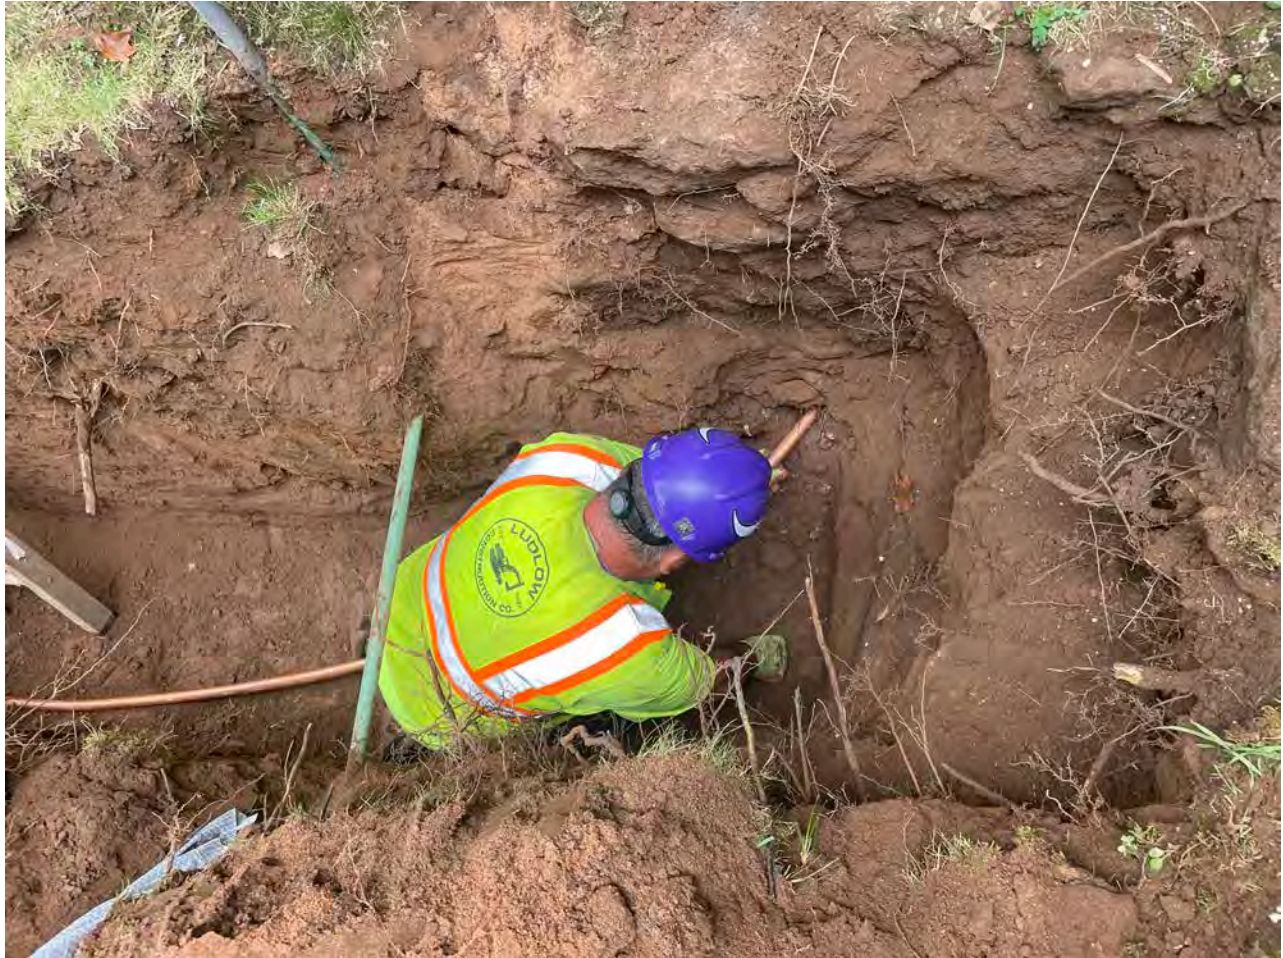
Picture 3: Ludlow inserting 1” copper water service line through a penetration they made through the north side of the foundation of the 316 Main Street residence.

0851: Ludlow penetrates the northern foundation of the residence at 316 Main Street with a rotary hammer for the installation of a 1" copper water service line. The penetration point is 10' 6" west of the home's northeast corner.

0911: Ludlow is inserting a 1" copper water service line through the field stone foundation through the northern side of the foundation of the 316 Main Street residence.

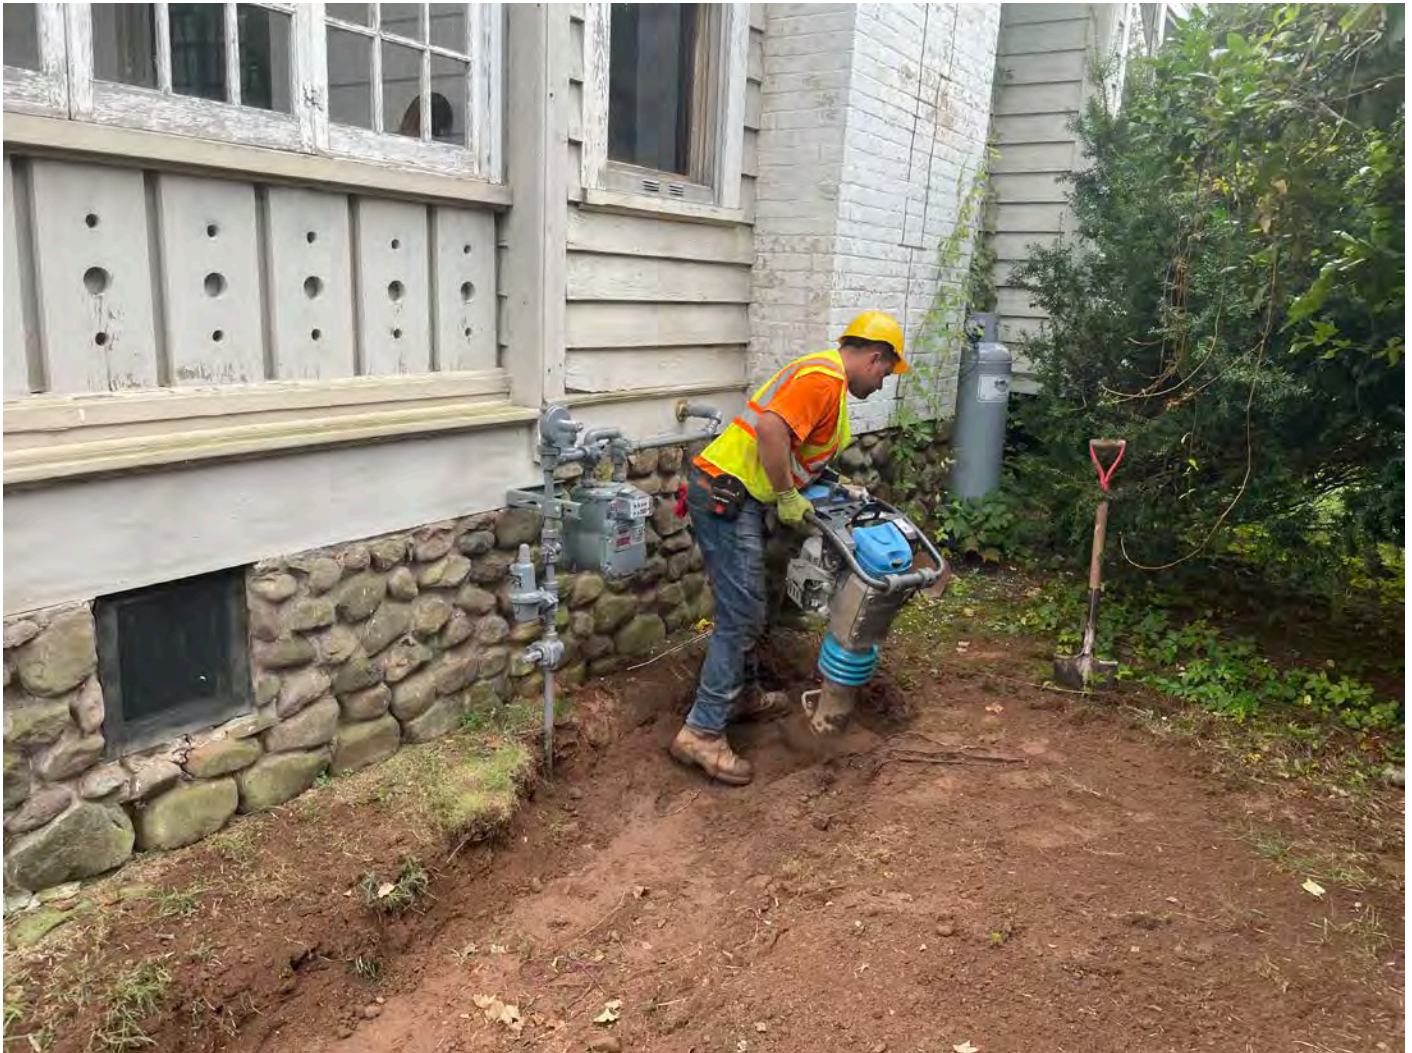
Picture 4: Ludlow using a jumping jack to compact fill that they used to backfill the trench they excavated during the installation of a 1" copper water service line on the north side of the 316 Main Street residence. View to the southwest.

0937: Ludlow begins backfilling over the 1" copper water service line they just installed at the 316 Main Street residence. Ludlow is currently placing 6" of sand over the pipe, followed by caution tape, followed by native and imported fill. The fill is being placed in 1' lifts and is being compacted with a jumping jack.

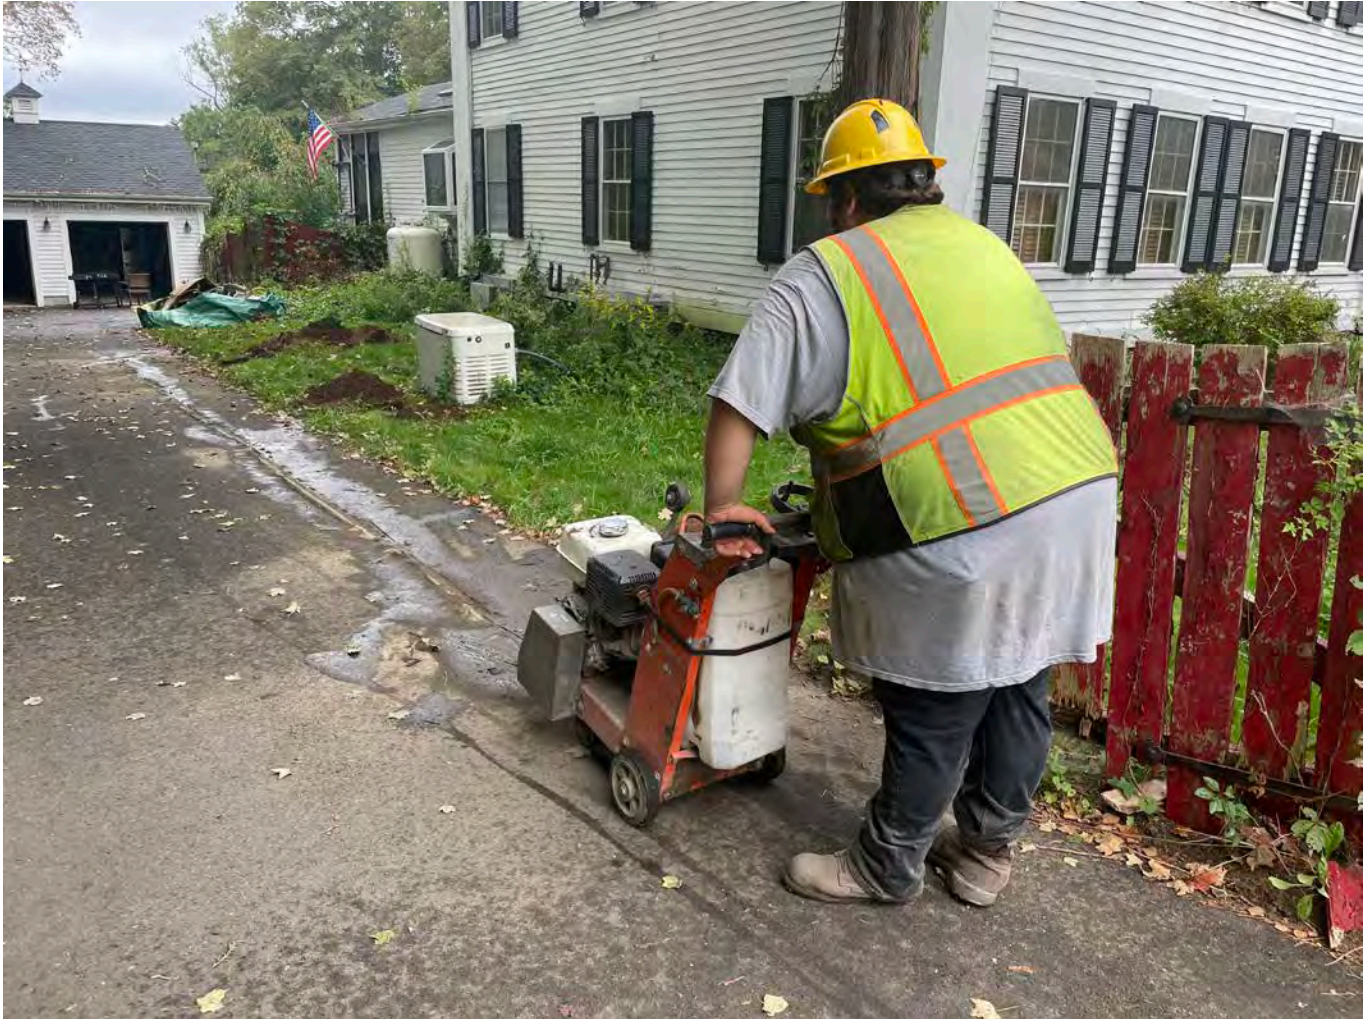
Picture 5: Ludlow saw cutting asphalt on the south side of the driveway of the 313 Main Street residence for the installation of a 1" copper water service line. View to the southeast.

0949: Ludlow has saw cut a section of pavement on the south side of the driveway for the 313 Main Street residence in order to move the installation pathway of the water line due to the conflicting presence of a newly installed gas line.

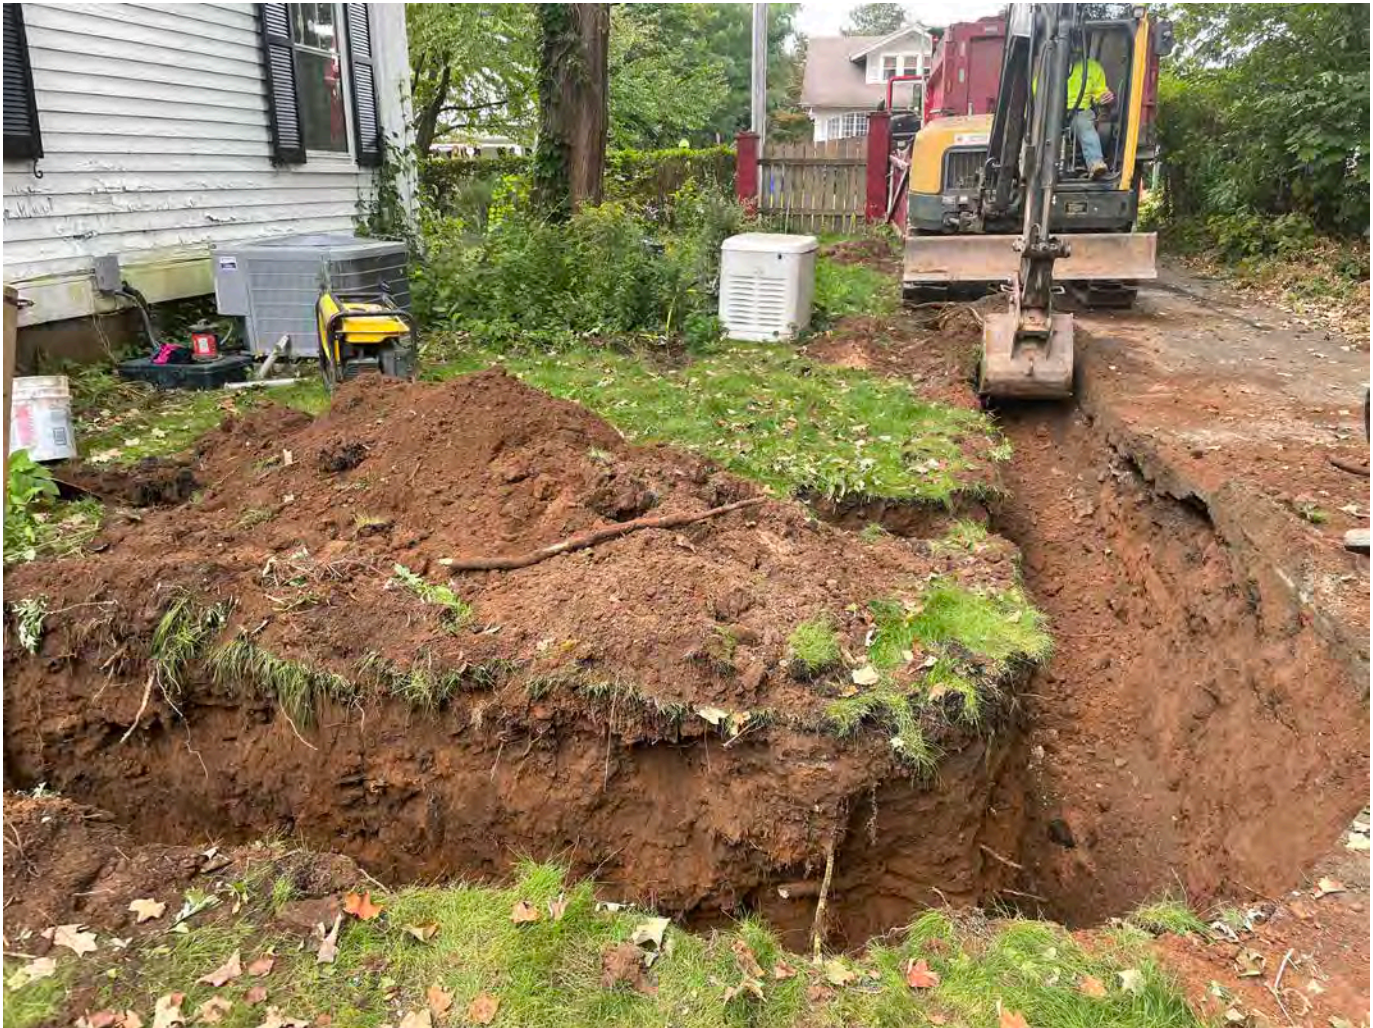
Picture 6: Ludlow excavating a trench on the north side of the 313 Main Street residence for the installation of a 1" copper water service line. View to the east.

1134: Ludlow is excavating a trench at the 313 Main Street residence for the installation of a 1" copper water service line. Ludlow has daylighted the residence's field stone foundation on its north side.

1210: Ludlow continues to excavate on the north side of the 313 Main Street residence. Ludlow has removed the strip of asphalt that they saw cut on the south side of the driveway.

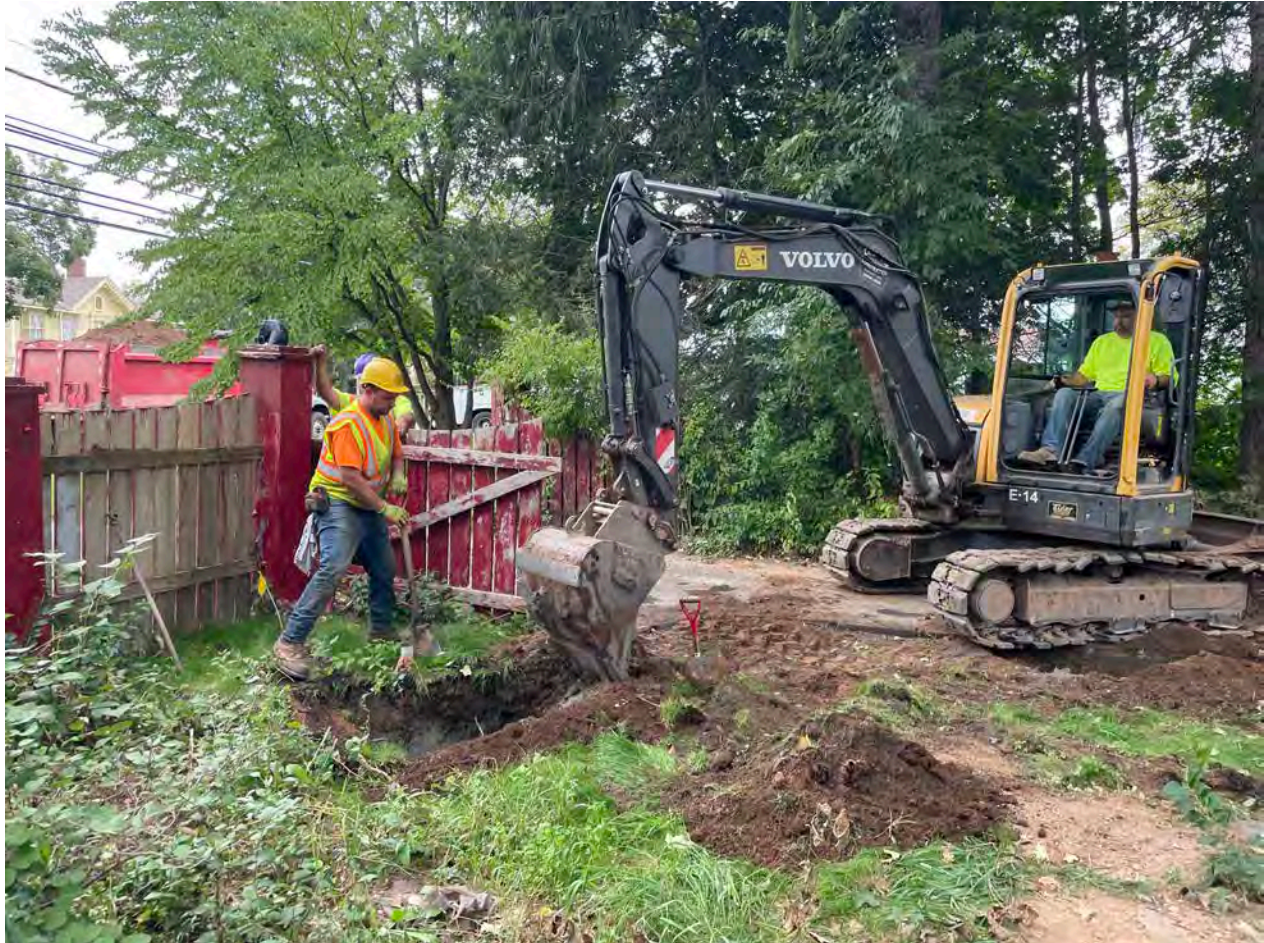
Picture 7: Ludlow excavating next to the curb stop for the 313 Main Street residence for the installation of a 1" copper water service line. View to the northwest.

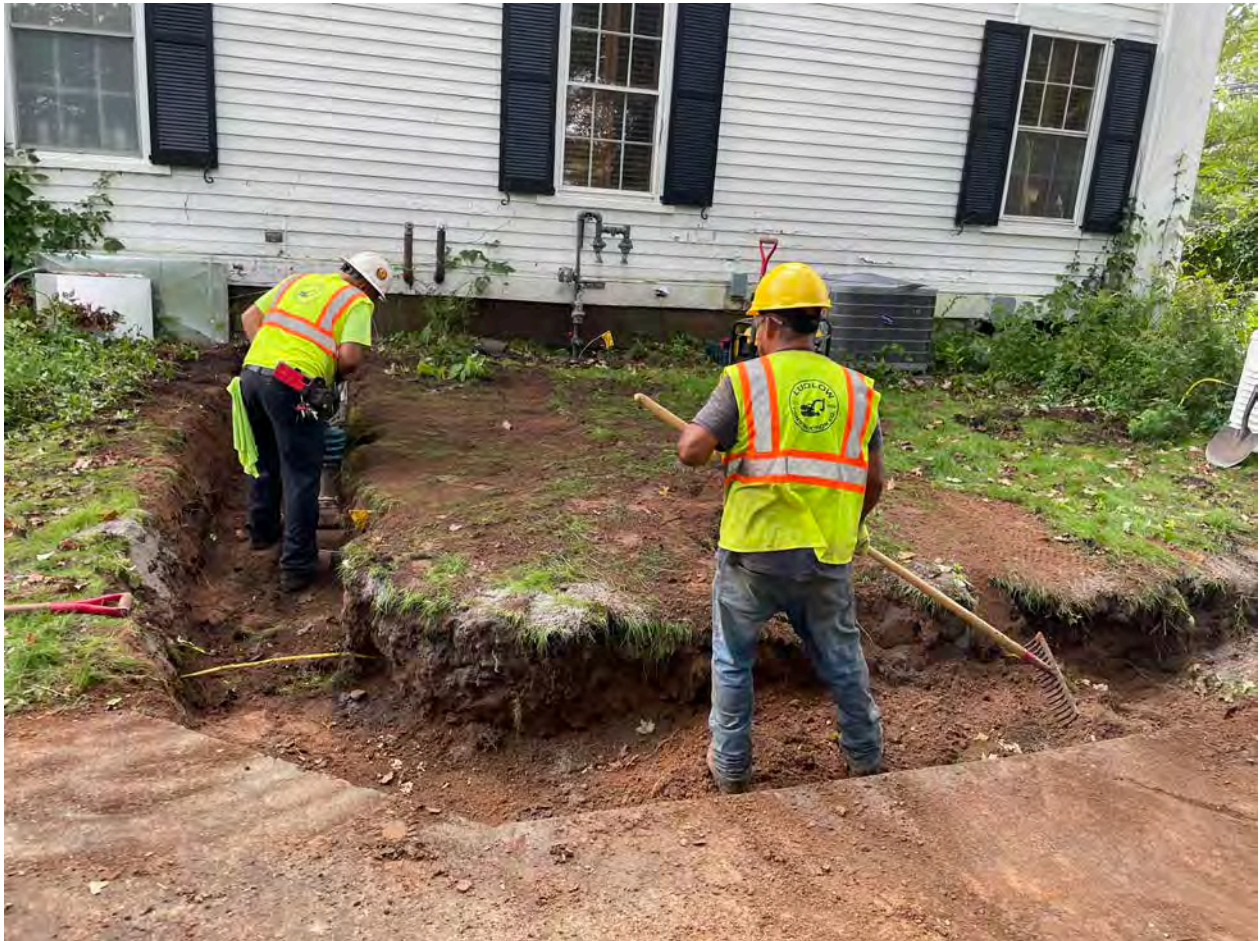
Picture 8: Ludlow compacting fill with a jumping jack that they placed over the 1" copper water service line they installed at the 313 Main Street residence. View to the south.

1249: Ludlow is placing 6" of sand followed by caution tape on the portions of 1" copper water service line that they've installed so far at the 313 Main Street residence.

1343: Ludlow continues backfilling the trench they excavated at the residence at 313 Main Street for the installation of 1" copper water service line.

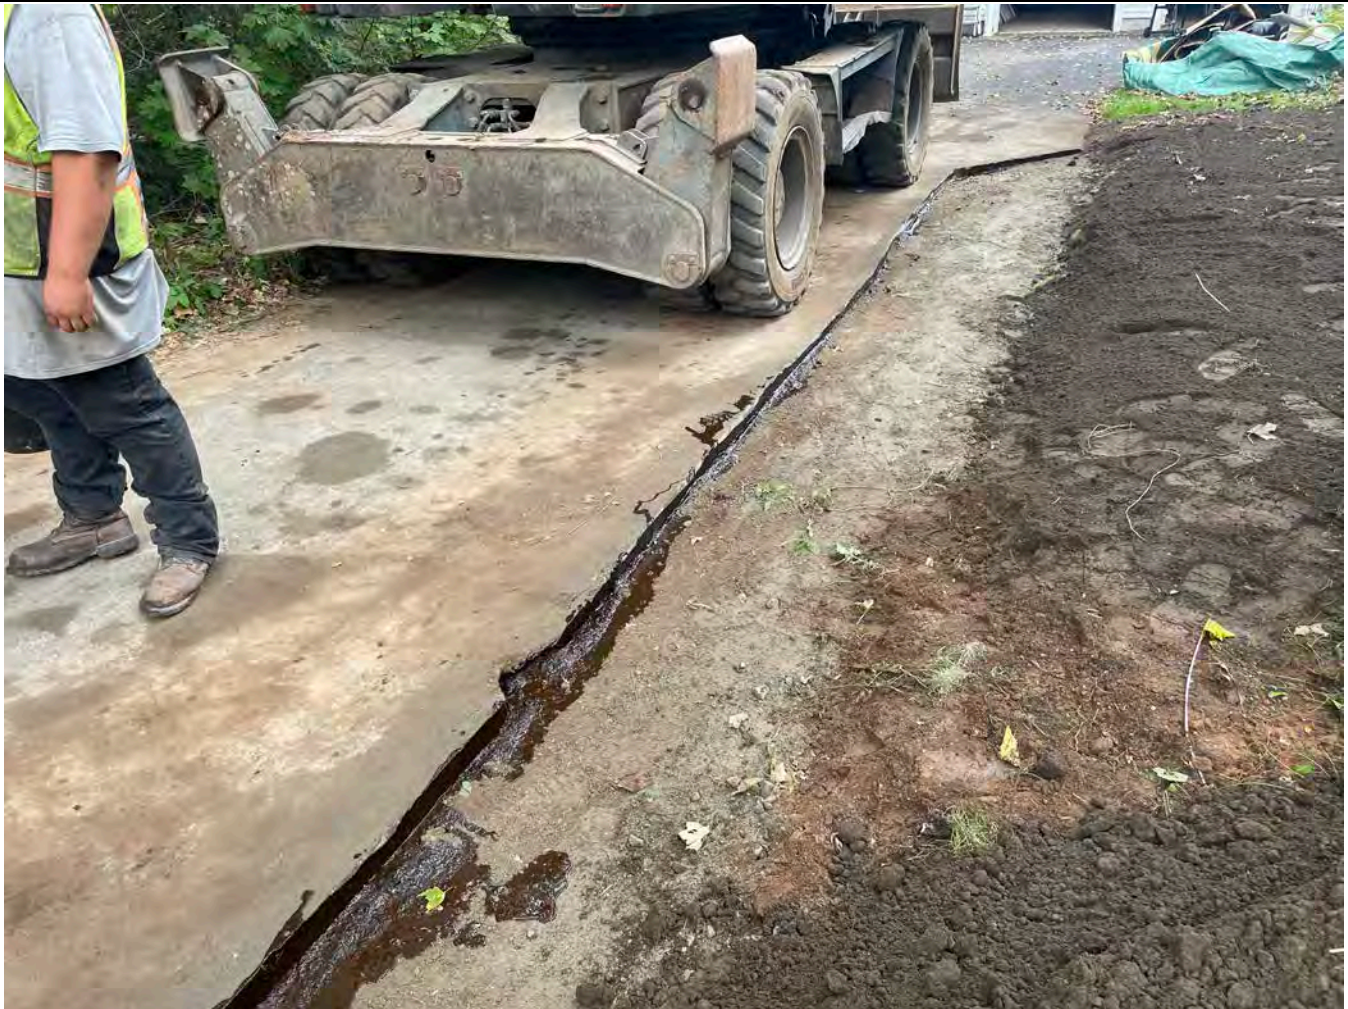
Picture 9: Tack coating that Ludlow placed on the cut edges of driveway pavement on the north side of the 313 Main Street residence for the installation of a 1" copper water service line. View to the east.

1452: Ludlow is placing tack coat on the edges of the saw cut pavement on the south side of the driveway of the 313 Main Street property.

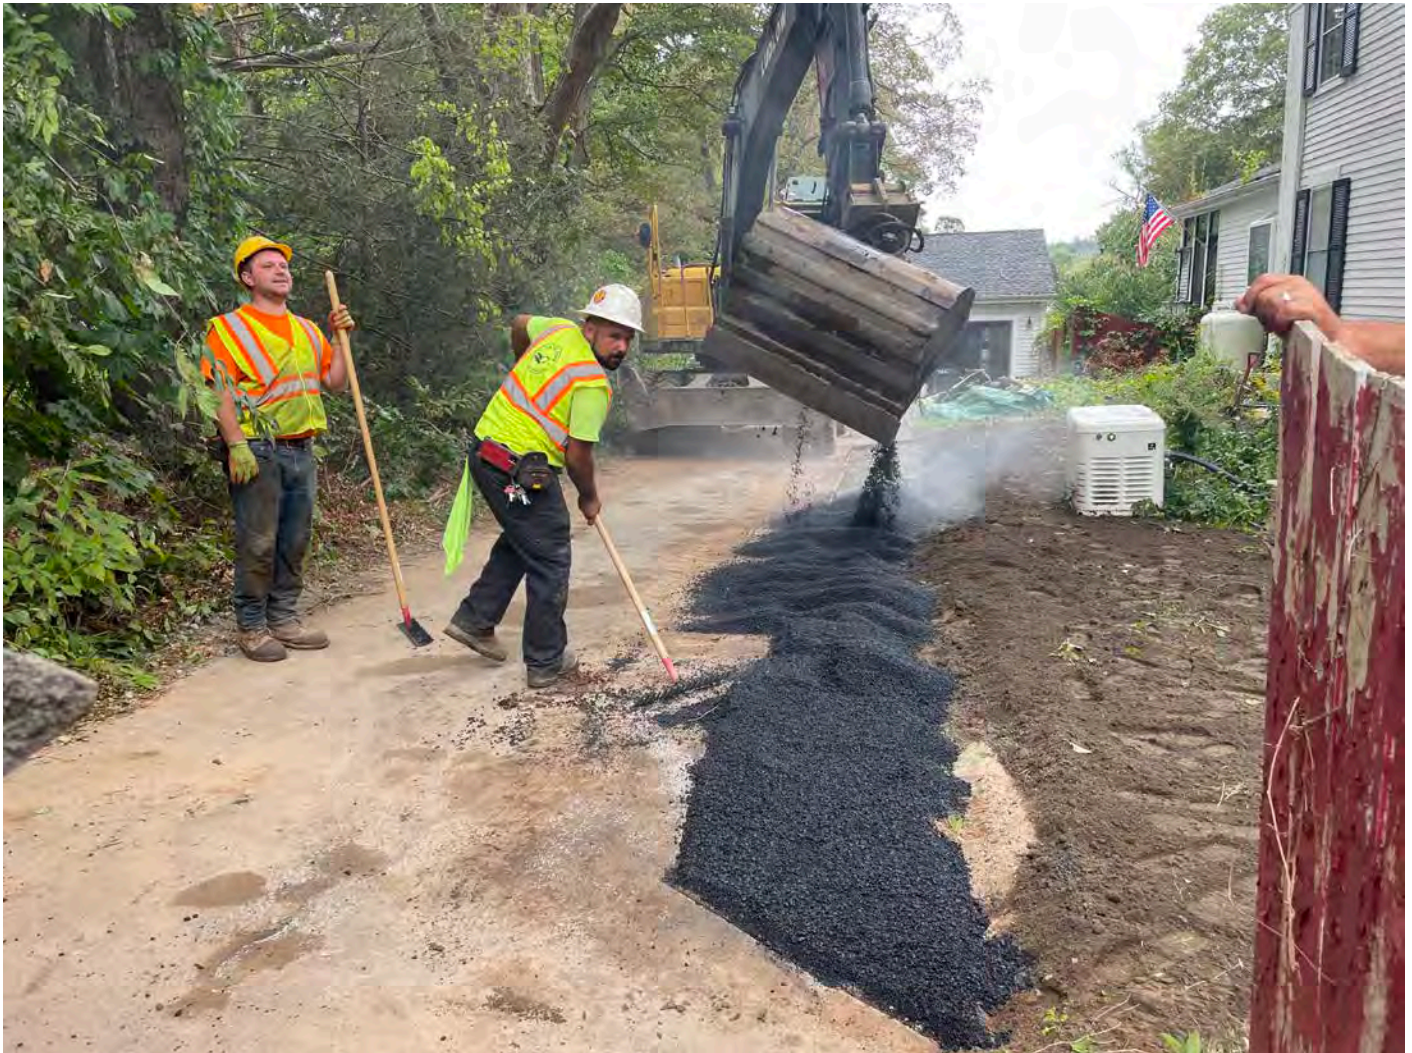
Picture 10: Ludlow placing asphalt at the 313 Main Street residence to repair the driveway after having cut out the south side of it for the installation of a 1" copper water service line. View to the east.

1507: Ludlow delivers a truckload of asphalt to the 313 Main Street property and begins to place it where they removed a strip of asphalt on the south side of the driveway.
