## Daily Report

<b>Project:</b>	Durham Meadows Pipeline Installation	<b>Date:</b>	November 01, 2021
<b>Location:</b>	Maple Avenue, Durham; S. Main Street, Middletown	<b>Day of Week:</b>	Monday
<b>Project #:</b>	AECOM: 6061487	<b>Report No:</b>	354
<b>Contractor:</b>	Ludlow Construction	<b>Page:</b>	1 of 13

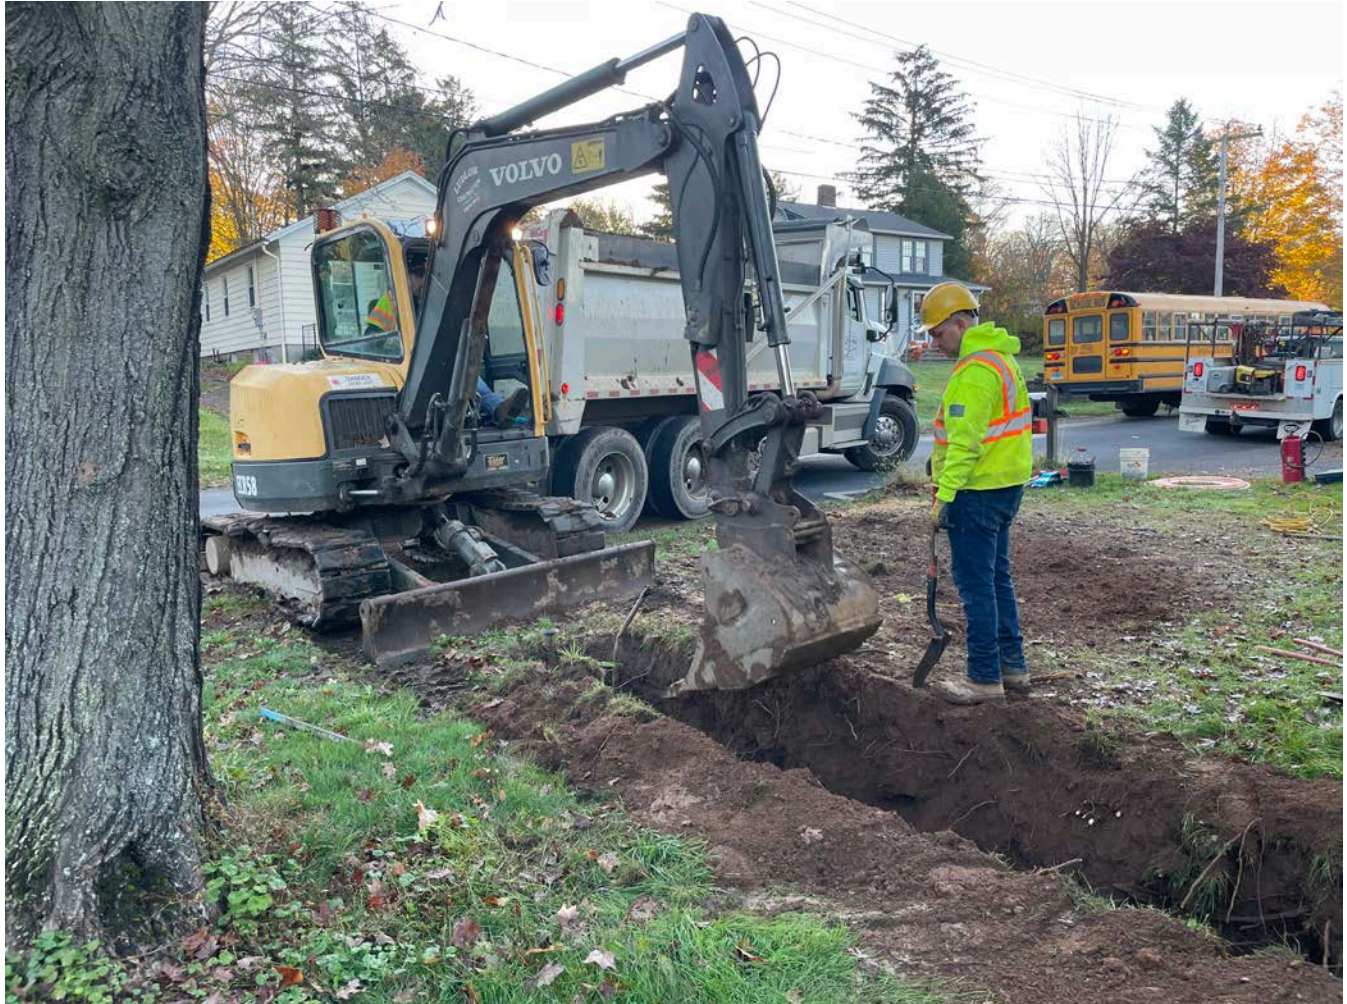
0743: Ludlow has begun excavating on the east side of the foundation of the 176 Maple Avenue residence for the installation of a 1" copper water service line.

**Picture 1:** Ludlow excavating on the east side of the 176 Maple Avenue, Durham, residence for the installation of a 1" copper water service line. View to the southeast.

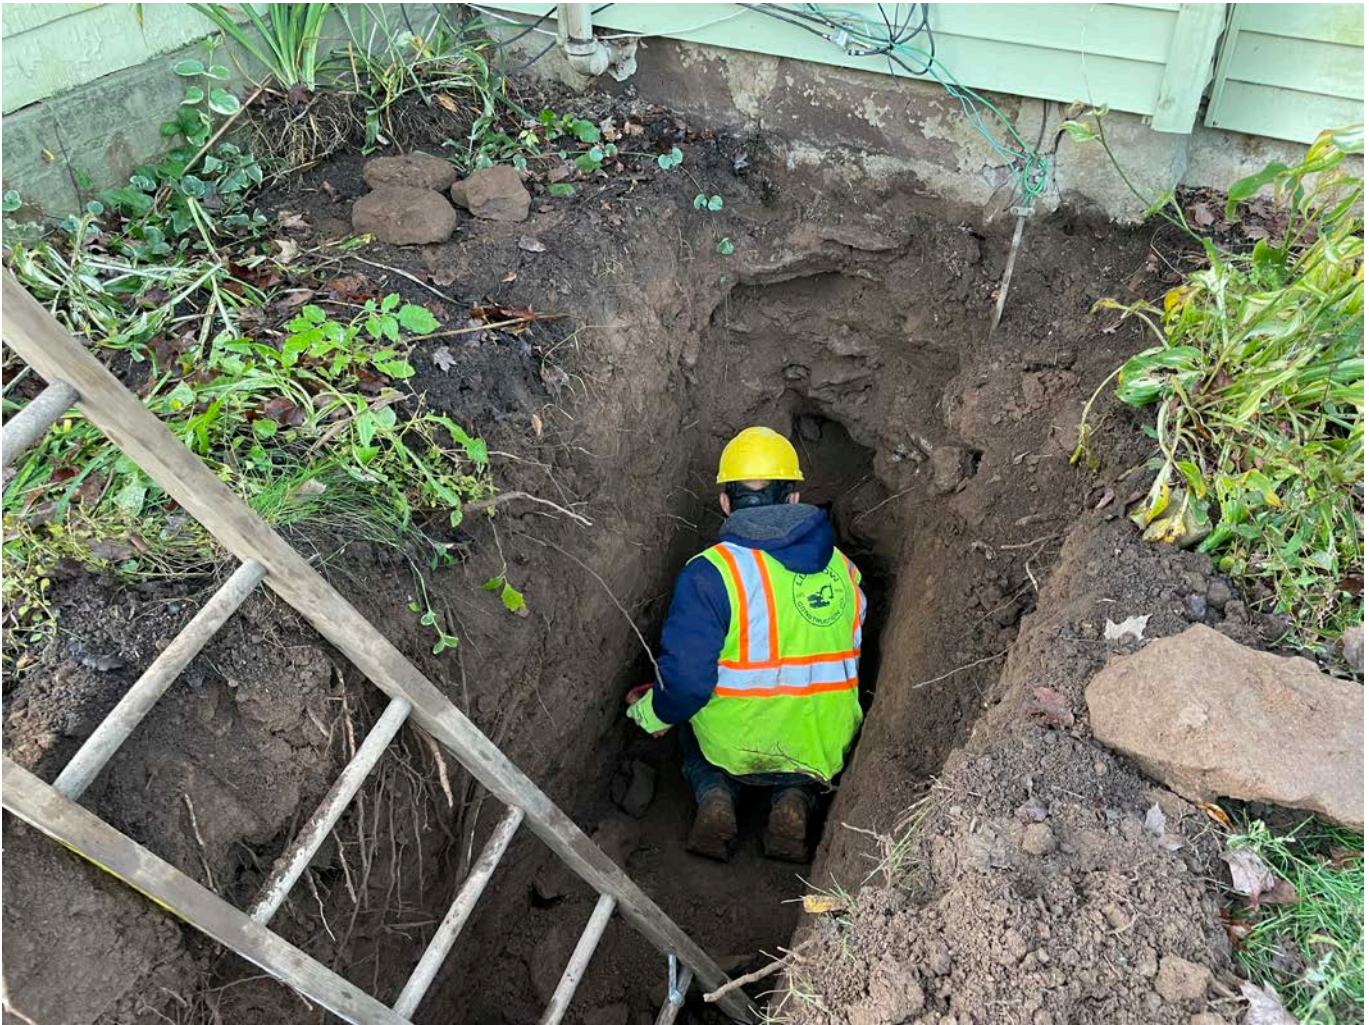
0811: Ludlow is continuing to excavate between the curb stop and the eastern foundation of the 176 Maple Avenue residence. Ludlow has daylighted the home's fieldstone foundation and has almost daylighted the curb stop.

**Picture 2: Ludlow hand-excavating the east side of the fieldstone foundation of the 176 Maple Avenue residence. View to the west.**

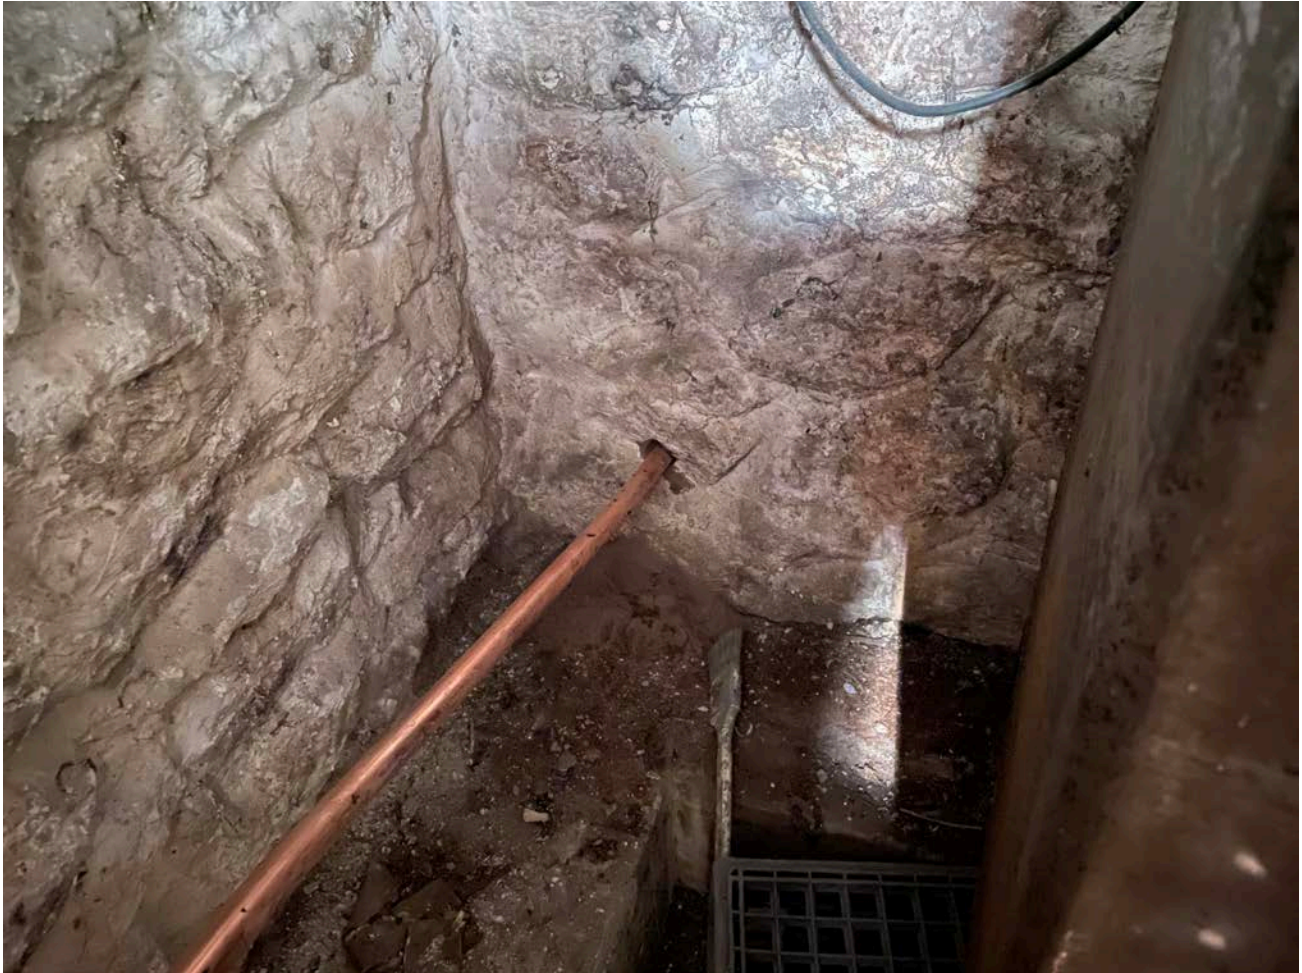
0842: Ludlow has attached 1" copper water service line to the curb stop at the 176 Maple Avenue property, placed it at the bottom of the trench, and ran it through the penetration they made on the eastern foundation of the residence with a rotary hammer. Ludlow is preparing to secure the copper pipe on both sides of the where it penetrates the field stone foundation with non-shrink grout. The penetration point on the eastern foundation of the 176 Maple Avenue residence is 120" south of the home's northeast corner.

Picture 3: 1" copper water service line that Ludlow installed through the eastern foundation of the 176 Maple Avenue, Durham, residence. View to the northeast.

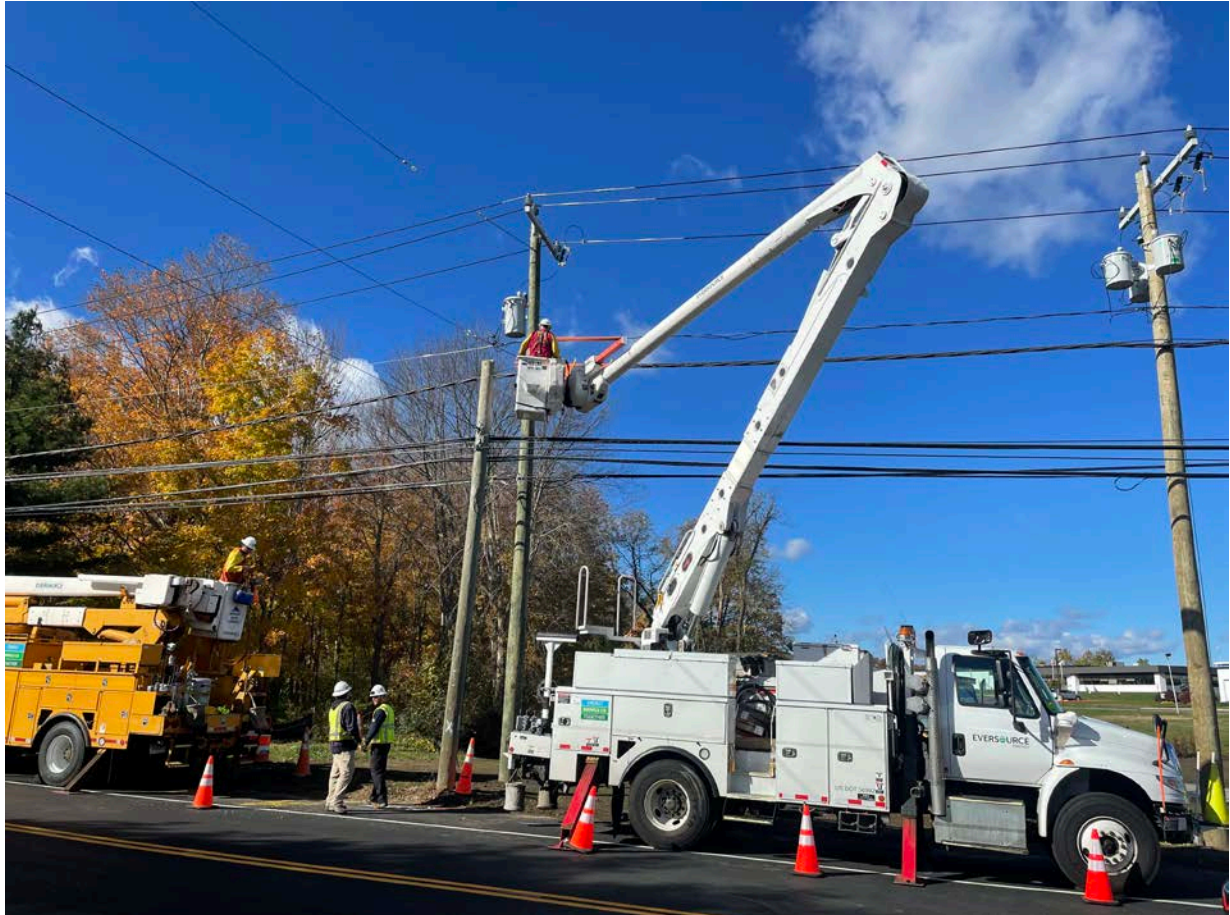
1044: Eversource arrives at the booster station located at Station 750+63 to work on the powerlines attached to one of the two new poles that were recently installed by Frontier. There is currently one police officer from the City of Middletown providing traffic detail.

1115: Eversource is currently placing shields on the powerlines they are working on at the booster station work zone.

**Picture 4: Eversource working on the powerlines at the booster station work zone located at Station 750+63 on S. Main Street, Middletown. View to the west.**

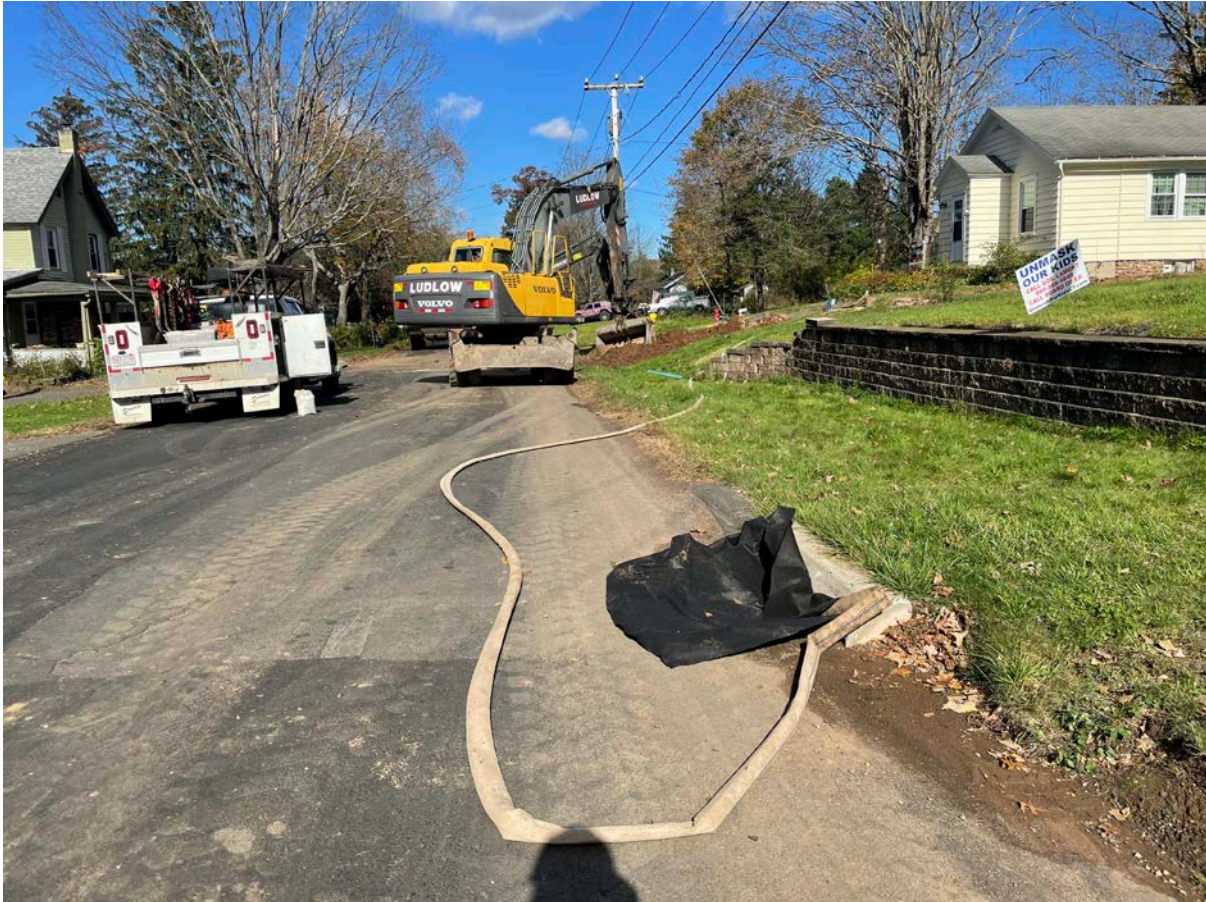
1039: Ludlow is encountering water in the trench they are excavating at the 175 Maple Avenue property (approximately 20 feet east of Maple Avenue). Ludlow is setting up to pump water out of the trench and into a catch basin located on the east side of Maple Avenue (in front of 173 Maple Avenue residence). Ludlow placed filter fabric over the catch basin to intercept the water prior to discharging into it.

**Picture 5: Ludlow set up to pump water out of the trench they excavated at the 175 Maple Avenue property for the installation of a 1" copper water service line. View to the north.**

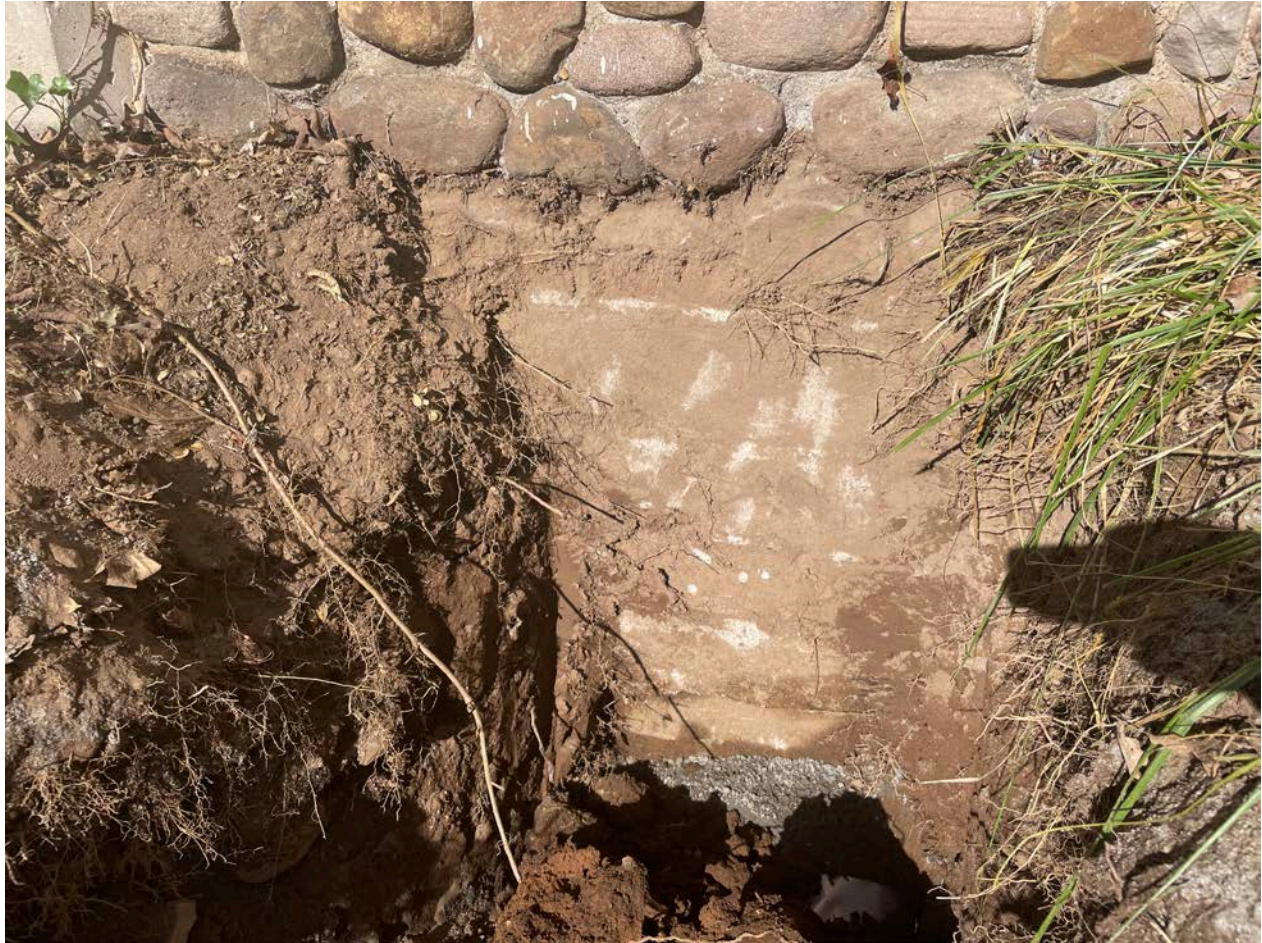
1013: Ludlow has just penetrated the southern foundation of the 175 Maple Avenue residence with a rotary hammer. The penetration point is 103" east of the homes southwest corner

**Picture 6: Concrete foundation on the south side of the 175 Maple Avenue residence that Ludlow has daylighted during the installation of a 1" copper water service line. View to the north.**

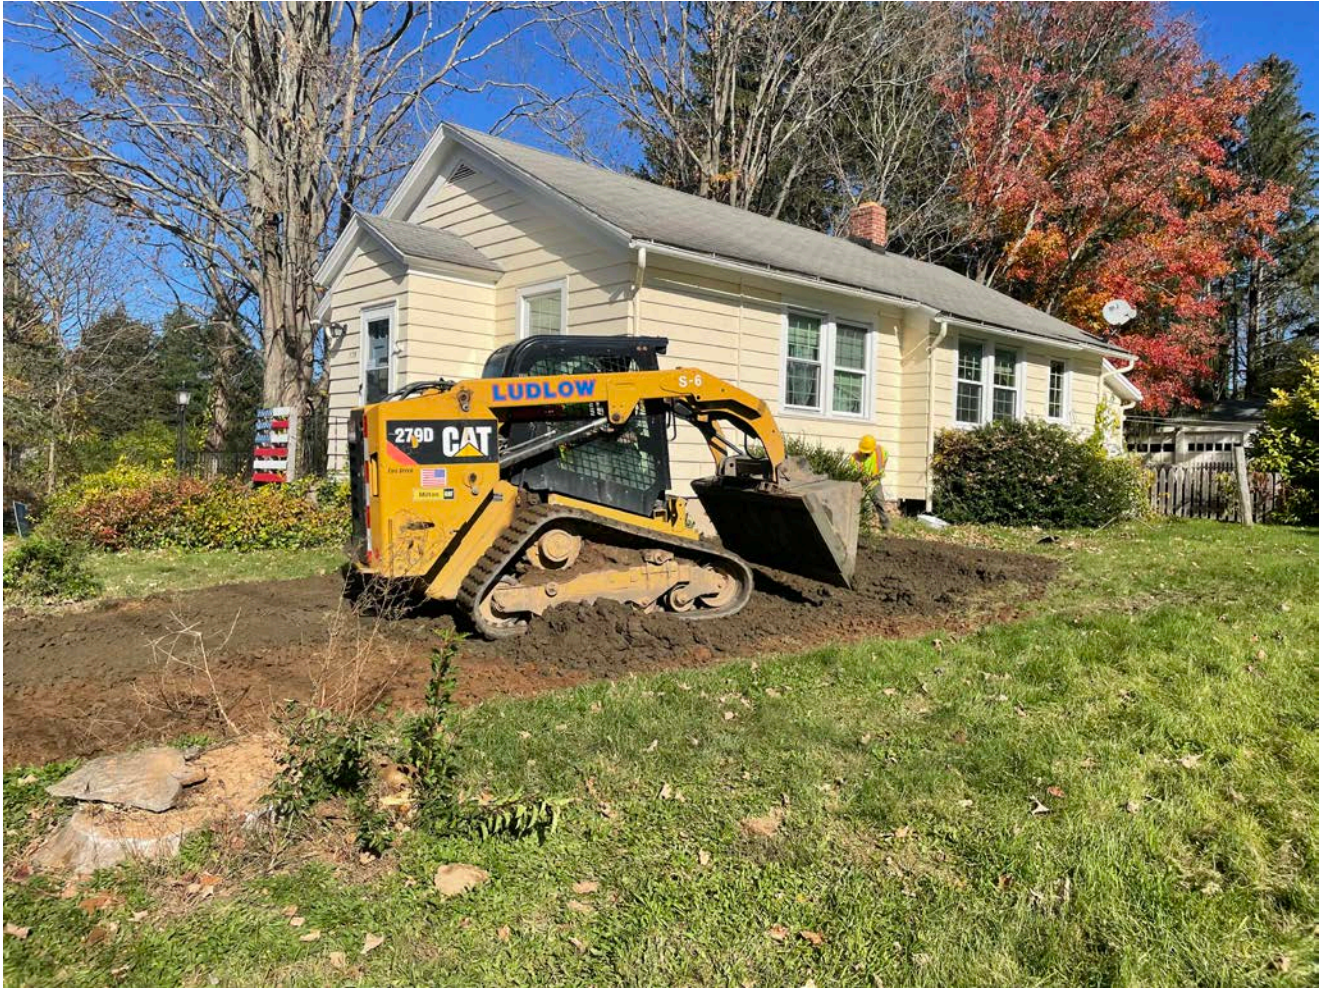
1350: Ludlow is placing and grading loam on those portions of the lawn at the 175 Maple Avenue property that were disturbed during the installation of a 1" copper water service line.

Picture 7: Ludlow grading loam as they restore the portions of the lawn at the 175 Maple Avenue residence that were disturbed during the installation of a 1" copper water service line. View to the northeast.

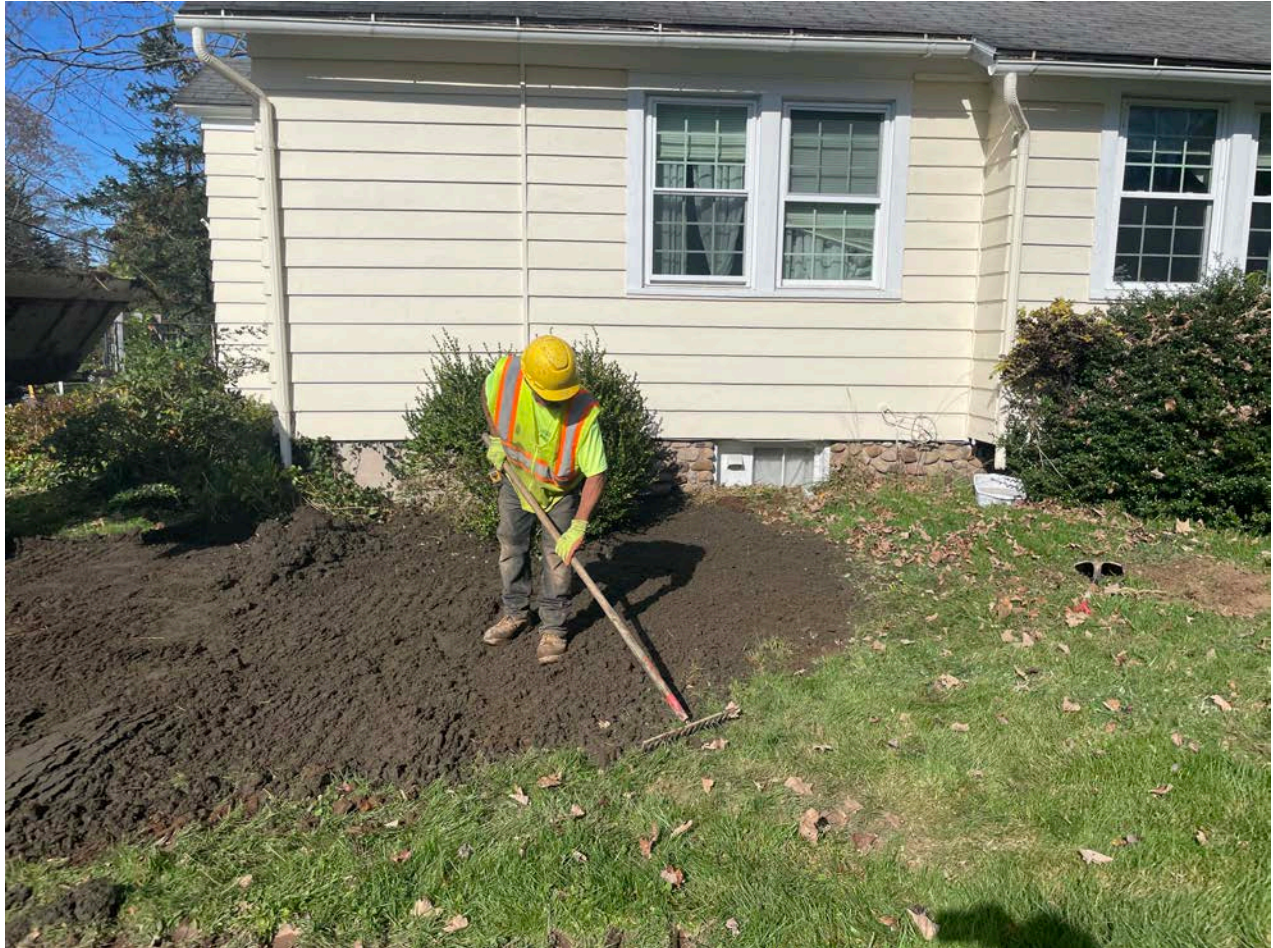
**Picture 8: Ludlow raking loam as they restore the portions of the lawn at the 175 Maple Avenue residence that were disturbed during the installation of a 1" copper water service line. View to the north.**

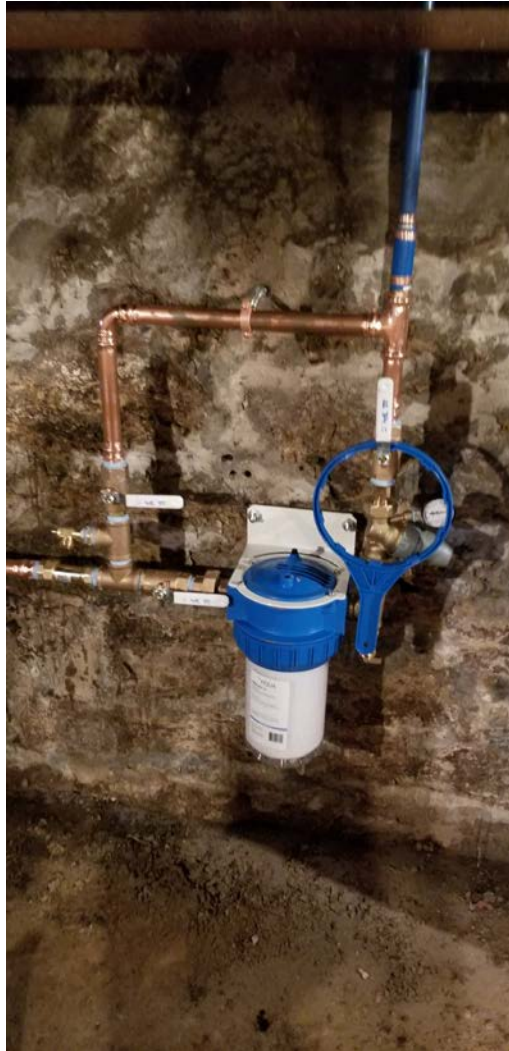
**Picture 9: Final water service components that Fazzino Plumbing installed at the 177 Main Street, Durham, residence.**

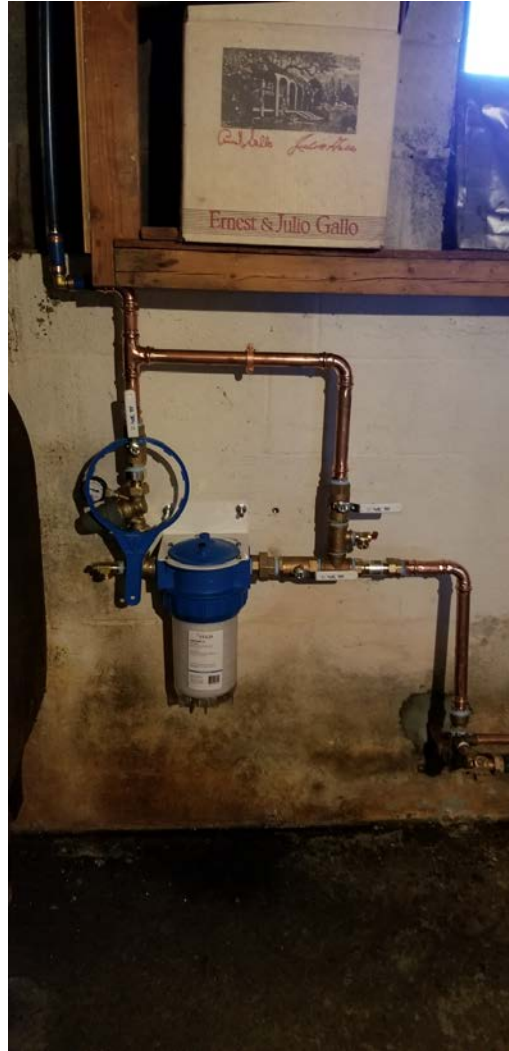
**Picture 10: Final water service components that Fazzino Plumbing installed at the 202 Main Street, Durham, residence.**
