#### **Daily Report**

Project:Durham Meadows Pipeline InstallationDate:November 09, 2021

Project #:
 AECOM: 6061487
 Report No:
 360

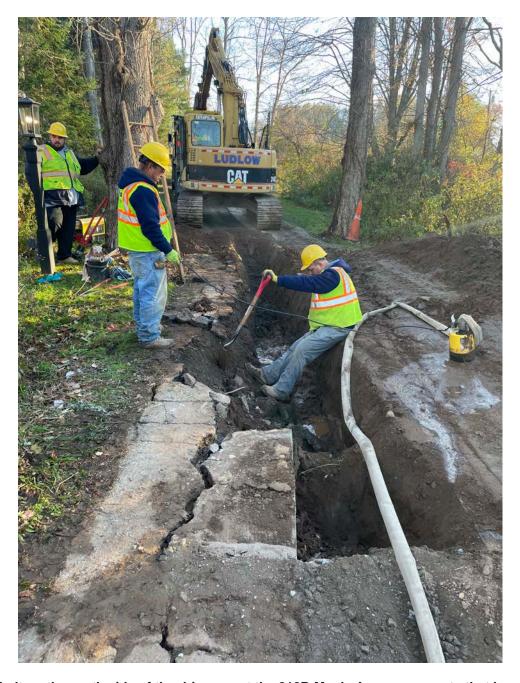
0756: Approximately 15' of the asphalt driveway at the 212R Maple Avenue property on the north side of the trench has been compromised by the weight of Ludlow's construction vehicles and will need to be replaced.

Picture 1: Asphalt on the north side of the driveway at the 212R Maple Avenue property that has been compromised by the weight of Ludlow's construction vehicles and will need to be replaced. View to the east.

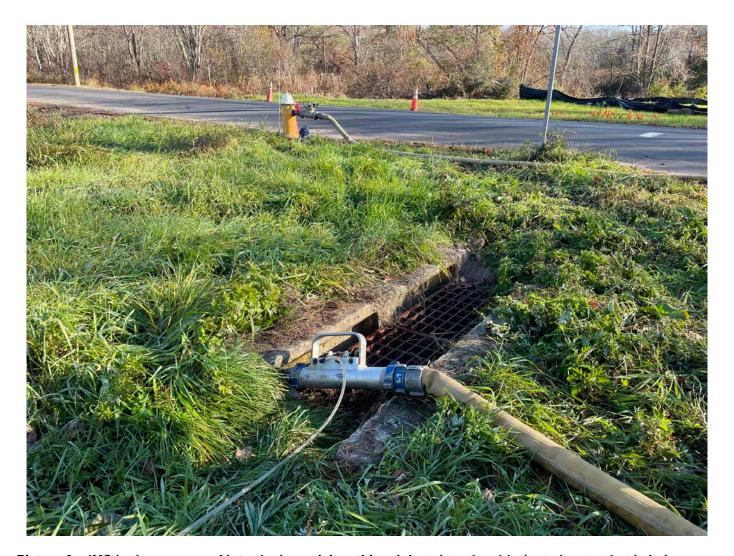
0833: JMS is in the process of dechlorinating the water that is being discharged from the waterlines on Pickett Lane and Maiden Lane. The water is being discharged into the catch basin on the northwest corner of the intersection of Brick Lane and Maiden Lane. JMS is using calcium thiosulfate to dechlorinate the water.

Picture 2: JMS in the process of introducing calcium thiosulphate into the chlorinated water that is being purged from the Pickett Lane and Maiden Lane water lines. The water is being discharged into a catch basin located on the northwest corner of the intersection of Brick Lane and Maiden Lane. View to the northeast.

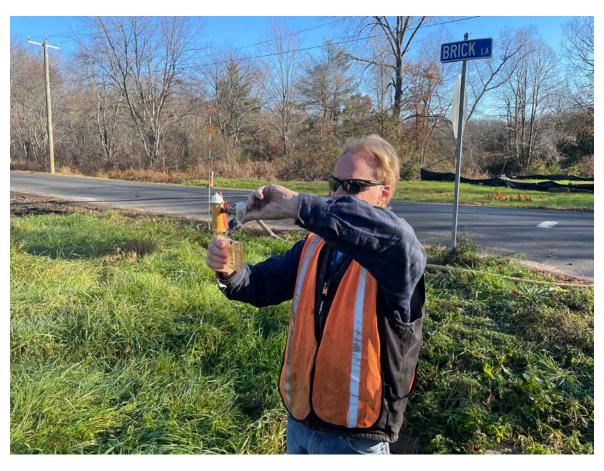
Picture 3: JMS testing for residual chlorine during the dechlorination process. View to the northeast.

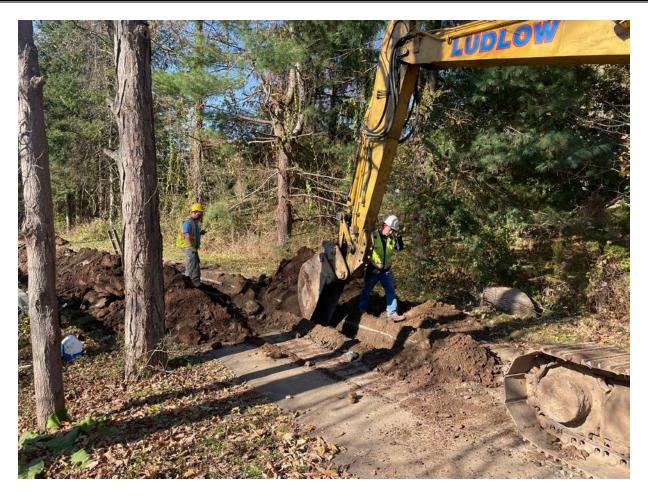
Picture 4: Ludlow excavating a trench on the driveway of the 212R Maple Avenue property for the installation of a 1.5" copper water service line. View to the west.

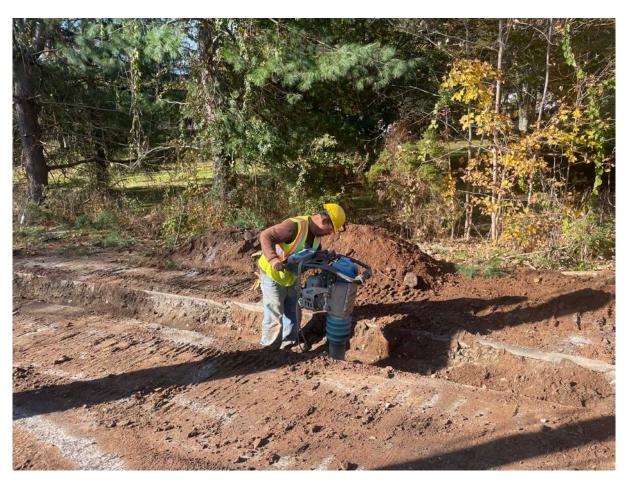
1143: Ludlow is backfilling over the 1.5" copper water service line they have installed so far at the 212R Maple Avenue property with sand, followed by caution tape, followed by native fill placed in 1' lifts. Ludlow is compacting the fill with a jumping jack.

Picture 5: Ludlow compacting native fill that was placed in 1' lifts over the sand and caution tape that was placed over the 1.5" copper water service line Ludlow installed at the 212R Maple Avenue property. View to the northwest.

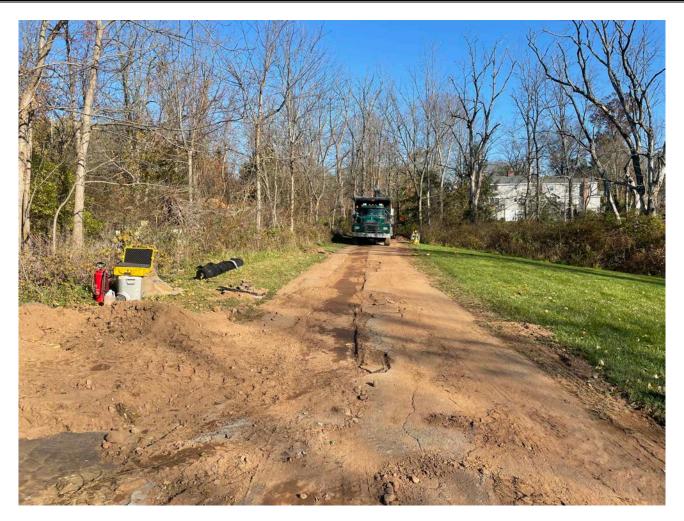
Picture 7: View of the progress at the end of the day at the 212R Maple Avenue property where Ludlow installed a 1.5" copper water service line. View to the east.

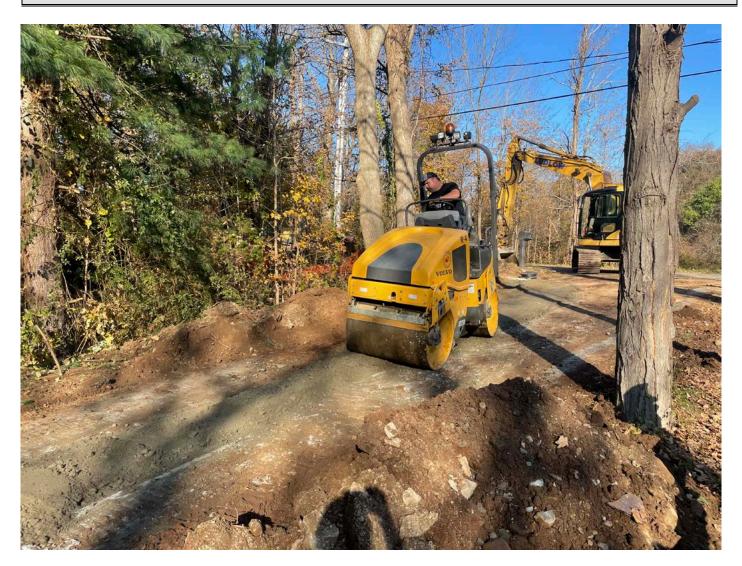
1325: Ludlow is placing 1.25"-minus gravel on the top 18" of the trench on the driveway for 212 Maple Avenue and compacting it with a rolling compactor.

Picture 8: Ludlow compacting 1.25"-minus gravel in the trench that was excavated for the installation of a 1.5" copper water service line at the 212R Maple Avenue property. View to the east.

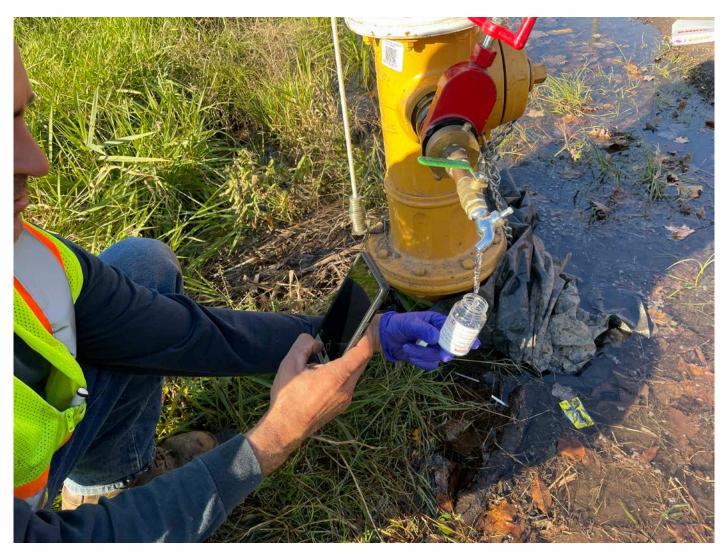
1357: Ludlow is preparing to collect chlorine and E.coli samples for lab analysis from the hydrant located on Brick Lane near the intersection of Maiden Lane.

Picture 9: Ludlow collecting a lab sample from the hydrant located on Brick Lane, next to where it intersects with Maiden Lane.
