## Daily Report

<b>Project:</b>	Durham Meadows Pipeline Installation	<b>Date:</b>	November 15, 2021
<b>Location:</b>	Maiden Lane, Pickett Lane, Maple Avenue, Durham	<b>Day of Week:</b>	Monday
<b>Project #:</b>	AECOM: 6061487	<b>Report No:</b>	363
<b>Contractor:</b>	Ludlow Construction	<b>Page:</b>	1 of 13

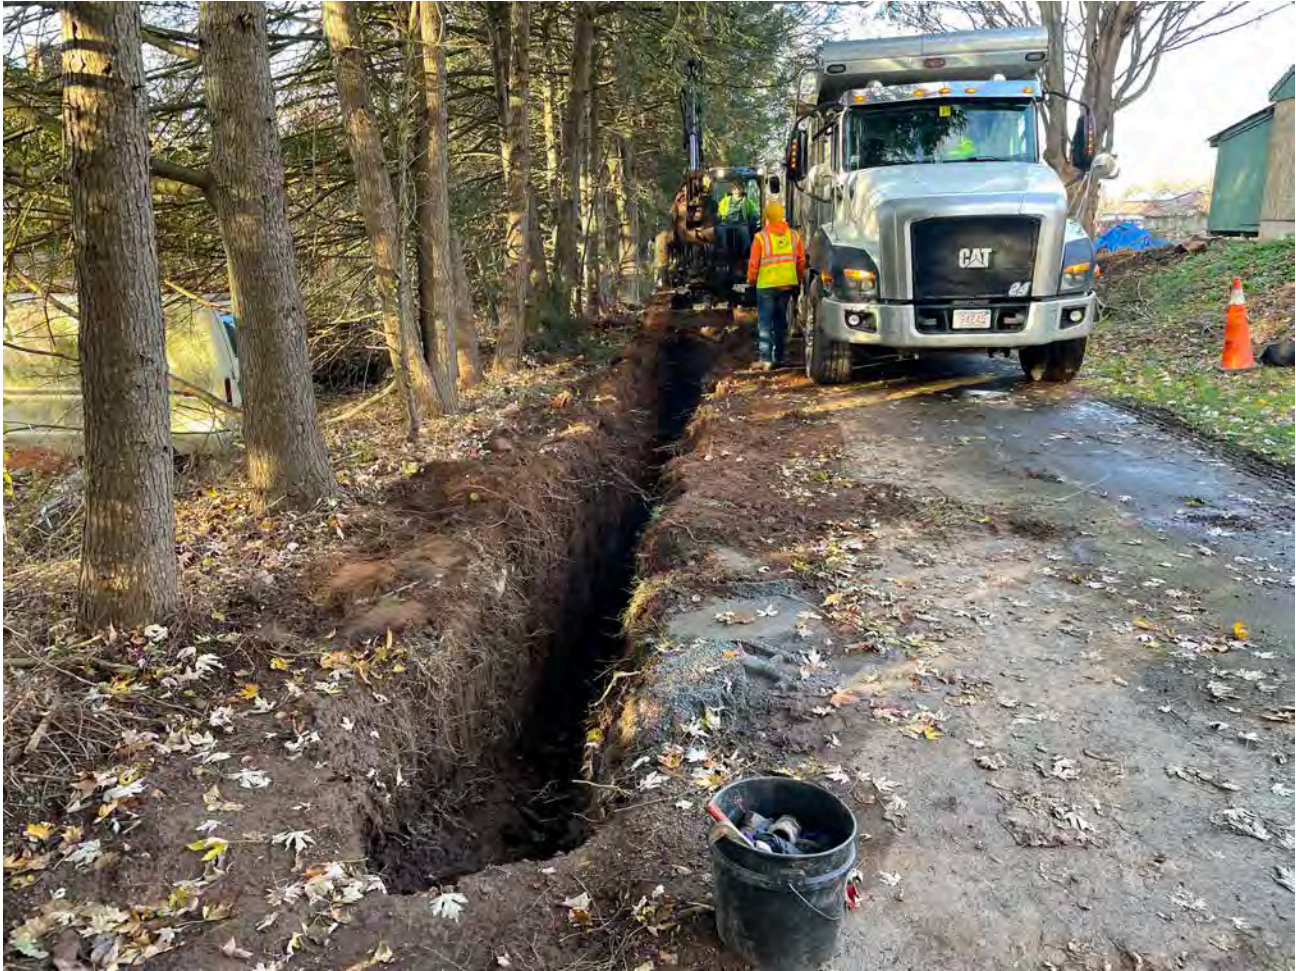
Picture 1: Trench that Ludlow is excavating on the south side of the driveway at the 228 Maple Avenue property for the installation of a 1.5" copper water service line. View to the west.

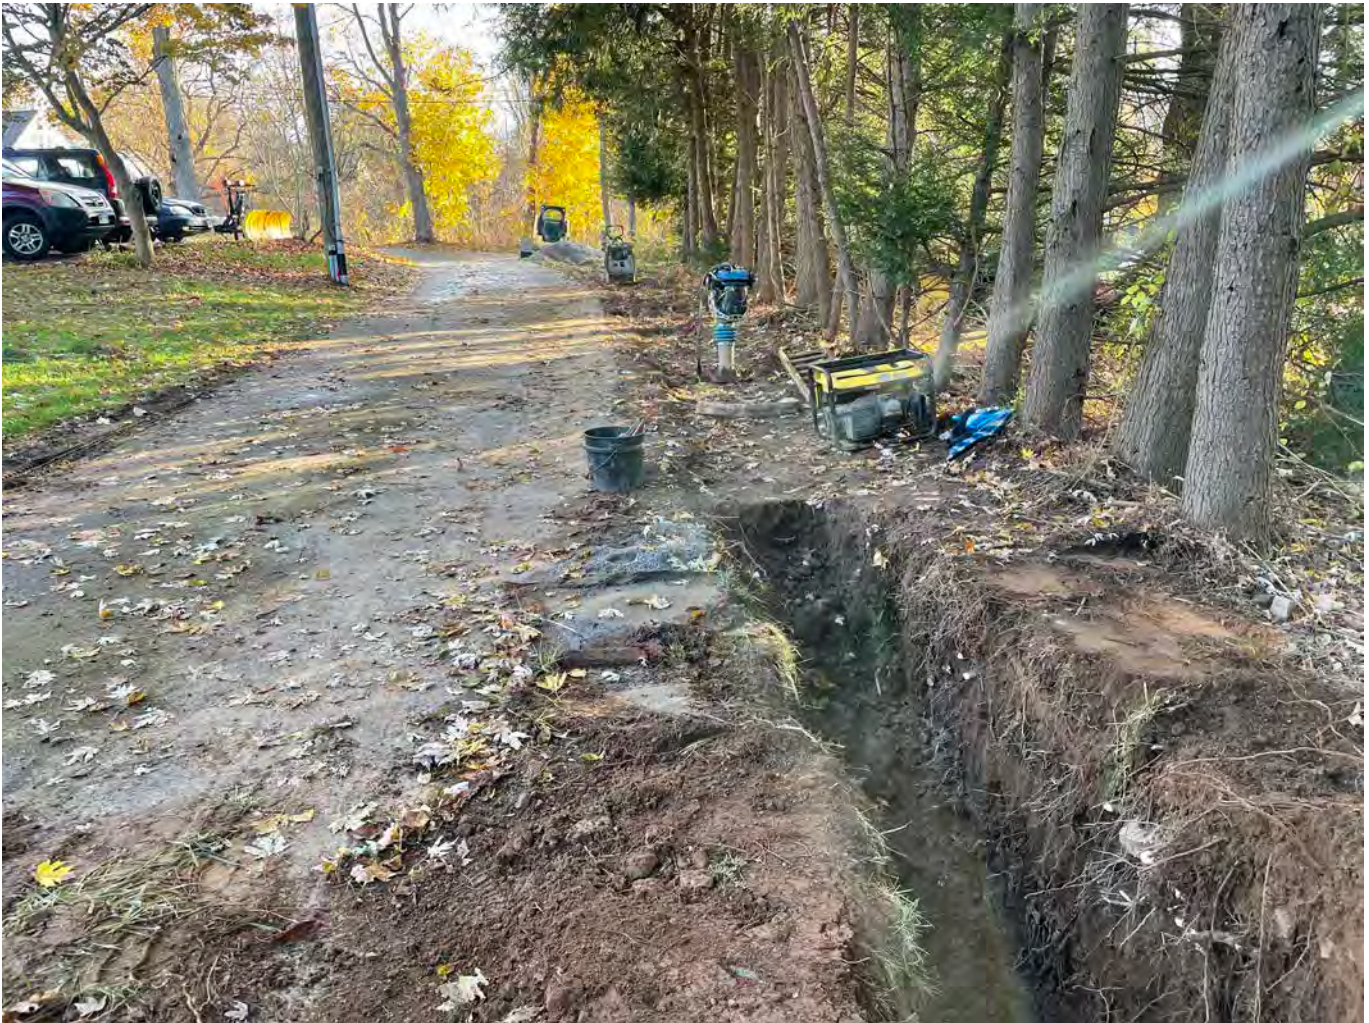
**Picture 2: Trench that Ludlow has begun to backfill over a 1.5" copper water service line at the 228 Maple Avenue property in Durham. View to the east.**

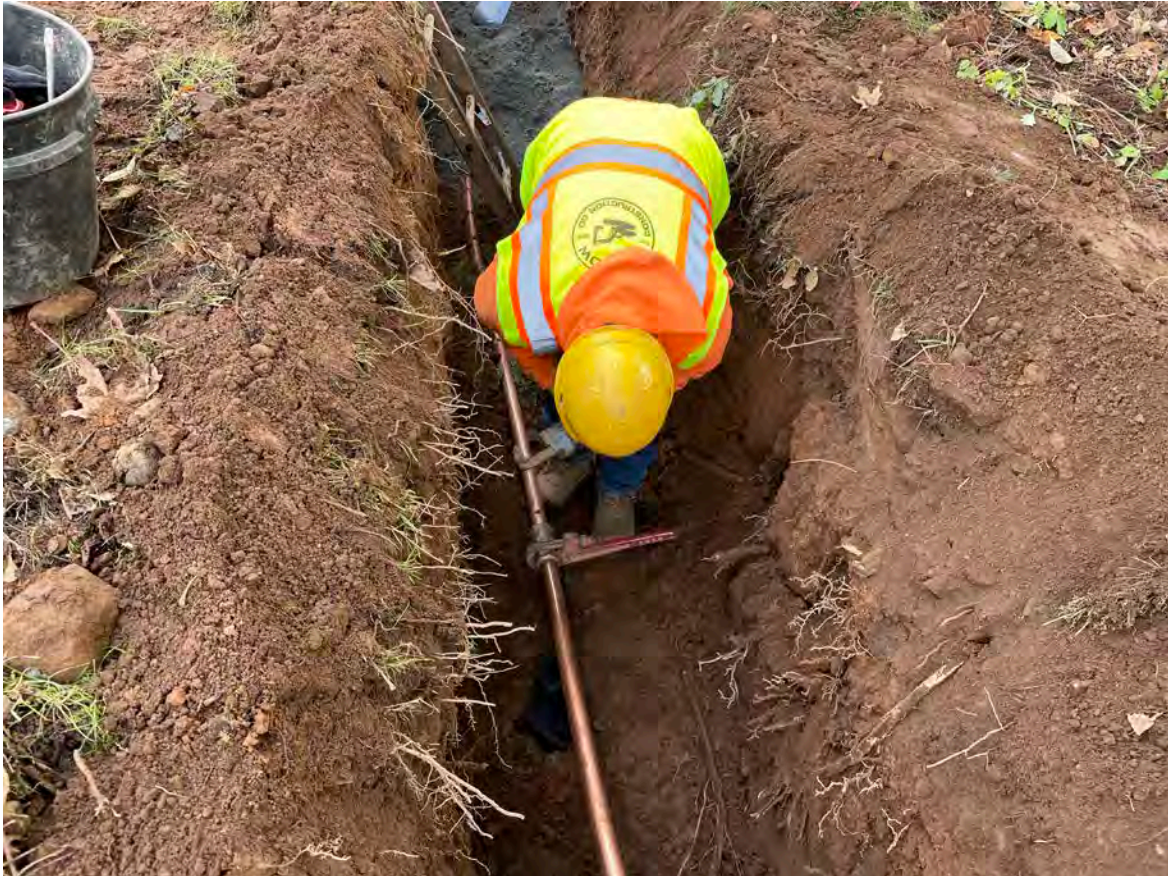
Picture 3: Ludlow joining two sections of 1.5" copper water pipe together at the 228R Maple Avenue property. View to the east.

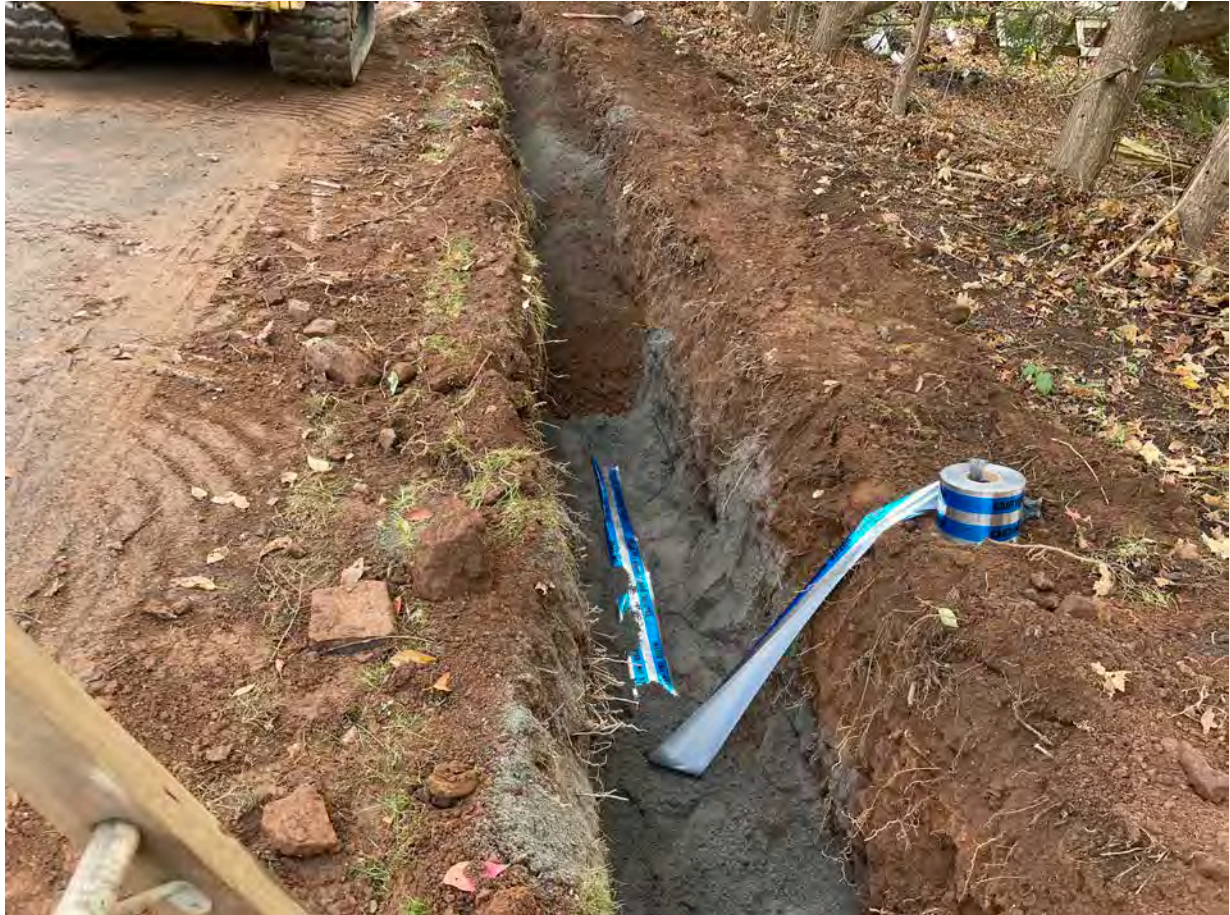
Picture 4: Sand, caution tape, and native fill that Ludlow has placed over the 1.5" copper water service line they installed at the 228R Maple Avenue property. View to the east.

1026: Ludlow has begun to backfill over the 1.5" copper water service line they are installing at the 228R Maple Avenue property. Ludlow is placing 6" of sand over the installed pipe, followed by caution tape, followed by native fill placed in 1' lifts that are being compacted with a jumping jack.

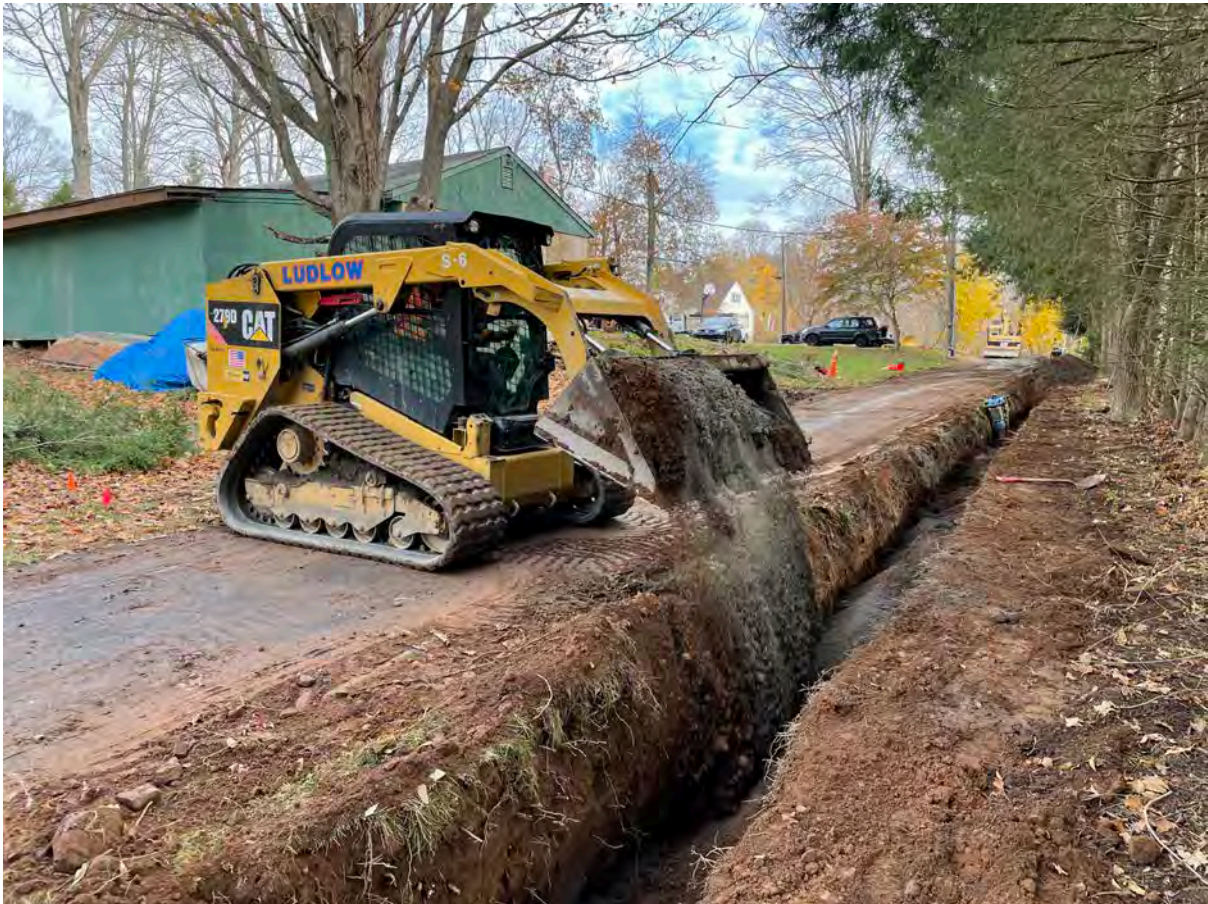
Picture 5: Ludlow placing sand over the 1.5" copper water service line they are installing at the 228R Maple Avenue property. View to the east.

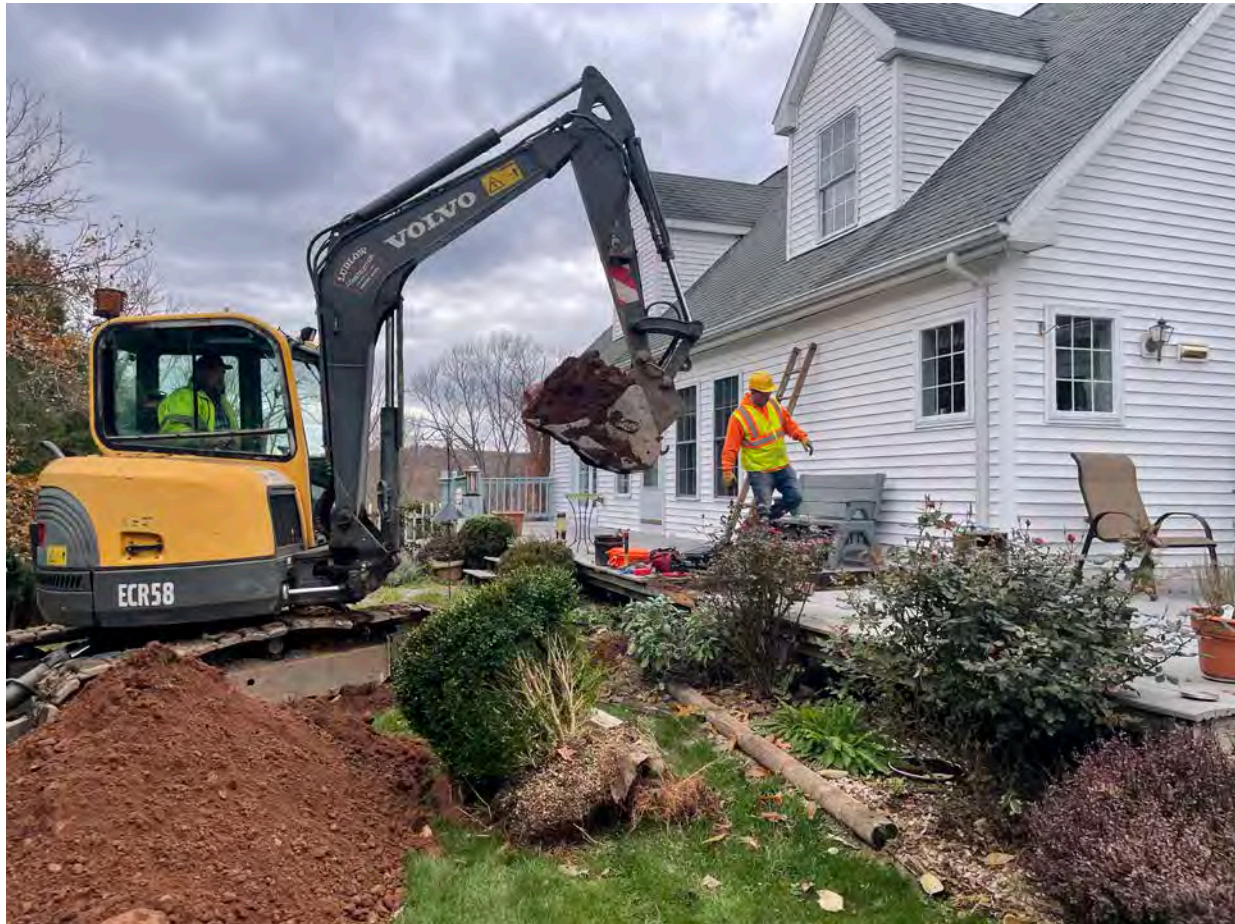
Picture 6: Ludlow excavating a trench on the south side of the 228R Maple Avenue residence for the installation of a 1.5" copper water service line. View to the west.

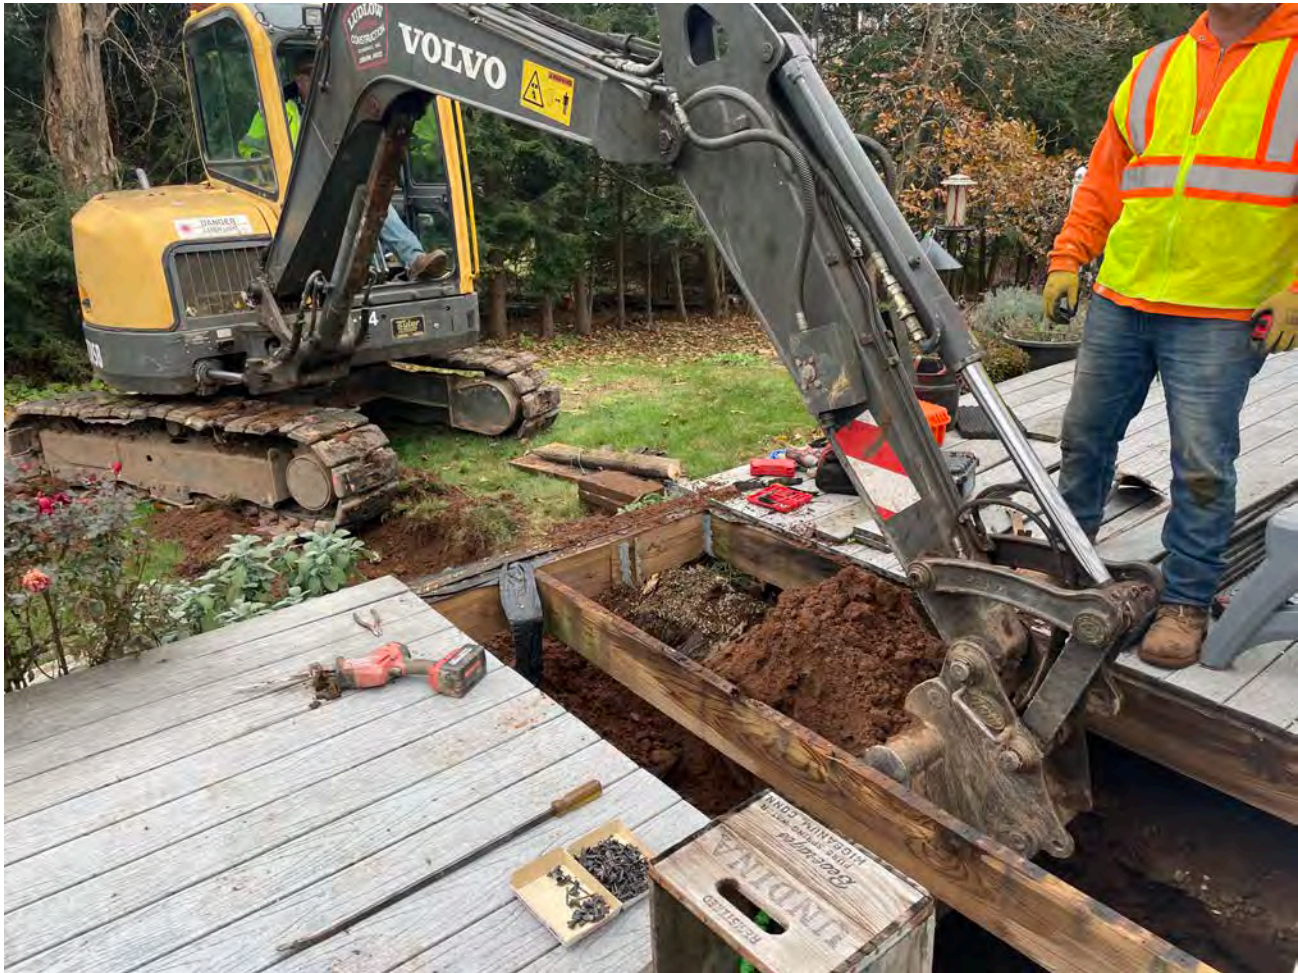
Picture 7: Ludlow excavating a trench on the south side of the 228R Maple Avenue residence for the installation of a 1.5" copper water service line. View to the southwest

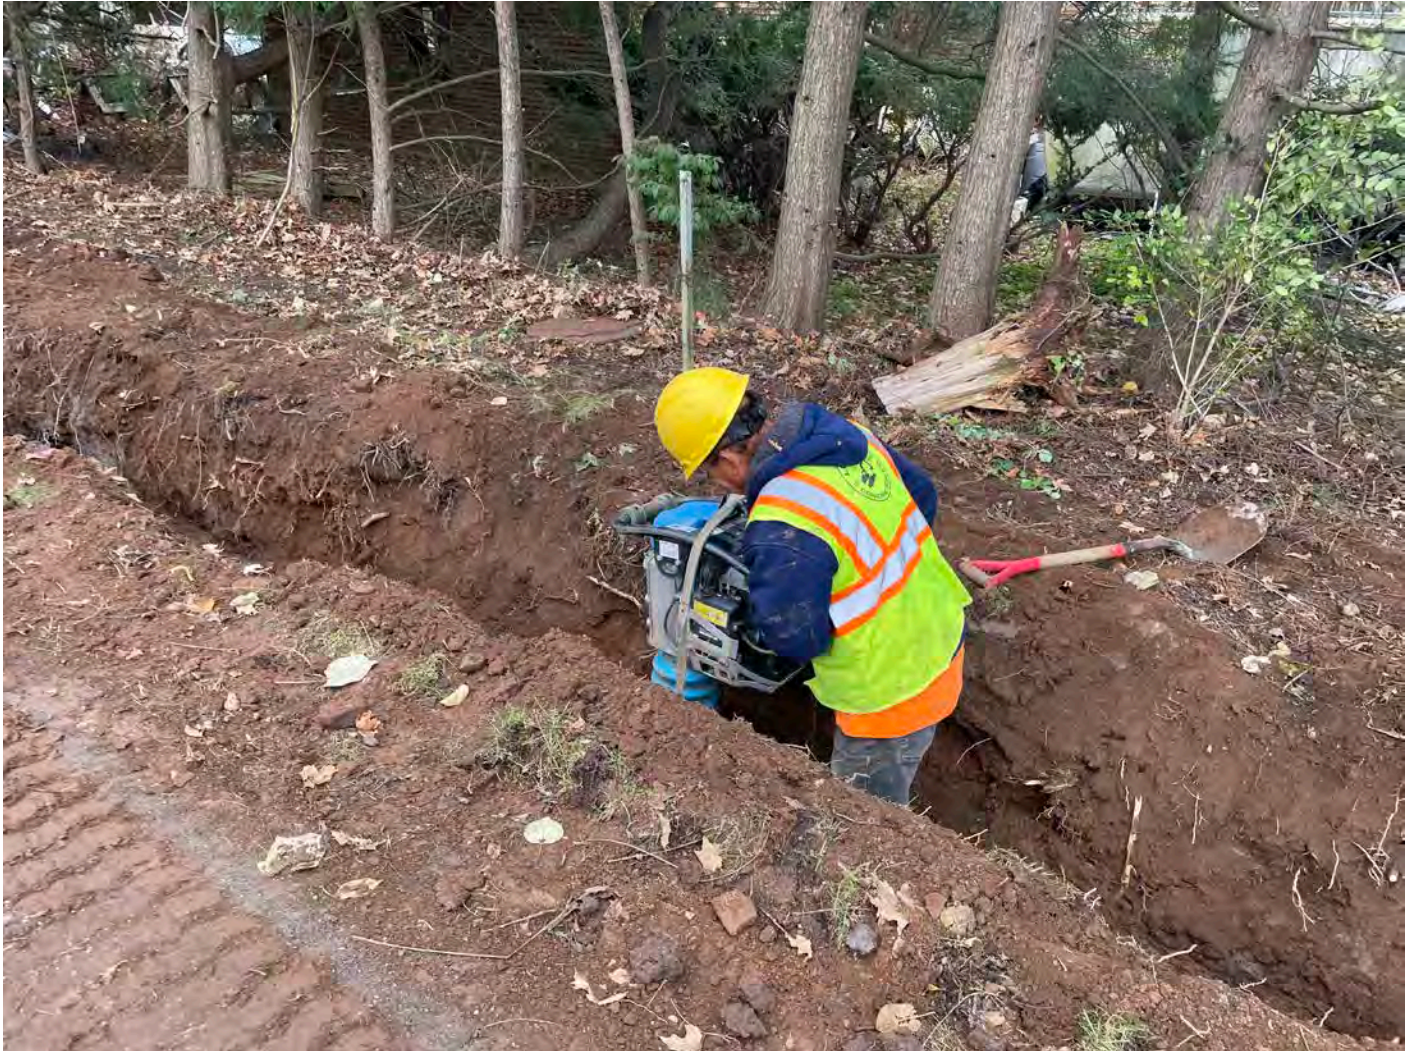
**Picture 8: Ludlow compacting native fill that has been placed in a 1' lift over they sand and caution tape that was placed over the 1.5" copper water service line they installed at the 228R Maple Avenue property. View to the southeast.**

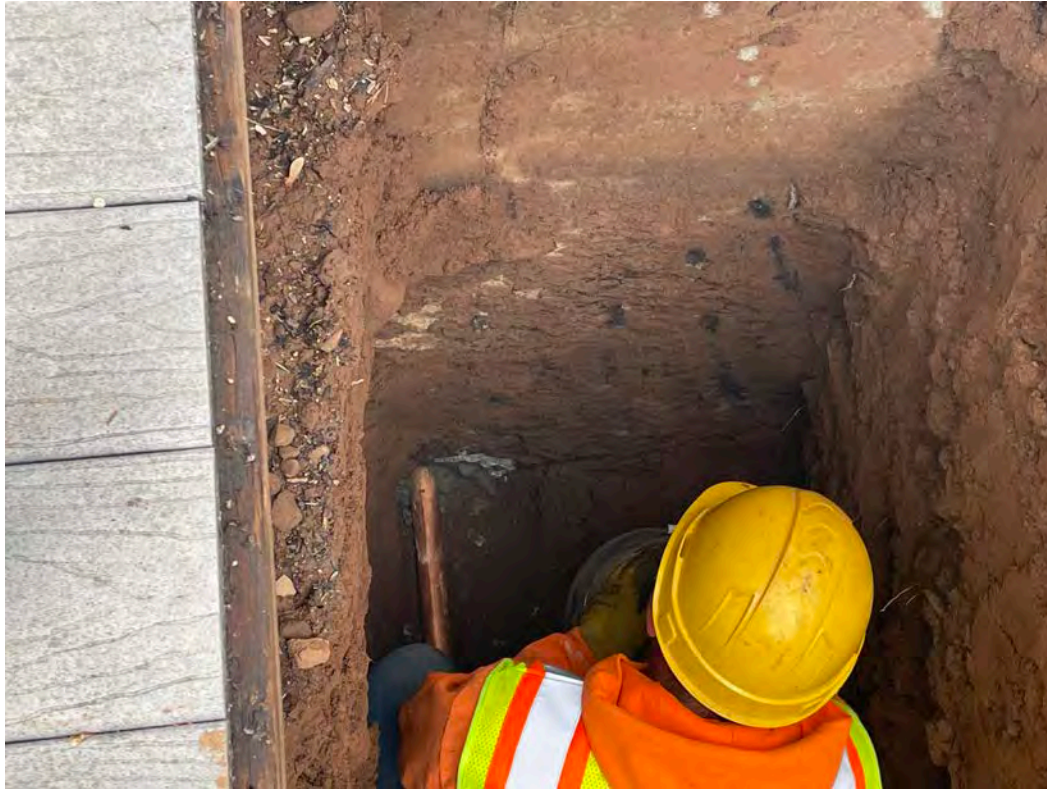
**Picture 9: Ludlow using non-shrink grout to secure a 1.5" copper water service line where it penetrates the southern foundation of the 228R Maple Avenue residence. View to the north**

1351: Ludlow has penetrated the south side of the poured-concrete foundation of the 228R Maple Avenue residence and has inserted the 1.5" copper water service line through it. Ludlow made the insertion with a rotary hammer: the insertion point is located 42' east of the home's southwest corner. Ludlow is preparing to use non-shrink grout to secure the copper waterline in place where it penetrates the foundation.

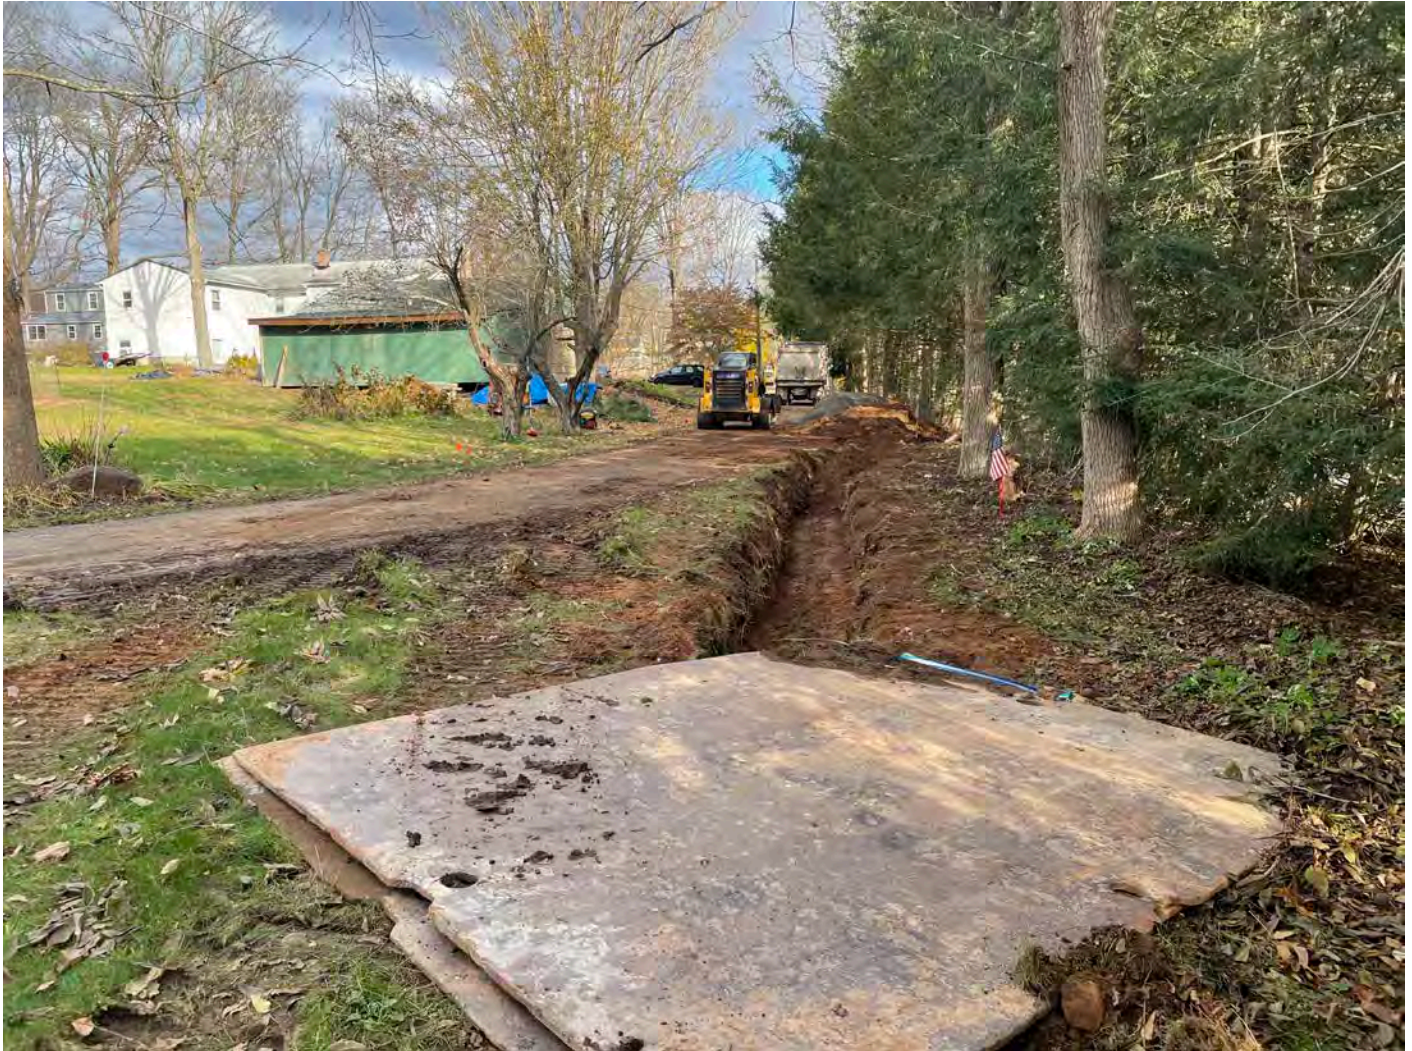
**Picture 10: View of the trench that Ludlow has partially backfilled over 1.5" copper water service line that they installed on the south side of the driveway at the 228R Maple Avenue property. View to the east.**
