Daily Report

Project:	Durham Meadows Pipeline Installation	Date:	December 1, 2021
Location:	Talcott Lane, Durham	Day of Week:	Wednesday
Project #:	AECOM: 6061487	Report No:	373
Contractor:	Ludlow Construction	Page:	1 of 9

Daily Activities – Installation of water lines, Main Street, Durham

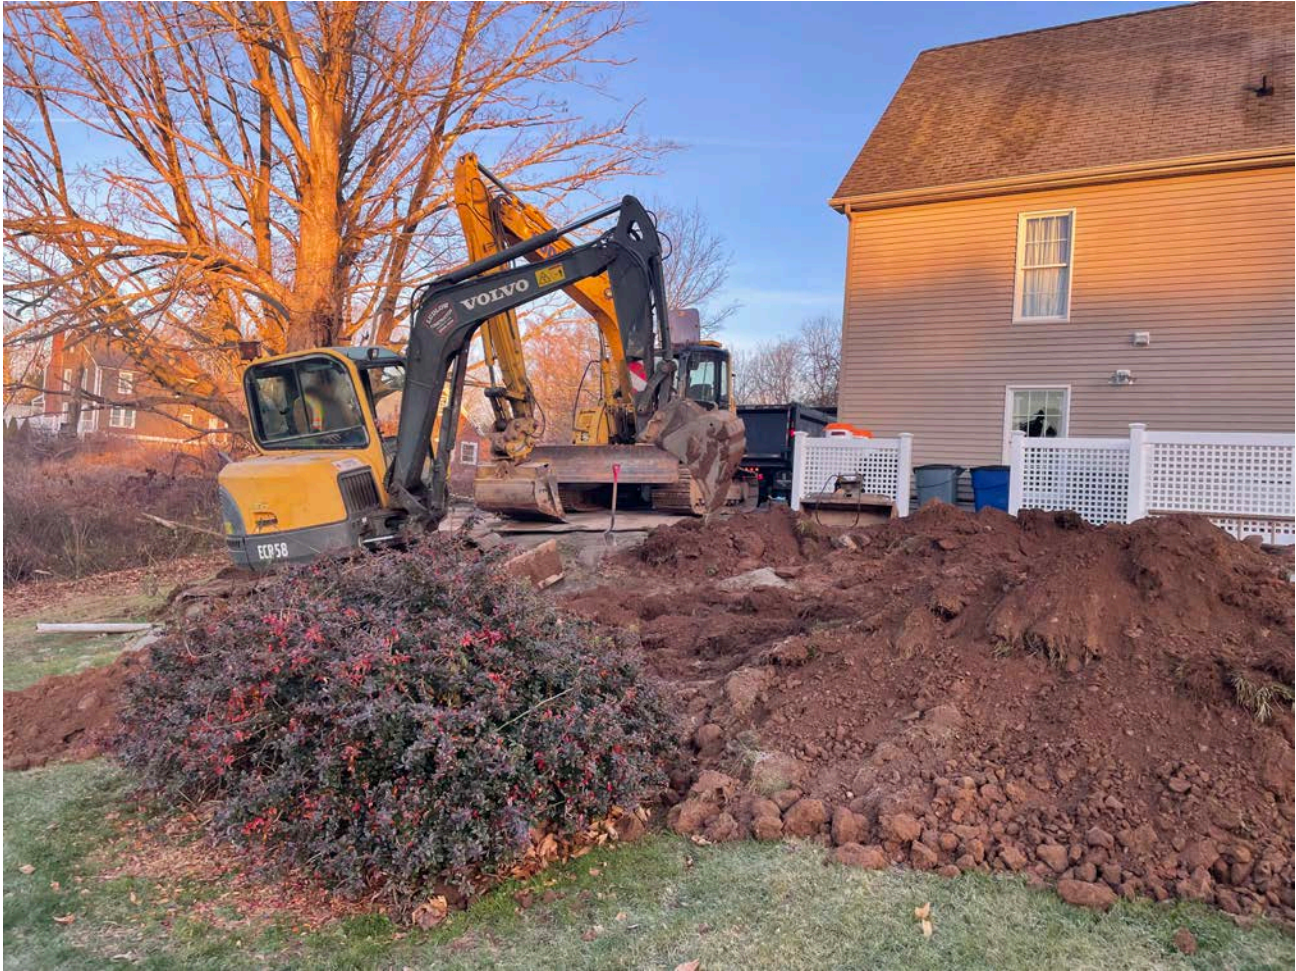
Picture 1: Ludlow excavating a trench on the south side of the 14 Talcott Lane residence for the installation of a 2" copper water service line. View to the northwest.

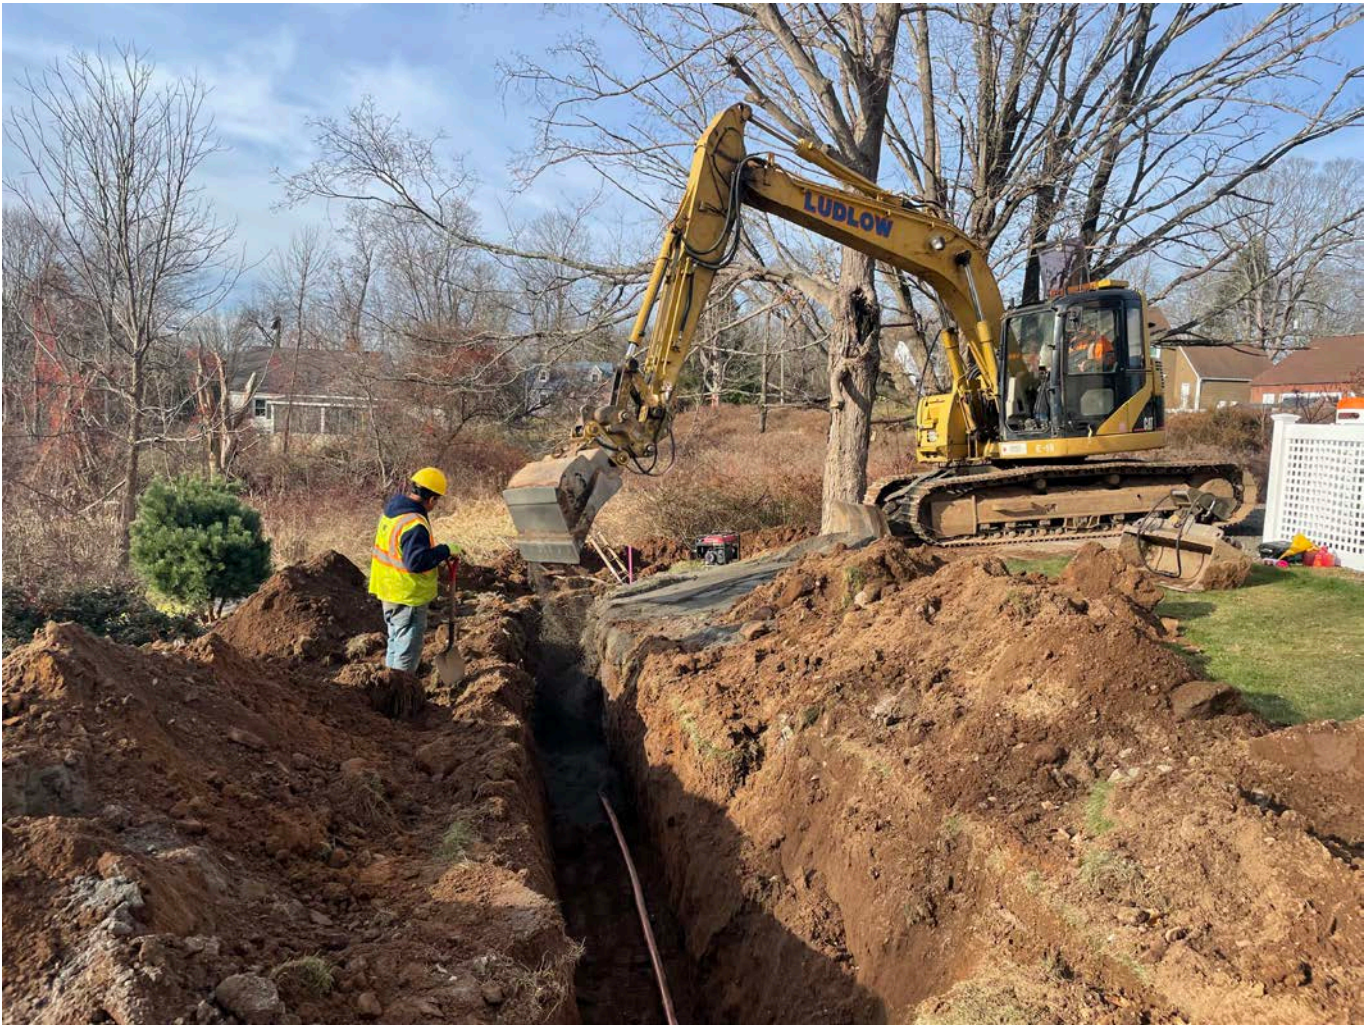
0940: Ludlow continues to excavate at the 14 Talcott Lane property for the installation of a 2" copper water service line. Ludlow has begun to place sand above and below the section of the 2" copper waterline they have already installed: 6" of sand was placed beneath the pipe and 12" of sand was placed over it.

Picture 2: Ludlow placing sand above and below the 2" copper water service line on the west side of the driveway for the 14 Talcott Lane property. View to the south.

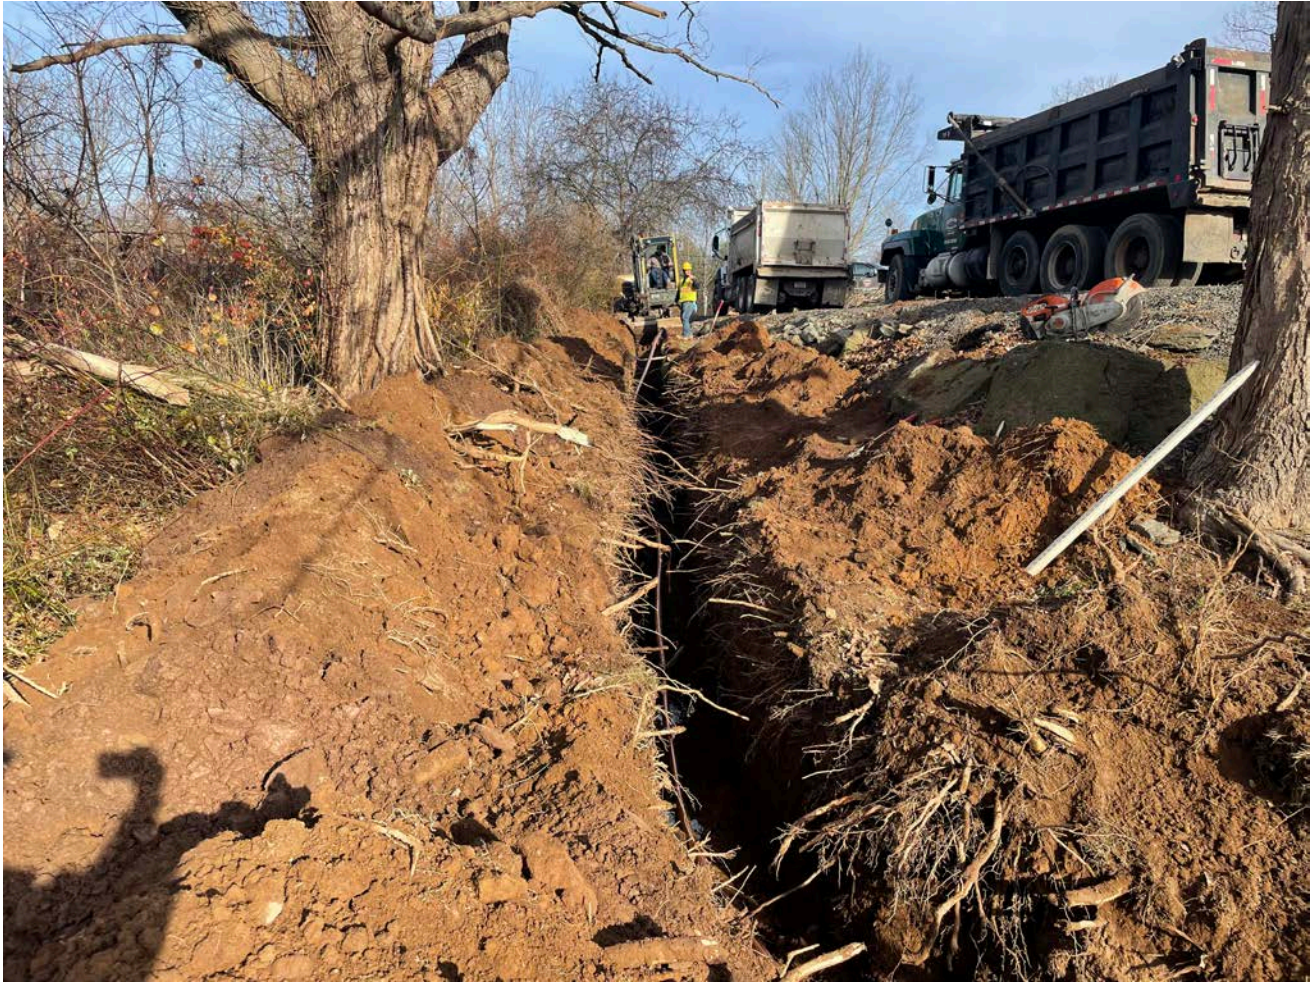
Picture 3: Trench that Ludlow has excavated on the west side of the 14 Talcott Lane property for the installation of a 2" copper water service line. View to the north.

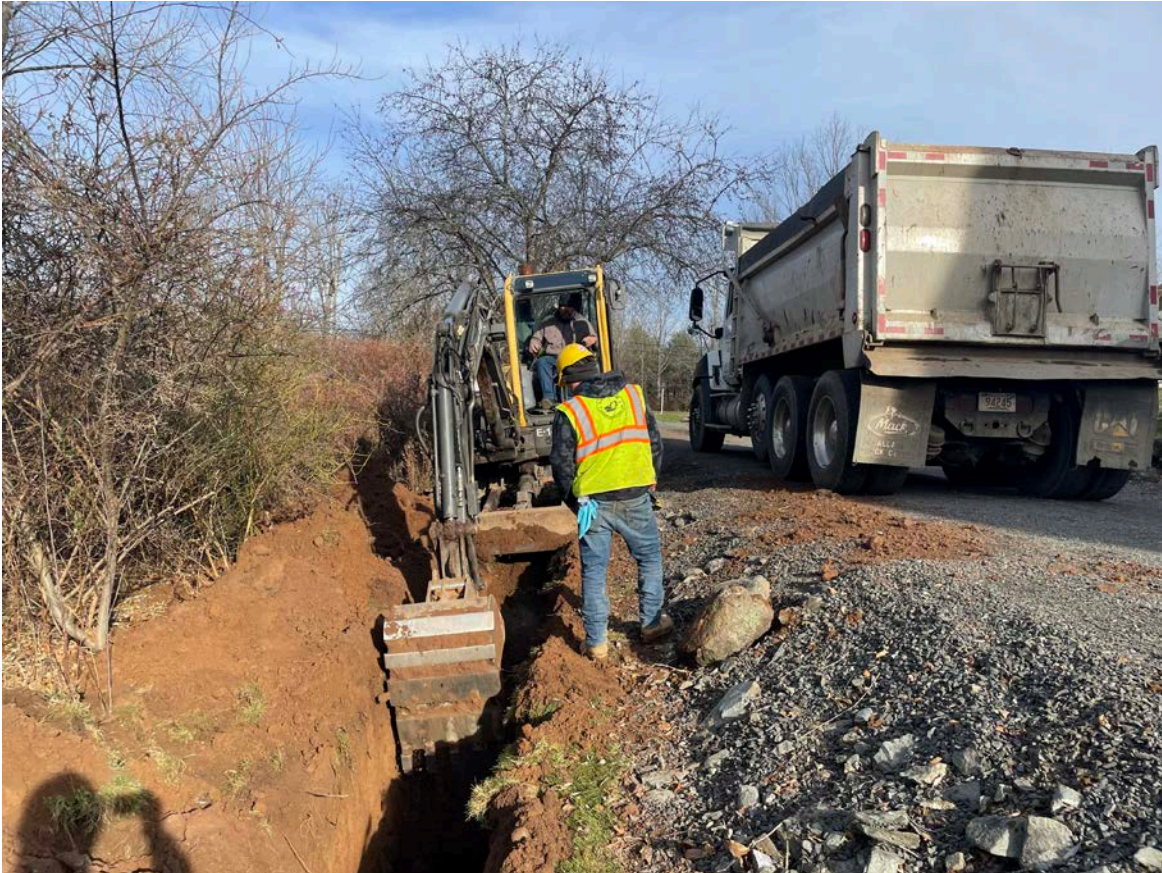
Picture 4: Ludlow excavating on the west side of the driveway for the 14 Talcott Lane property for the installation of a 2" copper water service line. View to the north.

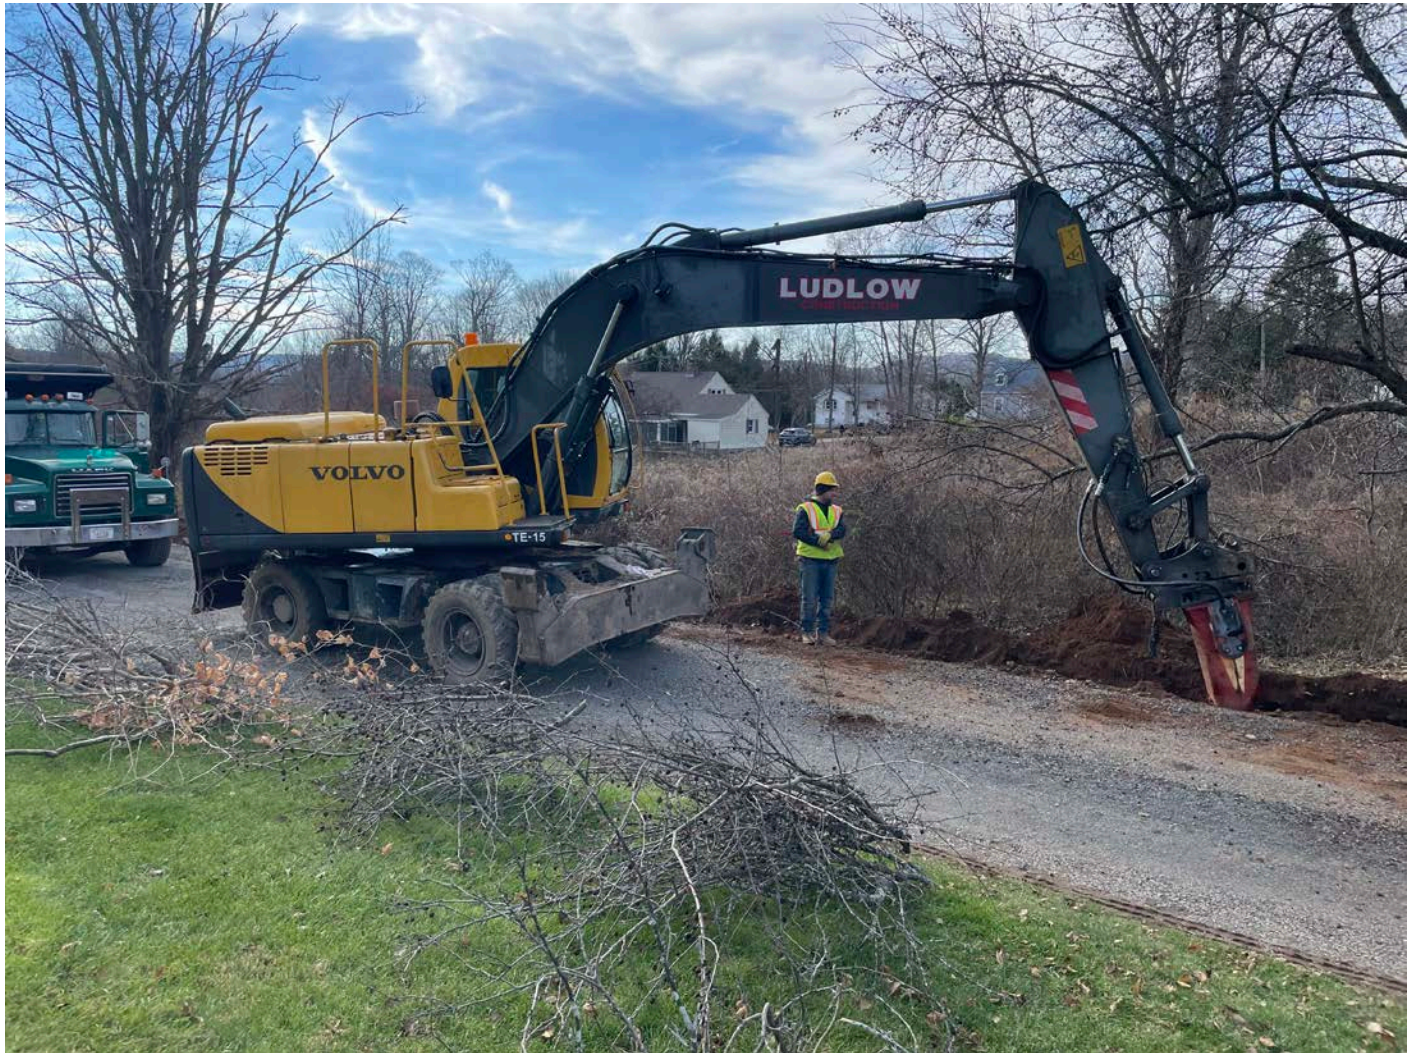
1157: Ludlow encounters more rock in the trench they are excavating on the west side of the driveway for the 14 Talcott Lane property. Ludlow is using a large excavator equipped with a hammer to break up the rock so the trench can be excavated to its target depth.

Picture 5: Ludlow hammering rock on the west side of the driveway at 14 Talcott Lane as they continue the installation of a 2" copper water service line. View to the southwest.

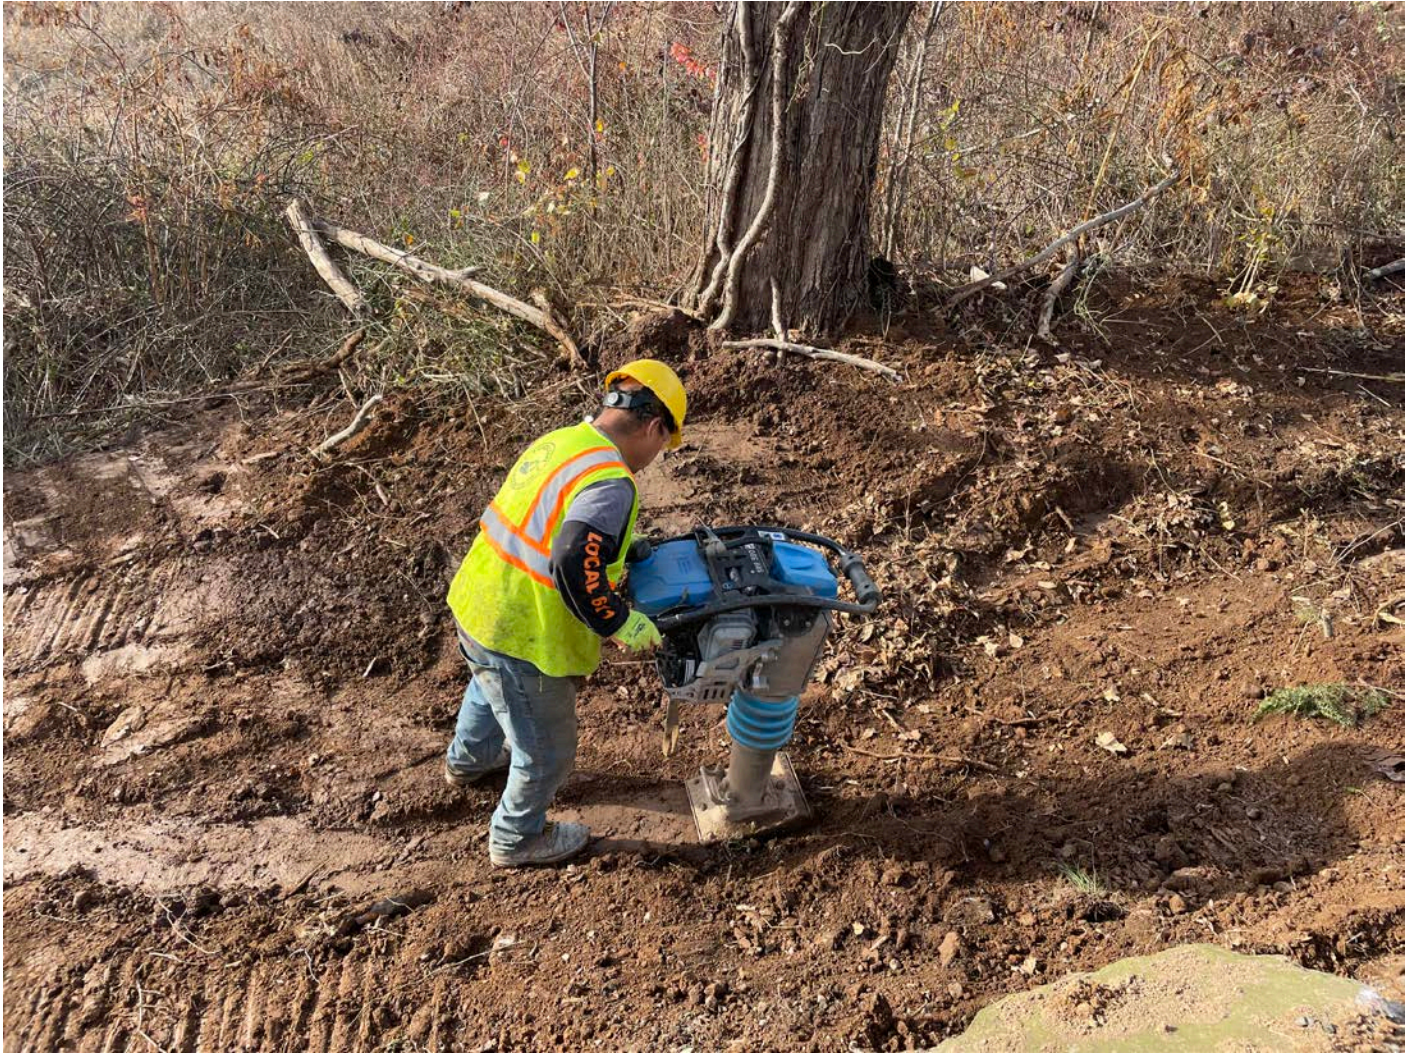
1300: Ludlow has the 2" copper water service line they have installed so far at the 14 Talcott Lane property backfilled up to a point located immediately west of the northwest corner of the residence. Ludlow continues to place sand, followed by caution tape, followed by native fill placed in 1' lifts as they work north towards Talcott Lane. Ludlow is compacting the 1' lifts of native fill with a jumping jack.

Picture 6: Ludlow using a jumping jack to compact native fill that they are backfilling the trench at the 14 Talcott Lane property with in 1' lifts View to the west.

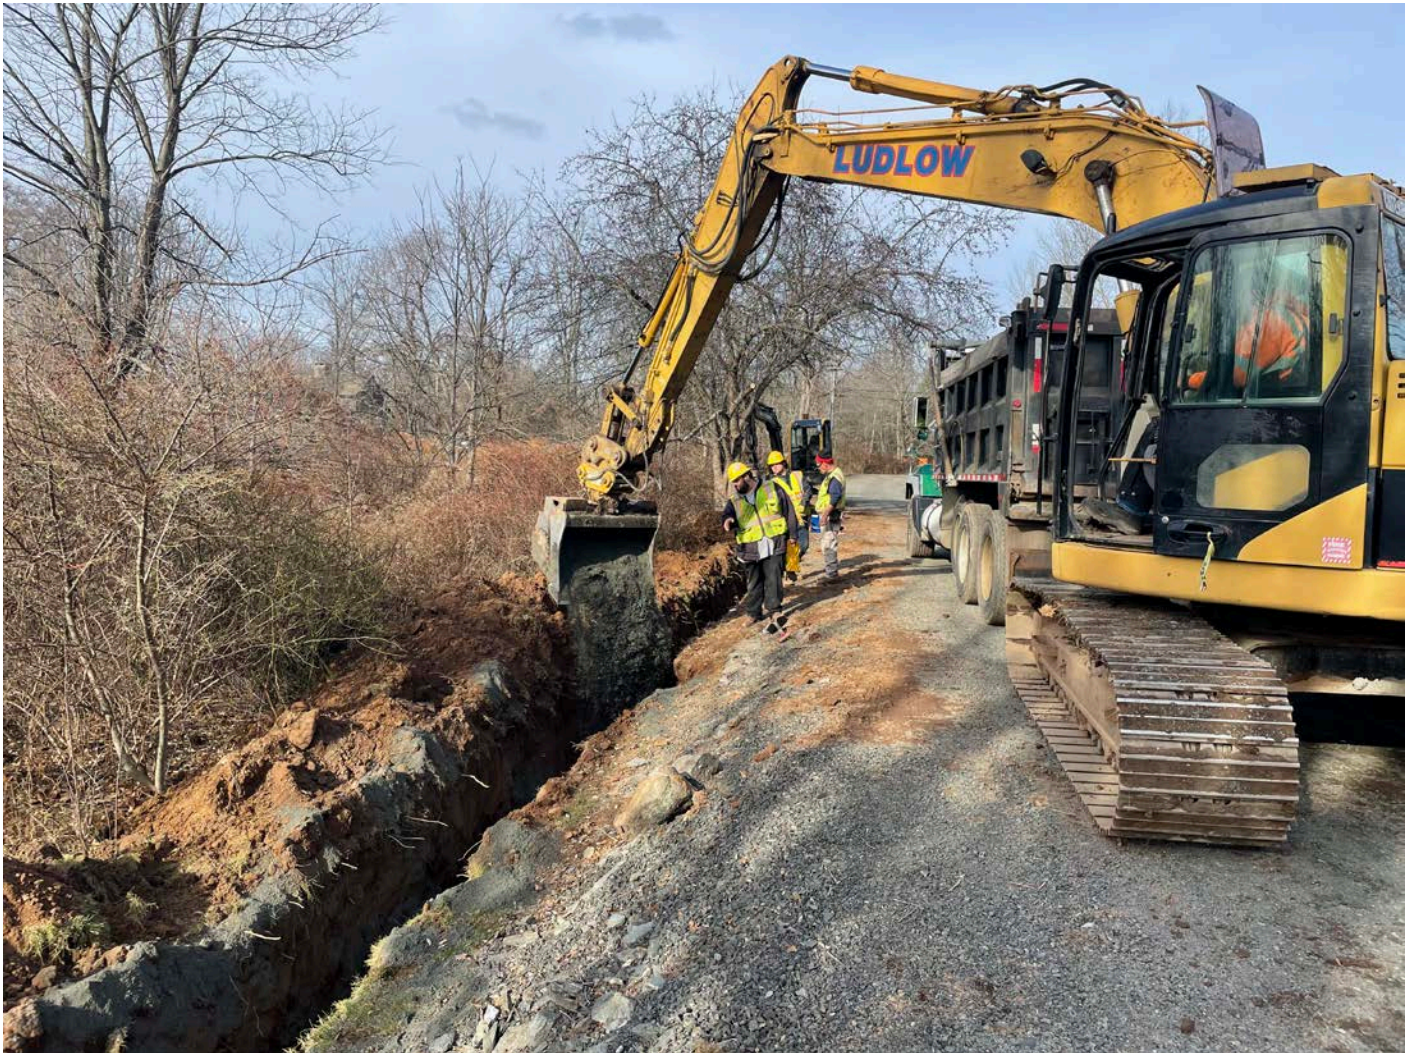
Picture 7: Ludlow placing sand over the 2" copper water service line they have installed on the west side of the driveway for the 14 Talcott Lane property. View to the north.
