## Daily Report

<b>Project:</b>	Durham Meadows Pipeline Installation	<b>Date:</b>	April 12, 2022
<b>Location:</b>	Main Street, Durham	<b>Day of Week:</b>	Tuesday
<b>Project #:</b>	AECOM: 6061487	<b>Report No:</b>	402
<b>Contractor:</b>	Ludlow Construction	<b>Page:</b>	1 of 12

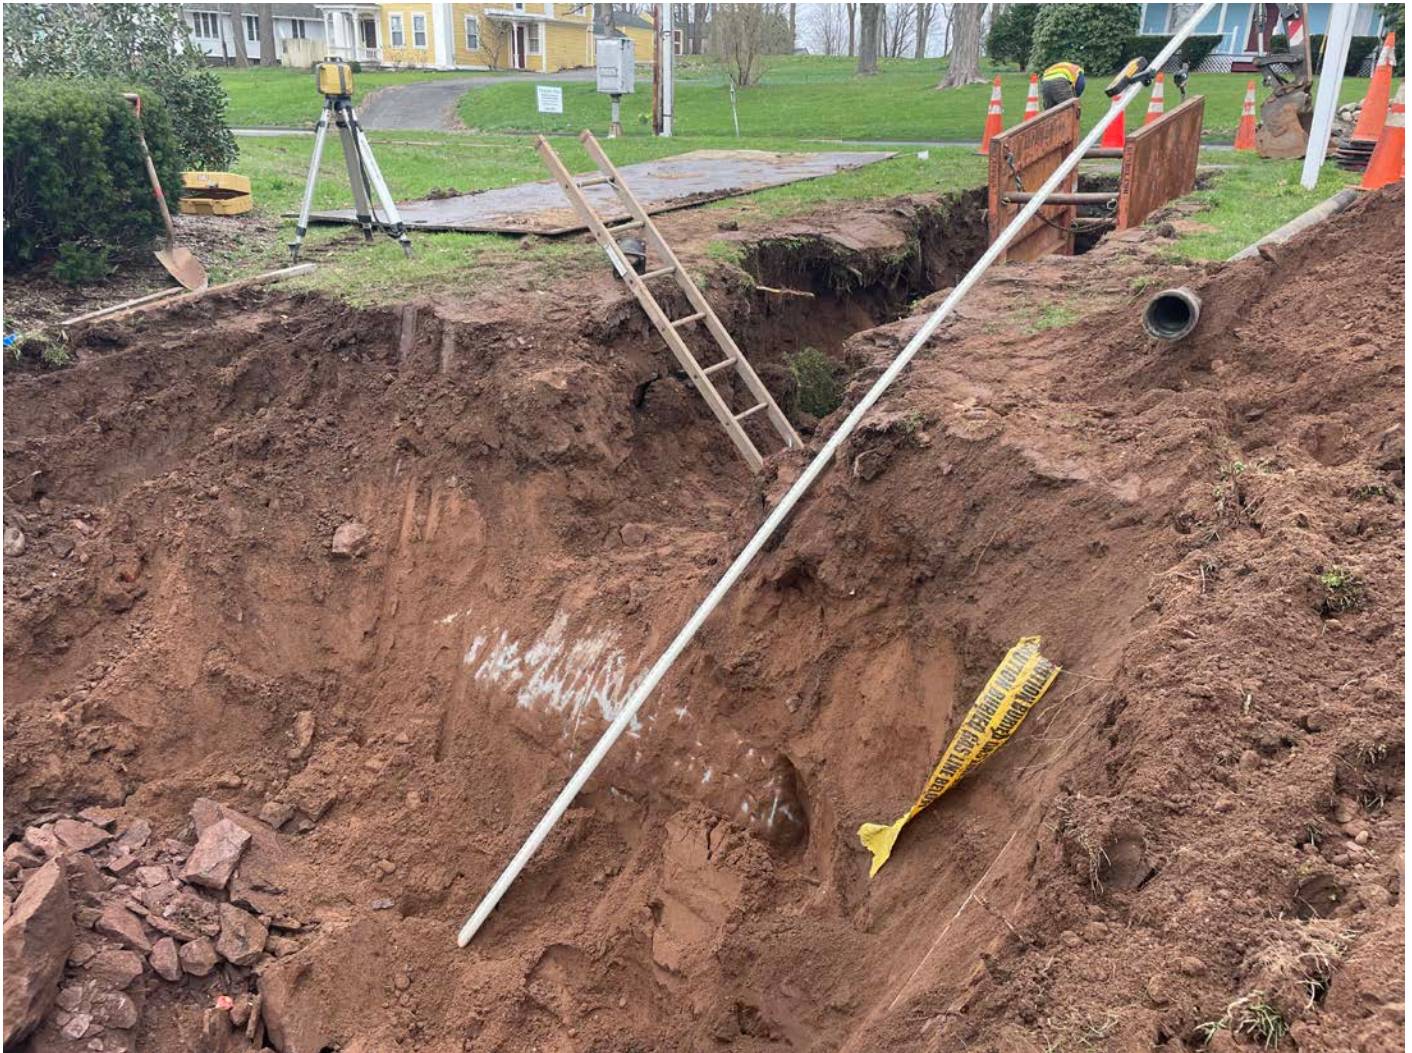
Picture 1: Pit that Ludlow is excavating for the placement of a water meter vault on 4-14-22. The east side of one of two underground water tanks can be seen approximately 4' below surface grade. View to the west/southwest.

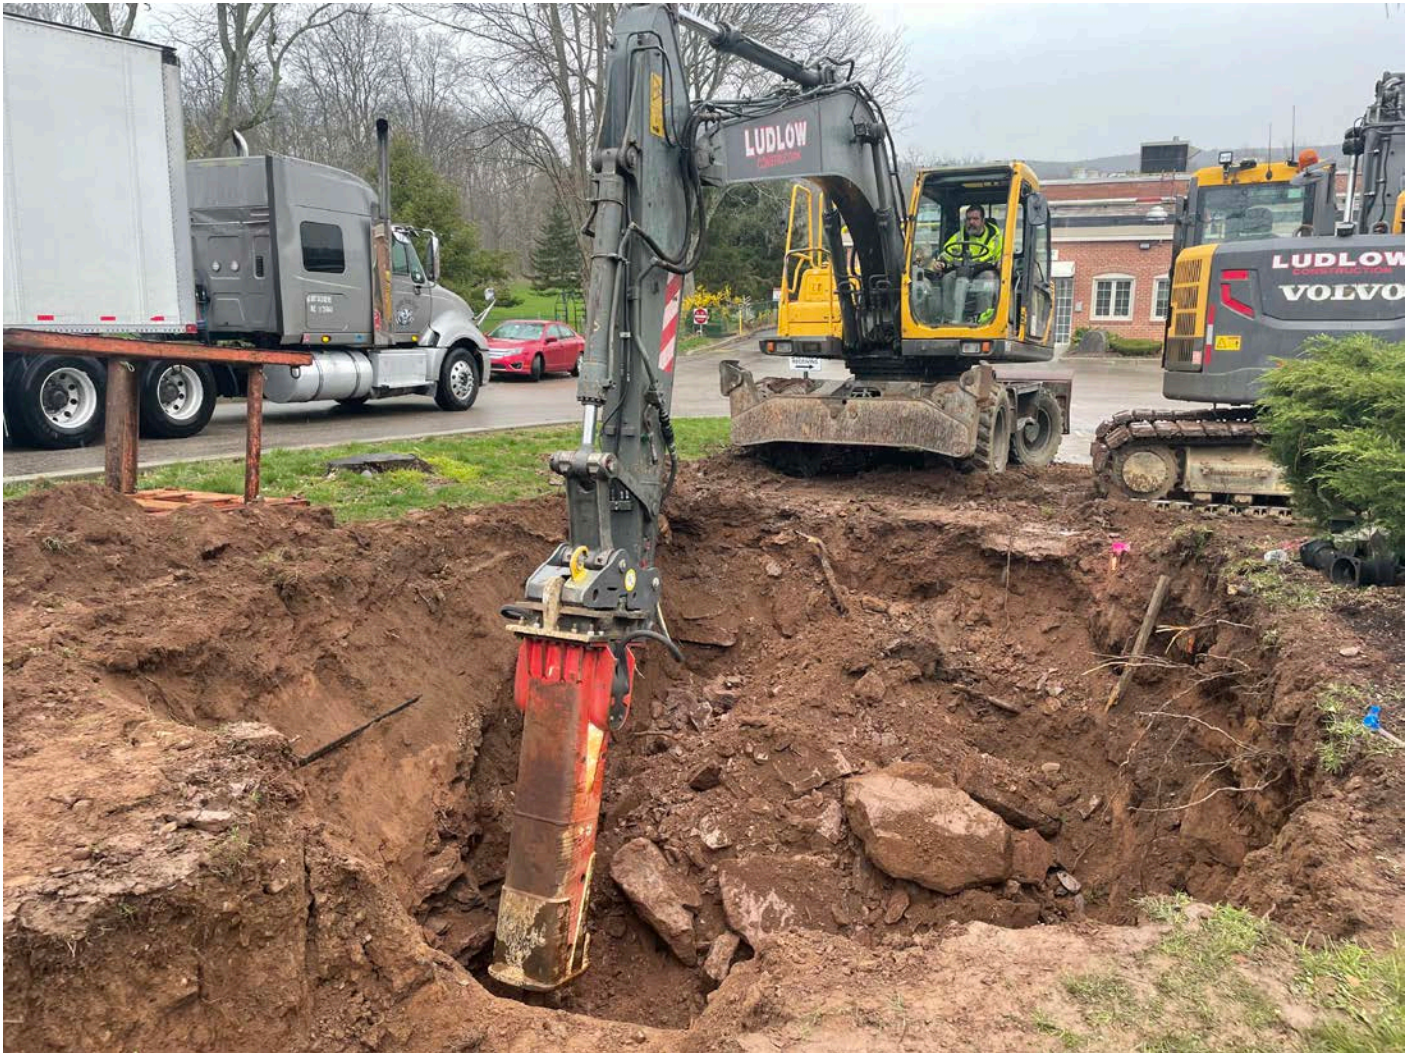
0941: Ludlow is using a pneumatic hammer attached to a mid-sized excavator to break up rock in the pit they are excavating for the placement of a water meter vault tomorrow.

Picture 2: Ludlow using a pneumatic hammer to break up rock as they excavate a pit for the placement of a water meter vault on 4-14-22. View to the west.

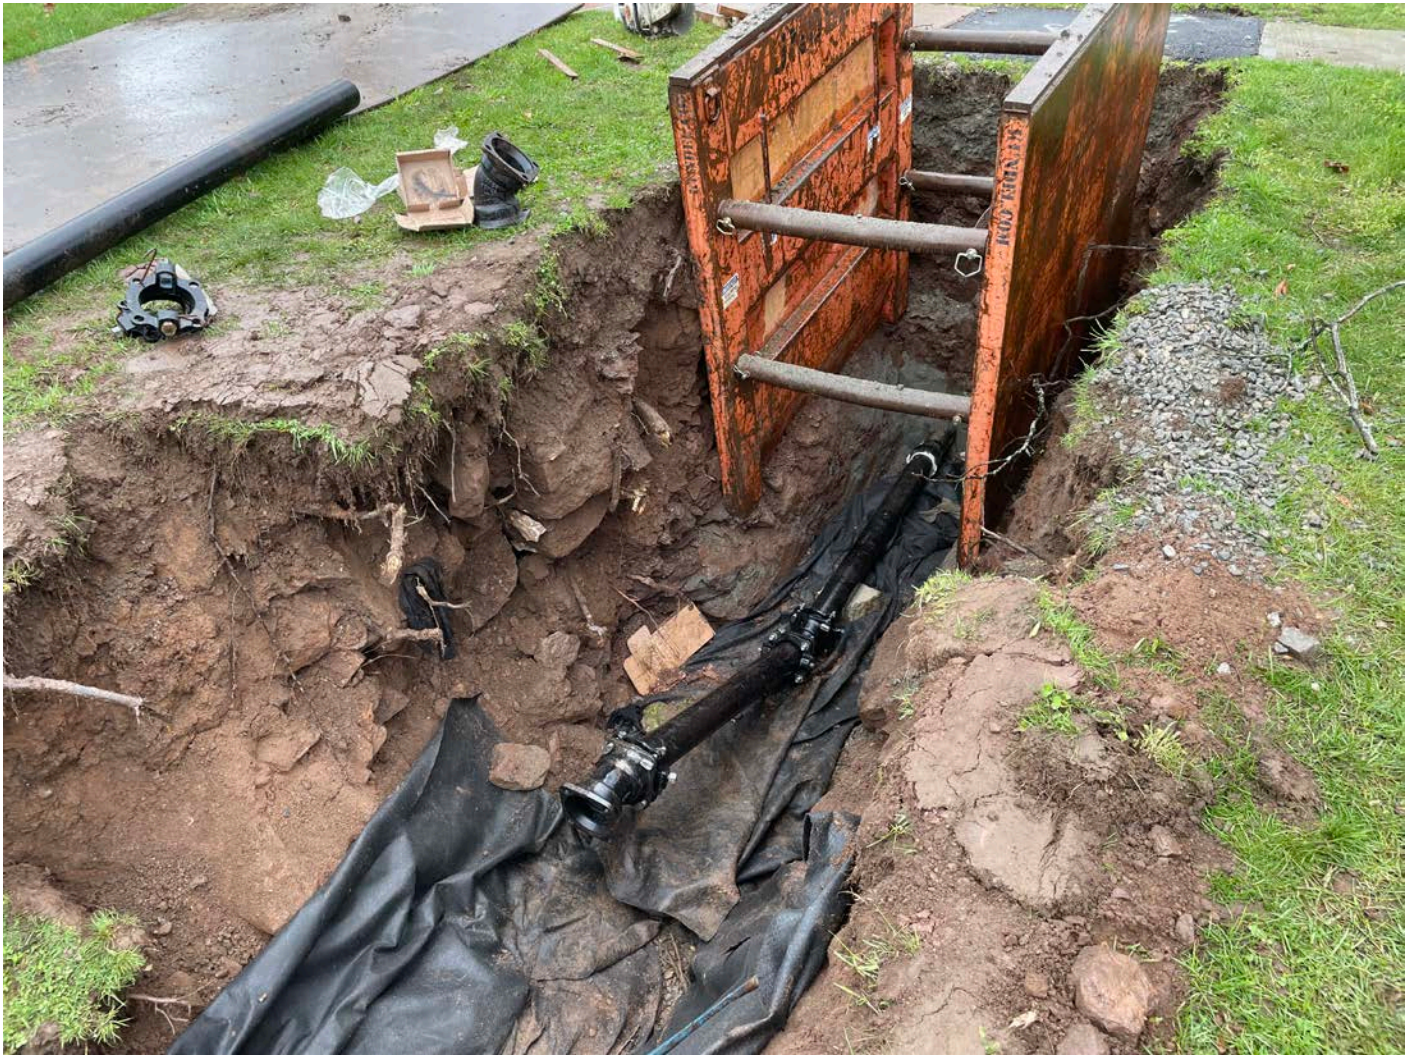
Picture 3: 4" DIP water service line that Ludlow has begun to install at the Durham Manufacturing property. View to the west.

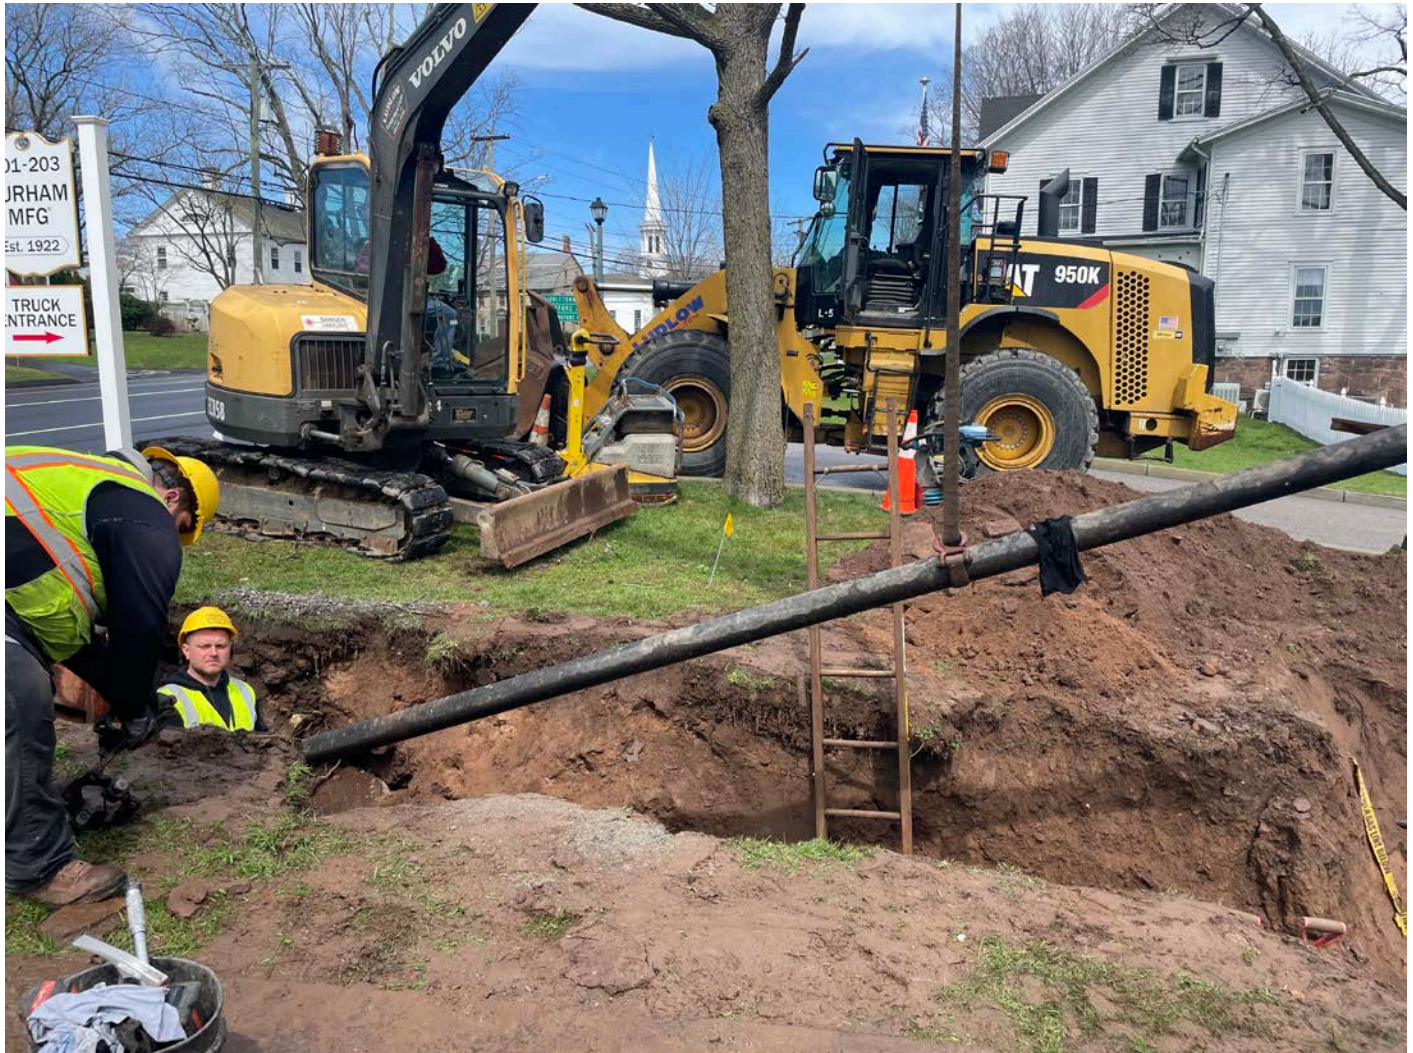
Picture 4: Ludlow in the process of installing 4" DIP water service line at the Durham Manufacturing property. View to the north.

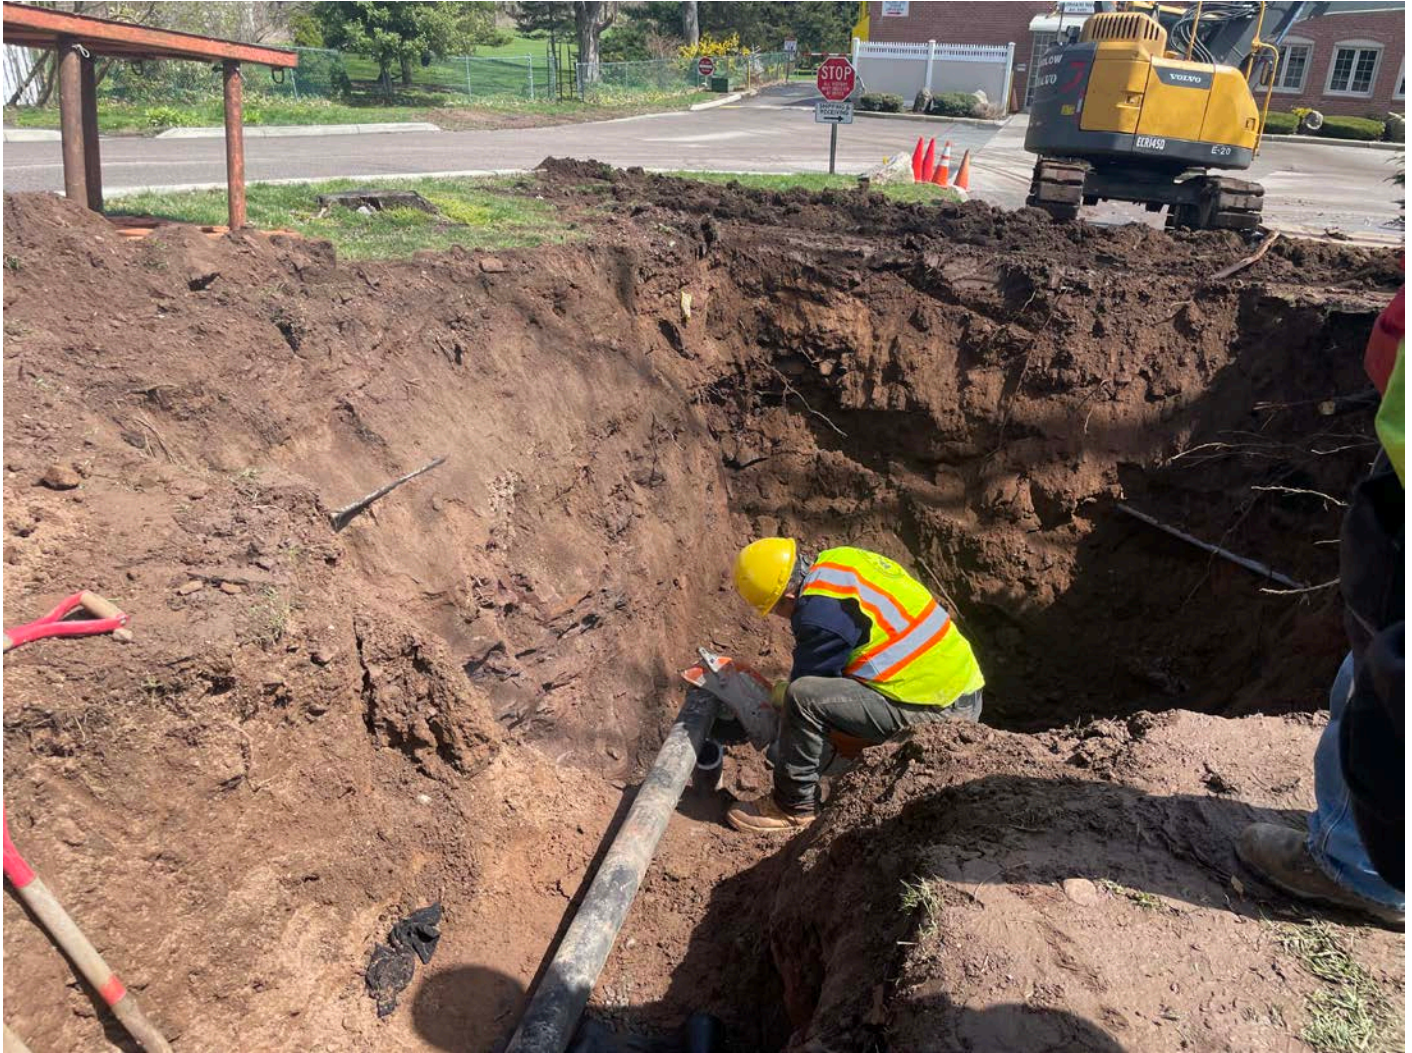
1224: Ludlow has cut approximately 4' off of the 18' section of 4" DIP they just installed on the west side of the water meter vault they will install tomorrow. Ludlow is currently setting a large trench box inside of the pit they excavated for the installation of the water meter vault tomorrow.

Picture 5: Ludlow saw cutting excess 4" DIP they just installed on the west side of where the water meter vault will be installed tomorrow. View to the east.

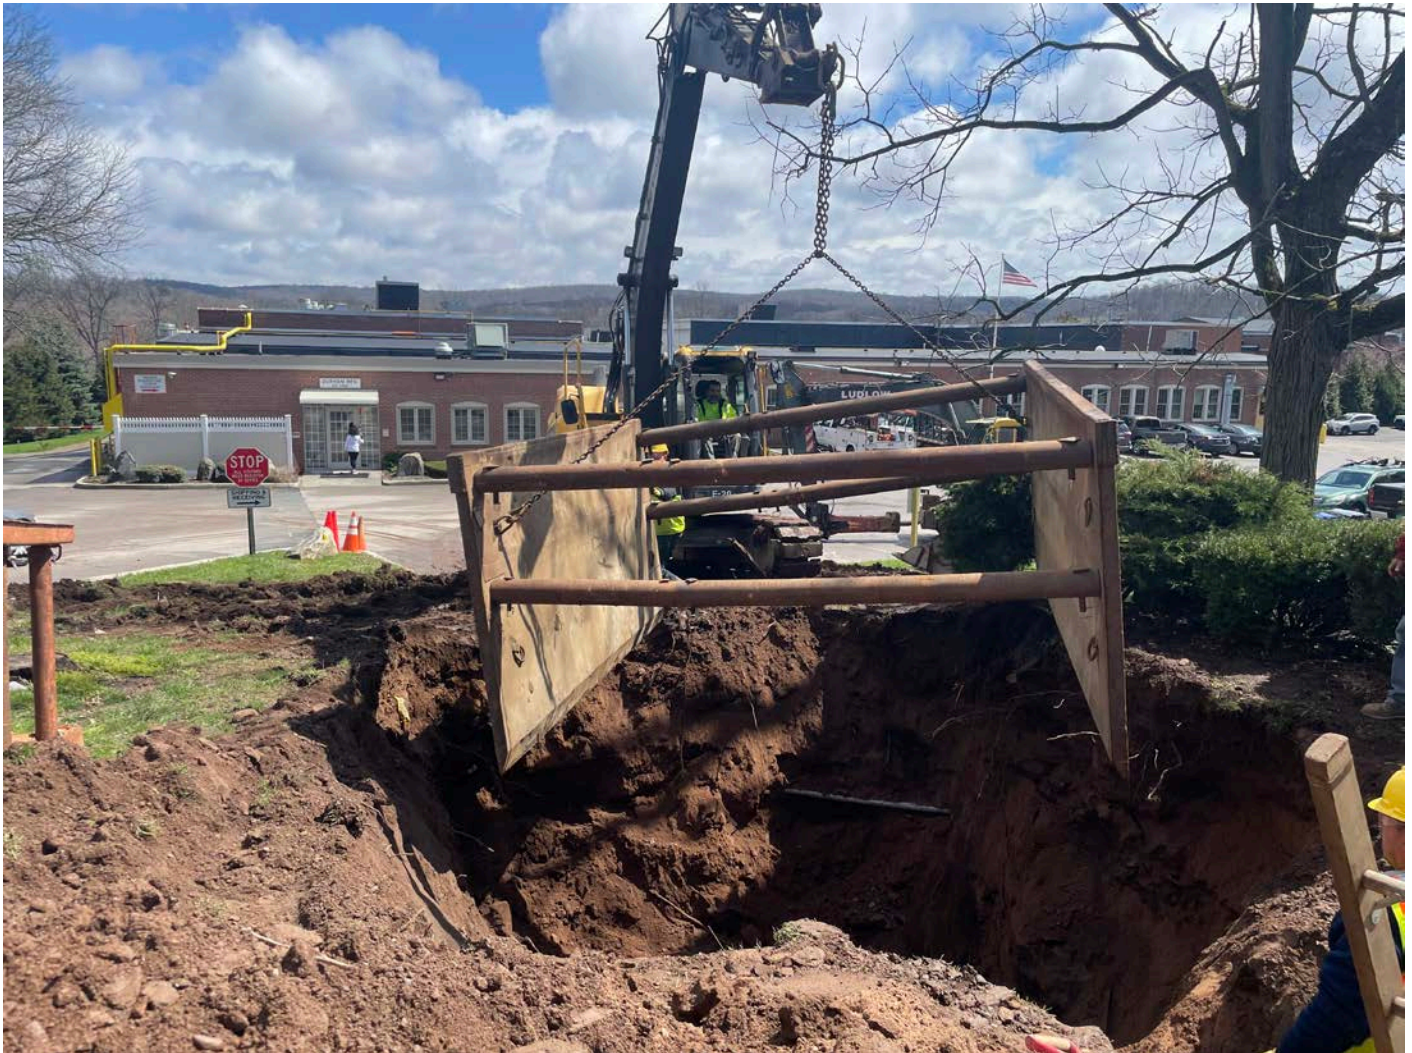
**Picture 6: Ludlow setting a trench box inside of the pit they excavated for the installation of a water meter pit at the Durham Manufacturing property. View to the east.**

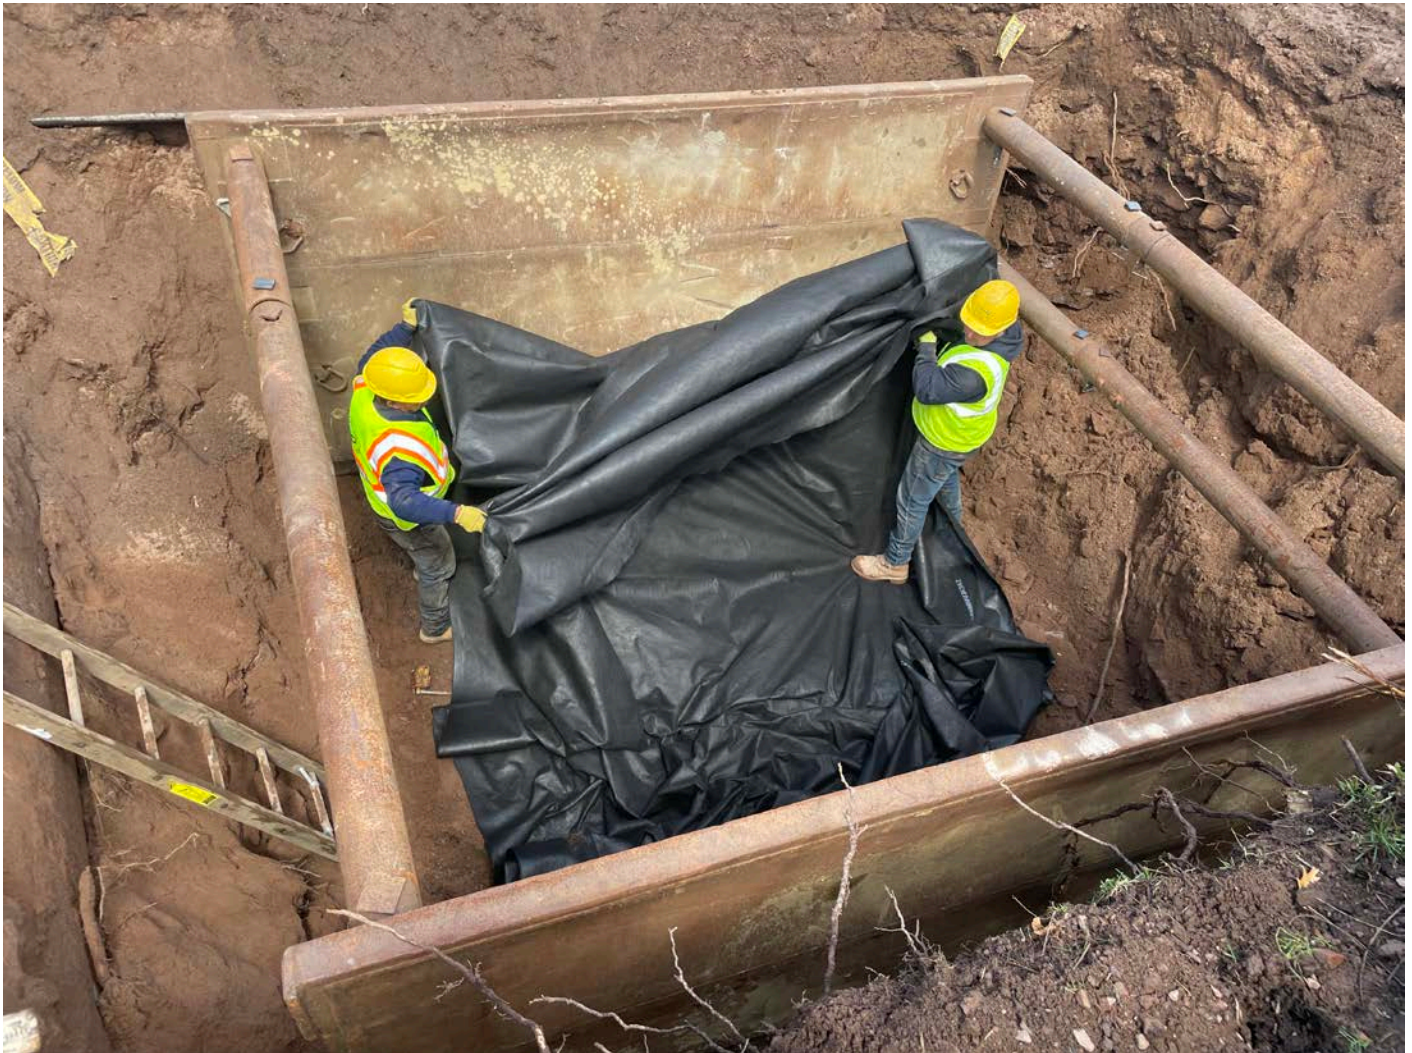
1241: Ludlow is lining the bottom of the excavation they made for the water meter vault with black geofabric that was set on top of native soil and rock.

**Picture 7: Ludlow placing geofabric inside of the pit they excavated for the installation of a water meter pit at the Durham Manufacturing property. View to the northeast.**

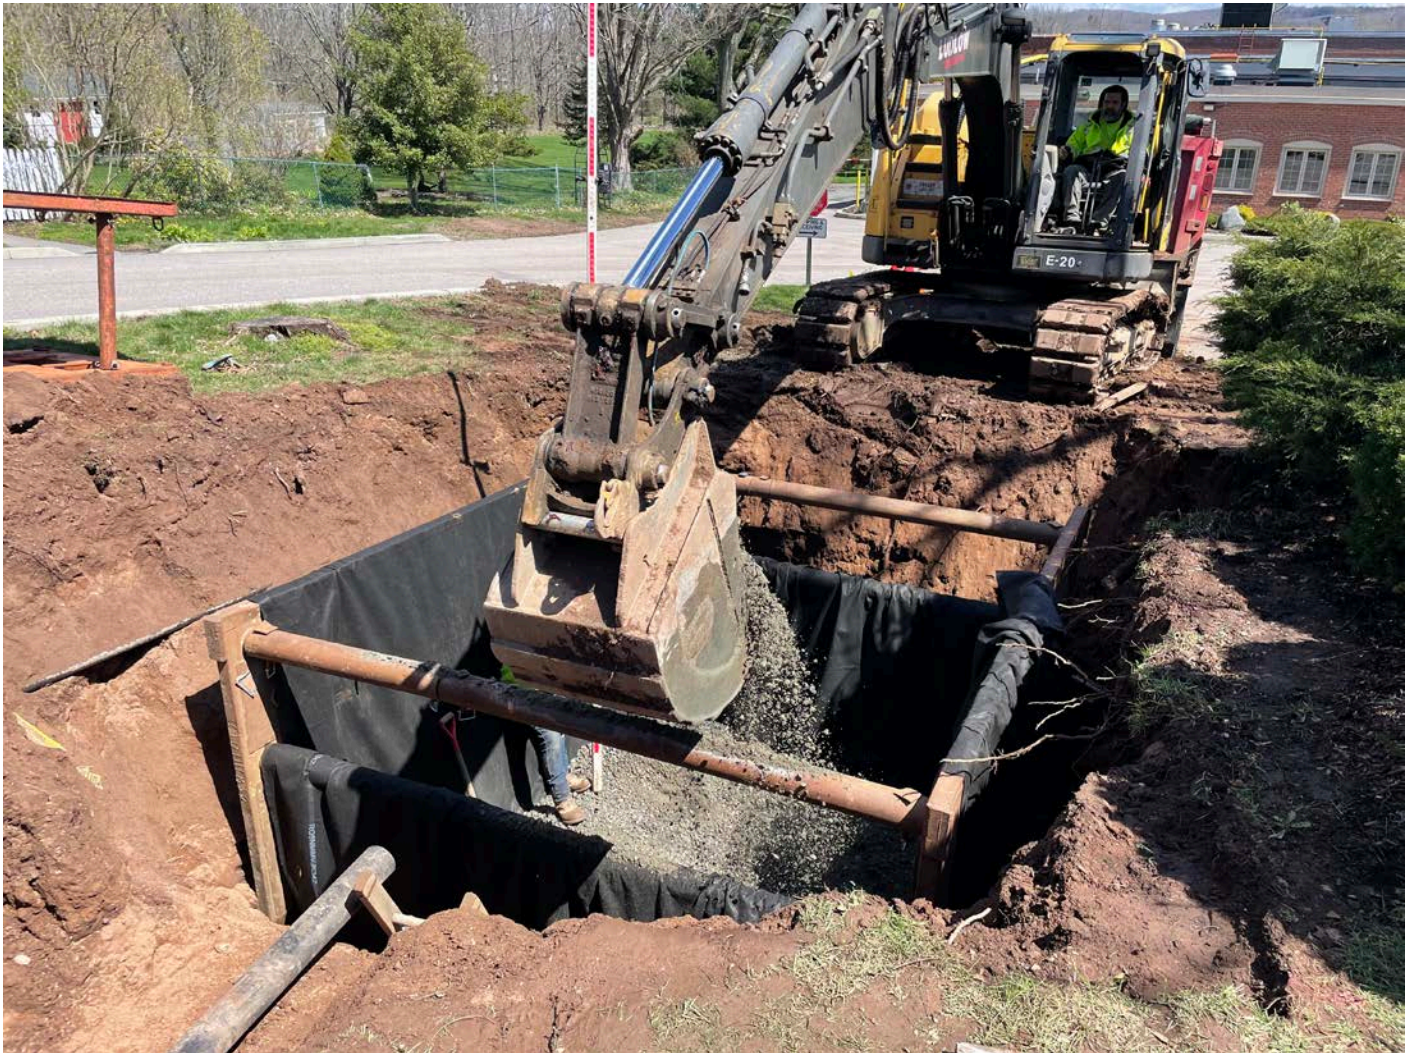
1258: Ludlow is placing ¾" stone on top of the black geofabric they placed on the bottom of the water vault excavation.

**Picture 8: Ludlow placing ¾" gravel on top of the geofabric they placed inside of the pit they excavated for the installation of a water meter pit at the Durham Manufacturing property. View to the east.**

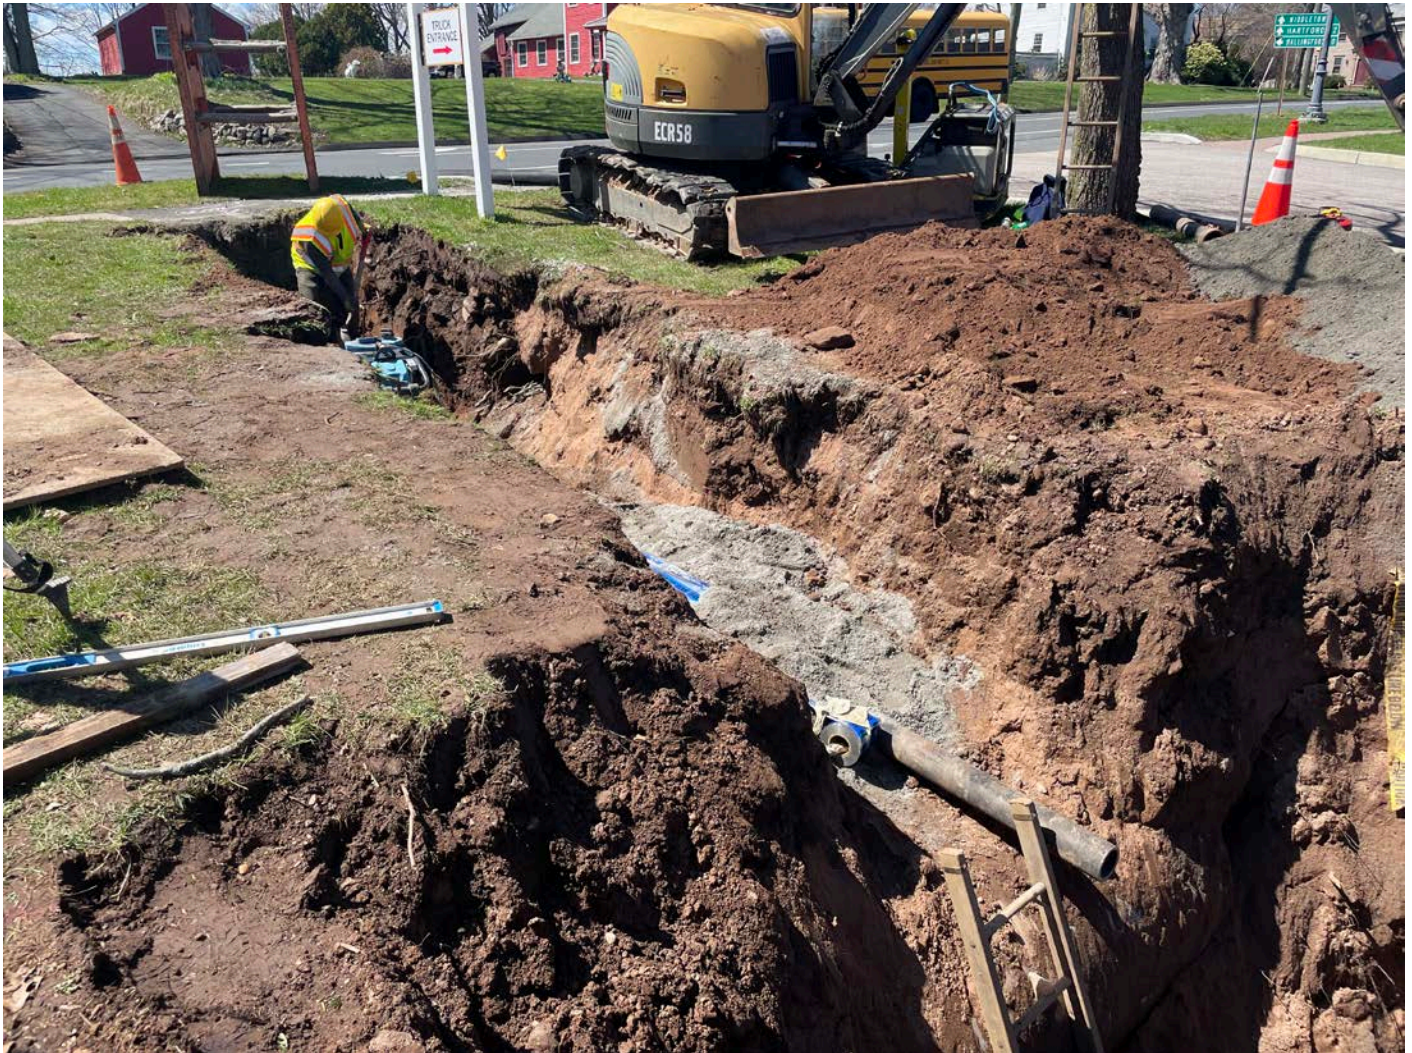
**Picture 9: View of partially-backfilled 4" DIP that Ludlow installed to the west of the pit they excavated for the installation of a water meter pit at the Durham Manufacturing property. View to the northwest.**

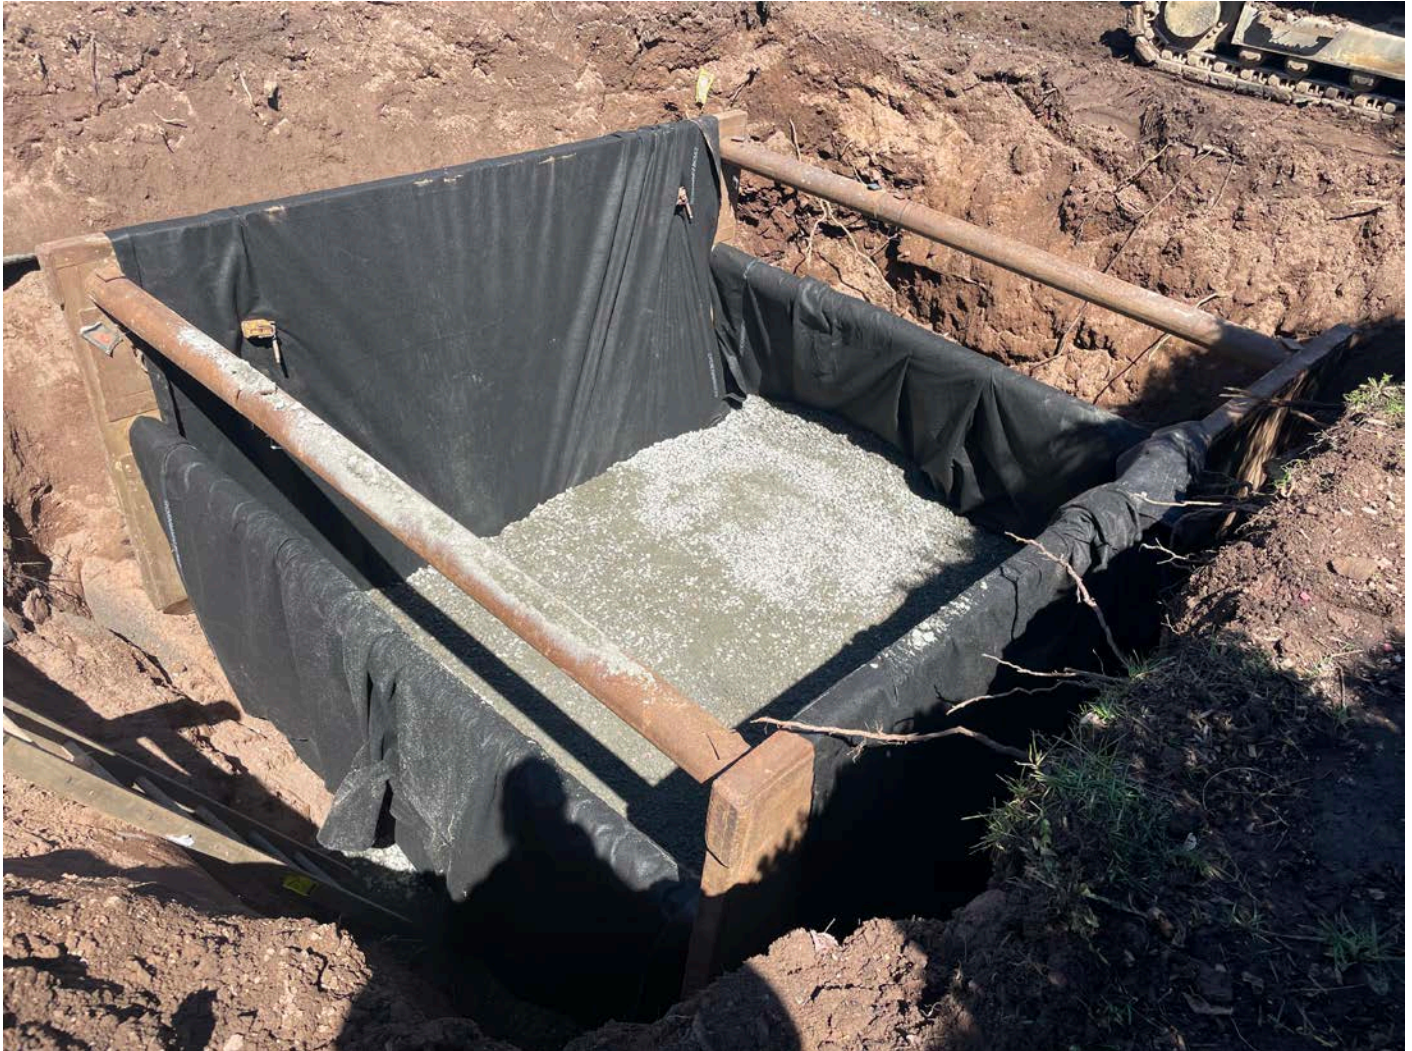
**Picture 10: Pit that Ludlow excavated for the installation of a water meter pit at the Durham Manufacturing property, after having placed  $\frac{3}{4}$ " gravel. View to the northeast.**
