Daily Report

Project:	Durham Meadows Pipeline Installation	Date:	April 26, 2022
Location:	Main Street, Maiden Lane, Wallingford Road, and Maple Avenue, Durham; Long Hill Road and the Shared Access Driveway, Middletown	Day of Week:	Tuesday
Project #:	AECOM: 6061487	Report No:	412
Contractor:	Ludlow Construction	Page:	1 of 17

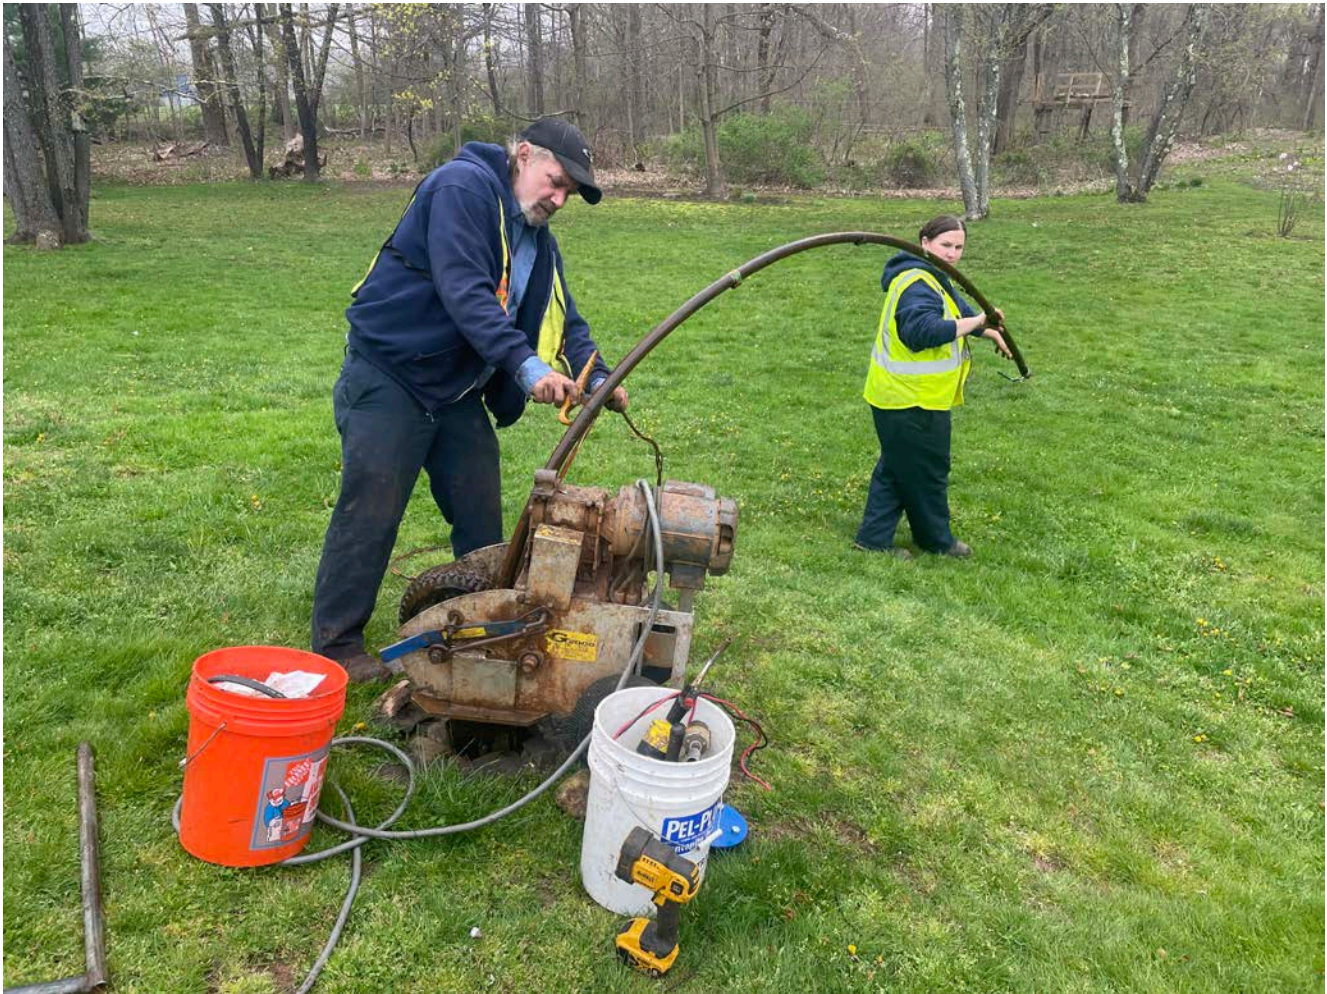
Picture 1: Grela pulling the pump from the well located at the 93R Maiden Lane, Durham, residence. View to the west.

1041: Grela begins to pull the pump from the well located at the 93R Maiden Lane property.

1048: Grela is collecting water level data from the well located at the 93R Maiden Lane property.

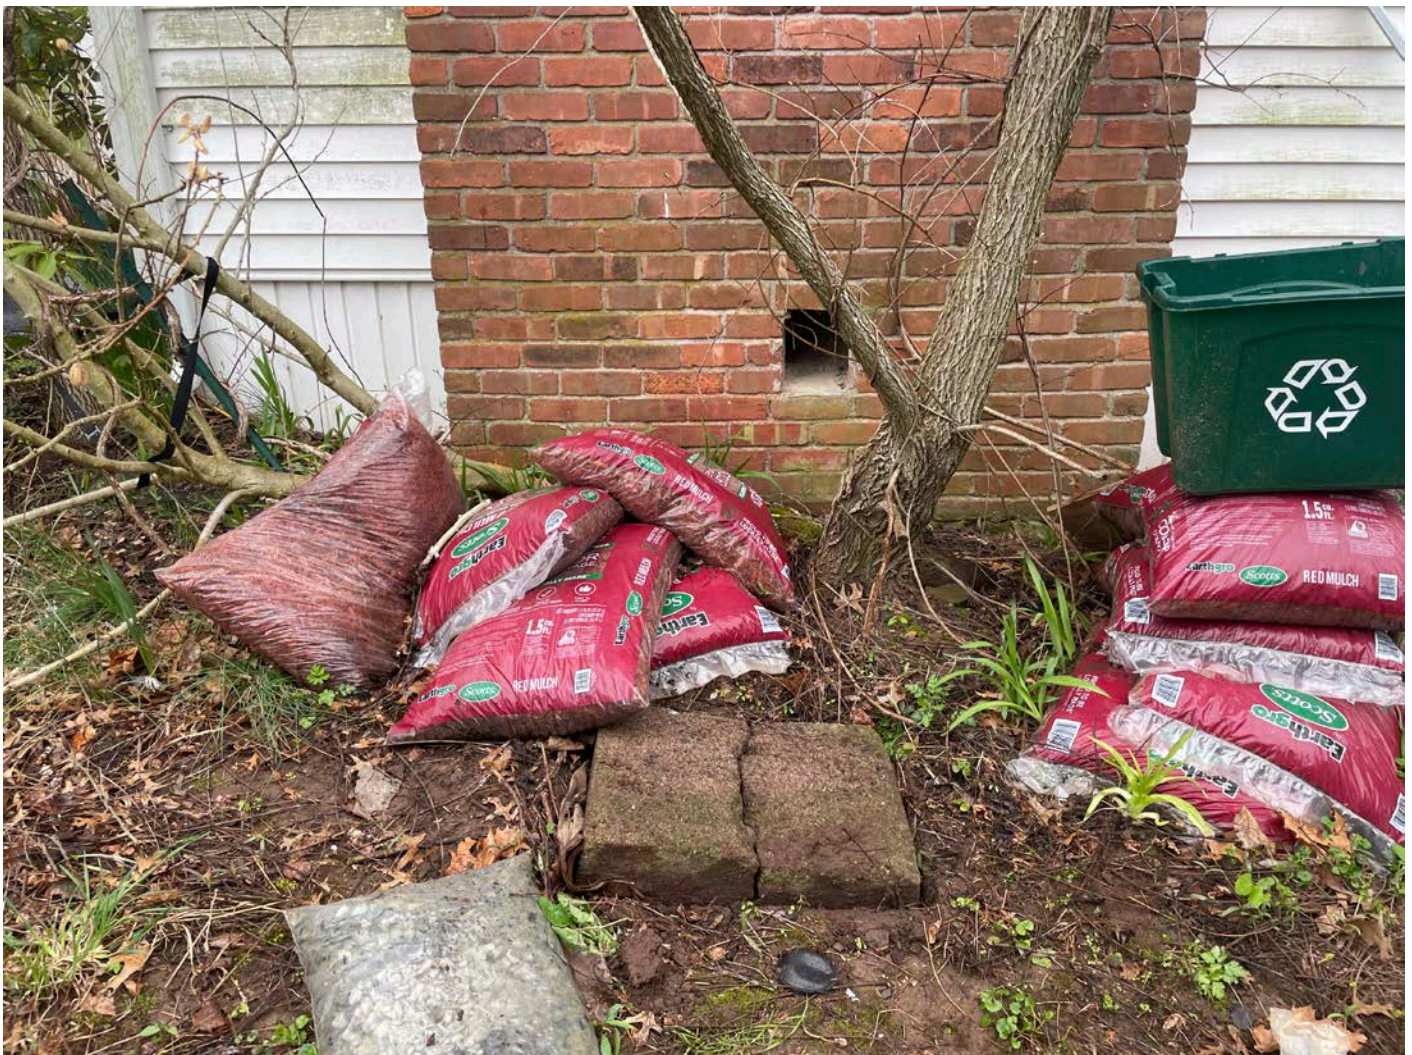
Picture 2: Well cover at the 162 Maple Avenue, Durham, residence. Grela removed the pump from this well. View to the south.

1245: Grela has just finished removing the pump from the well located at the 162 Maple Avenue property.

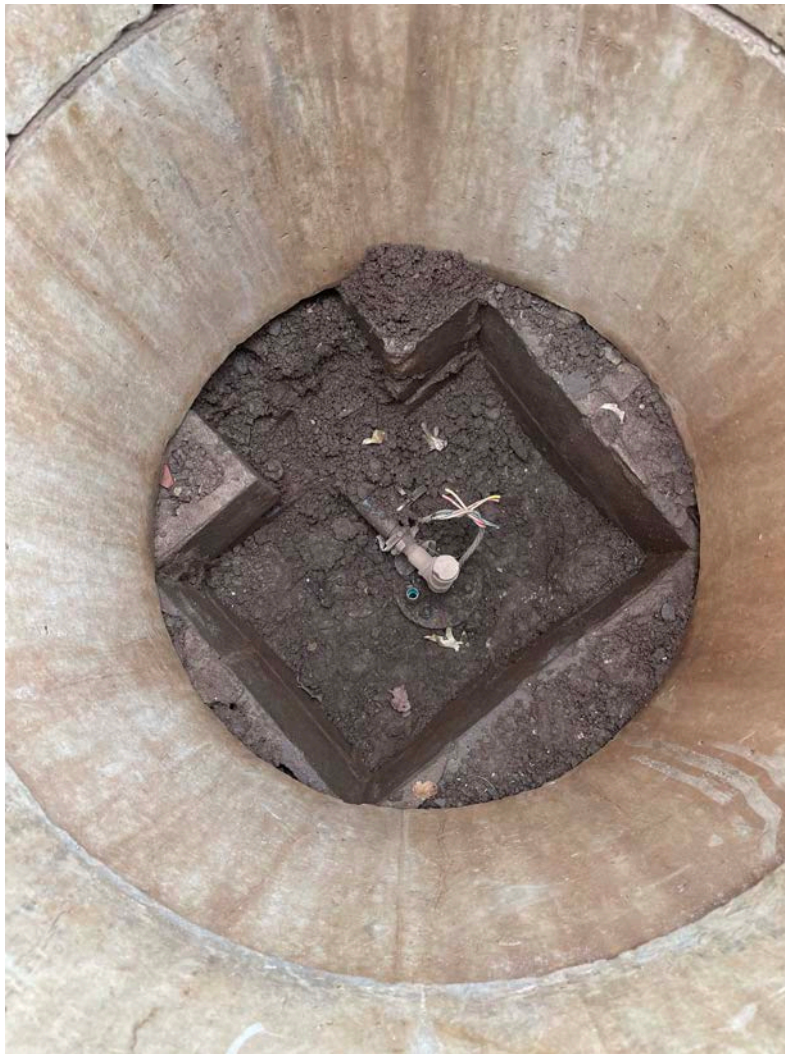
Picture 3: Inside of the tile where the well at the 17 Wallingford Road, Durham, property is located. Grela was unable to remove the pump from this well today due to logistical issues.

0958: Grela has mobilized to the 17 Wallingford Road property to remove the pump from the well located on the south side of the residence. The well is set inside of a cement tile that has a heavy cement lid that's approximately 30" in diameter.

1013: Grela having difficulty pulling the top off of the well at the 17 Wallingford Road property due to the tight space inside of the well tile.

1022: Grela is unable to pull the pump from the well located at the 17 Wallingford Road property today.

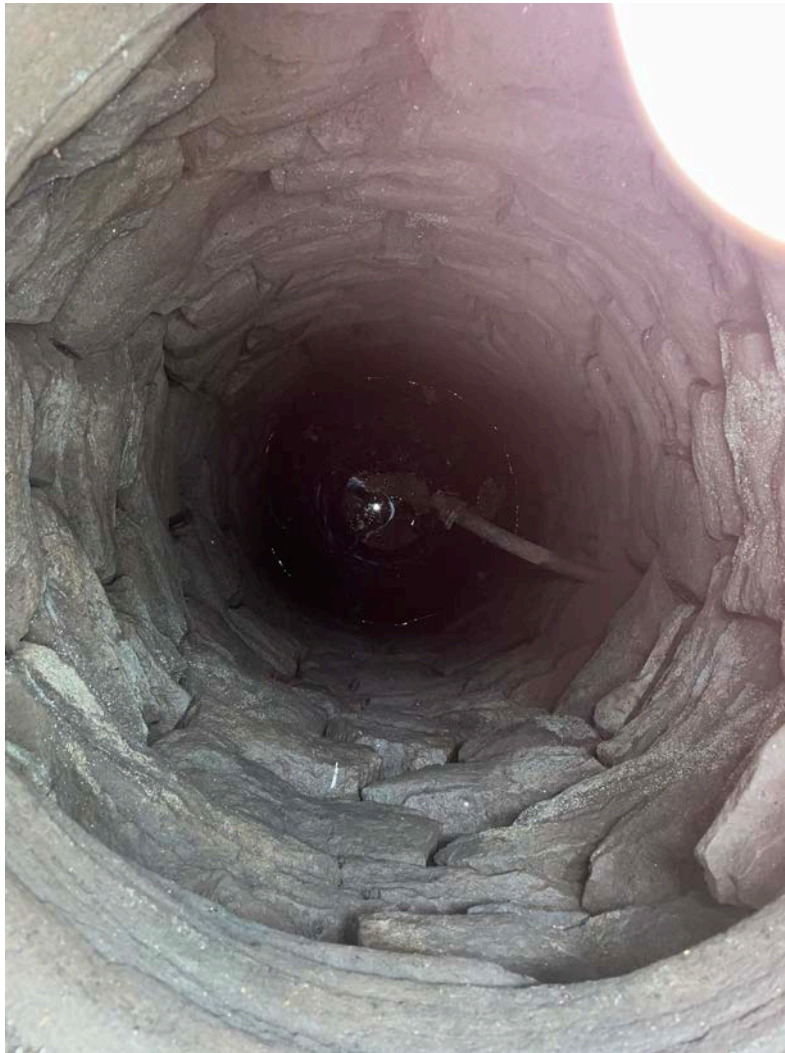
Picture 4: Inside of the dug well where the well at the 119 Main Street, Durham, property is located. Grela was unable to remove the pump from this well today due to logistical issues.

1345: Grela mobilizes to the 119 Main Street residence to remove the pump from the property's well. Grela discovers that the well was installed inside of a hand-dug well that was operated with a jet pump inside of the residence. The dug well is lined with fieldstone and is approximately 30" in diameter. The top of the well that was installed inside of the dug well is located approximately 8' below surface grade. The depth of the well is approximately 19' below surface grade. Grela is unable to currently access or remove the pump from the well due to the logistics of how it was installed. This work will need to be rescheduled.

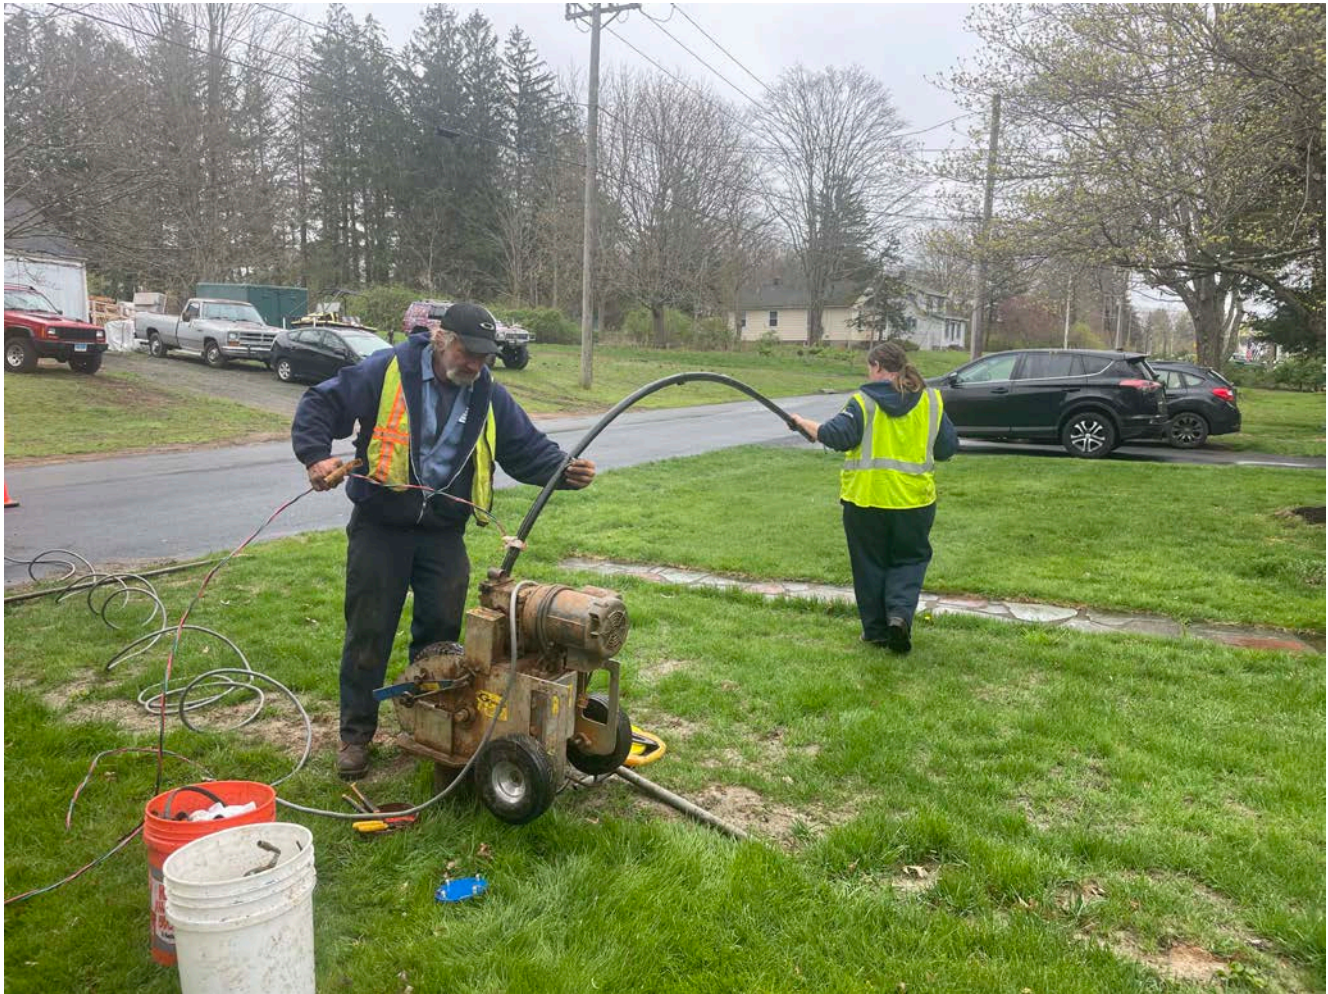
Picture 5: Grela having just pulled the pump from the well located at the 188 Maple Avenue, Durham, property. View to the southeast.

1253: Grela has mobilized to the 188 Maple Avenue property to remove the pump from the residence's well.

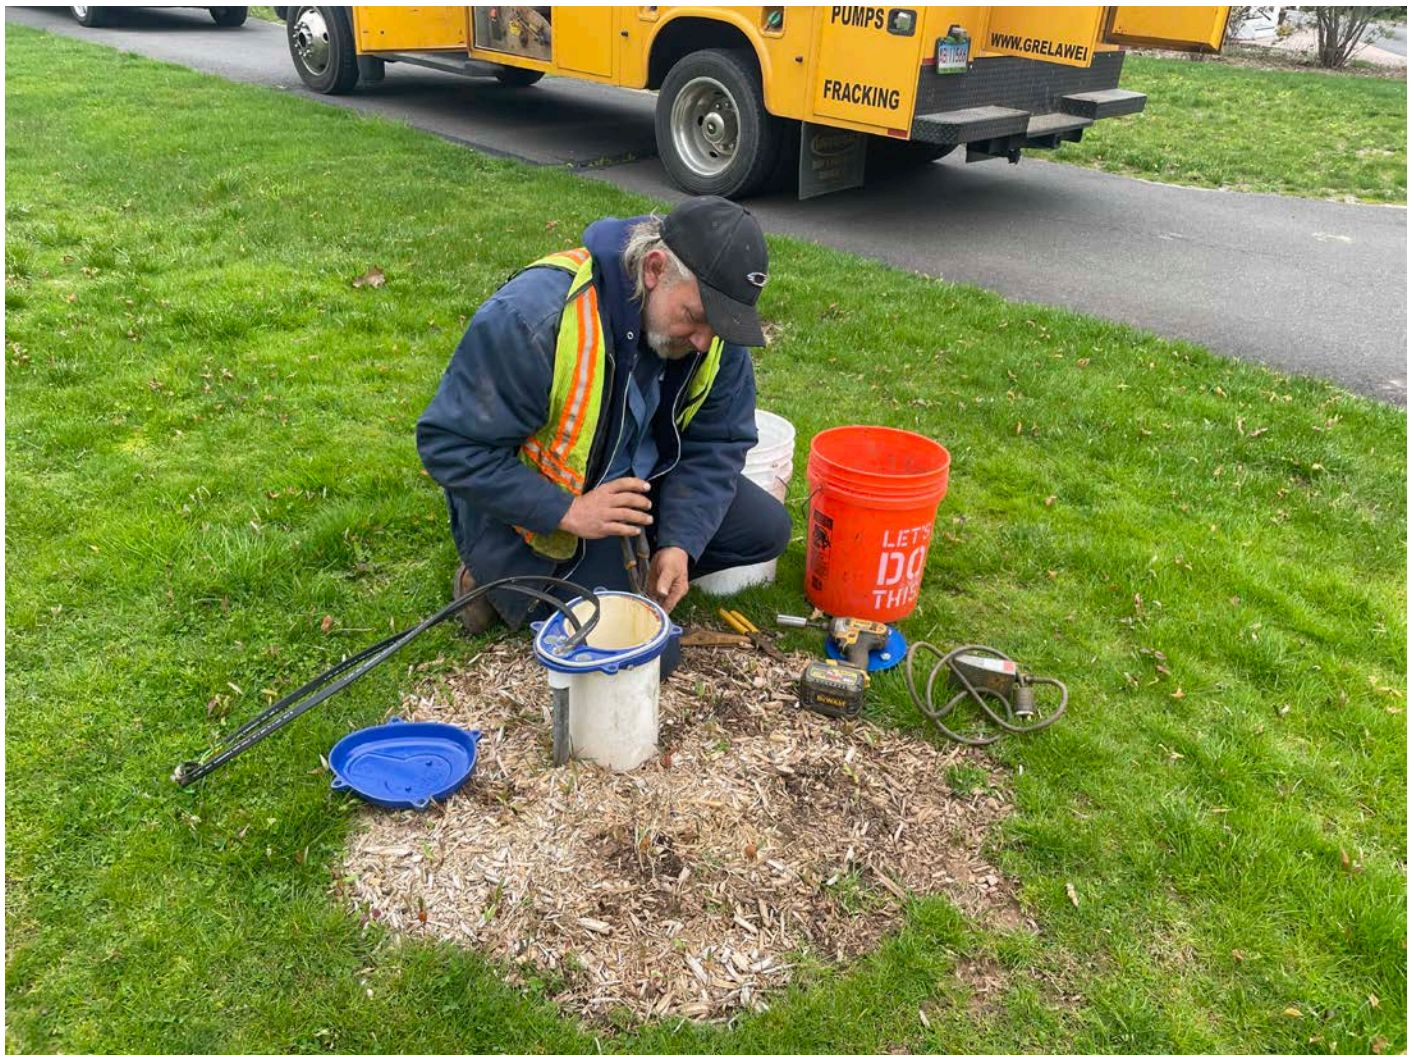
Picture 6: Grela pulling the pump from the well located at the 261 Main Street, Durham, residence. View to the northwest.

0830: Grela has mobilized to the 261 Main Street property to remove the pump from the residence's well as part of well decommissioning activities.

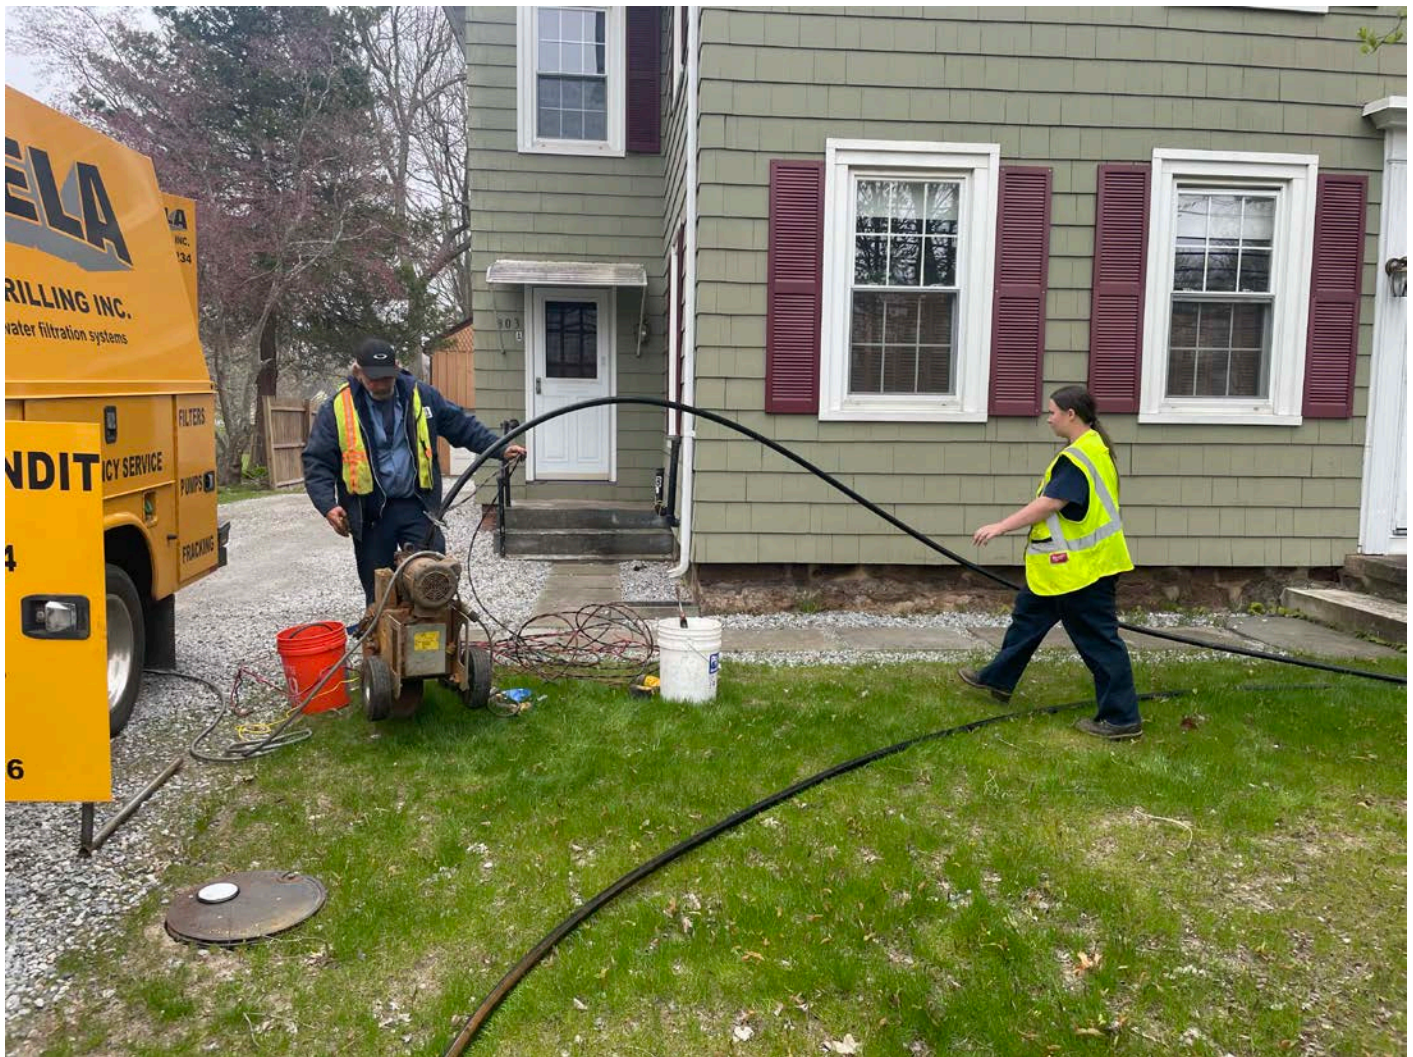
Picture 7: Grela pulling the pump from the well located at the 303 Main Street, Durham, property. View to the east.

0932: Grela is in the process of removing the pump from the well located on the southwest corner of the 303 Main Street residence.

0942: Grela has completed the removal of the pump from the well that services the 303 Main Street residence.

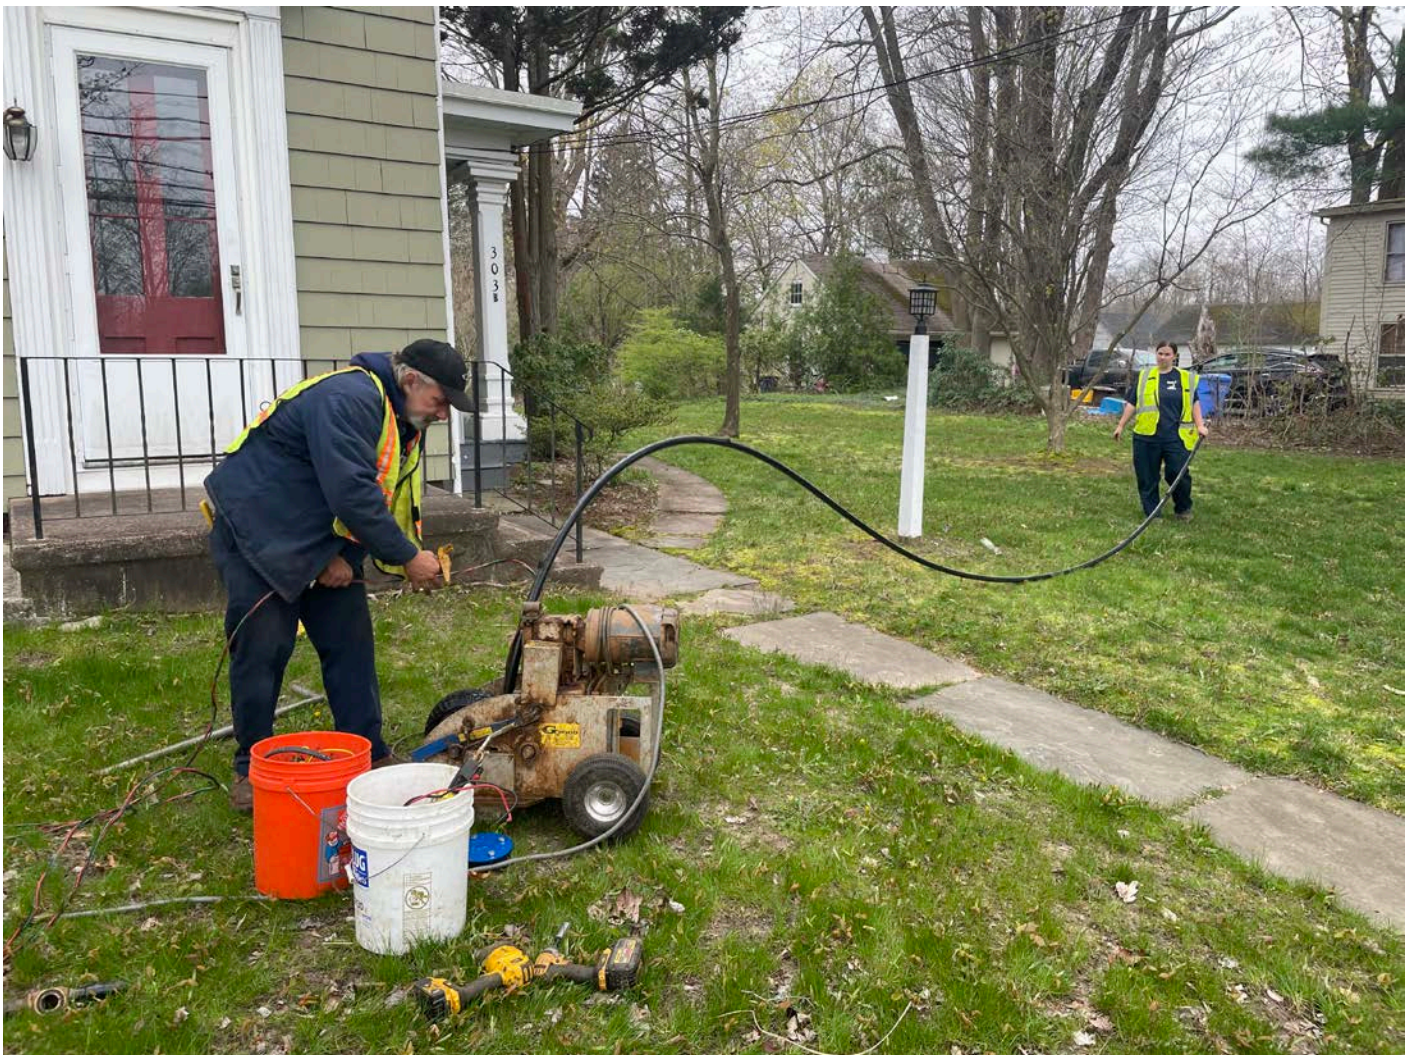
Picture 8: Grela pulling the pump from the well located at the 305B Main Street, Durham, property. View to the southeast.

0902: Grela has mobilized to the 303/305R Main Street, Durham residences to pull the pumps from the two wells on the property. Grela is currently setting up on the well that services the 305R building.

0929: Grela is collecting water level depths and measuring the location of the 305R Main Street well relative to the 303 Main Street structure.

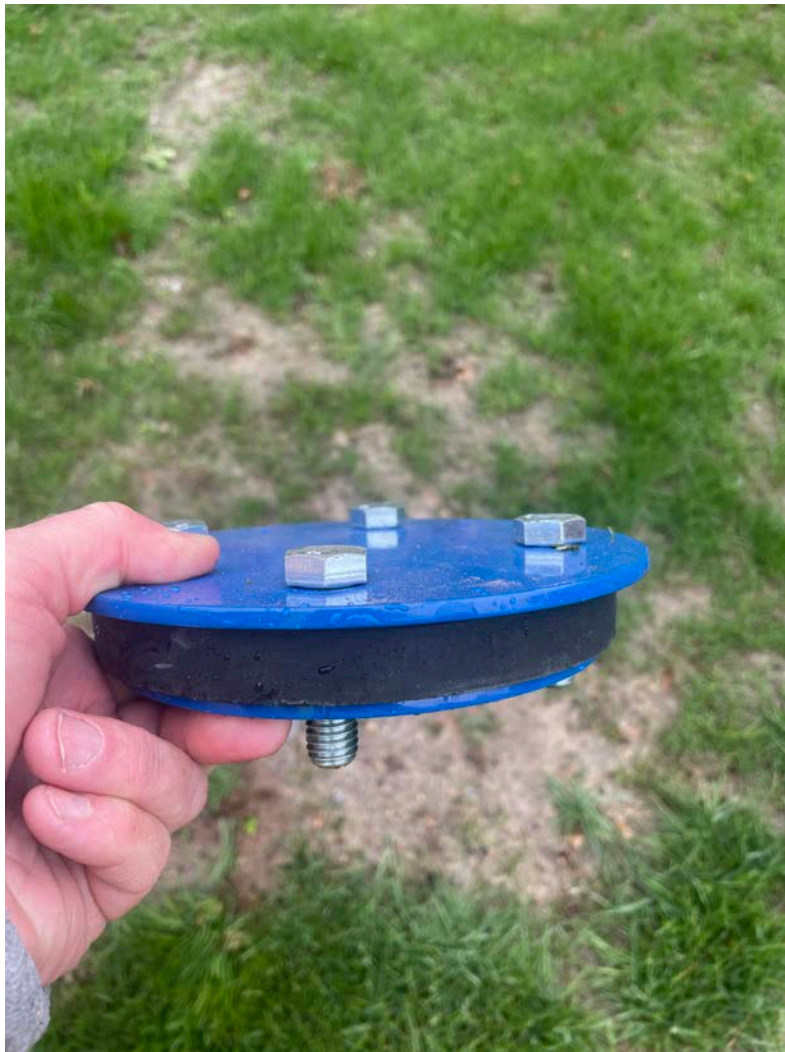
Picture 9: Expanding well cap that Grela has been placing on top of the well casing after removing a pump from a well.

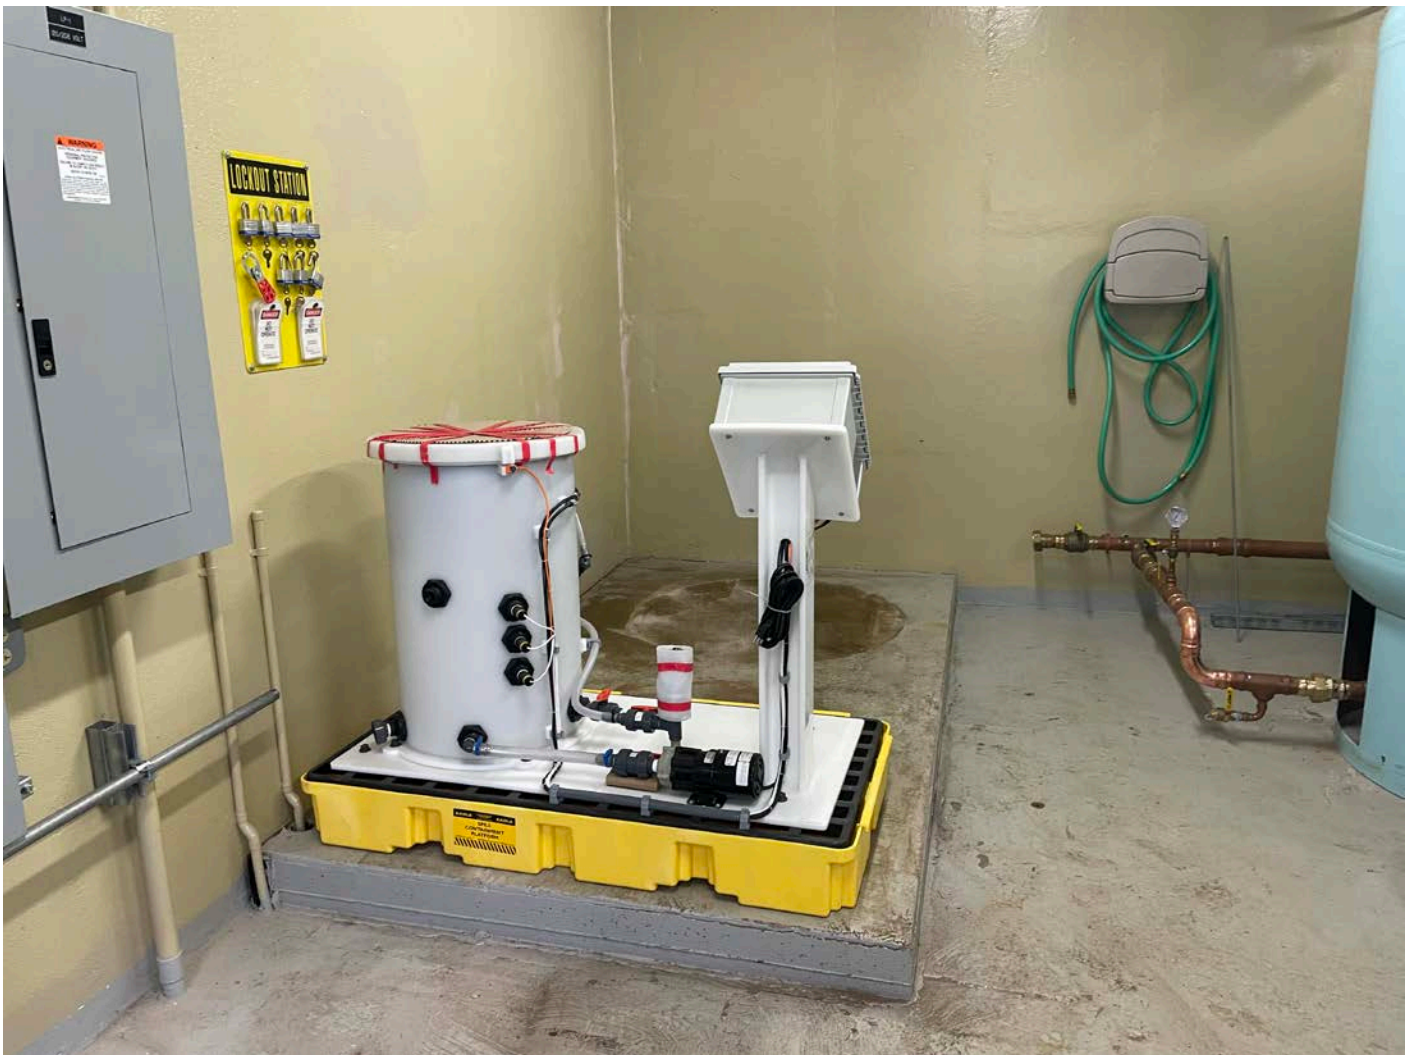
Picture 10: Chlorination station that Ludlow has placed on the concrete pad located at the southeast corner of the Long Hill pump station. View to the south.

0707: Ludlow is preparing to move the chlorination station into the Long Hill pump station using a skid steer to bring the station to the entrance of the pump station.

0731: Ludlow has placed the chlorination station in the southeast corner of the Long Hill pump station. Ludlow has departed the pump station after securing the pump station and the gate leading onto the property.

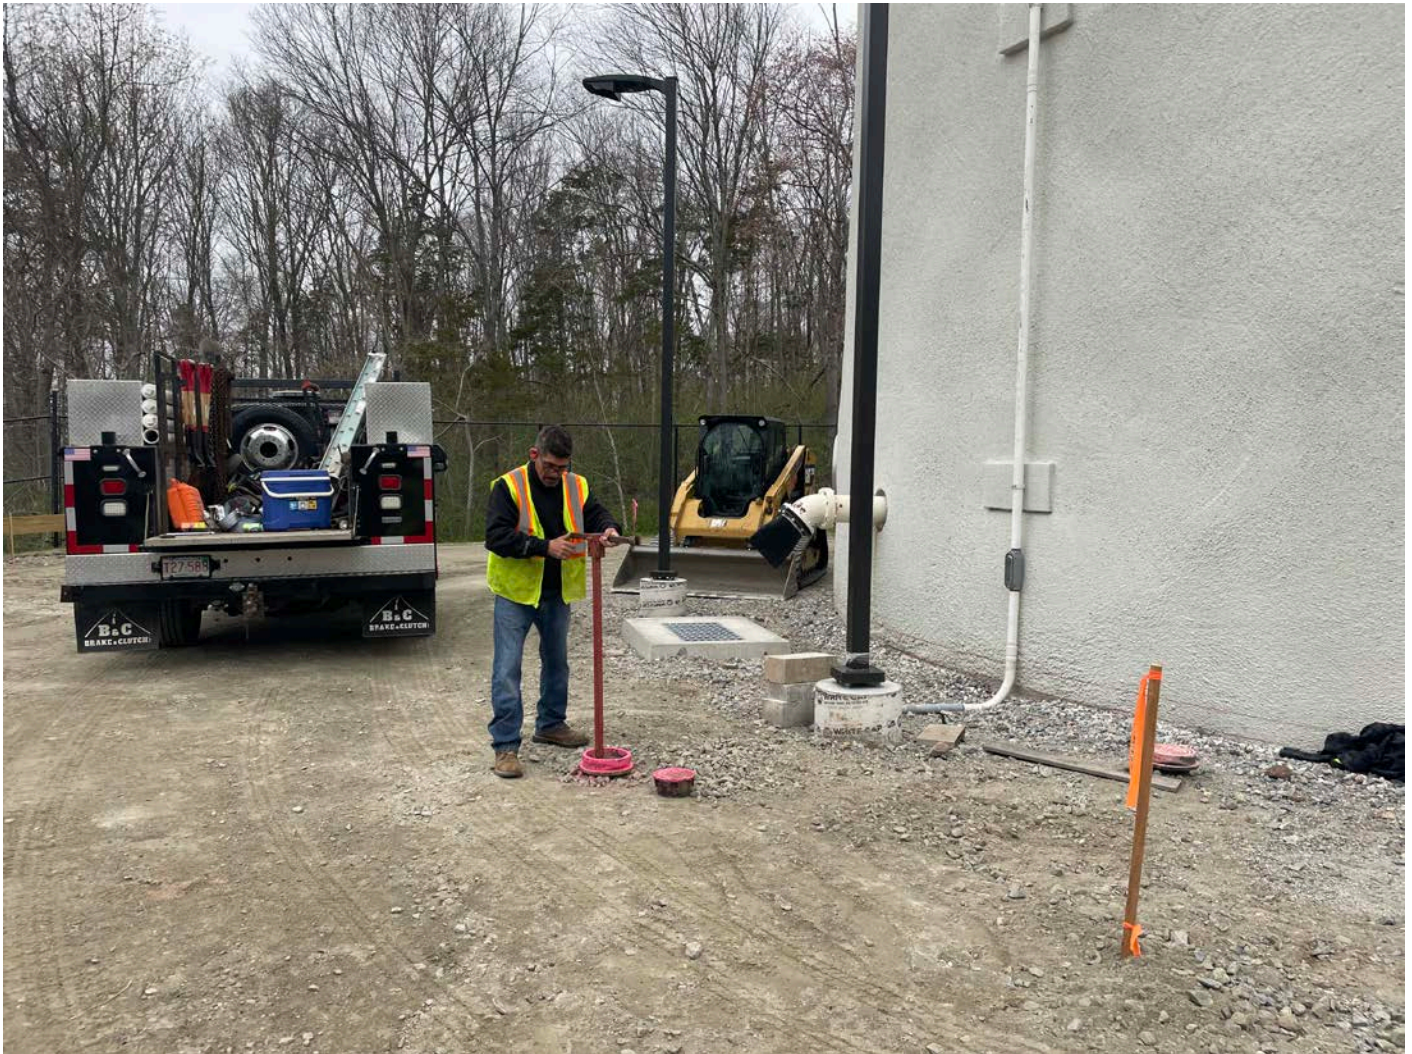
Picture 11: Ludlow opening a valve in order to fill the water tank located east of the Shared Access Driveway in Middletown. View to the north.

Ludlow began filling the water tank and placing stone along the fence that surrounds the water tank located east of the Shared Access Driveway in Middletown.

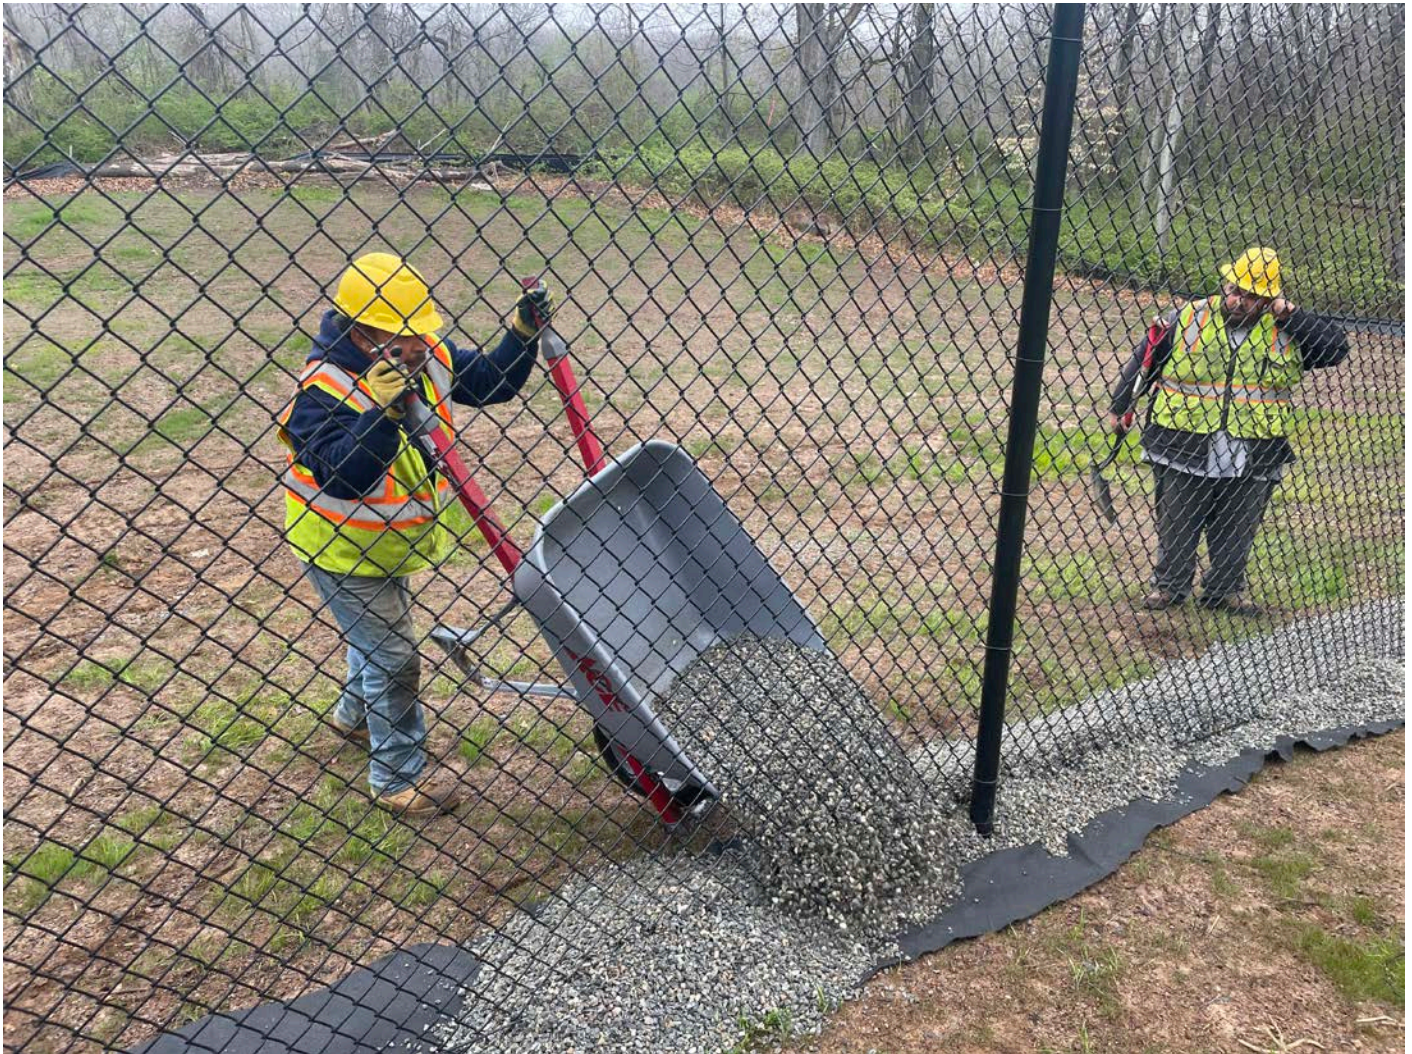
Picture 12: Ludlow placing 3/8" stone over black geofabric along the east side of the fence that surrounds the water tank located east of the Shared Access Driveway in Middletown. View to the southeast.

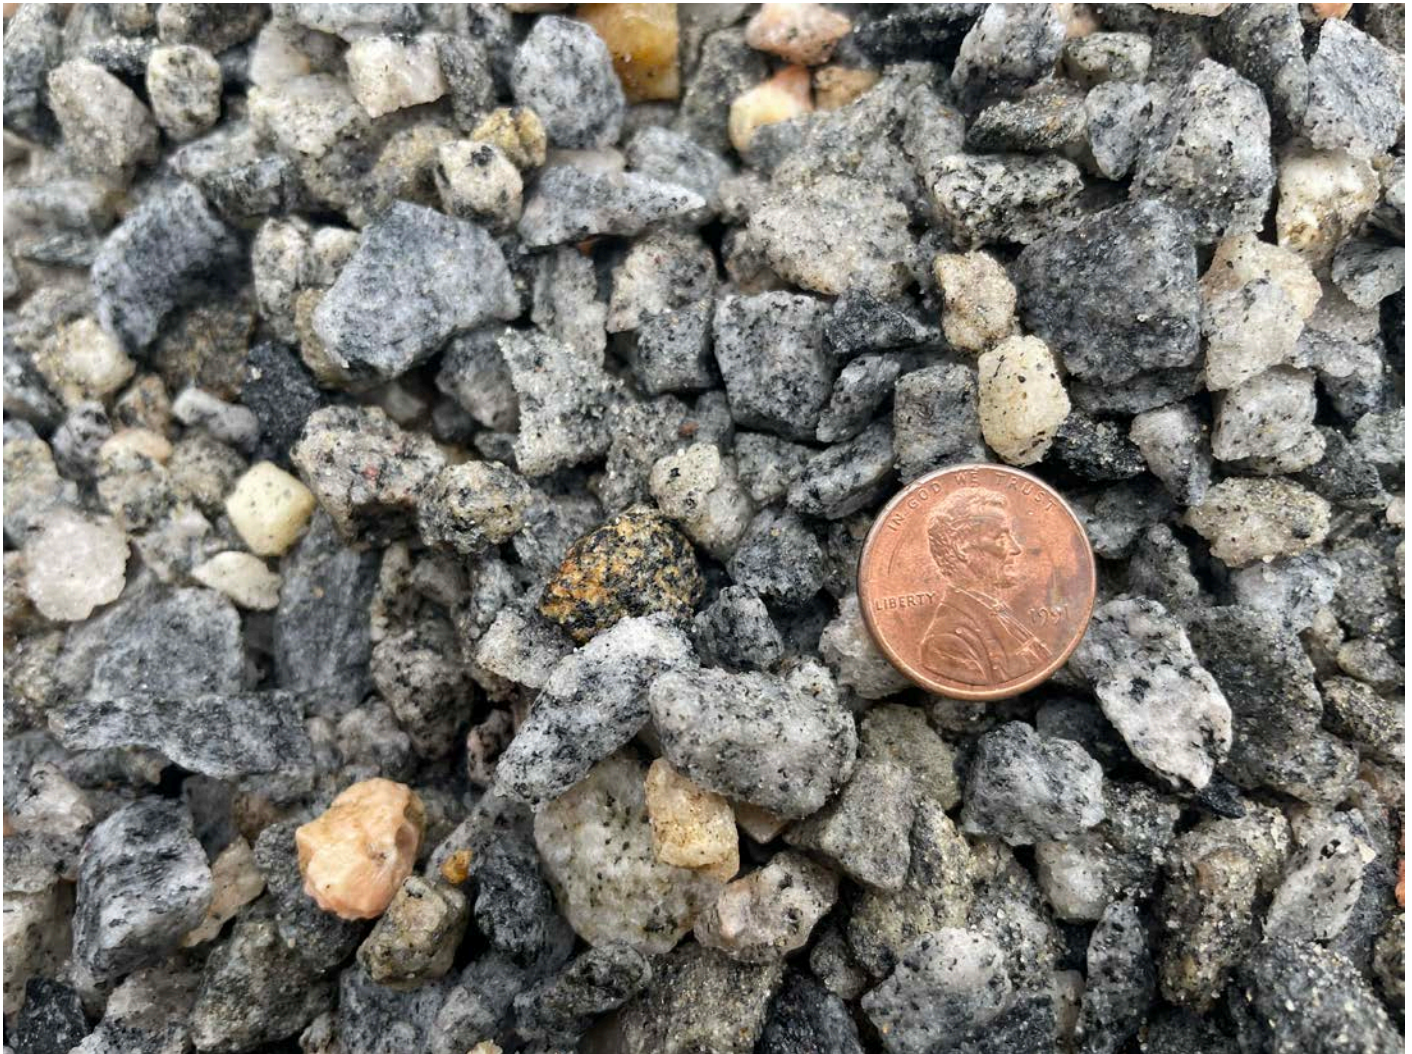
Picture 13: Closeup of the 3/8" stone that Ludlow is placing over black geofabric along the bottom of the fence that surrounds the water tank located east of the Shared Access Driveway in Middletown.

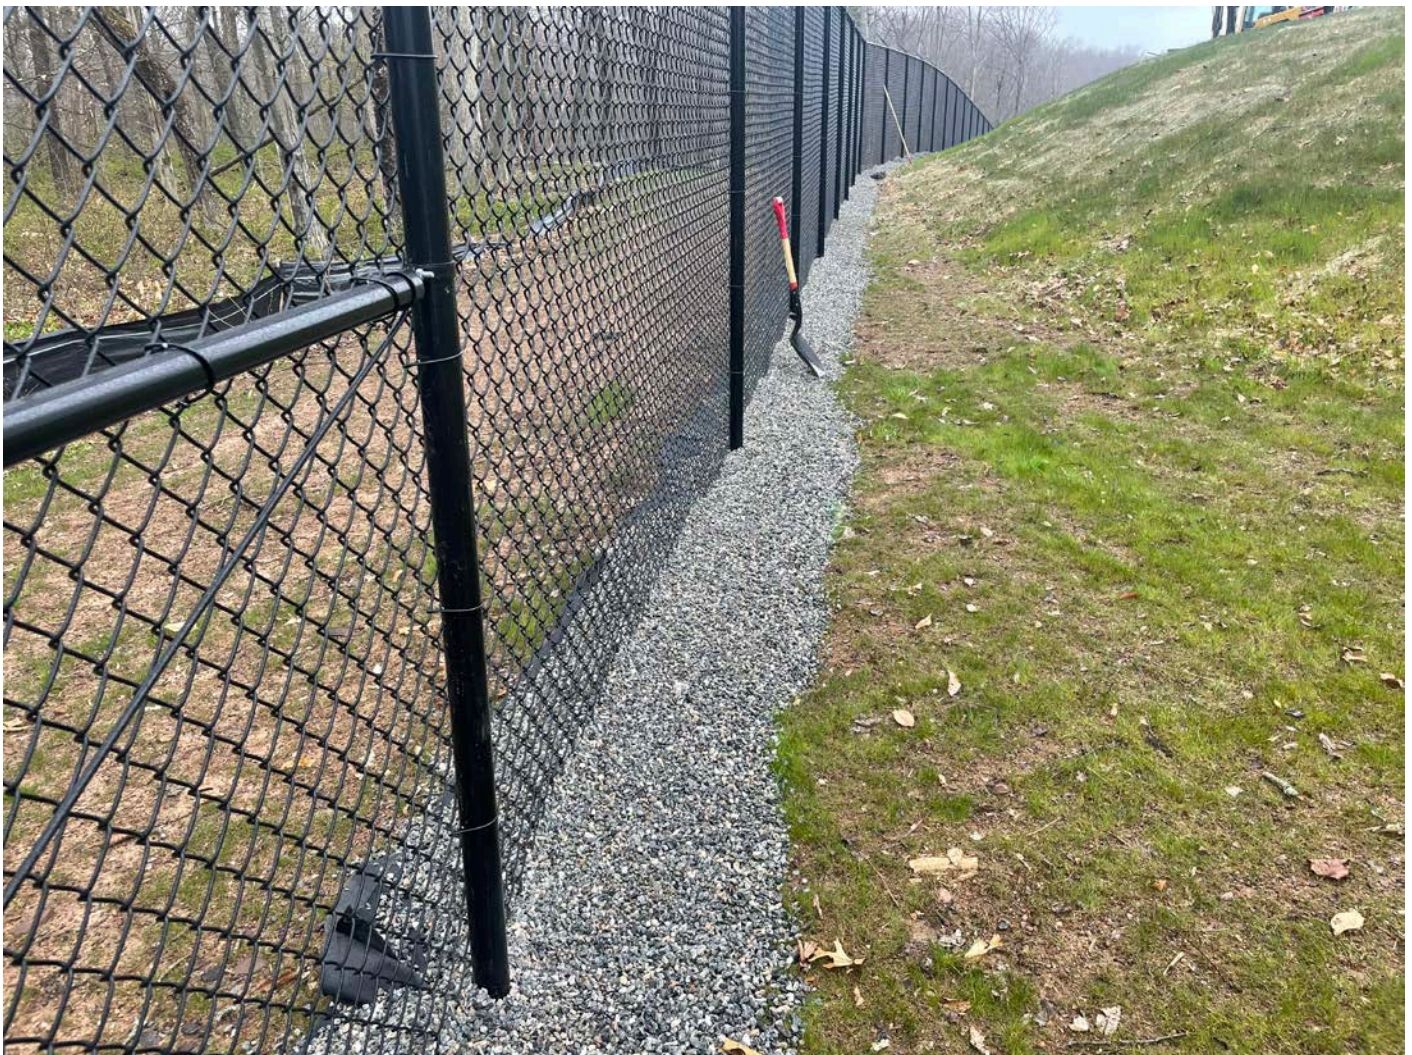
Picture 14: 3/8" stone that Ludlow placed over black geofabric along the bottom of the fence located south of the water tank located east of the Shared Access Driveway in Middletown. View to the west.
