## Daily Report

<b>Project:</b>	Durham Meadows Pipeline Installation	<b>Date:</b>	April 27, 2022
<b>Location:</b>	Main Street, Maiden Lane, and Maple Avenue, Durham; Long Hill Road and the Shared Access Driveway, Middletown	<b>Day of Week:</b>	Wednesday
<b>Project #:</b>	AECOM: 6061487	<b>Report No:</b>	413
<b>Contractor:</b>	Ludlow Construction	<b>Page:</b>	1 of 13

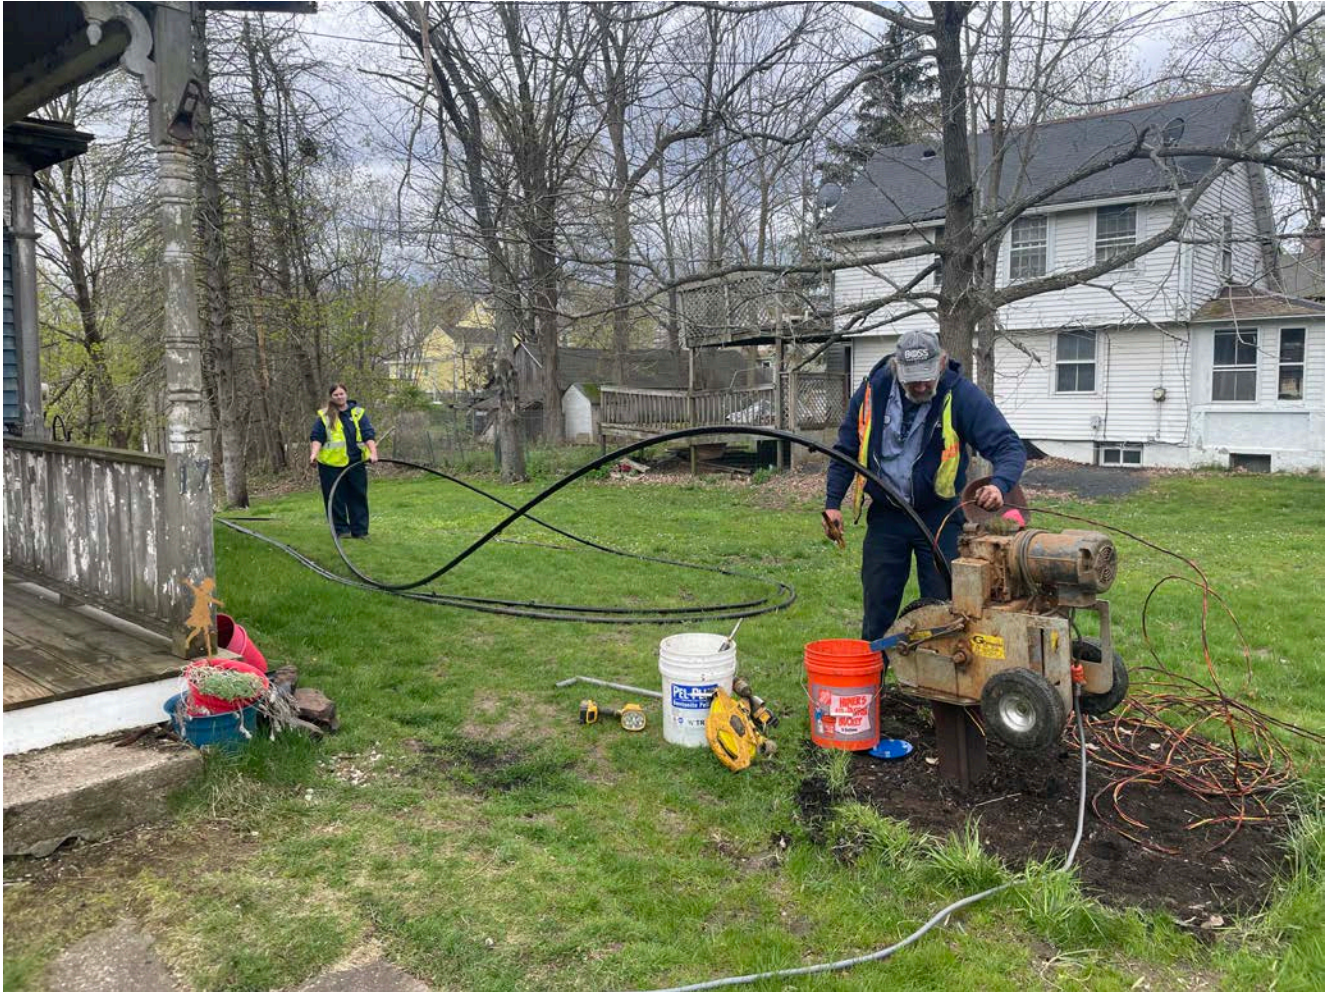
Picture 1: Grela pulling the pump from the well located at the 17 Maiden Lane, Durham, property. View to the southeast.

0937: Grela has mobilized to the 17 Maiden Lane, Durham, residence to remove the pump from the property's well.

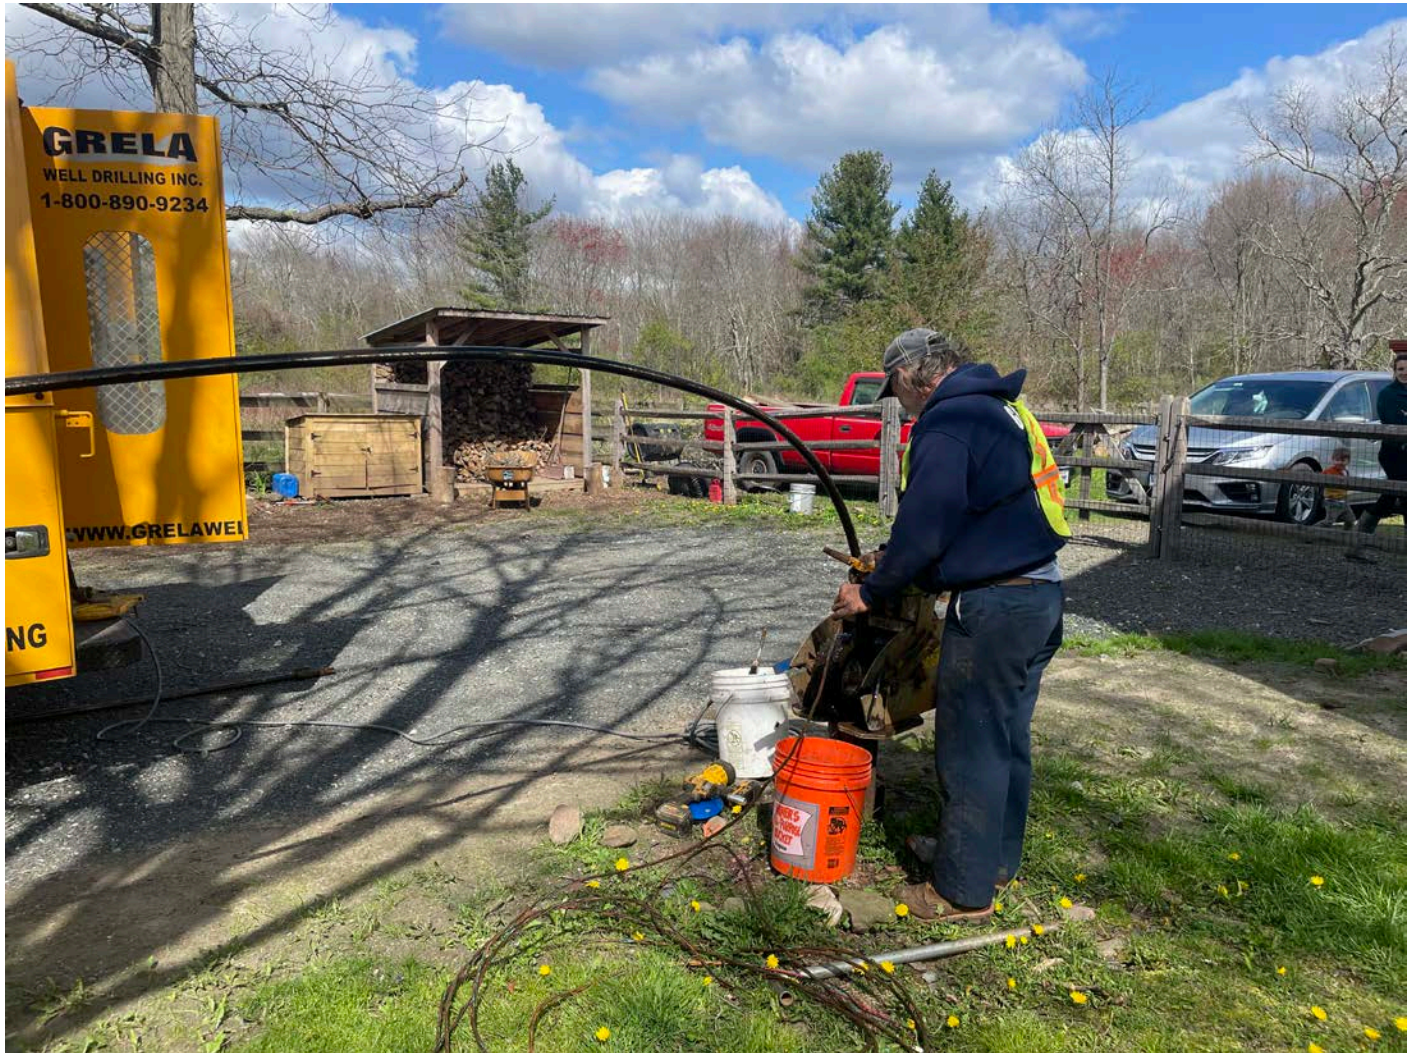
Picture 2: Grela pulling the pump from the well located at the 78 Maiden Lane, Durham, property. View to the northwest.

1006: Grela has mobilized to the 78 Maiden Avenue, Durham, residence to pull the pump from the well located southwest of the southwest corner of the house.

1016: Grela is in the process of pulling the pump from the well located on the 78 Maiden Lane residence.

10:20: Grela has removed the pump from the well located on the 78 Maiden Lane property and is currently collecting water level data.

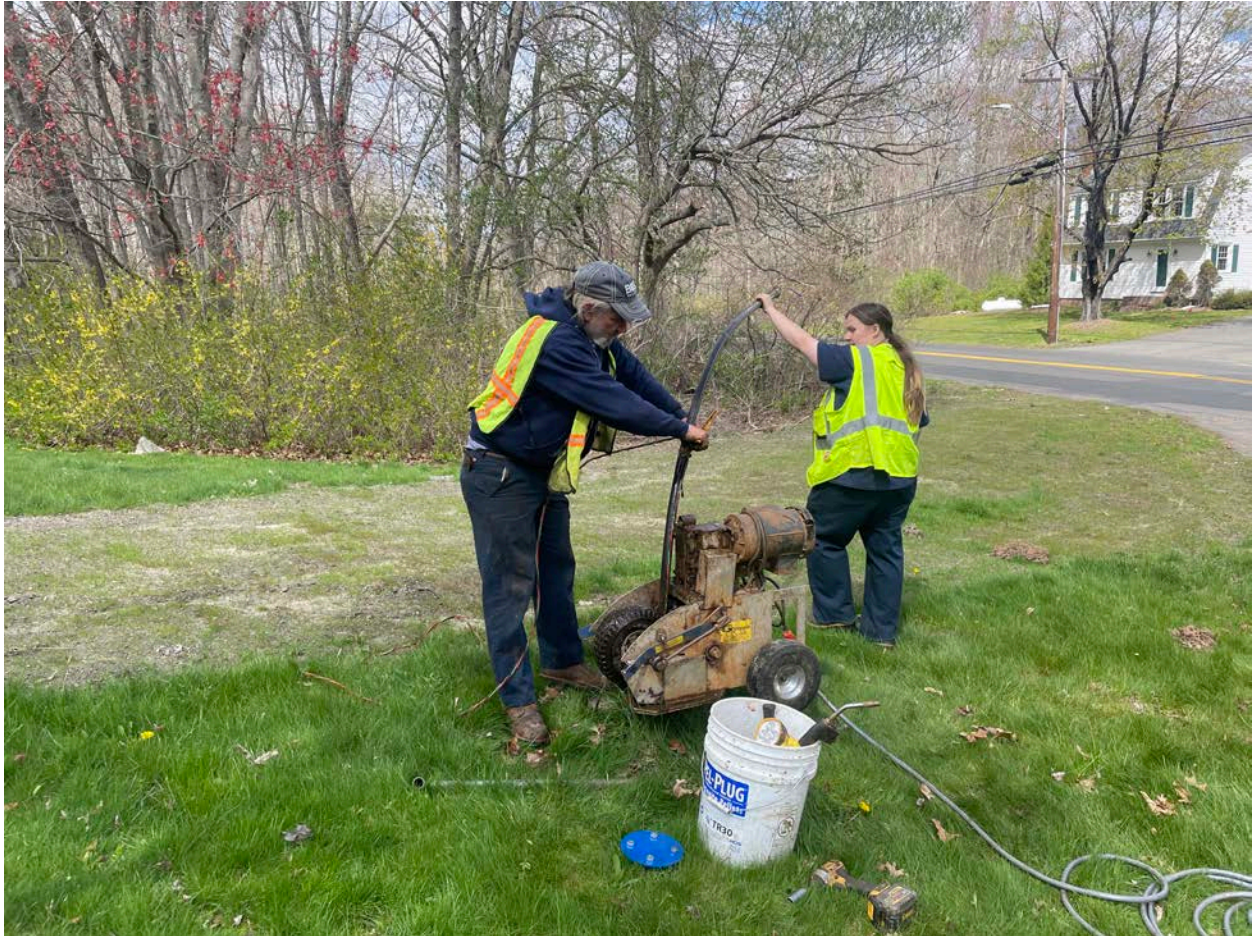
Picture 3: Grela pulling the pump from the well located at the 105 Maiden Lane, Durham, property. View to the northwest.

1047: Grela has mobilize to the 105 Maiden Lane, Durham, property to pull the pump from the well located on the north side of the house.

1053: Grela starts to pull the pump at the 105 Maiden Avenue property.

1106: Grela has just removed the pump from the well at 105 Maiden Avenue and is currently in the process of putting the black poly well line back down well to use later when they tremie grout. Grela is also placing a plastic plug in the plastic conduit that brought power to the well pump.

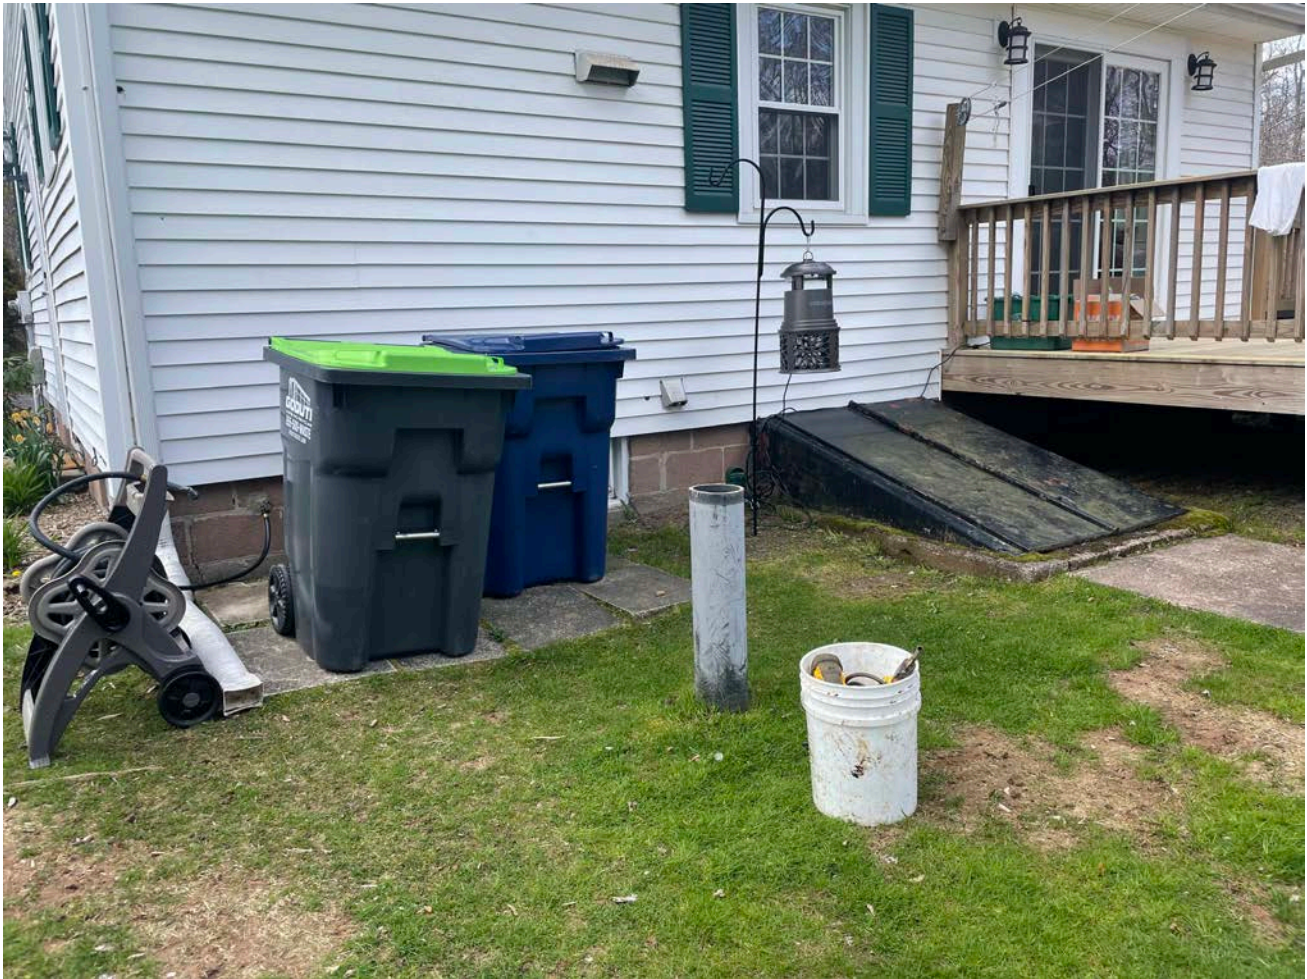
Picture 4: The well located on the north side of the 110 Maiden Lane, Durham, residence that Grela is preparing to remove the pump from. View to the southwest.

1029: Grela has mobilized to the 110 Maiden Avenue, Durham, property to address the well located on the north side of the house near its northeast corner. The jet pump that was connected to the well was previously removed. Grela tried to put a new lid onto the well riser but it was too wide for the schedule 80 PVC riser. Grela secured the well by placing the old lid back on the top of the PVC riser.

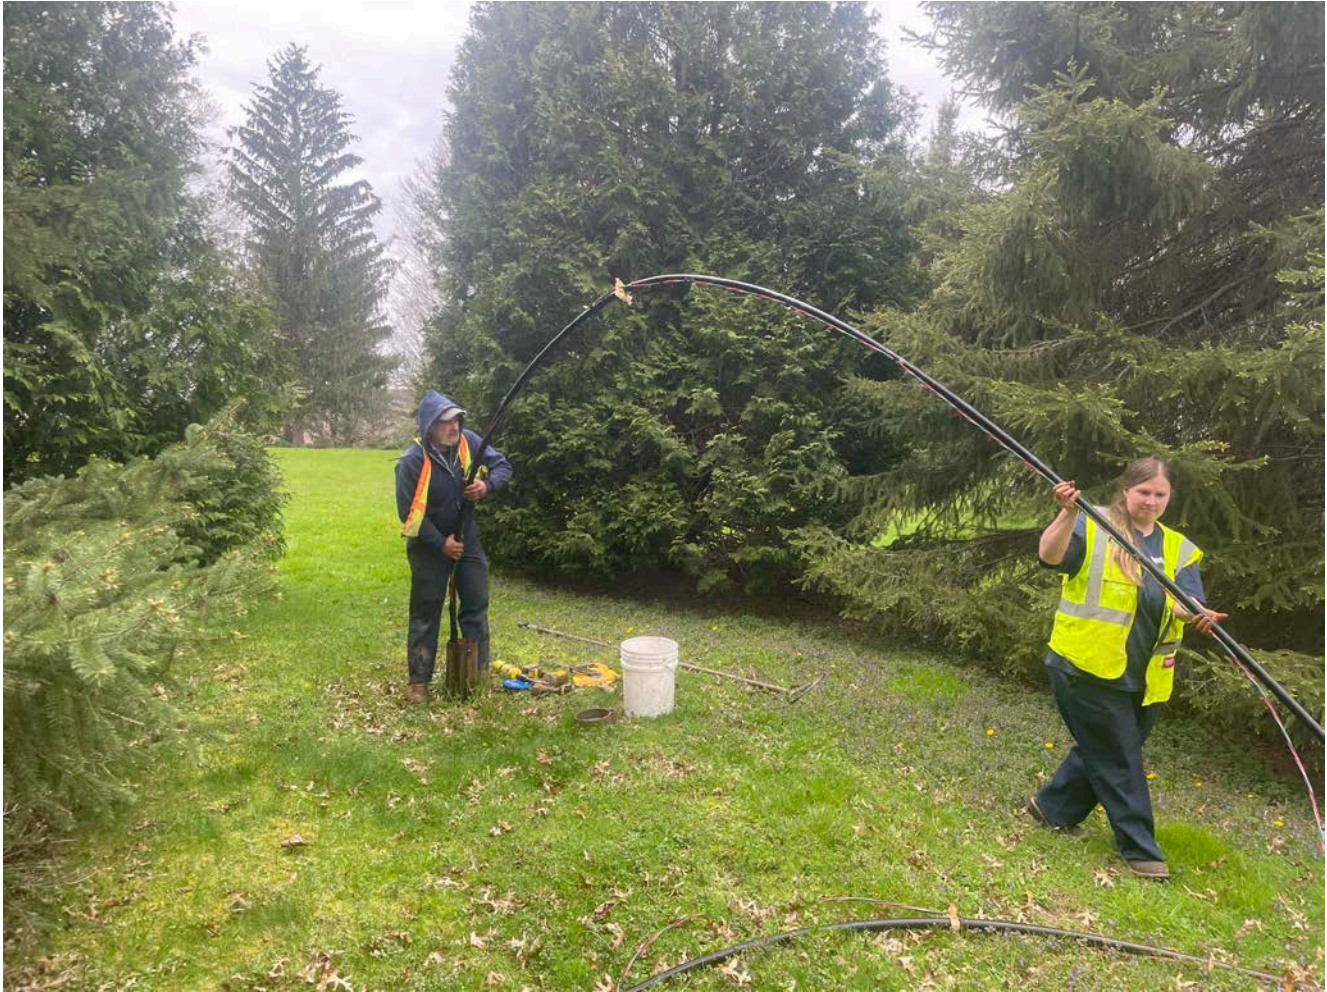
Picture 5: Grela having just pulled the pump from the well located at the 120 Main Street, Durham, property. View to the west.

1416: Grela mobilizes to the 120 Main Street, Durham, residence to pull the pump from the well located on the west side of the property.

1436: Grela is in the process of pulling the pump from the well located on the west side of the 120 Main Street residence.

1449: Grela has finished pulling the pump from the well located at the 120 Main Street property.

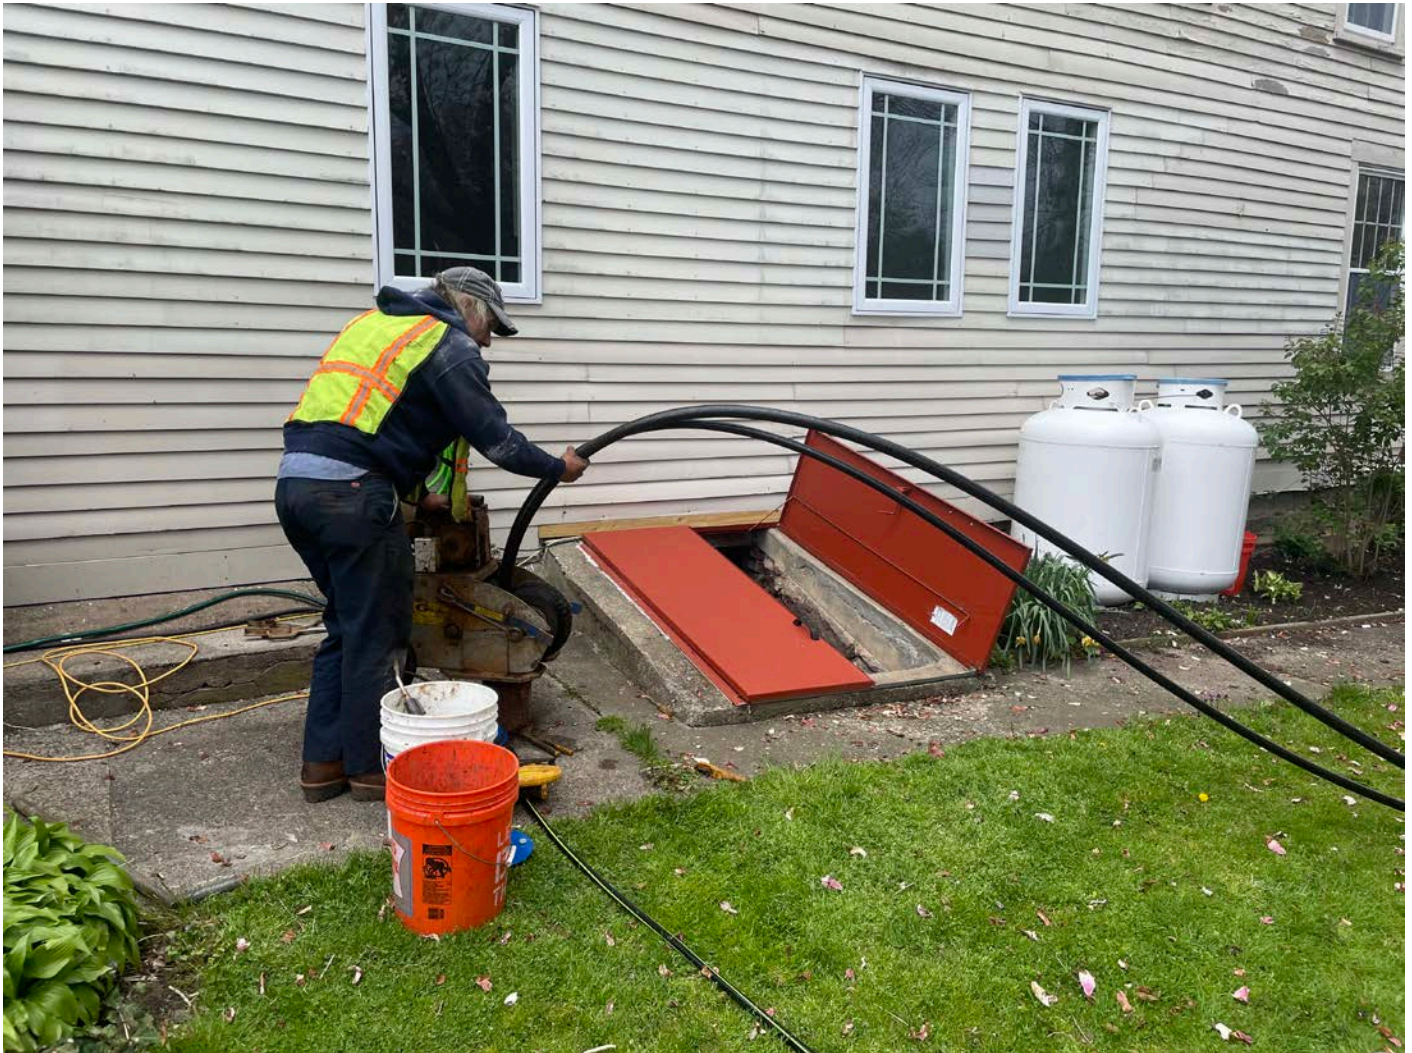
Picture 6: Grela pulling the pump from the well located at the 168 Main Street, Durham, residence. View to the northeast.

1302: Grela mobilizes to the 168 Main Street, Durham, property to remove the pump from the well located on the south side of the house immediately west of a bulkhead door to the basement.

1321: Grela is currently using an electric saw to cut the metal cap off the steel well riser at the 168 Main Street property.

1401: Grela has removed the pump from the well at 168 Main Street property and is currently sending one of the two black poly waterlines back down the well for future use when they tremie grout the well.

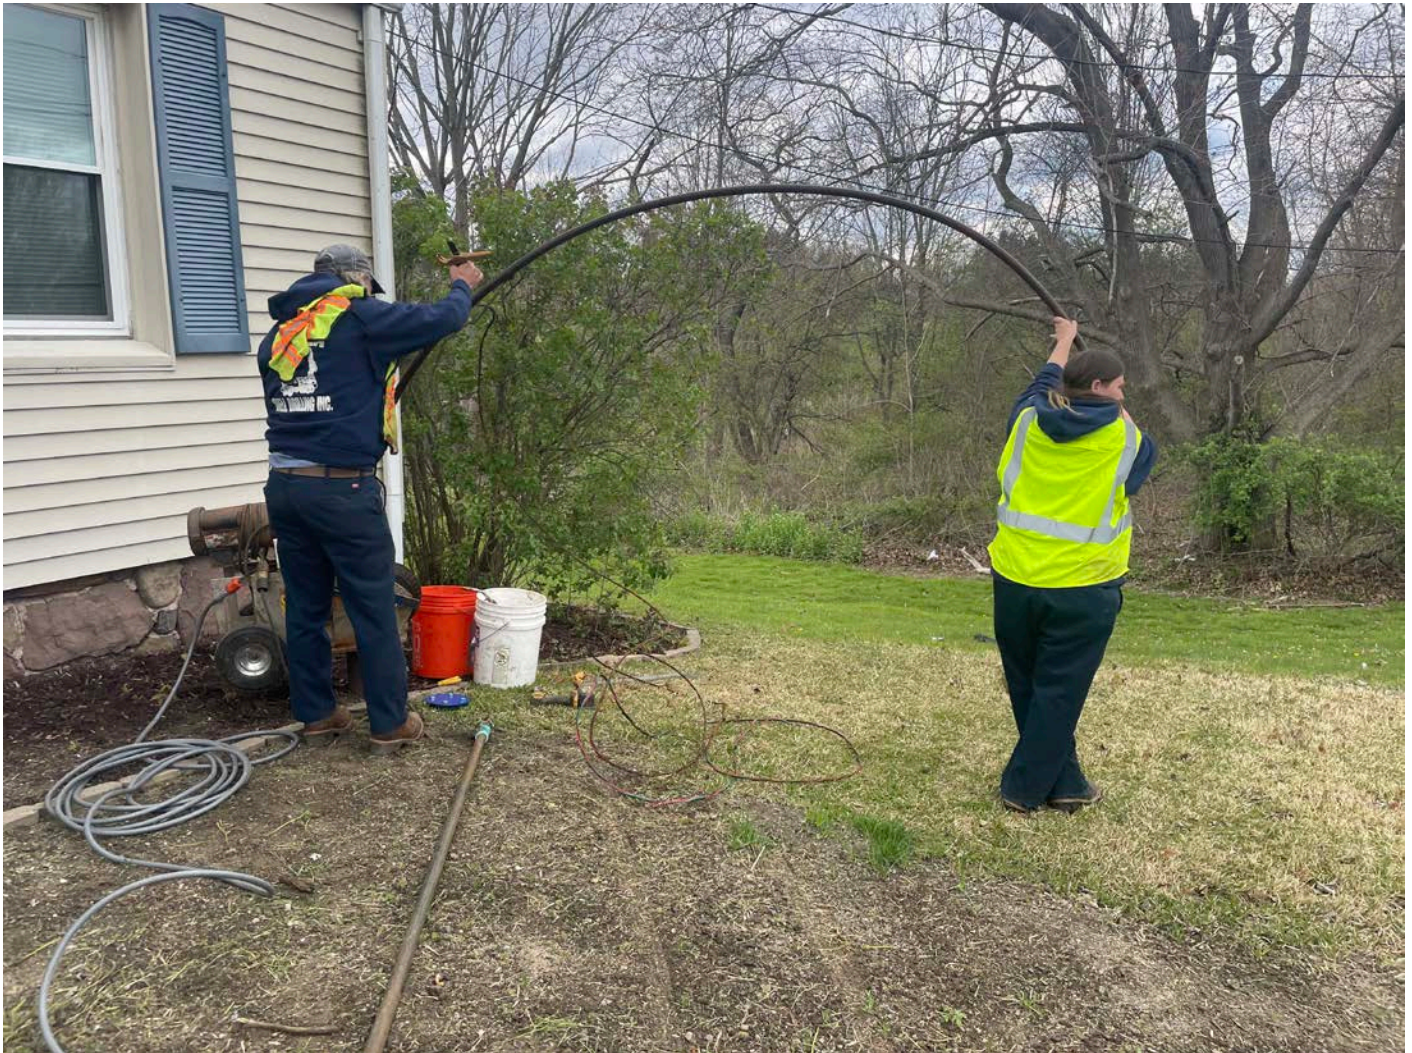
Picture 7: Grela pulling the pump from the well located at the 235 Maple Avenue, Durham, property. View to the southeast.

0857: Grela mobilizes to the 235 Maple Avenue, Durham, property to remove the pump from the residence's well.

0903: Grela has just cut the power to the submersible pump located in the well at 235 Main Street. The well is located on the west side of the house near the south west corner.

0919: Grela has just pulled the pump from the well located at the 235 Maple Avenue property.

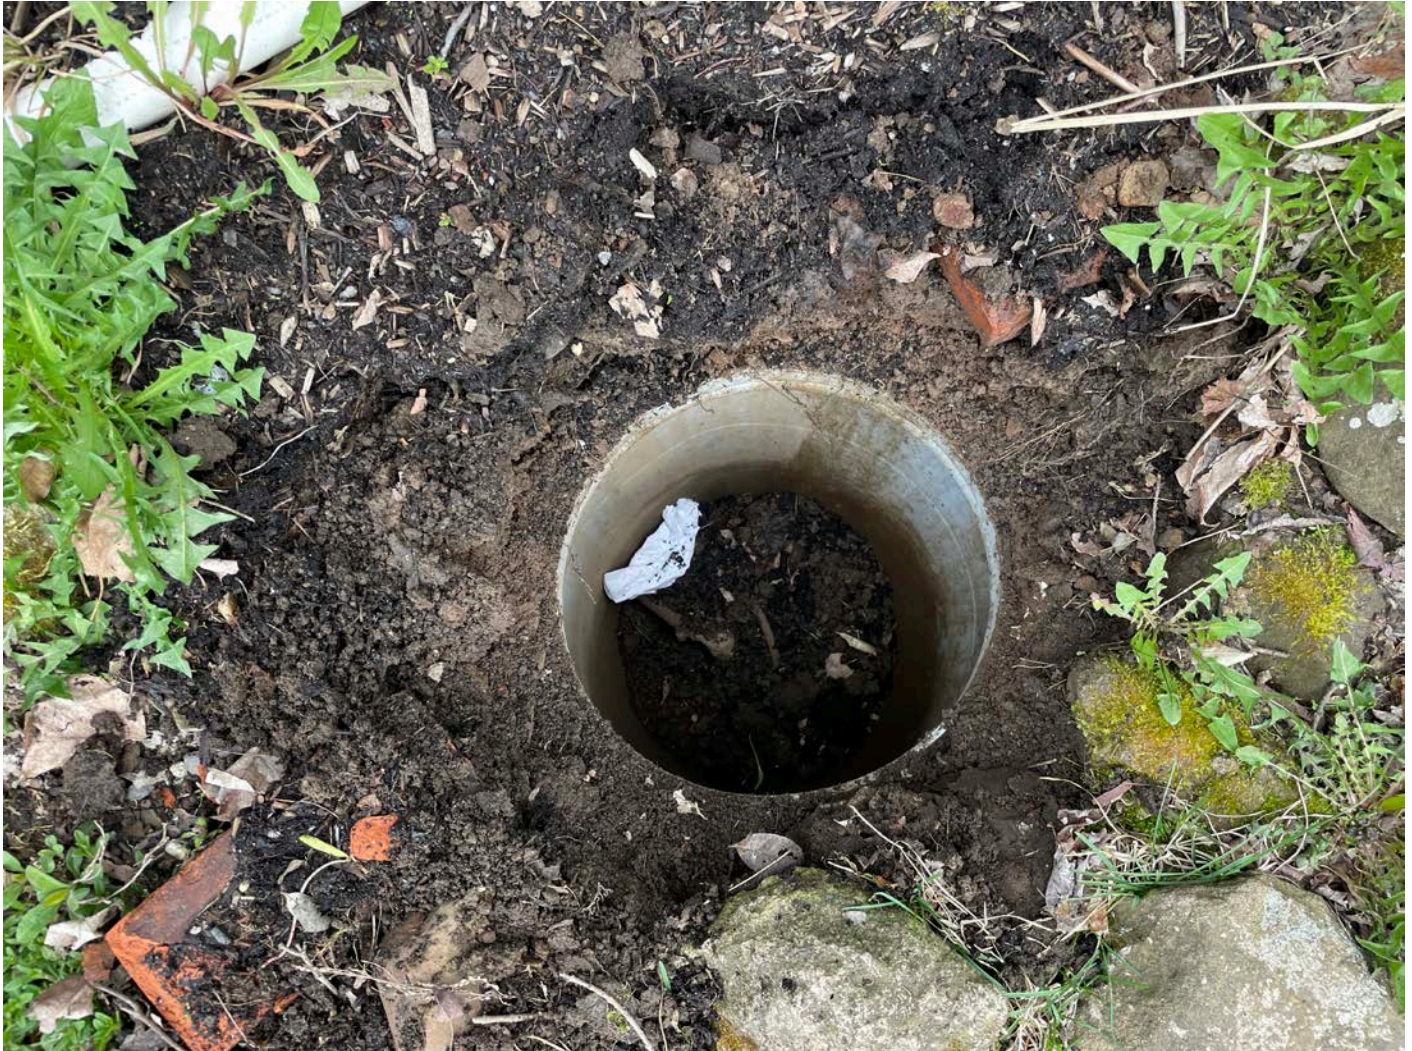
1211: Grela has arrived at the 271 Main Street, Durham, property to pull the pump from the well located on the north side of the house. The well was found buried beneath ~15" of soil and inside of a ~12" plastic tile. The location as well is marked as a septic system on the Appendix B plans.

1228: Grela was unable to pull the pump from the well located on the 271 Main Street property due to logistical issues (the narrow diameter of the 12" plastic tile that the well is set inside of made it impossible to reach the top of the well with the correct tools to remove it).

**Picture 8: The well located on the north side of the 271 Main Street, Durham, residence. The space restrictions imposed by the 12" plastic tile surrounding the well head made it impossible for Grela to access the well head in order to remove the well pump today.**

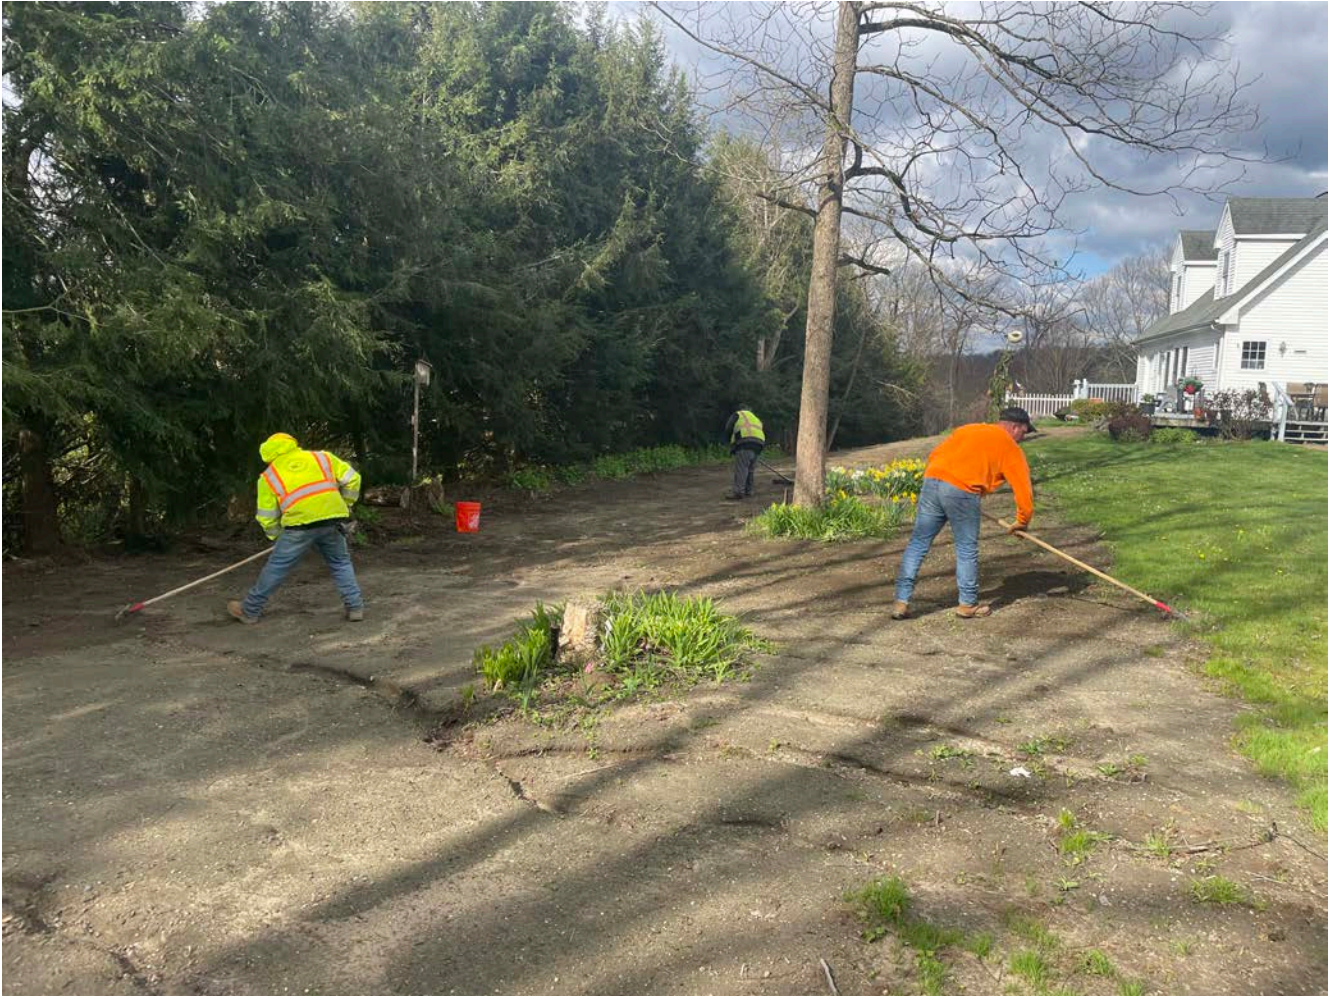
**Picture 9: Ludlow performing restoration activities on the areas of the 228R Maple Avenue property that were disturbed last year during the installation of a copper water service line. View to the west.**

0806: Ludlow is working at the 228R Maple Avenue property restoring portions of the lawn that were disturbed during the installation of a copper water service line last year.

0855: Ludlow continues to work at the 228R Maple Avenue property restoring portions of the lawn that were disturbed during the installation of a copper water service line last year.

0943: Ludlow continues to work at the 228R Maple Avenue property restoring portions of the lawn that were disturbed during the installation of a copper water service line last year.

1051: Ludlow continues lawn restoration activities at the 228R Maple Avenue property.

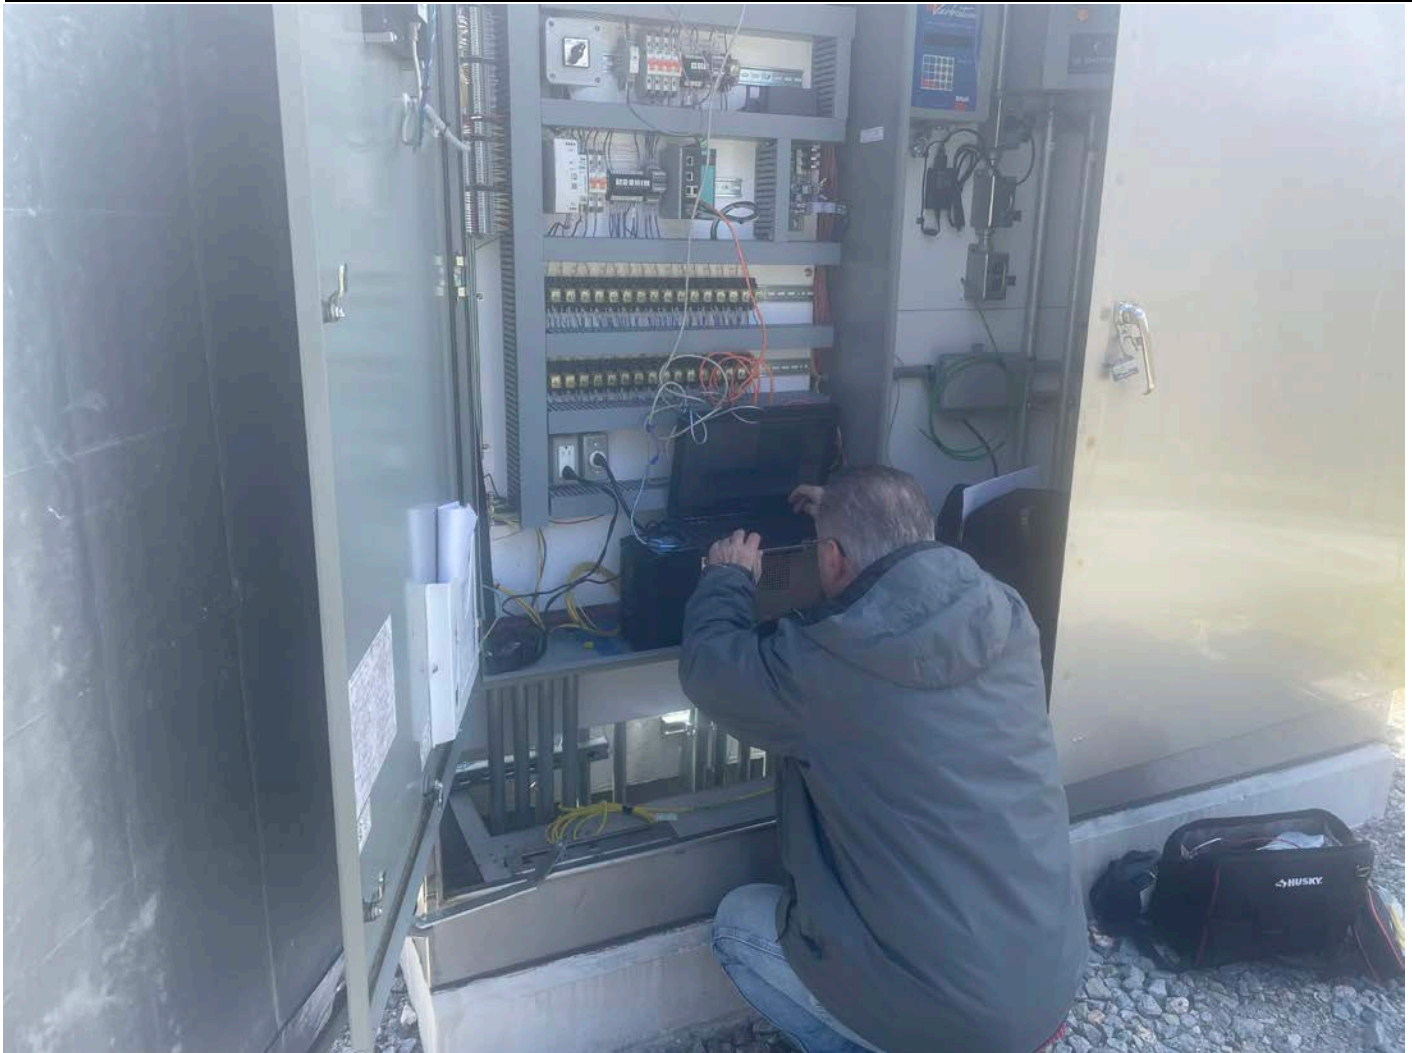
**Picture 10: Knapp Engineering working on setting up relays inside of the electrical enclosure located on the west side of the water tank located east of the Shared Access Driveway in Middletown. View to the south.**

Ludlow continued to fill the water tank located east of the Shared Access Driveway in Middletown. Knapp Engineering worked on setting relays in the electrical enclosure located west of the water tank.
