Daily Report

Project:	Durham Meadows Pipeline Installation	Date:	June 21, 2022
Location:	Maple Avenue and Maiden Lane, Durham	Day of Week:	Tuesday
Project #:	AECOM: 60614871	Report No:	451
Contractor:	Ludlow Construction	Page:	2 of 11

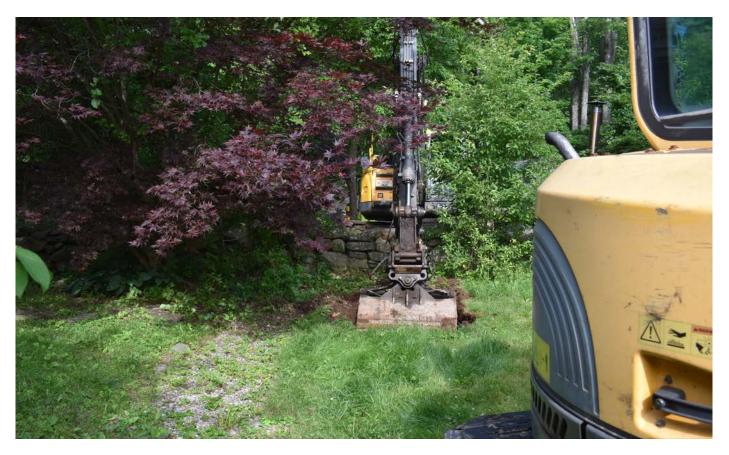
Photo 1: Ludlow crew starting to excavate trench for new pipe on west side of house at 114 Maiden Lane. View to the west.

0900: Ludlow crew beginning excavation of pipe trench at northeast corner of house.

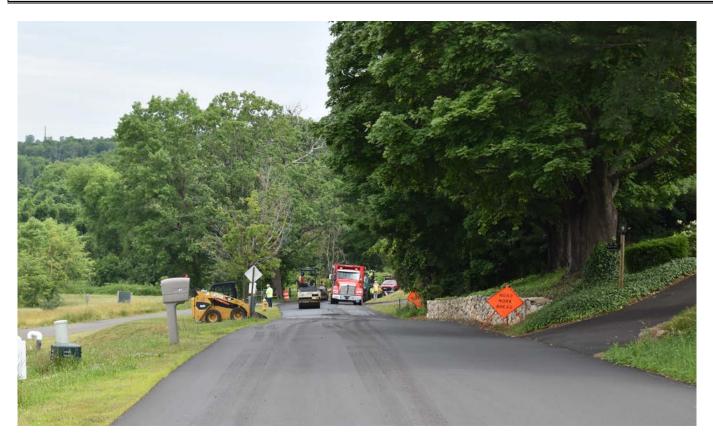
Photo 2: Laydon paving crew installing asphalt surface on Maple Avenue near intersection with Old Cemetery Road. View to the north.

0945: Laydon paving crew installing pavement on Maple Avenue near intersection with Old Cemetery Road.

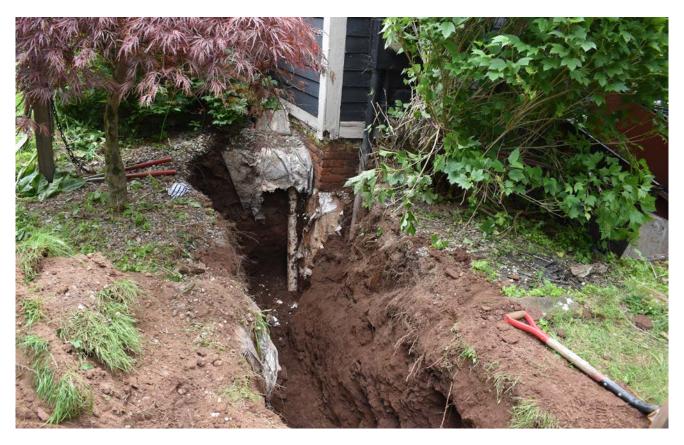
Photo 3: Trench excavated to northwest house corner at 114 Maiden Lane. View to the east.

1125: Ludlow crew at 114 Maiden Lane has excavated trench from northwest house corner over 40 feet in length. Soil changed from mostly fine soil adjacent to foundation to very rocky material approximately 10 feet from stone wall.

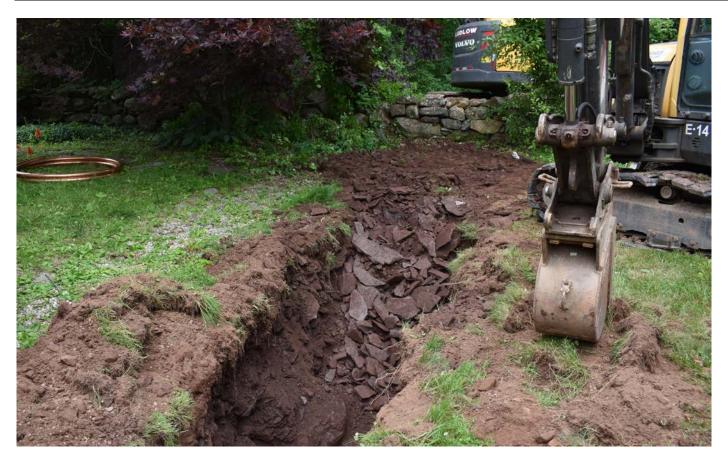
Photo 4: West end of pipe trench at 114 Maiden Lane, showing presence of dense rocky material. Stone wall seen beyond trench. View to the west.

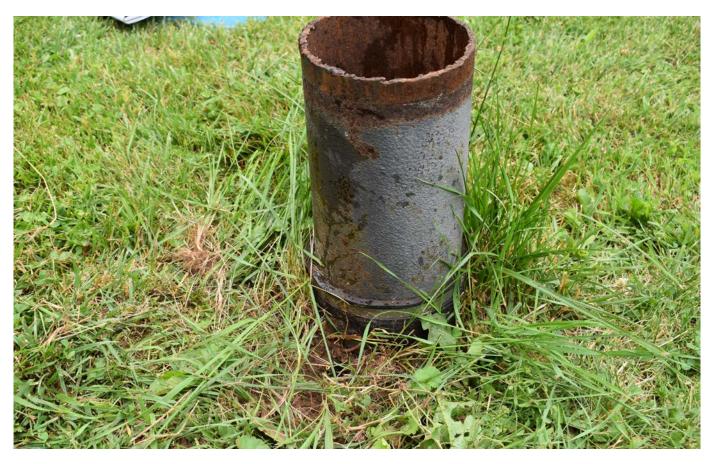
Photo 5: Well casing for former drinking water well at 110 Maple Avenue. The top edge of the rubber coupler can be seen just above the surrounding grass. View to the southeast.

1420: Grela pulled pump from well at 110 Maple Avenue. Above-ground casing (approx. 1 foot above grade) had a rubber coupler ("Fernco") around the standpipe at the ground surface to cover corroded metal. Grela did not have a cover on hand to install on the open pipe after cutting it to grade. They will bring the cover tomorrow and cut the pipe. They installed a temporary cover on the standpipe.

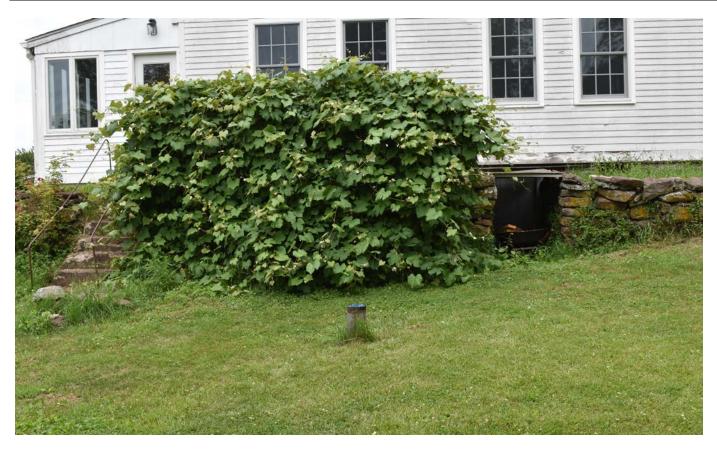
Photo 6: Location of former well casing at 110 Maple Avenue. Temporary cover installed on top of pipe. View to the north.

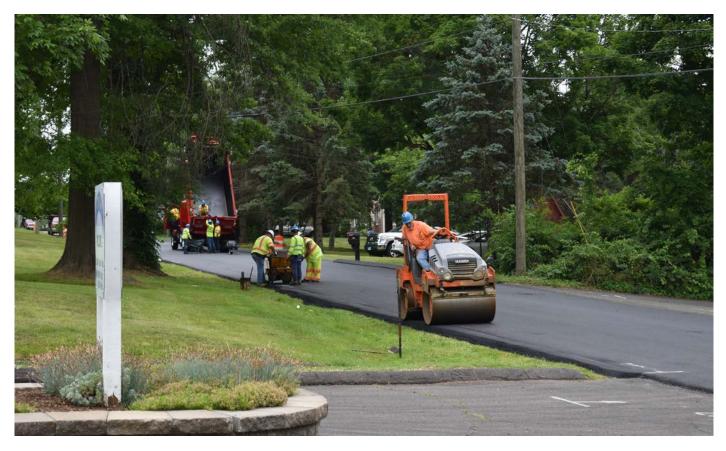
Photo 7: Laydon paving crew installing curbs on Maple Avenue. View to the southwest.

1430: Laydon paving crew installing curbs in the area of 200 Maple Avenue.

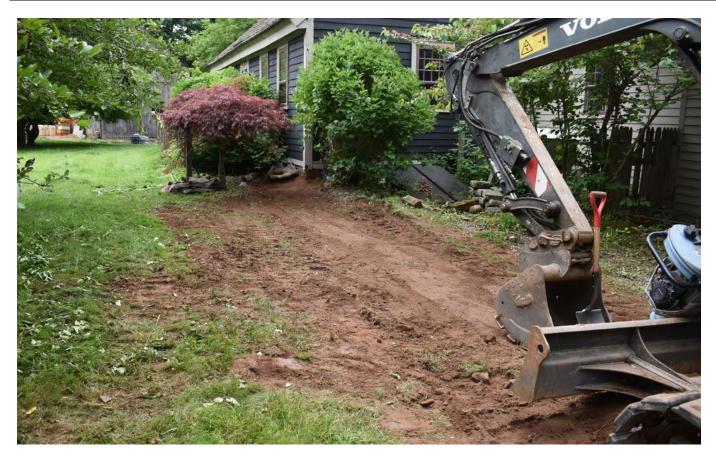
Photo 8: Eastern end of pipe trench at 114 Maiden Lane after backfilling. View to the east.

1445: Ludlow completed installation of 40 feet of 2-inch copper water pipe at 114 Maiden Lane. Trench was backfilled over most of pipe length. The open trench between the end of the pipe and the stone wall was covered with the small excavator and a small trench box. The crew will attempt to make an opening below the stone wall to continue the 2-inch copper pipe installation.

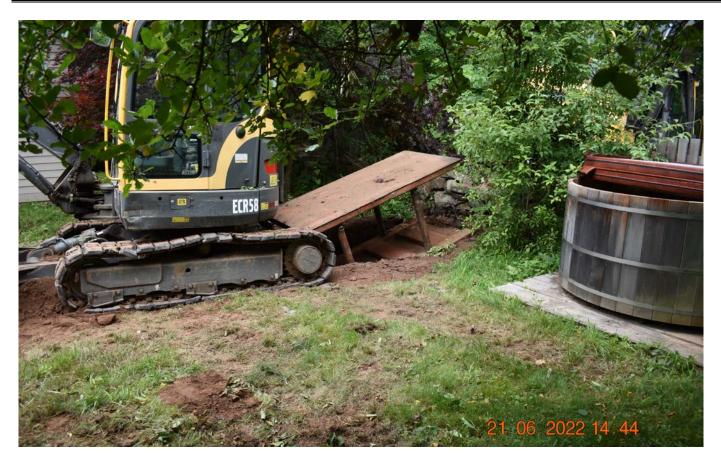
Photo 9: Western end of pipe trench at 114 Maiden Lane. Small excavator and small trench box used to provide barriers for approx. 8-foot length of open trench; remainder of trench has been backfilled. View to the south.
