Daily Report

Project:	Durham Meadows Pipeline Installation	Date:	July 01, 2022
Location:	Pickett Lane and Maiden Lane, Durham, S. Main Street, Middletown	Day of Week:	Friday
Project #:	AECOM: 6061487	Report No:	459
Contractor:	Ludlow Construction	Page:	1 of 14

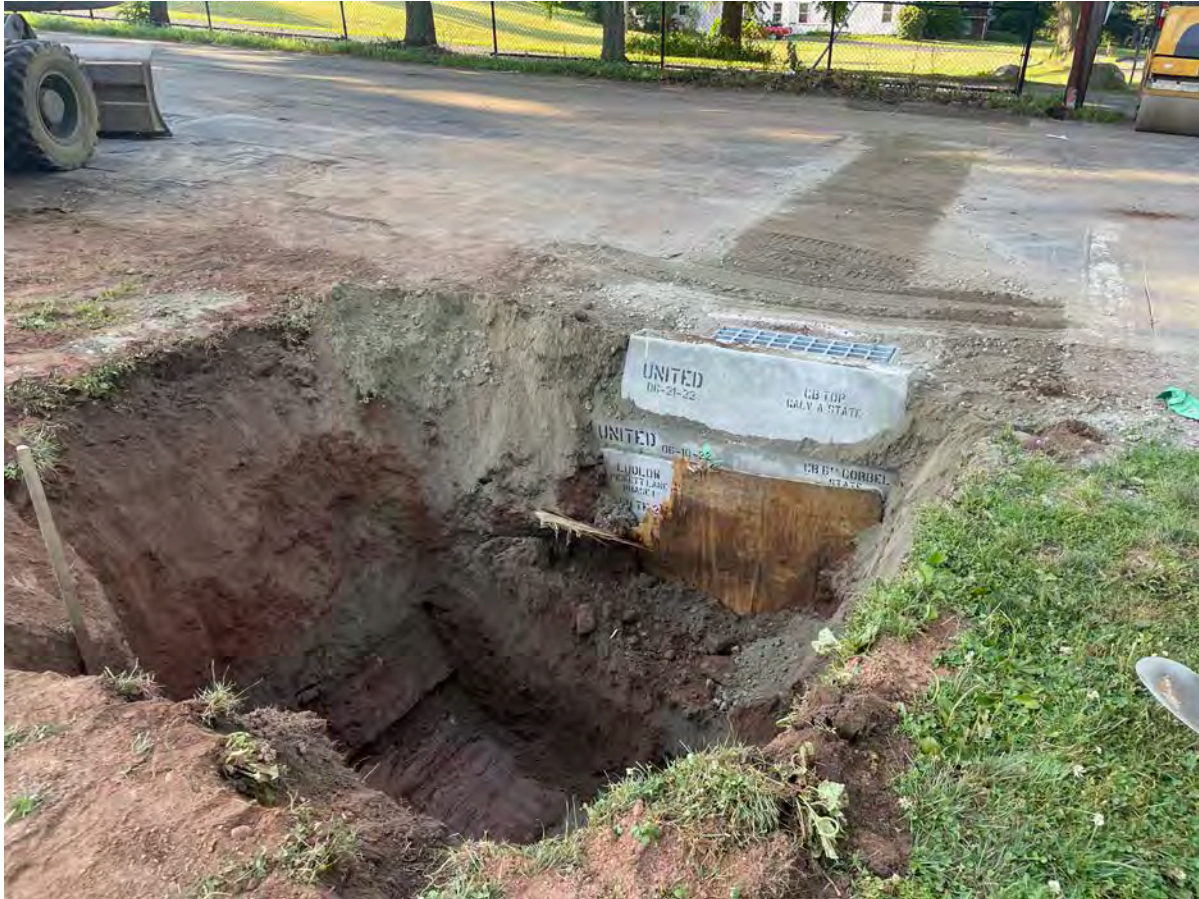
Picture 1: Excavation that Ludlow made on the north side of the catch basin they installed on June 30, 2022 at Station 500+50 on the north side of Pickett Lane, Durham. Ludlow will be installing a second catch basin in the excavation. View to the south.

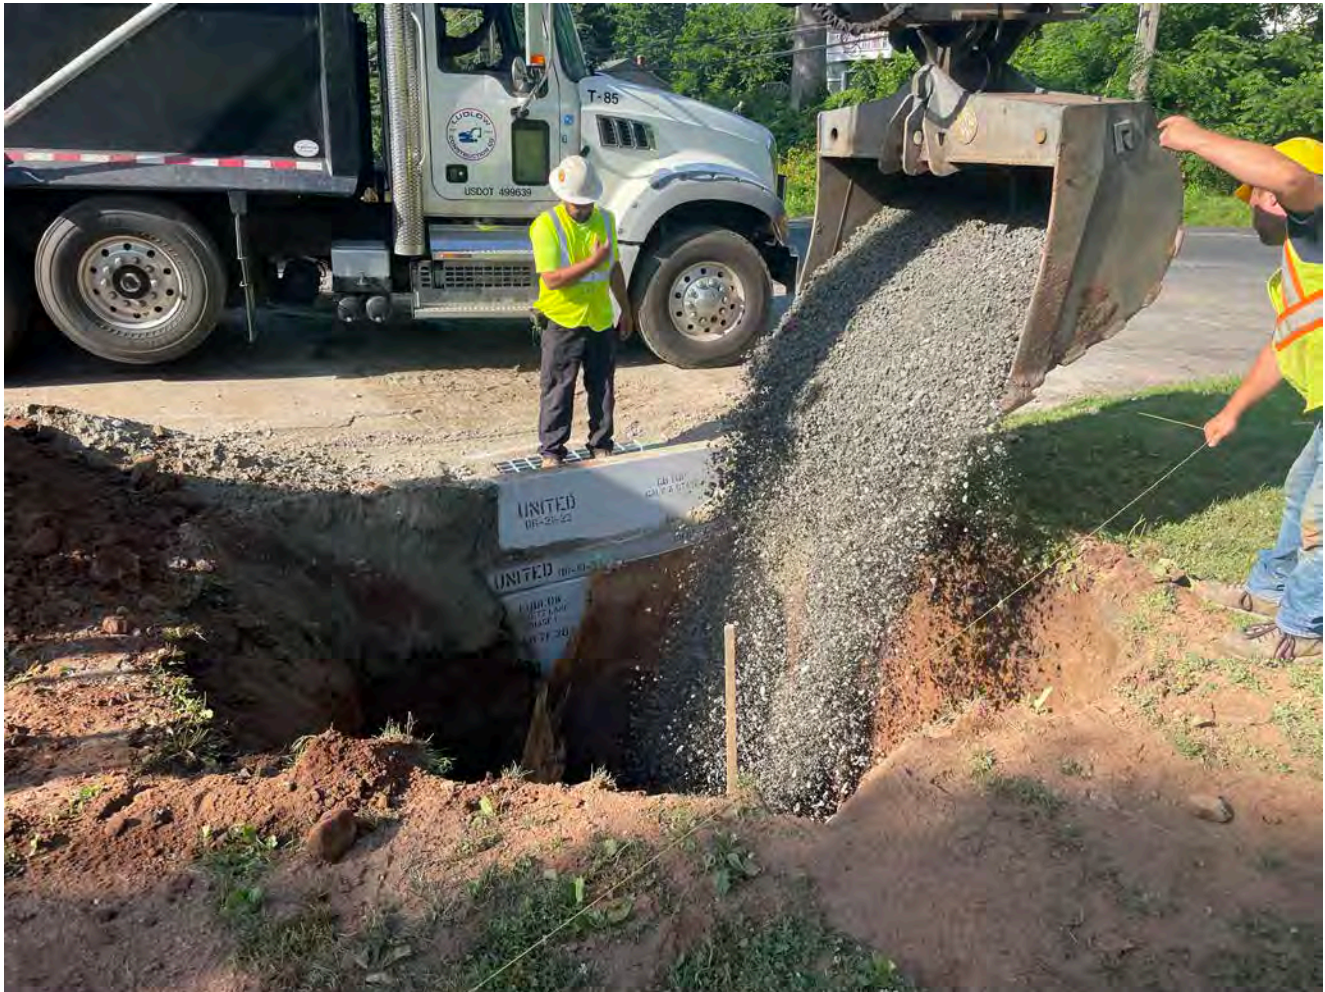
Picture 2: Ludlow placing ¾" stone into the bottom of the excavation that Ludlow made on the north side of the catch basin they installed on June 30, 2022 at Station 500+50 as they prepare to install a second catch basin. View to the southwest.

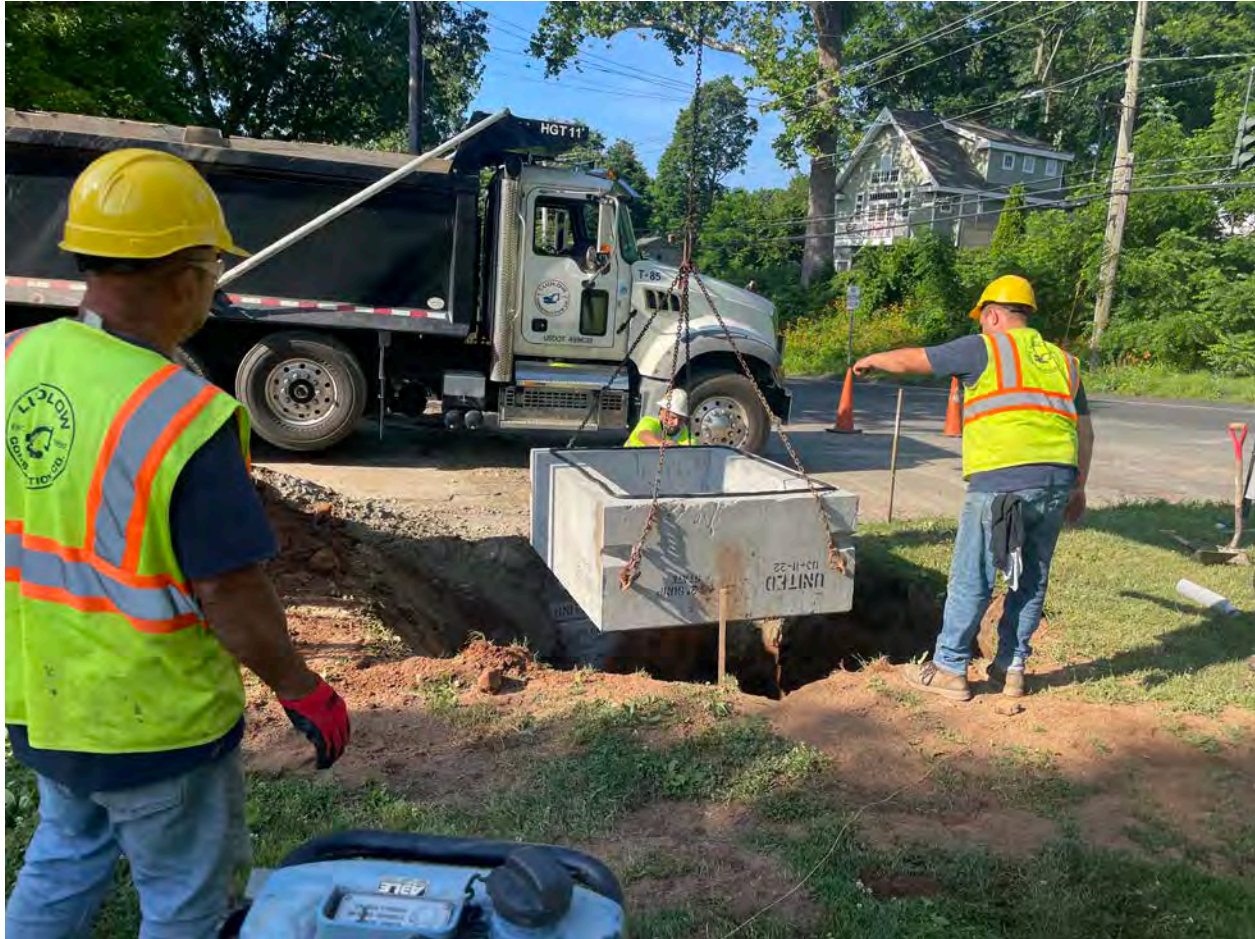
Picture 3: Ludlow placing a section of the second catch basin they are installing at Station 500+50; immediately north of the catch basin they installed on Pickett Lane on June 30, 2022. View to the southwest.

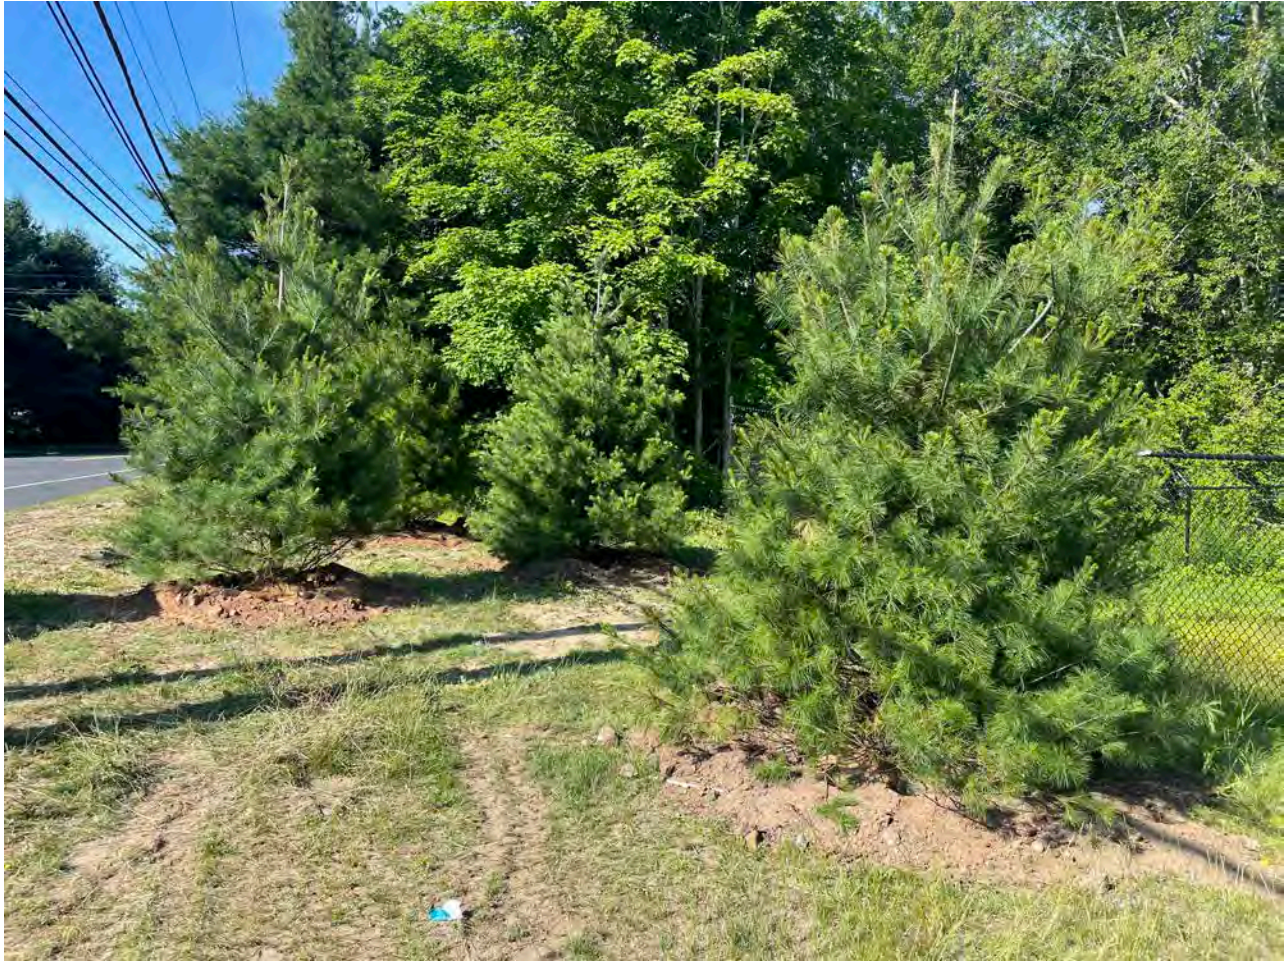
Picture 4: White pines planted by Jay's Landscaping on the east side of the Booster Station located on S. Main Street in Middletown. View to the south.

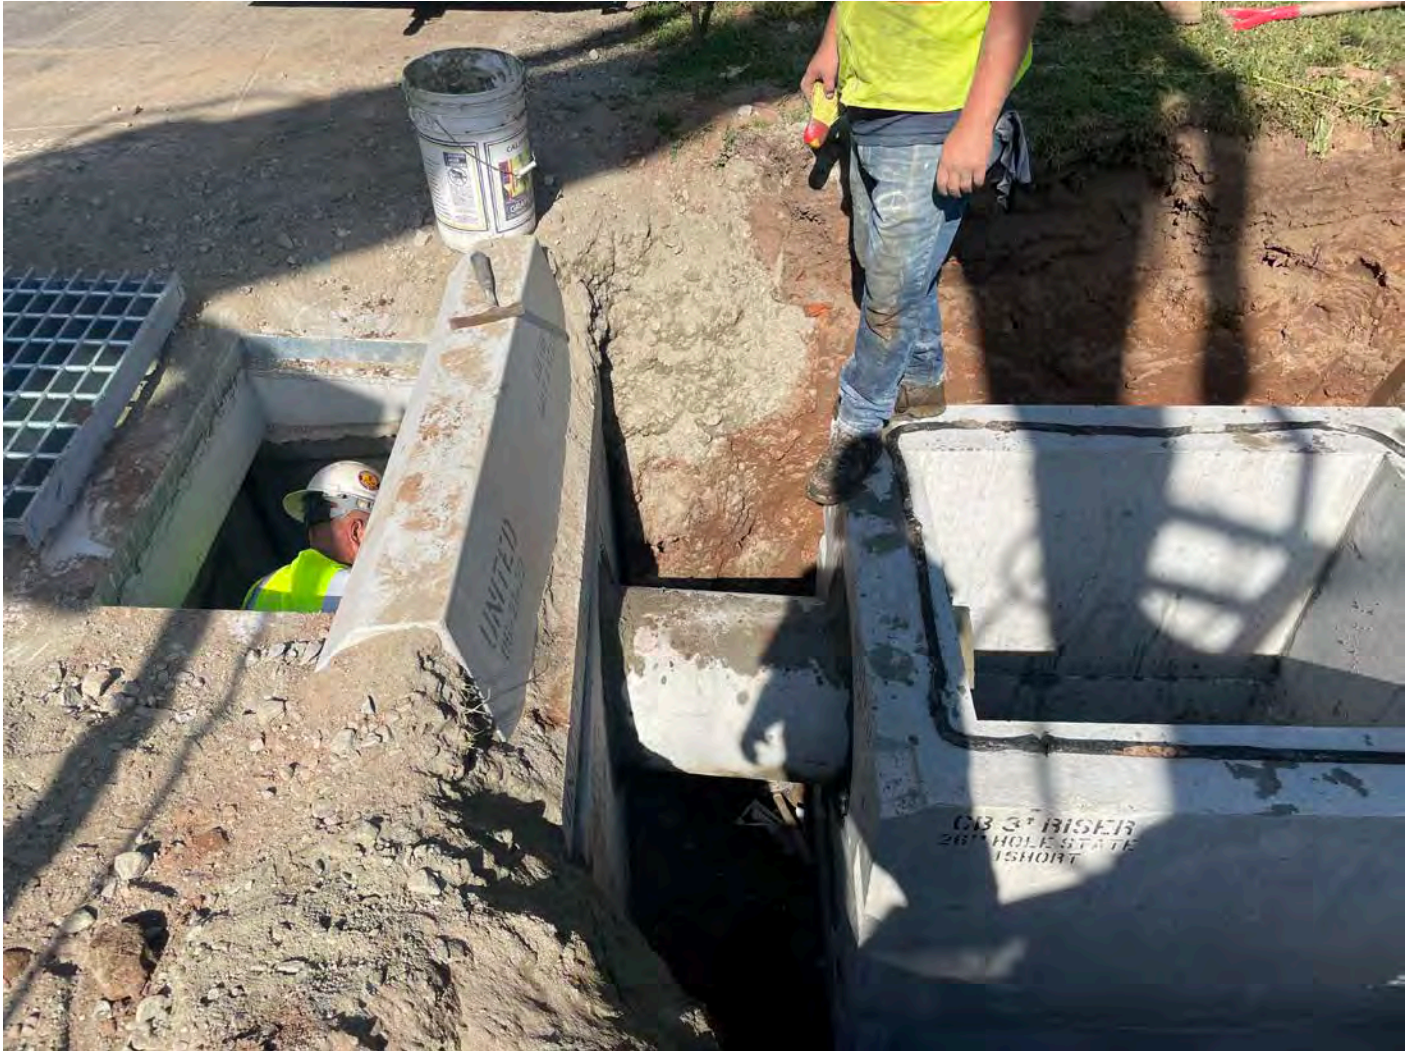
Picture 5: Ludlow placing mortar around a section of 15" RCP that connects the catch basin that Ludlow installed at Station 500+50 to the catch basin they installed today on July 1, 2022. View to the west.

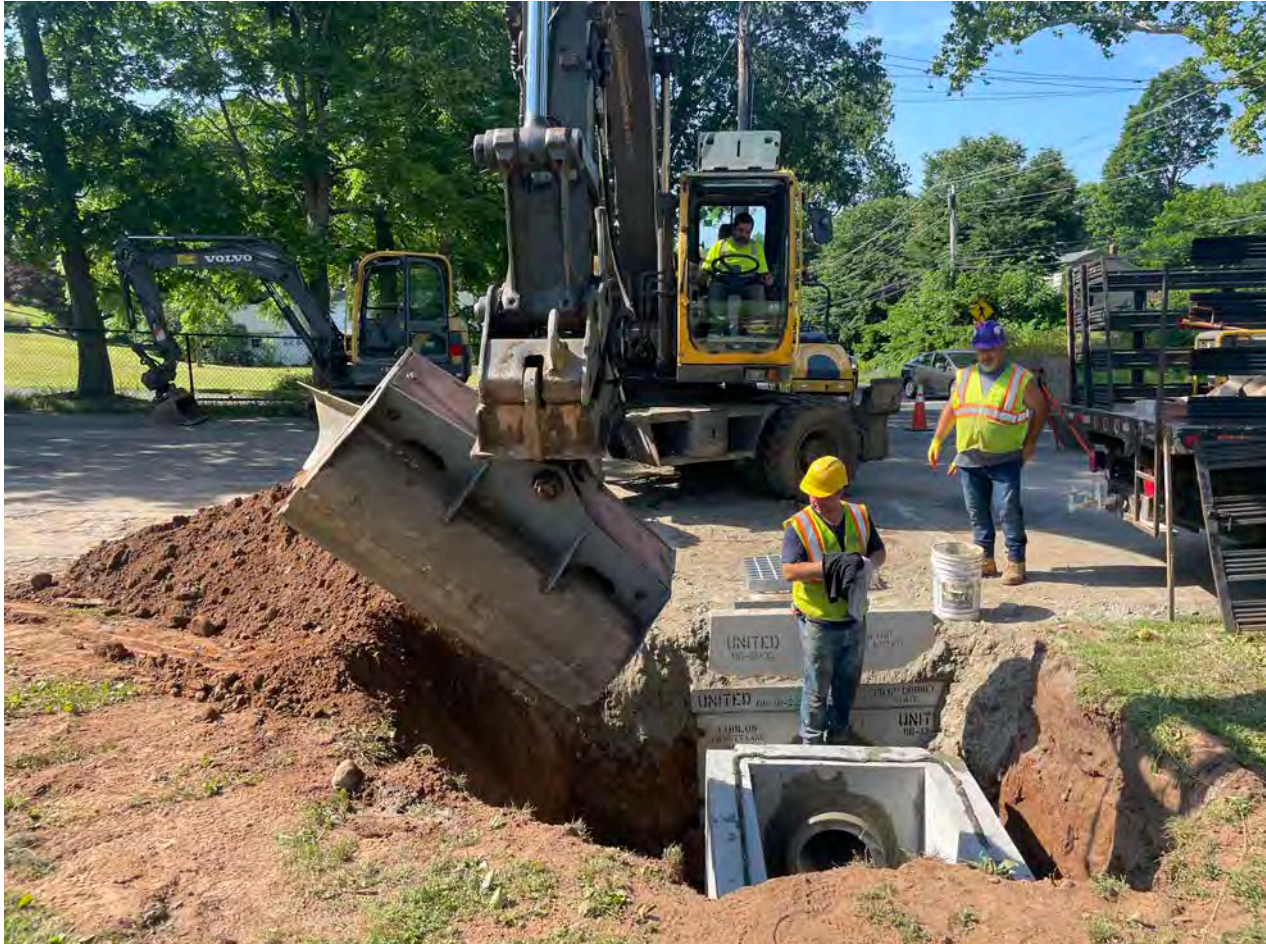
Picture 6: Ludlow placing fill on the east side of the catch basin they are installing at Station 500+50. View to the south.

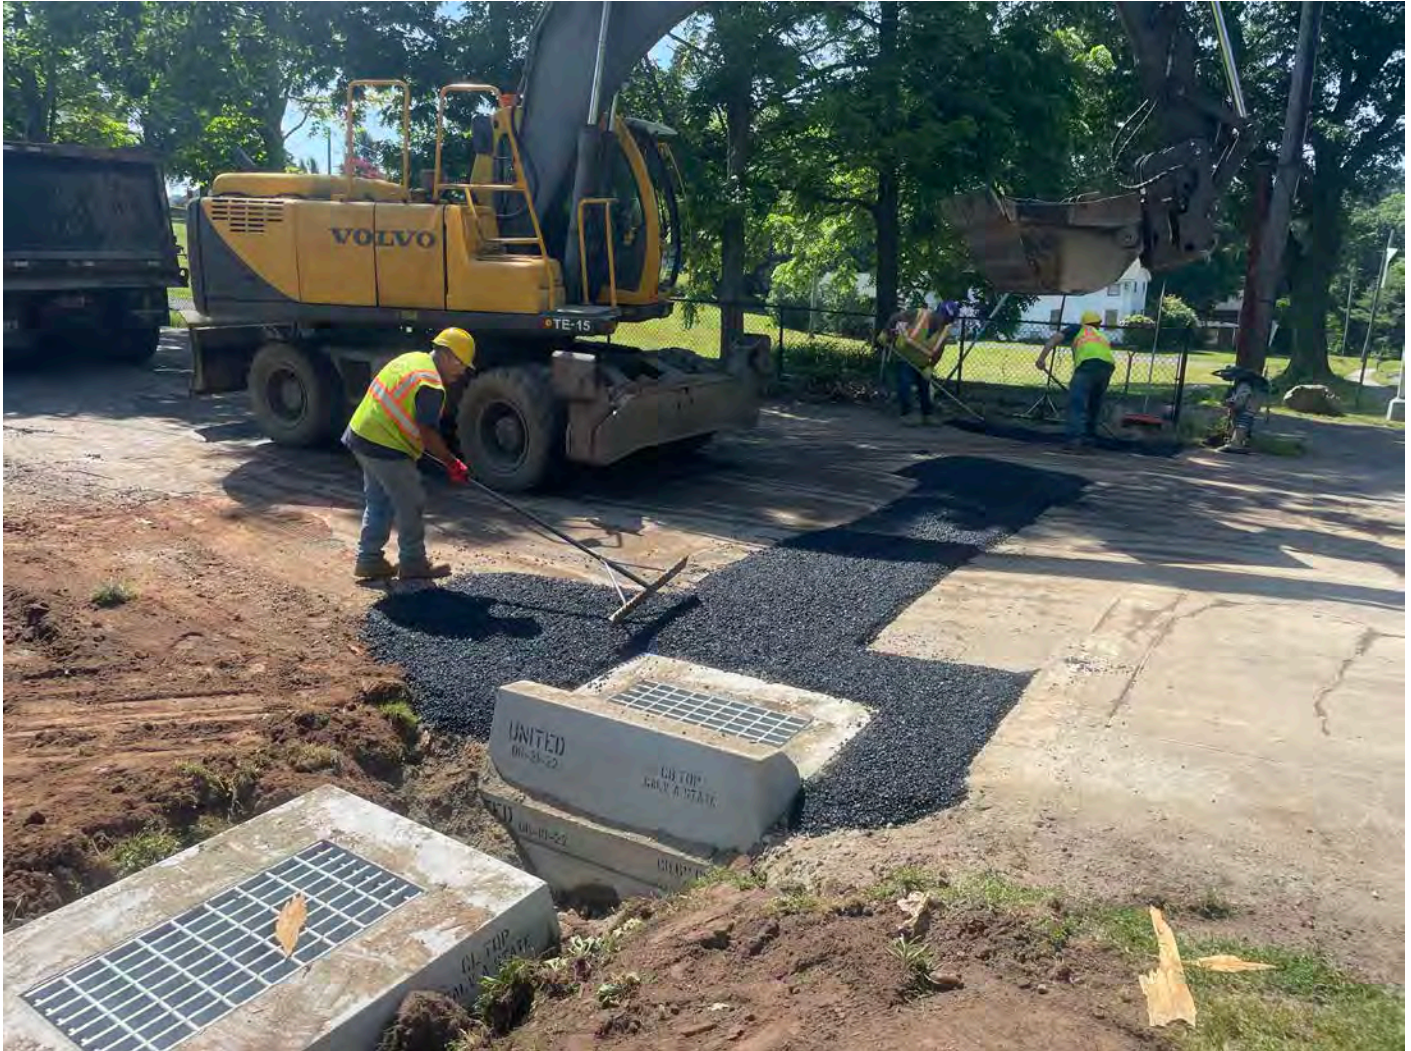
Picture 7: Ludlow raking out freshly-placed asphalt on Pickett Lane at Station 500+50, where they replaced a section of 12" RCP and installed a catch basin on the north side of the road. View to the south.

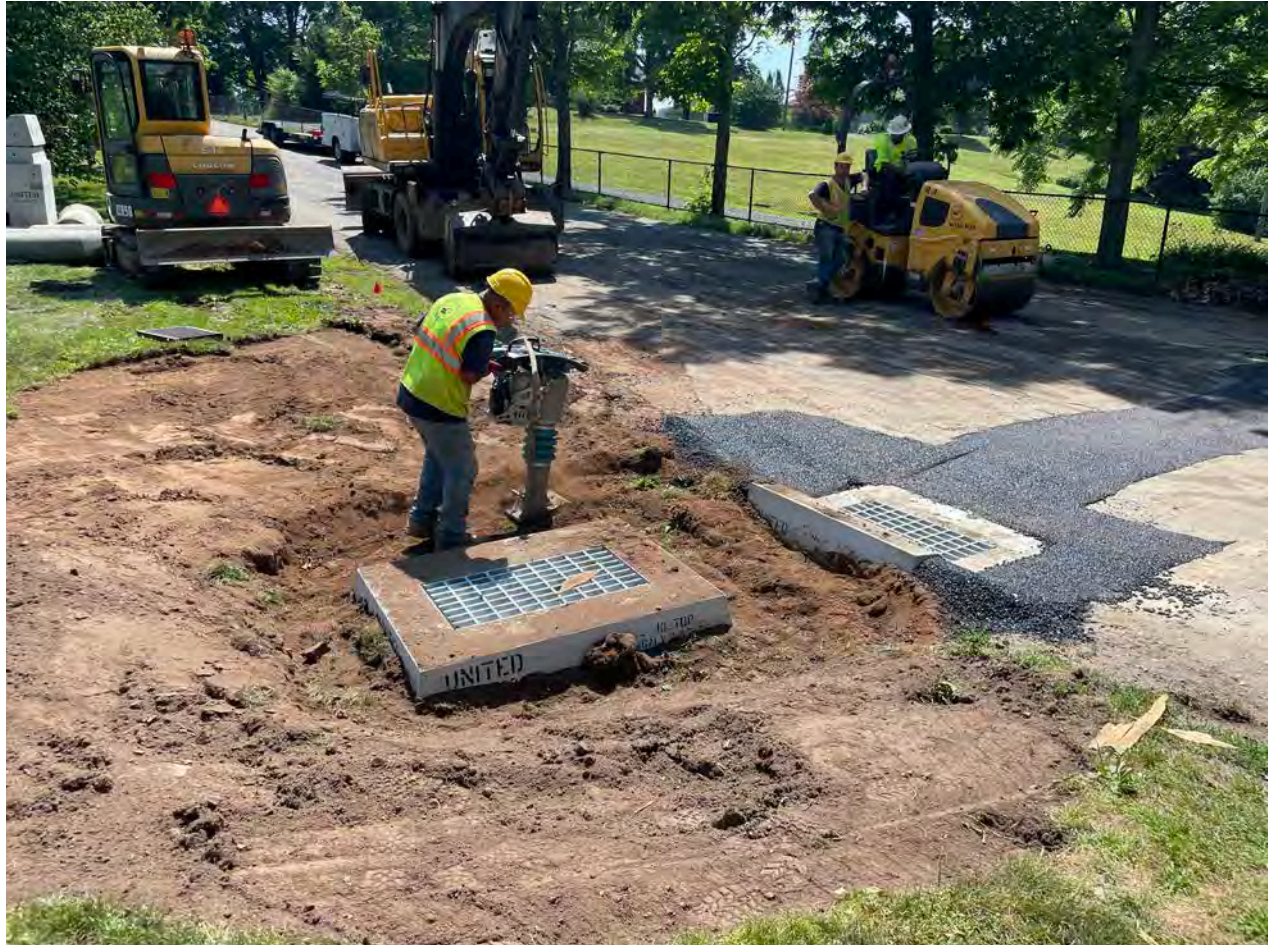
Picture 8: Ludlow compacting backfill around the catch basin they installed today at Station 500+50 to the north of Pickett Lane. View to the southeast.

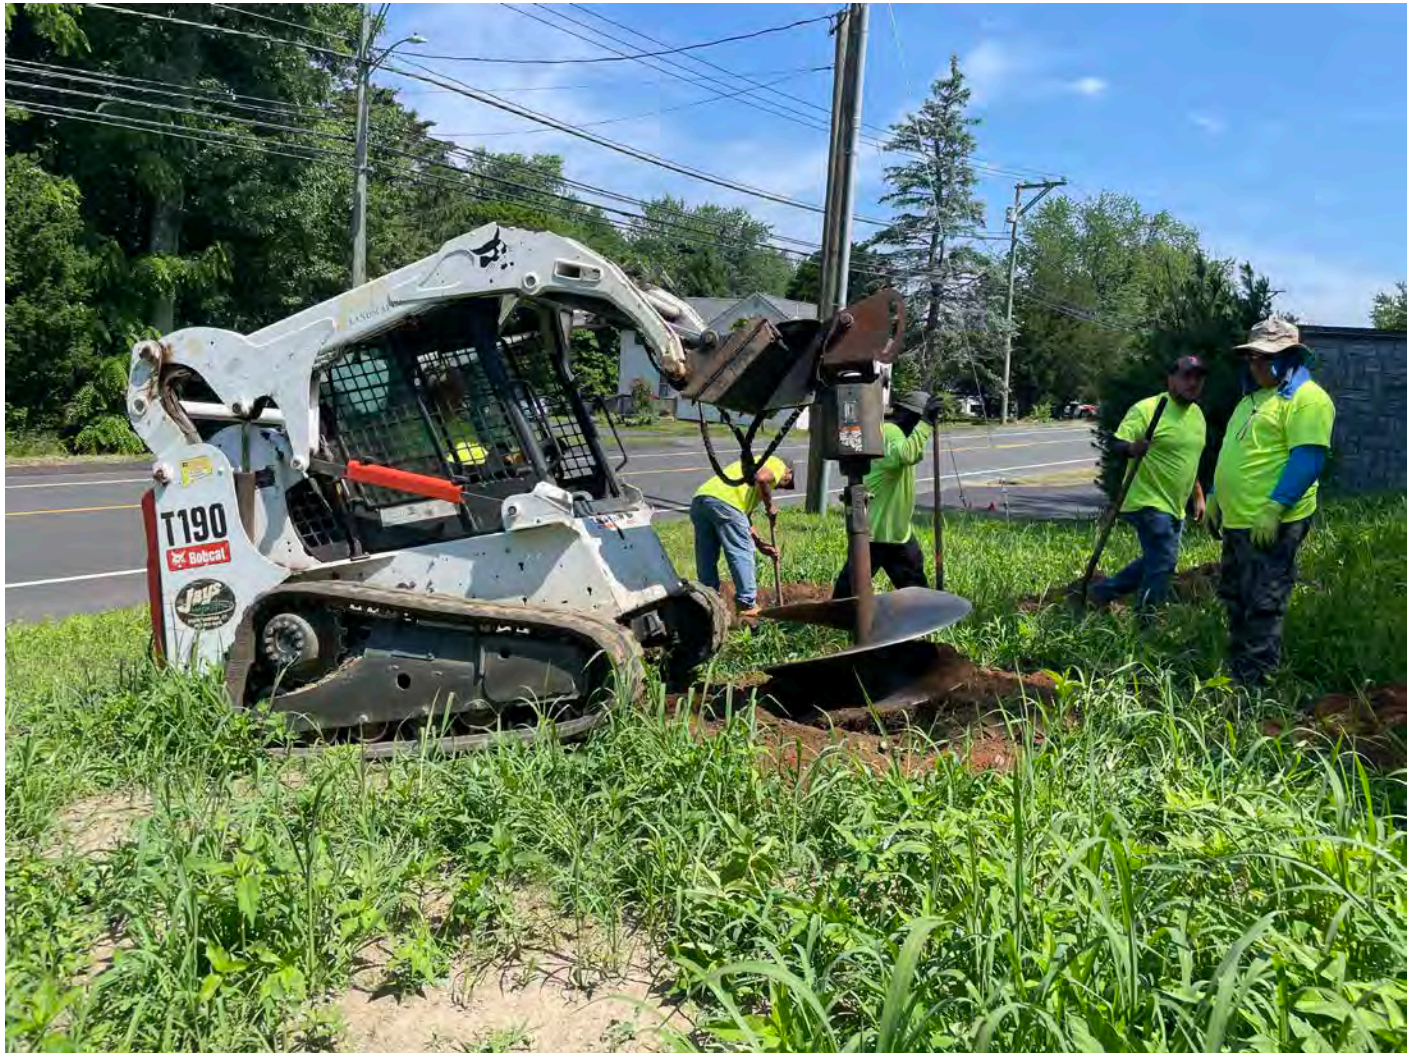
Picture 9: Jay's Landscaping auguring a hole for the planting of a white pine on the south side of the Water Meter Building located on S. Main Street in Middletown. View to the northwest.

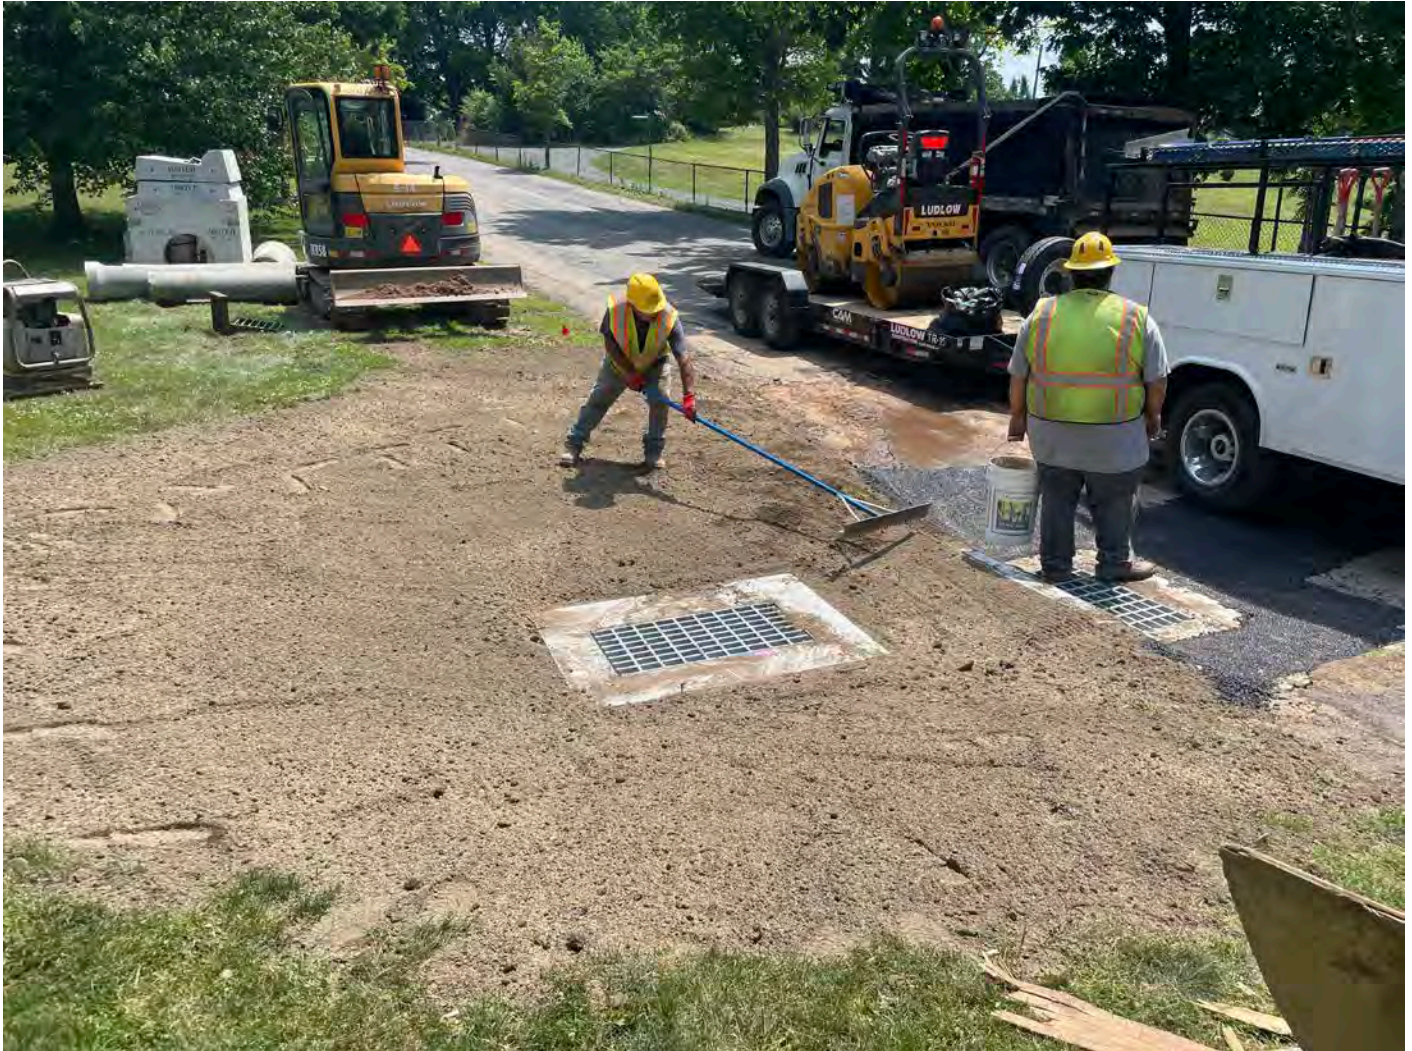
Picture 10: Ludlow raking out loam and grass seed that was spread around the catch basin they just installed at Station 500+50 north of Pickett Lane. View to the southeast.

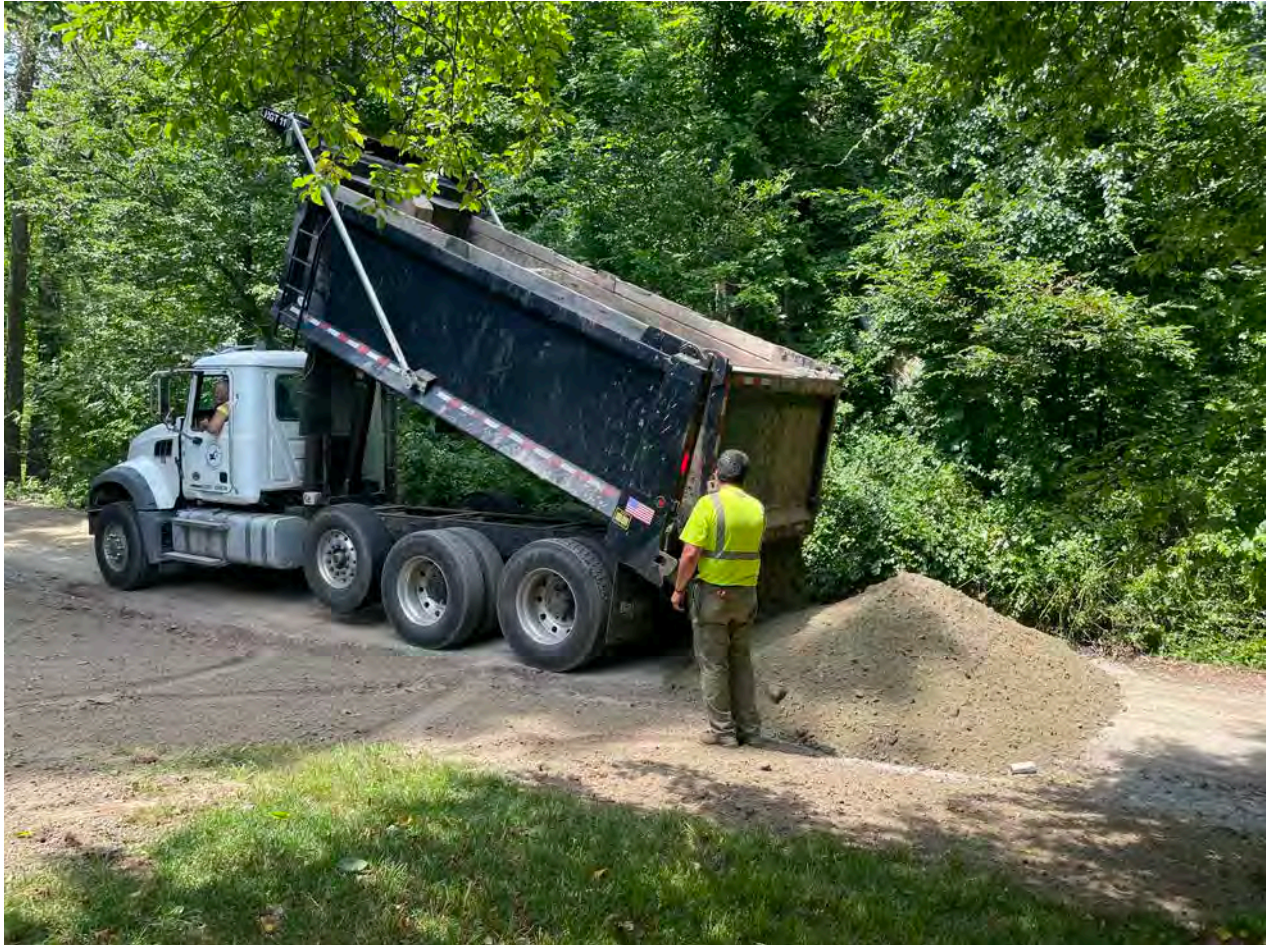
Picture 11: Ludlow placing gravel on the driveway of the 114 Maiden Lane as they work to finish restoration efforts after the installation of a 2" copper water service line. View to the west.

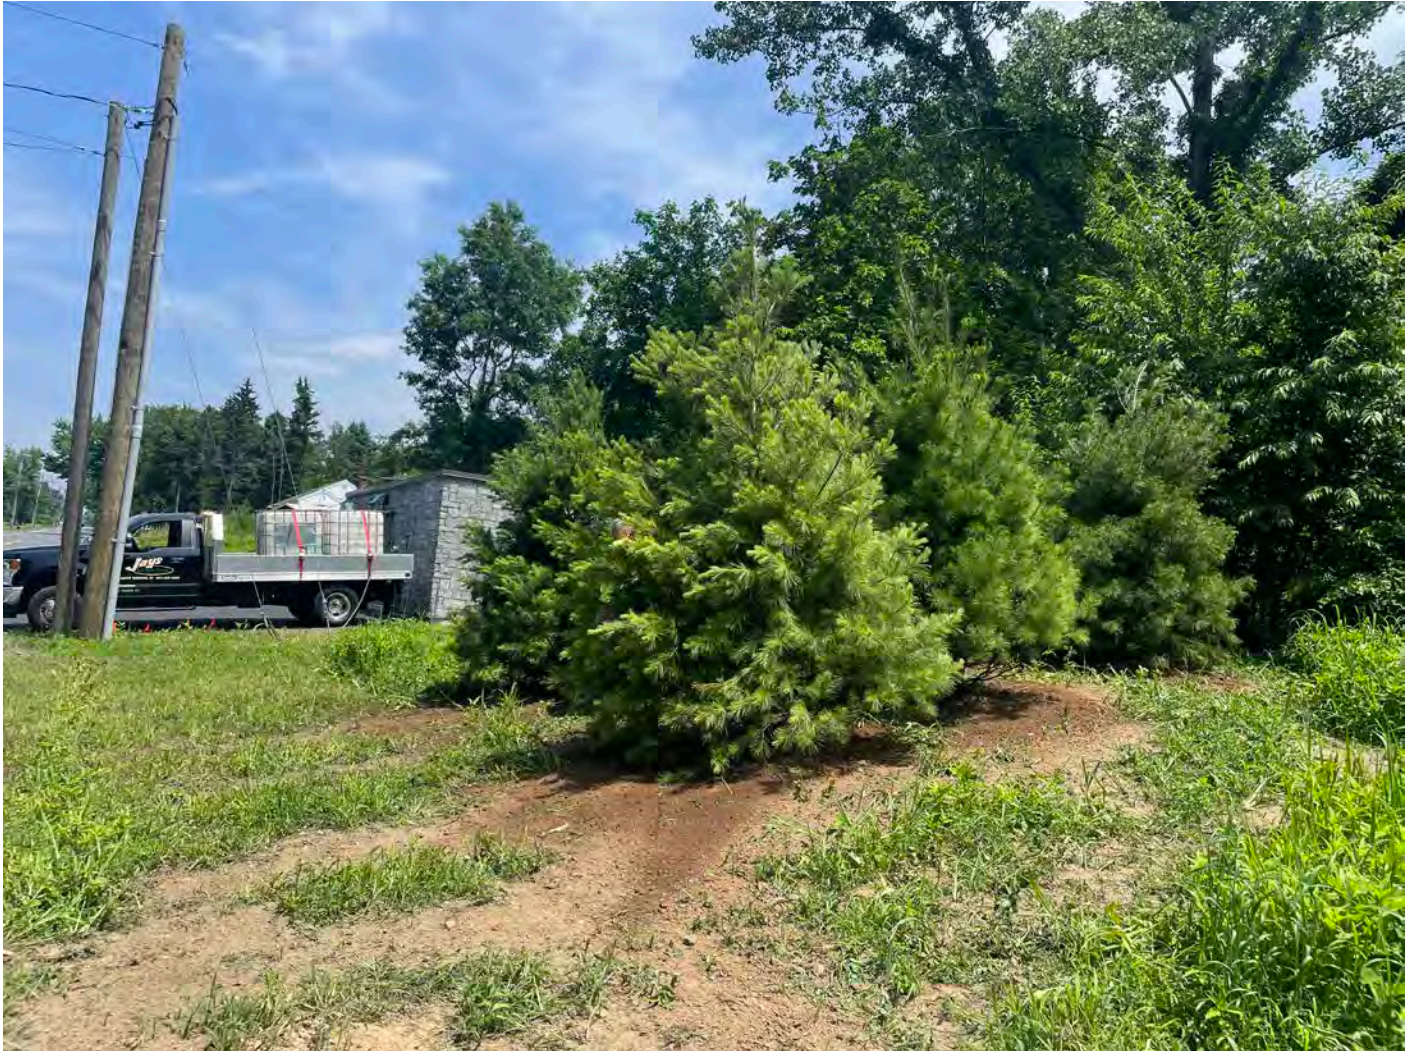
Picture 12: White pines that Jay's Landscaping installed on the south side of the Water Meter Building located on S. Main Street in Middletown. View to the northeast.
