Daily Report

Project:	Durham Meadows Pipeline Installation	Date:	July 14, 2022
Location:	Pickett Lane, Durham	Day of Week:	Thursday
Project #:	AECOM: 6061487	Report No:	467
Contractor:	Ludlow Construction	Page:	1 of 10

Daily Activities – Installation of water services, Pickett Lane, Durham

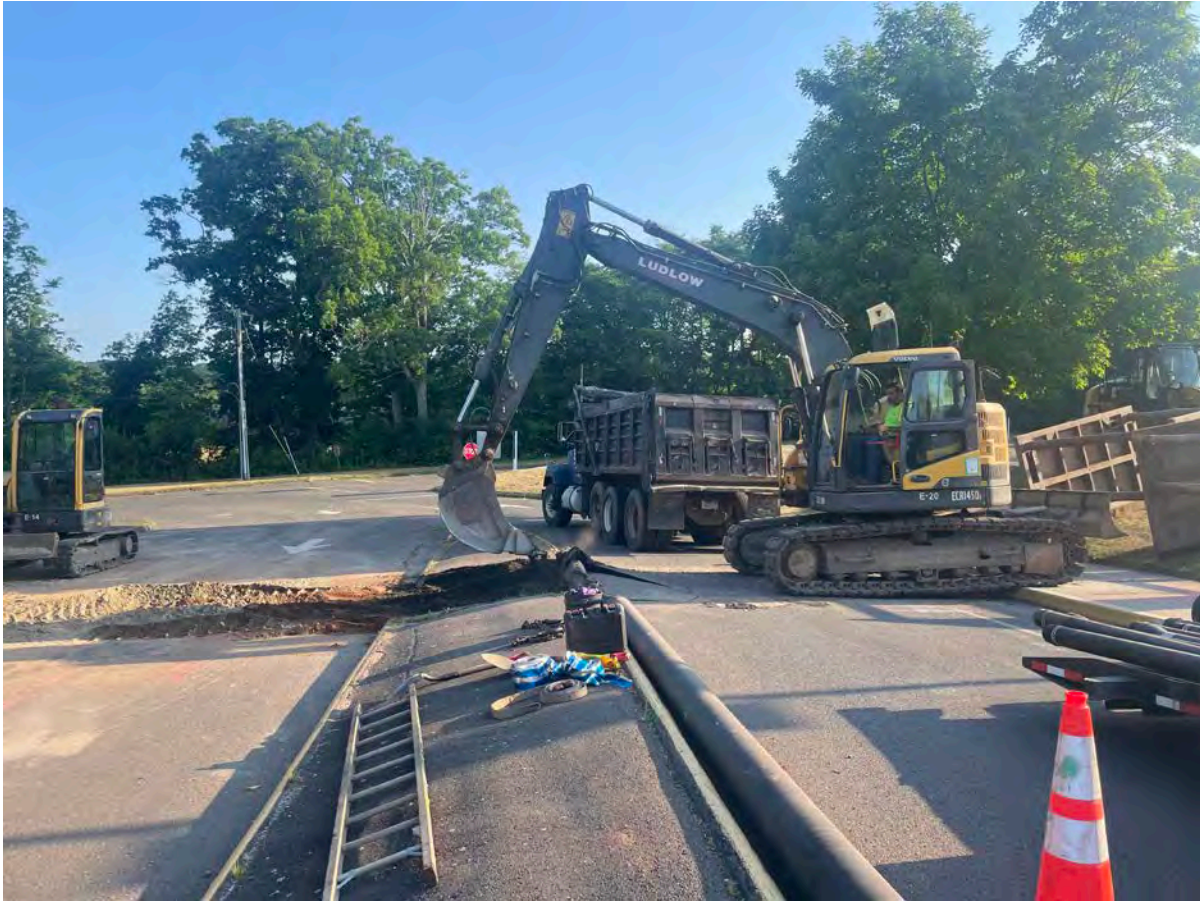
Picture 1: Ludlow removing asphalt from the median strip located on the west side of the CRHS as they continue to install 4" and 8" DIP. View to the north.

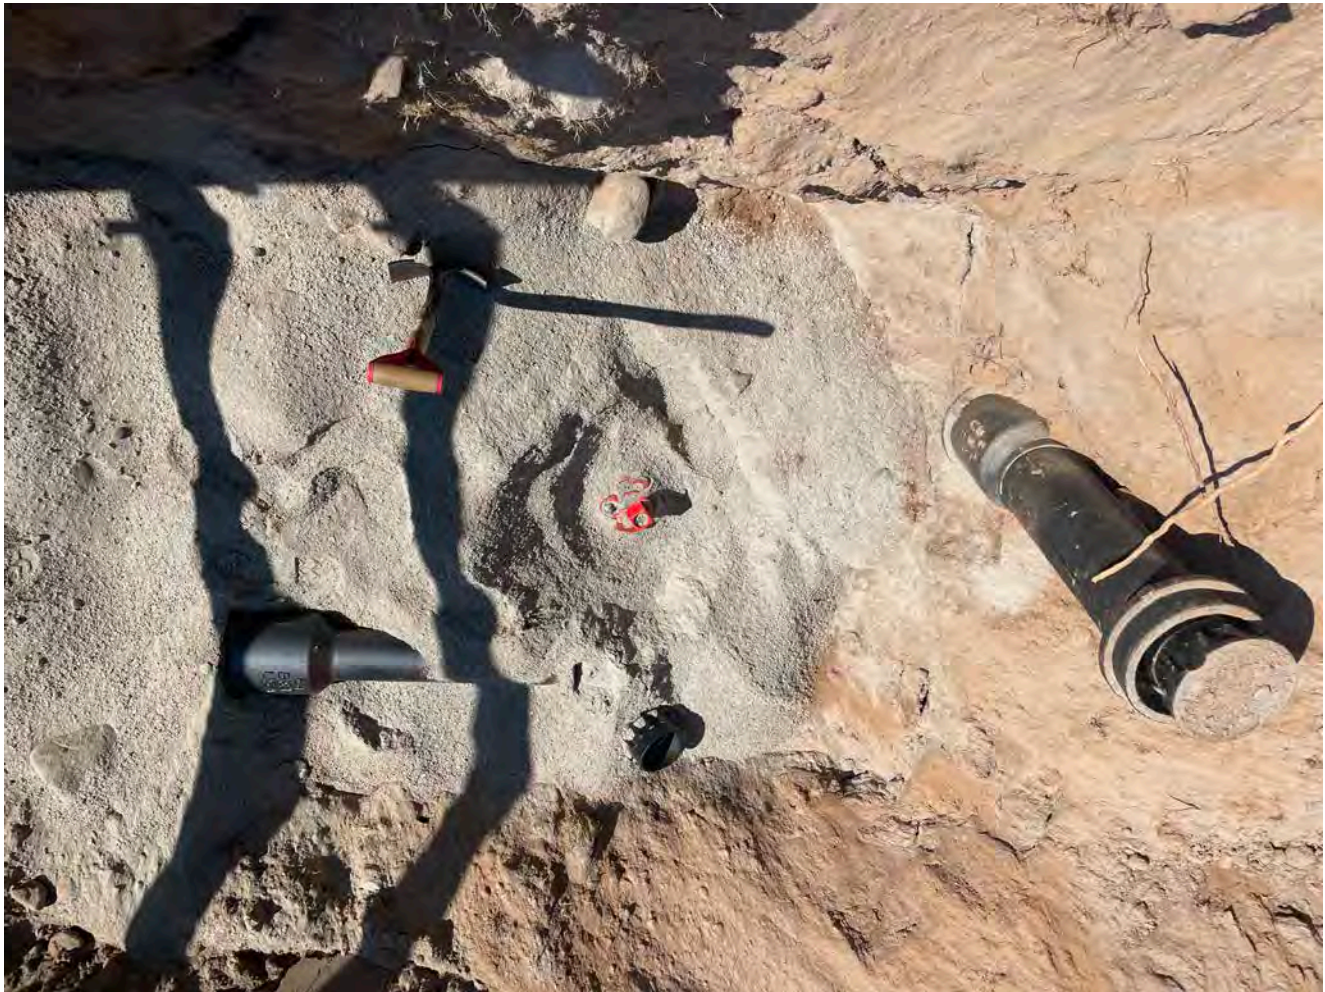
Picture 2: 8" Gate valve that Ludlow installed at Station 551+78 (the red top of the valve is visible in the center of the photograph).

0730: AECOM notices that Ludlow forgot to install an 8" gate valve yesterday. Ludlow begins to excavate back to Station 551+78 to install the valve.

0932: Ludlow has excavated back to Station 551+78 and has installed an 8" gate valve, along with ~10 section of 8" DIP coming off of the east side of the gate valve. Ludlow is currently excavating east toward the high school as they continue pipe installation activities.

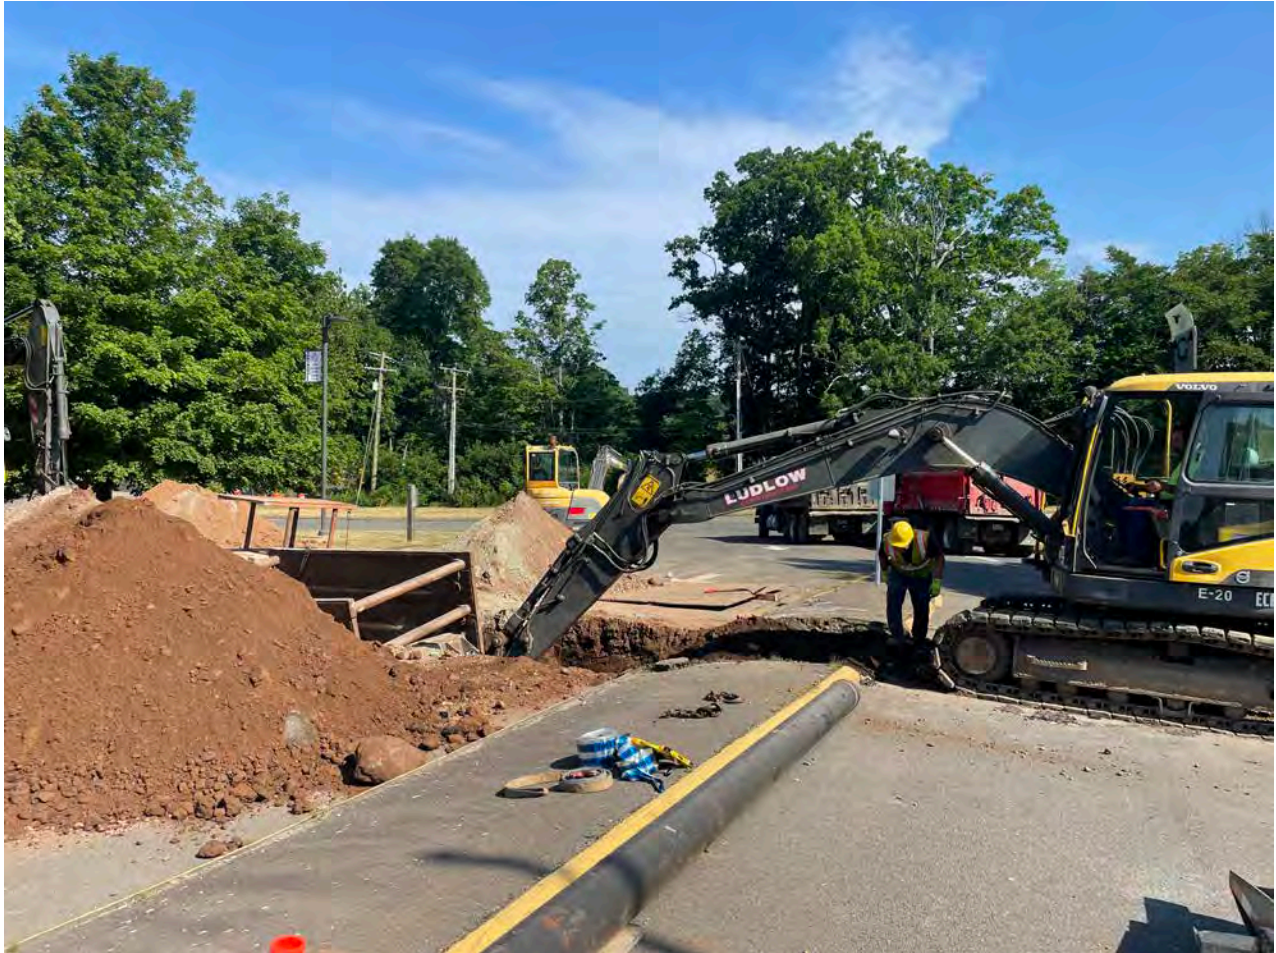
Picture 3: Ludlow excavating a trench across the southbound lane of the access road located on the west side of the CRHS as they continue to install 4" and 8" DIP. View to the north.

1253: Ludlow continues to install 4" and 8" DIP across the access roads located on the west side of the high school. Ludlow has progressed across the southbound lane so far. Ludlow continues the saw cut they footprint of a trench across the parking lot located on the north side of the high school.

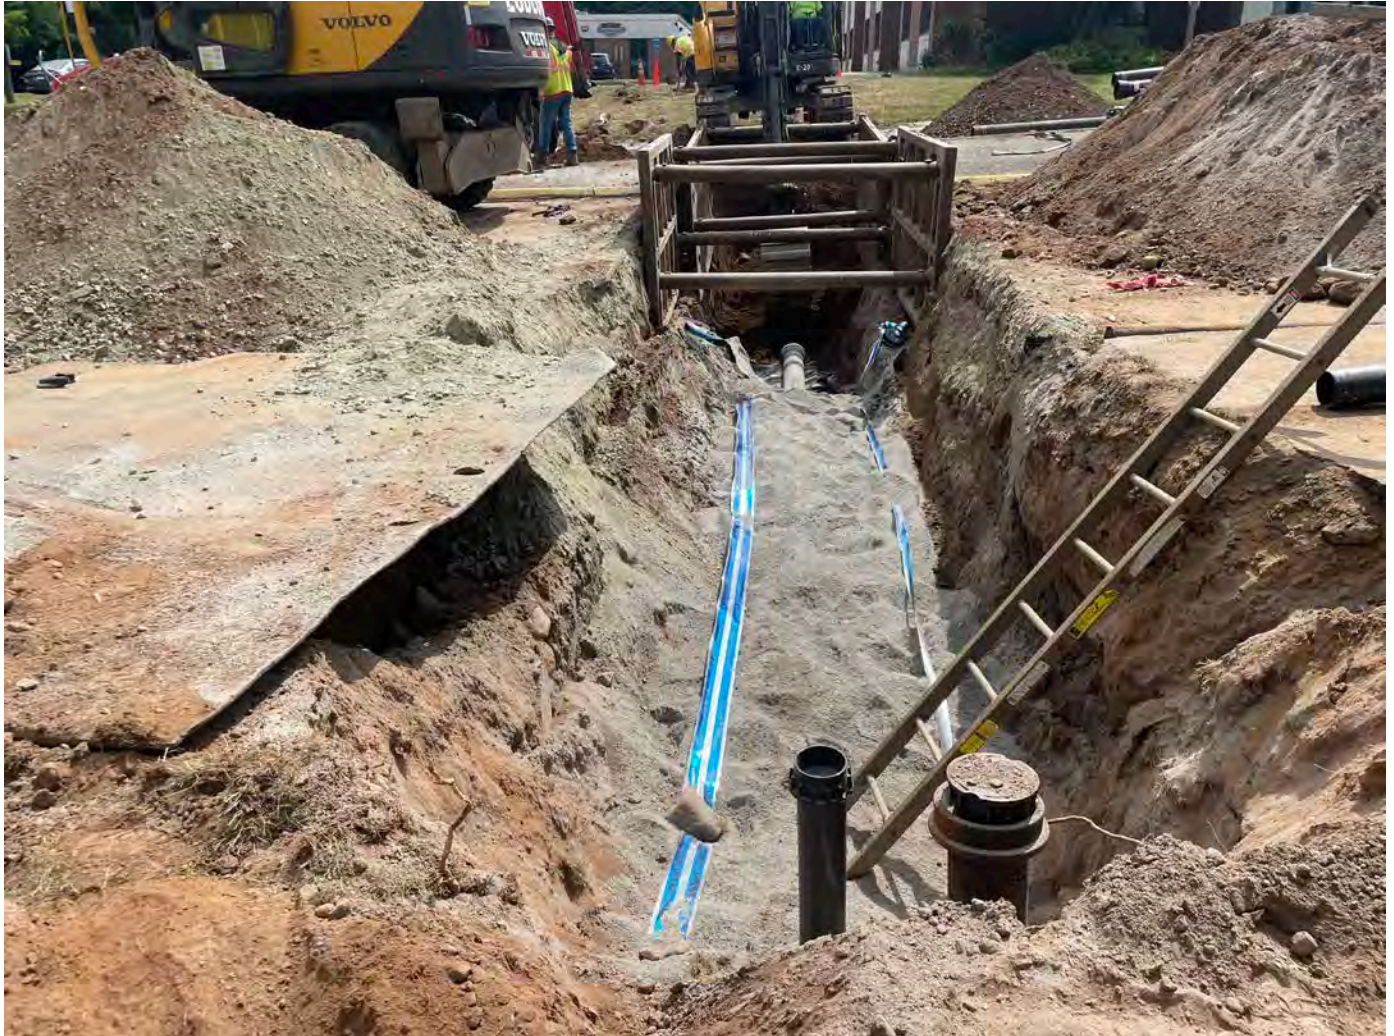
Picture 4: Sand and caution tape that Ludlow placed over 4" and 8" DIP that they installed at Stations 529+64 and 529+56, respectively. View to the east.

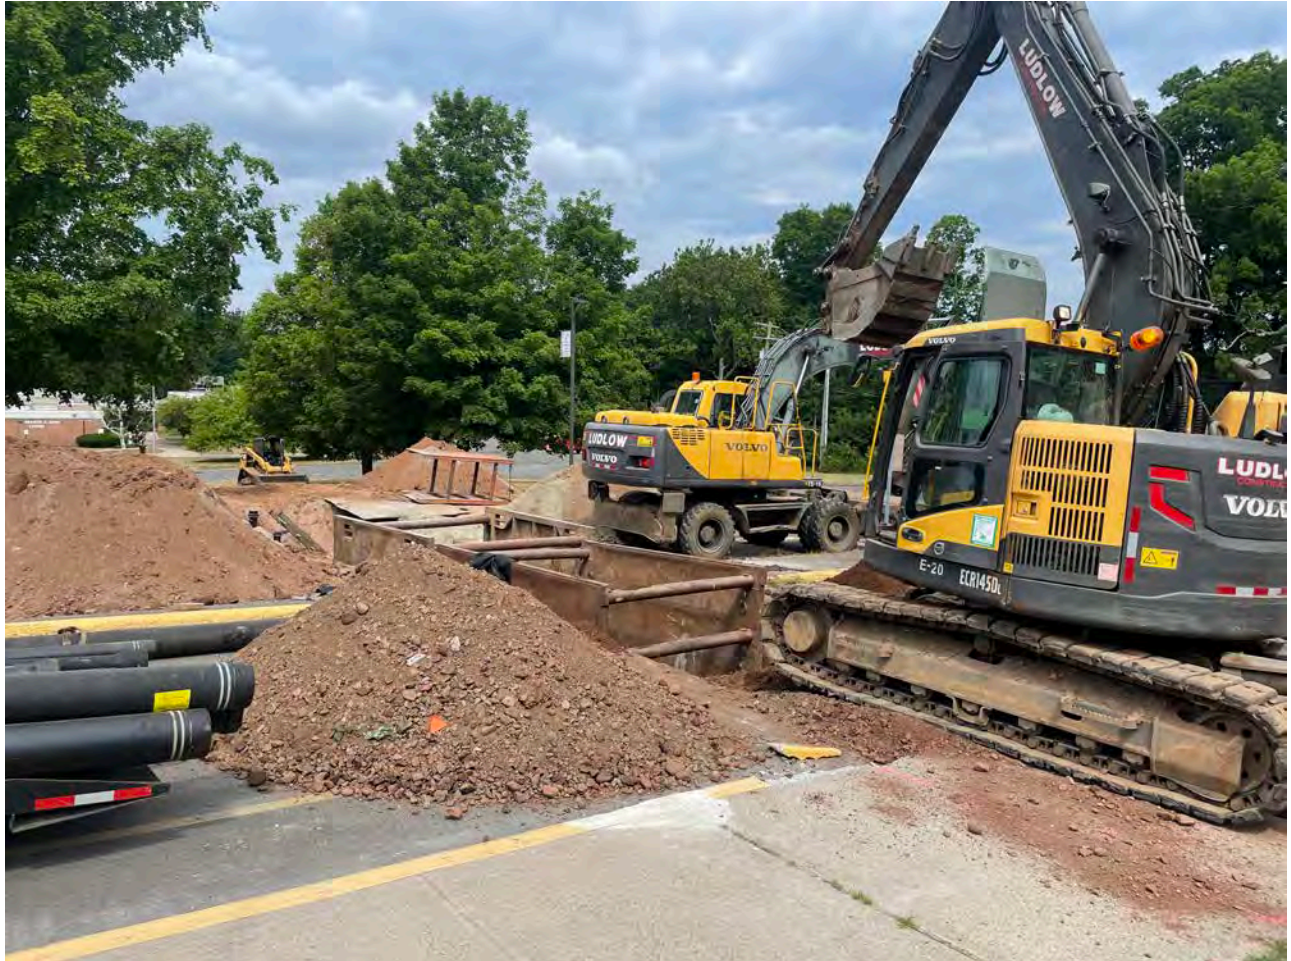
Picture 5: Ludlow excavating across the northbound lane of the access road located on the west side of the CRHS as they continue to install 4" and 8" DIP. View to the northwest.

1406: Ludlow continues to install 4" and 8" DIP across the access roads located on the west side of the high school. Ludlow has progressed across the northbound lane of the access road and is currently excavating through the sidewalk located on the west side of the high school.

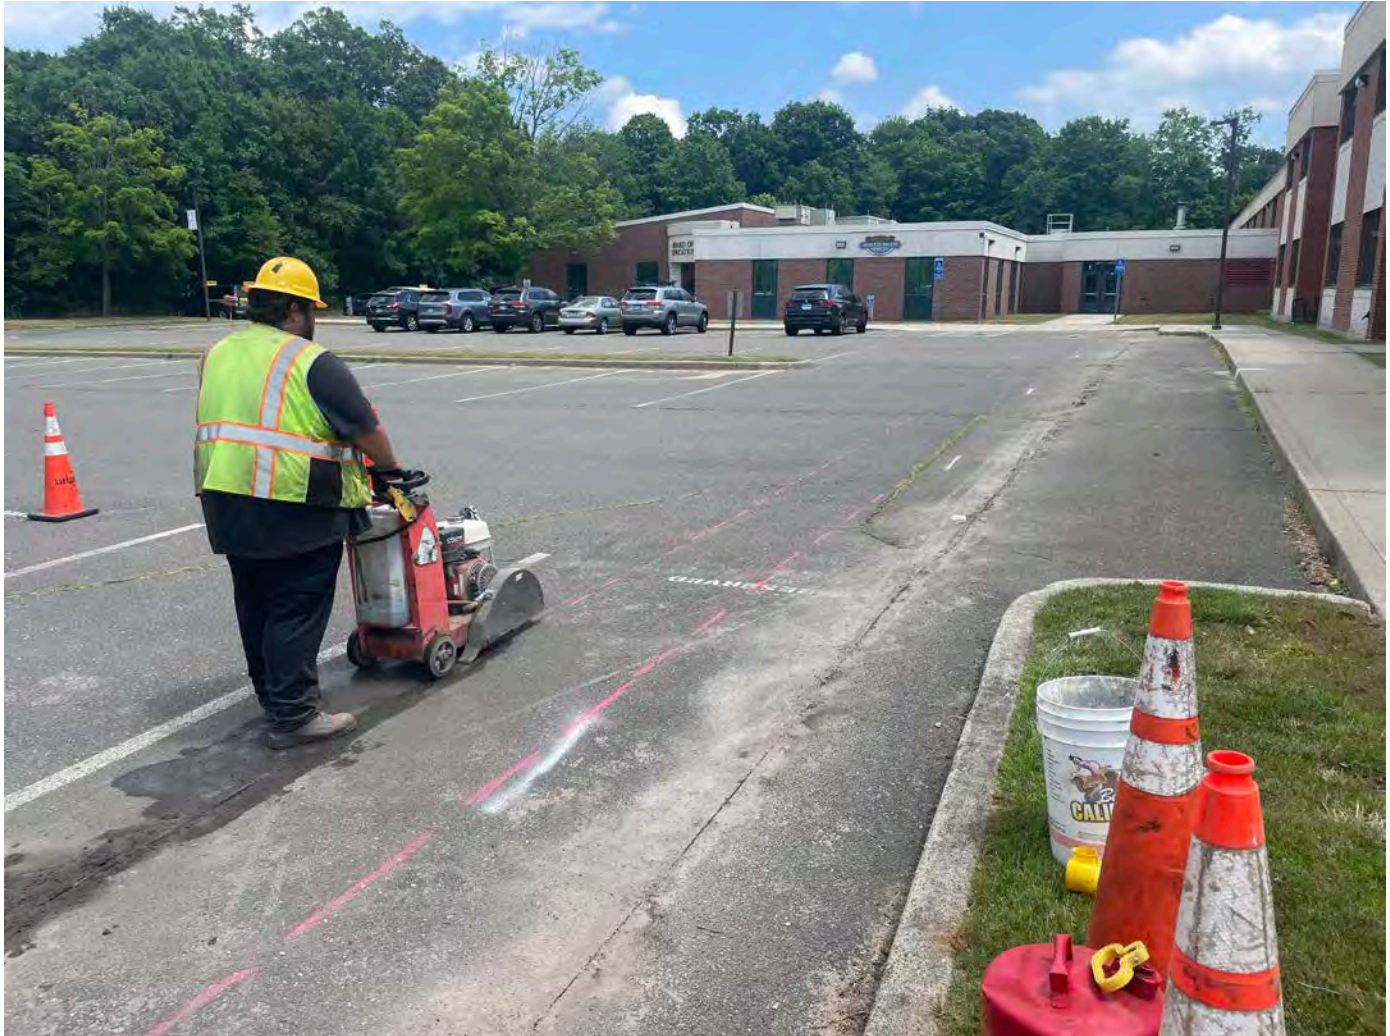
Picture 6: Ludlow saw-cutting the footprint of a trench on the pavement of the parking lot located on the north side of the CRHS. View to the east.

0937: Ludlow is saw-cutting the footprint of a trench on the pavement of the parking lot located on the north side of the CRHS.

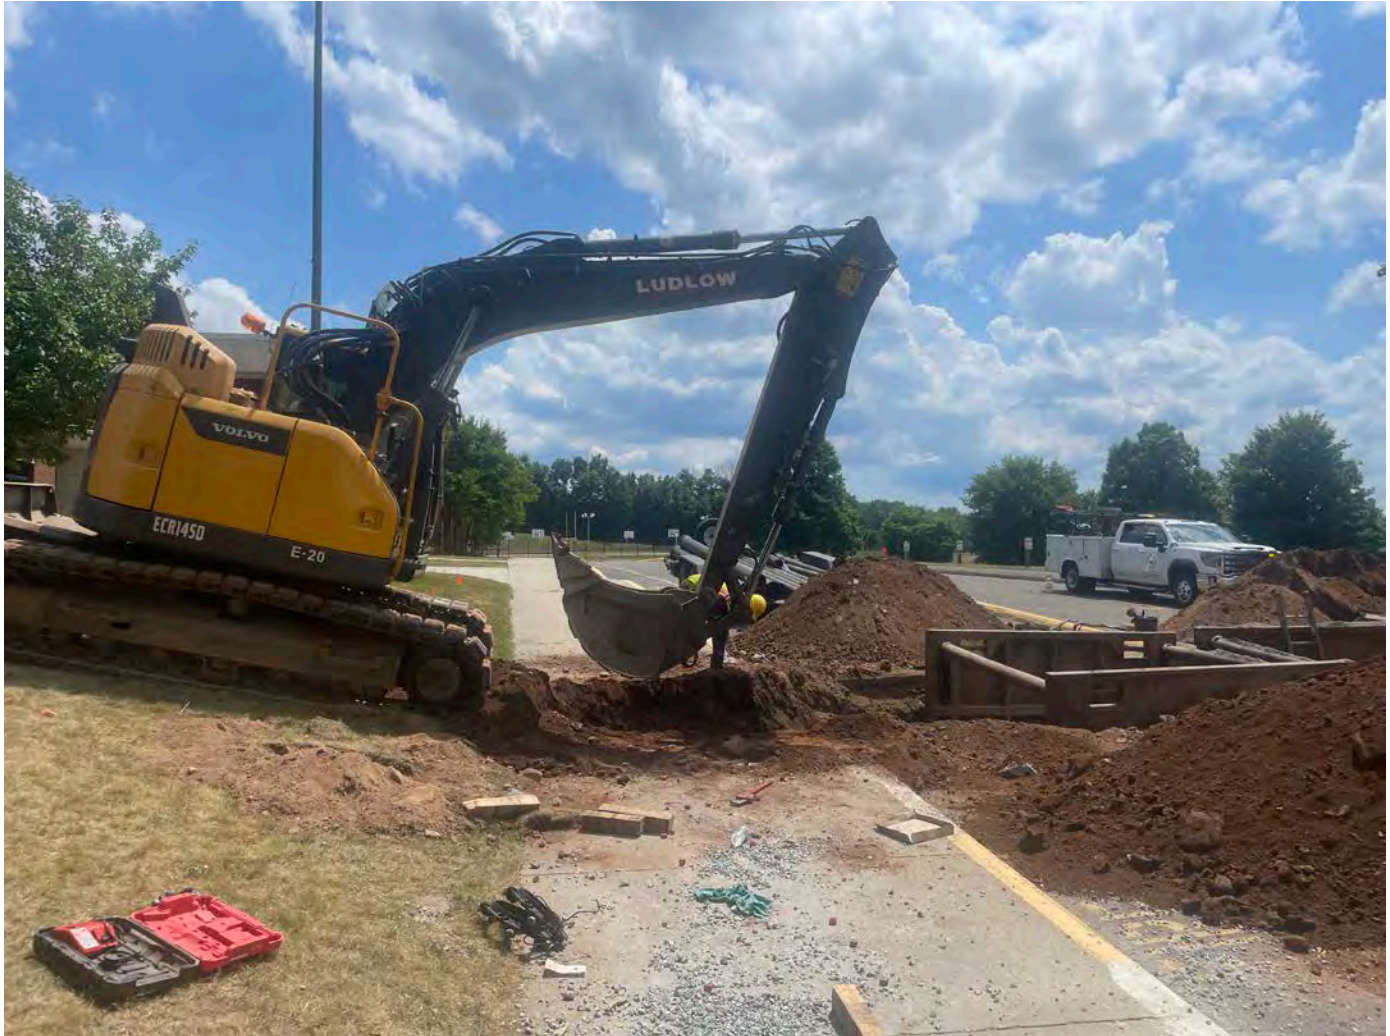
Picture 7: Ludlow excavating a trench across the sidewalk located on the west side of the CRHS as they continue to install 4" and 8" DIP. View to the south.

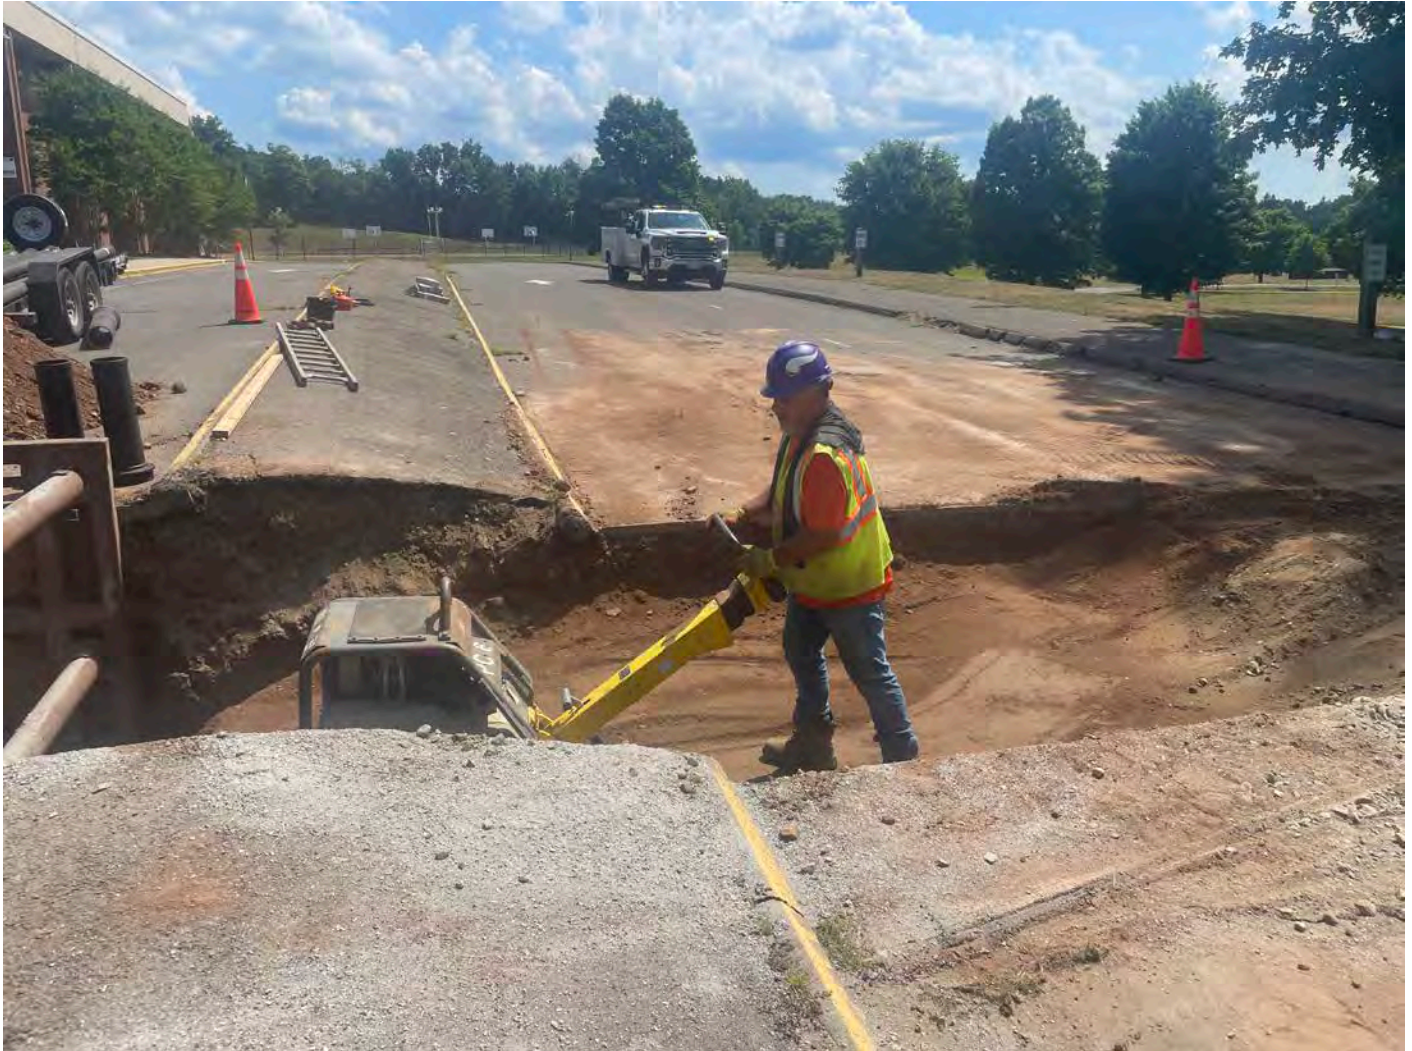
Picture 8: Ludlow using a plate compactor on the backfill they have placed over the 4" and 8" DIP they installed today at Stations 529+56 and 529+64. View to the south.

1446: Ludlow continues to install 4" and 8" DIP across the access roads located on the west side of the high school. They have placed temporary covers over the ends of each pipe and have begun to backfill and compact over the pipe they installed today.

1513: Ludlow continues to backfill the trench they excavated across the access road located on the west side of the high school as they work to secure the excavation.
