Daily Report

Project:Durham Meadows Pipeline InstallationDate:August 5, 2022

Location: Coginchaug Regional High School, Pickett Lane, Durham

Project #: AECOM: 60614871 **Report No:** 483

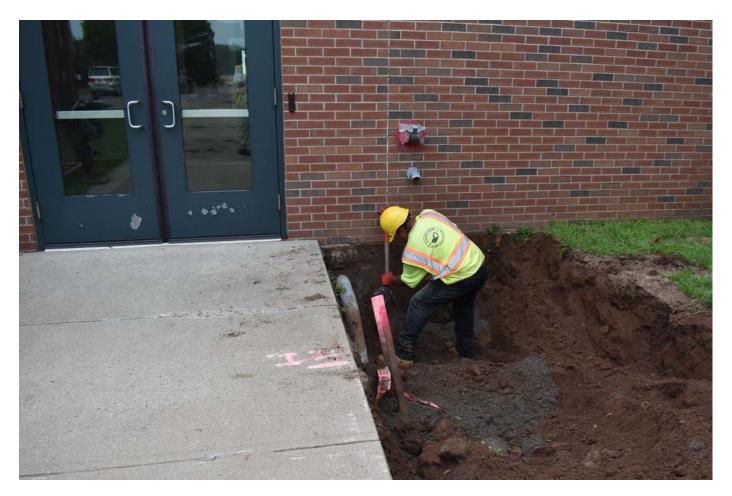
Photo 1: Ludlow laborer beginning excavation of supply line at school building wall. Electrical conduits visible adjacent to sidewalk. View to the east.

0730: Ludlow crew initiating excavation at existing water supply connection to high school building.

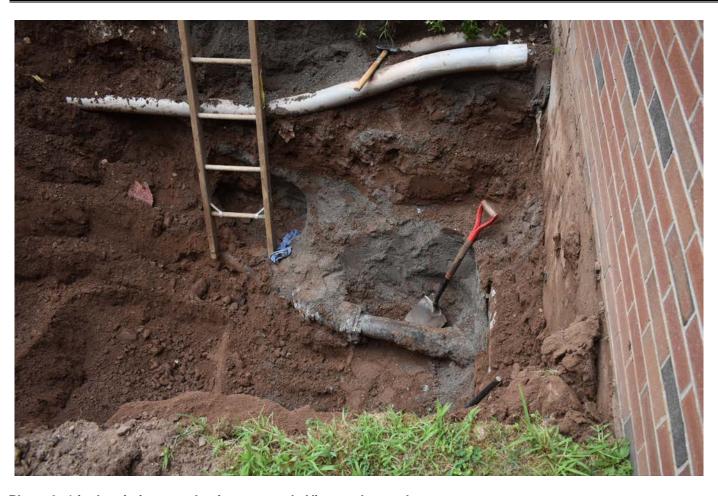
Photo 2: 4-inch existing supply pipe exposed. View to the north.

0830: Existing water supply pipe (4" iron pipe) exposed. High School maintenance supervisor goes to valve vault in Pickett Lane to turn off supply to building.

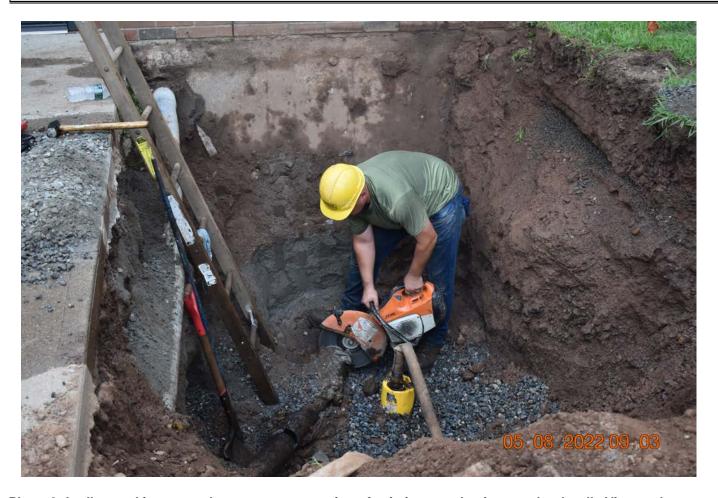
Photo 3: Ludlow making second cut to remove section of existing supply pipe at school wall. View to the east.

0900: Ludlow cuts pipe on either side of existing elbow adjacent to building wall and removes pipe section. Ludlow caps outlet end of existing pipe.

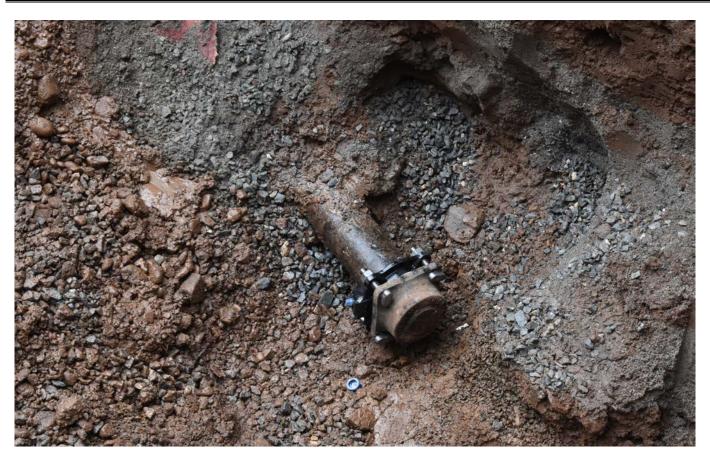
Photo 4: Capping completed at end of existing supply pipe adjacent to school. View to the northwest.

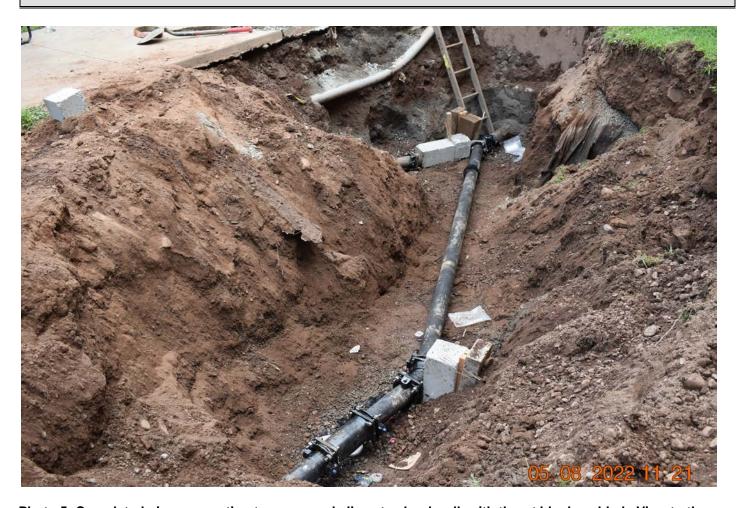
Photo 5: Completed pipe connection to new supply line at school wall, with thrust blocks added. View to the east.

1105: Pipe connection completed. Ludlow finishes adjusting and tightening fittings, adds thrust blocks at bends in pipe.

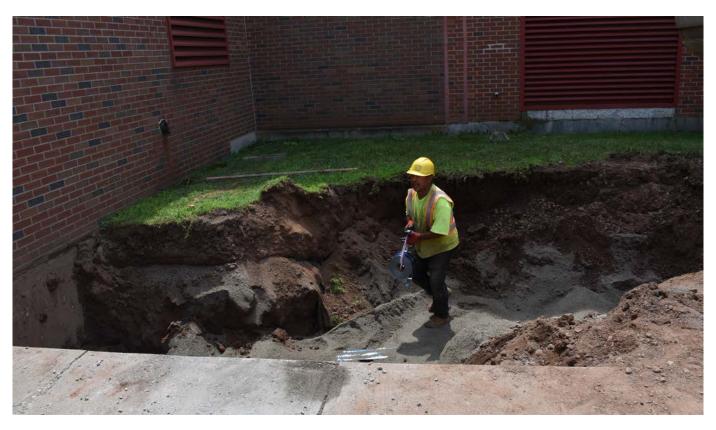
Photo 6: Ludlow laborer placing marker tape over new supply line. View to the south.

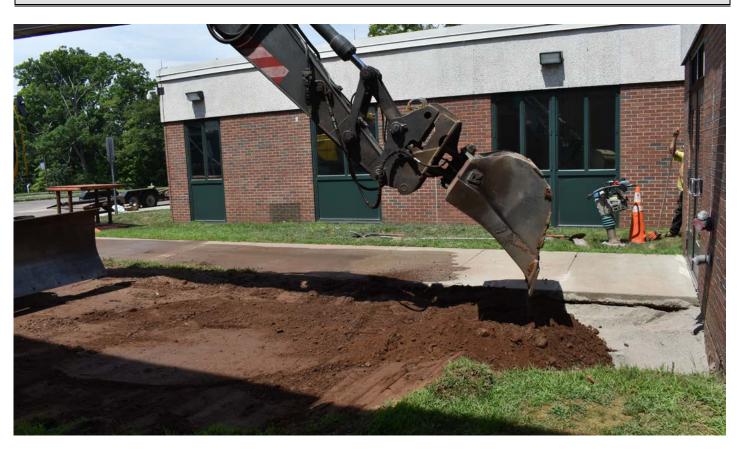
Photo 7: Ludlow placing backfill over pipe trench. View to the north.

1210: Ludlow begins backfilling pipe trench.

1430: Backfilling complete. Ludlow prepares to leave site.
