Daily Report

August 12, 2022 Project: **Durham Meadows Pipeline Installation** Date: Day of Week: Friday Location: Maple Avenue, and Main Street, Durham **Report No:** 488 Project #: AECOM: 6061487 Page: 1 of 13 Contractor: **Ludlow Construction** Weather Conditions Conditions: Daylight hours: Cloudy. Wind variable 0-3 mph. Temperature (°F): High 84°F Low 62°F Equipment in Use Contractors & Subcontractors Workforce # x hrs # X hrs Trade Trade Type # x hrs USACE Ludlow Construction Concrete/Asphalt Road Saw x 8 1 x 8 Field Engineer 1 8 Superintendent 0 Χ 8 Dump truck Х Safety Officer 1 Χ 8 Excavator – Large 1 x 8 Χ Excavator - Mid-Size **United Concrete** 0 8 Foreman 1 Χ 8 0 x 8 Χ 1 0 x 8 West State Mechanical 0 8 Dump truck Operator Χ 8 Excavator - Rubber Wheeled 0 x 8 Barnhart 0 Χ 8 Excavator Operator 1 Χ 8 Skid Steer / Bucket Loader Χ x 8 Grela Well Drilling 0 Skid Steer/Bucket Loader 1 Χ Rolling Compactor 0 8 8 Fazzino Plumbing 1 Χ 8 Laborers 2 Χ 8 Plate Compactor 1 x 8 Χ Note that some persons operate United Concrete 8 x 8 0 Jumping Jack Compactor 1 Knapp Engineering 0 Х 8 Multiple pieces equipment. Street Sweeper (Broce Broom) 0 x 8 Material Hopper Apuzzo Electric 8 x 0 0 Χ 8

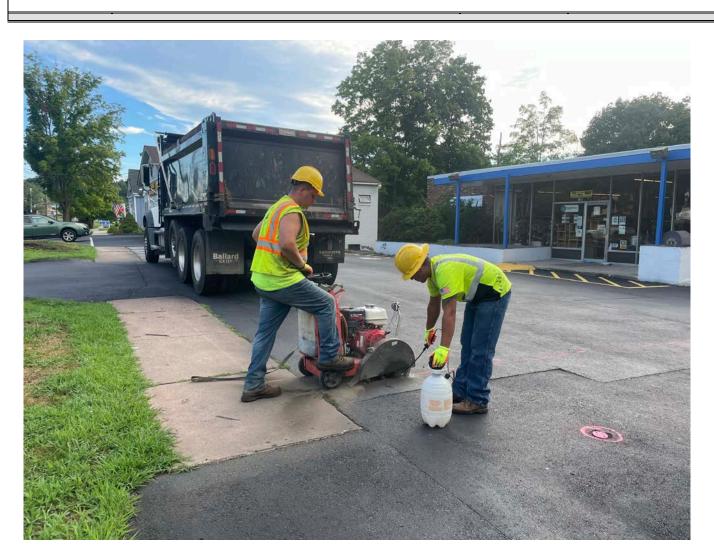
Picture 1: Ludlow saw-cutting the footprint of a trench overcut in order to place permanent pavement on the driveway of the 321 Main Street, Durham, property. View to the north.

0736: Ludlow continues to saw cut the footprint of trench overcut at the 321 Main Street property.

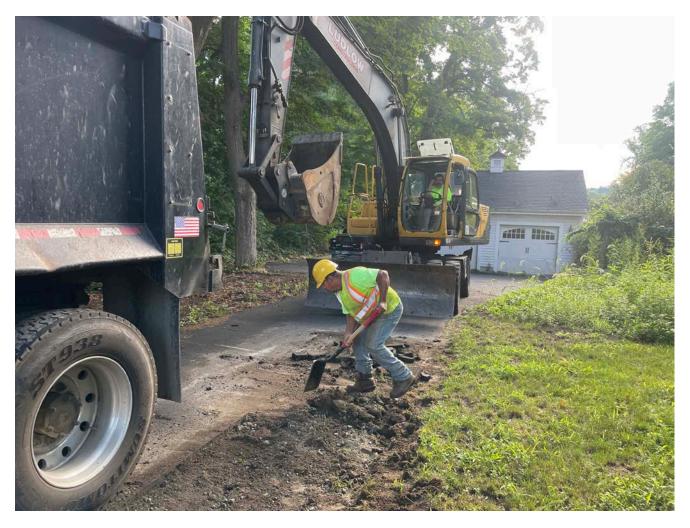
Picture 2: Ludlow excavating temporary paving on the south edge of the driveway of the 313 Main Street, Durham, property as they prepare to place permanent paving. View to the east.

0740: Ludlow is stripping pavement from the south side of the driveway of the 313 Main Street, Durham, property where they previously brought a copper water service line to the house.

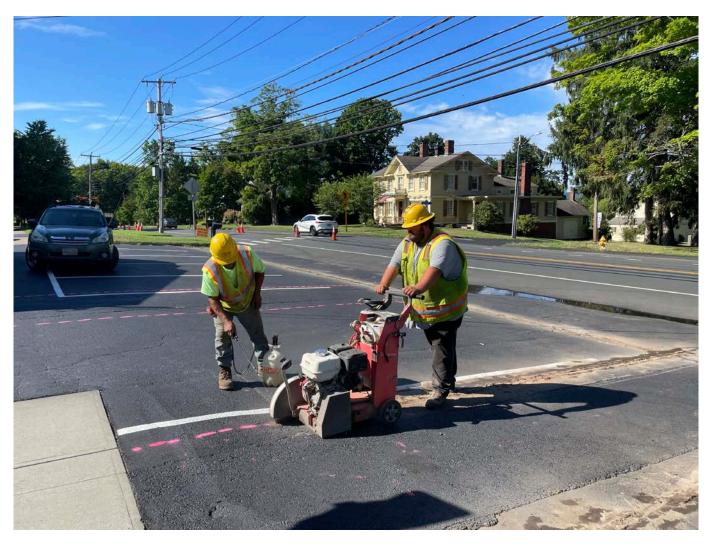
Picture 3: Ludlow saw-cutting the footprint of a trench overcut in order to place permanent pavement on the parking area of the 327 Main Street, Durham, property. View to the southwest.

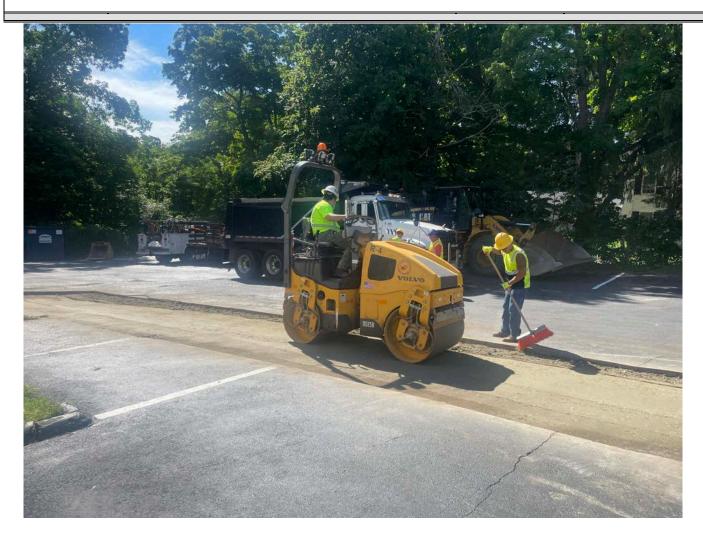
Picture 4: Ludlow compacting -1.25" processed gravel that they placed in the footprint of the trench overcut at the 321 Main Street, Durham, property. View to the southeast.

1002: Ludlow is compacting the 1.25" processed gravel that they placed at 321 Main Street property with a Volvo DD25B rolling compactor.

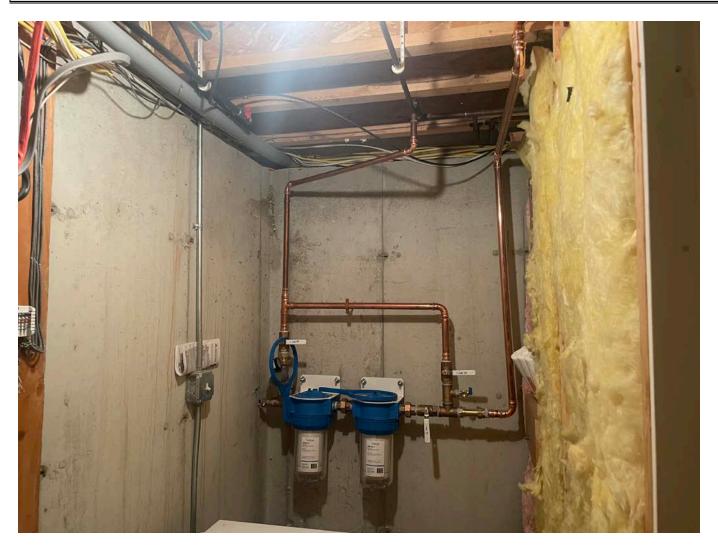
Picture 5: Final water service components that Fazzino installed at the 228R Maple Avenue, Durham, residence.

1149: Fazzino Plumbing has completed the installation of final water service components at the 228R Maple Avenue property. Fazzino Plumbing is turning the water on at the street to test the line.

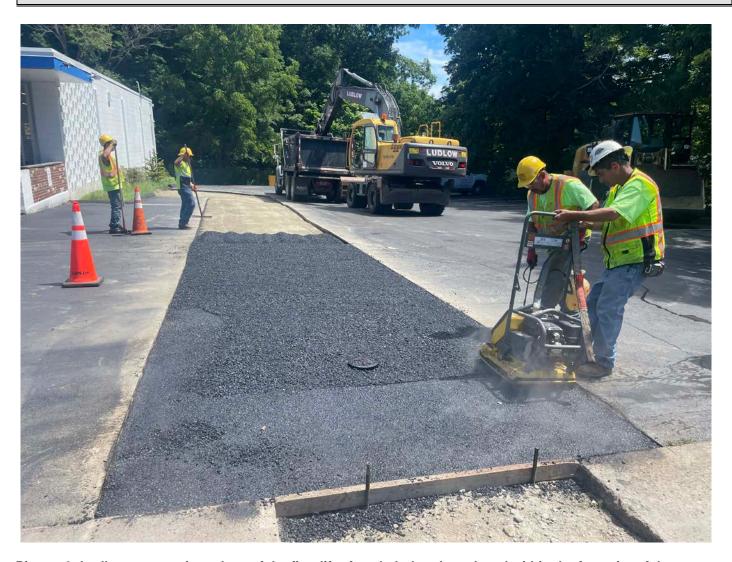
Picture 6: Ludlow compacting edges of the first lift of asphalt that they placed within the footprint of the trench overcut at the 321 Main Street, Durham, property. View to the east.

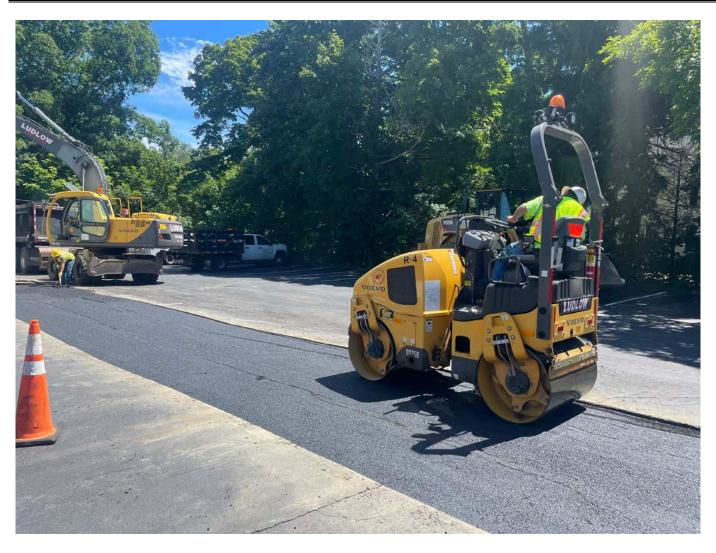
Picture 7: Ludlow using a rolling compactor on the first lift of asphalt that they placed within the footprint of the trench overcut at the 321 Main Street, Durham, property. View to the southeast.

1259: Ludlow is using a Volvo rolling compactor on the asphalt that they placed on the trench overcut footprint of the 321 Main Street property.

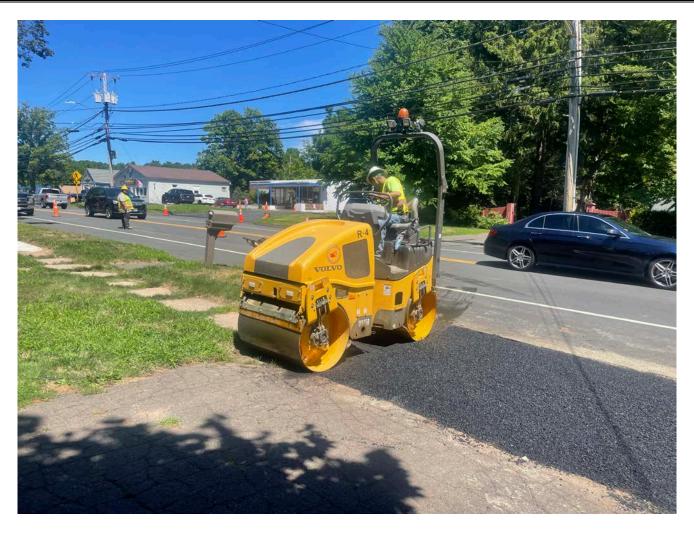
Picture 8: Ludlow using a rolling compactor on the first lift of asphalt that they placed within the footprint of the shared driveway apron for the 312 and 316 Main Street, Durham, properties. View to the northeast.

1319: Ludlow is using a Volvo rolling compactor on the first lift of asphalt they placed on the driveway apron for the 312/316 Main Street properties.

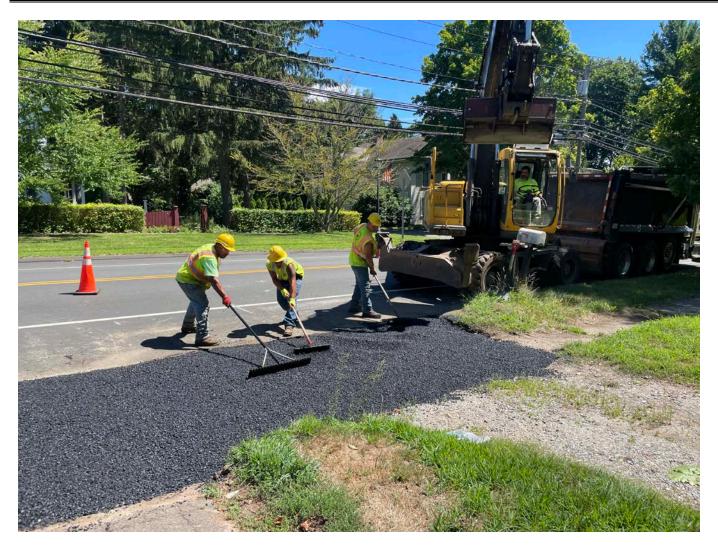
Picture 9: Ludlow grading the first lift of asphalt they placed within the footprint of the shared driveway apron for the 312 and 316 Main Street, Durham, properties. View to the northeast.

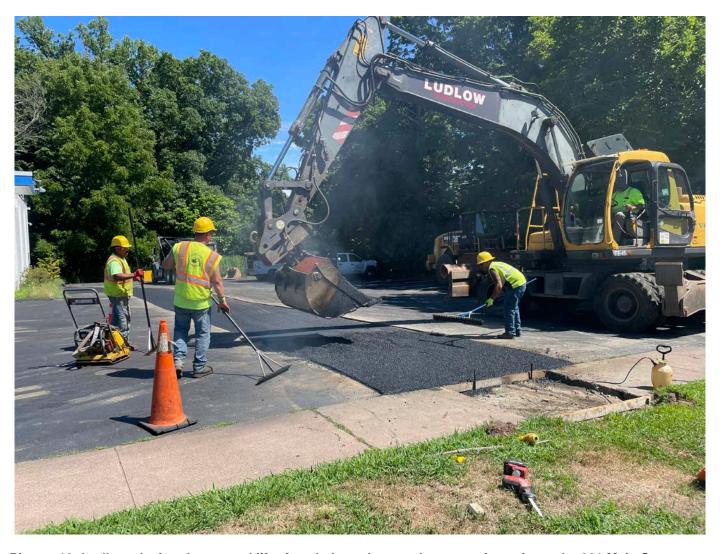
Picture 10: Ludlow placing the second lift of asphalt on the trench overcut footprint at the 321 Main Street, Durham, property. View to the southeast.

1407: Ludlow begins placing the second and final lift of asphalt on the trench overcut on the 321 Main Street property.
