## Daily Report

<b>Project:</b>	Durham Meadows Pipeline Installation	<b>Date:</b>	August 30, 2022
<b>Location:</b>	Main Street, Maple Avenue, and Pickett Lane, Durham	<b>Day of Week:</b>	Tuesday
<b>Project #:</b>	AECOM: 6061487	<b>Report No:</b>	500
<b>Contractor:</b>	Ludlow Construction	<b>Page:</b>	1 of 13

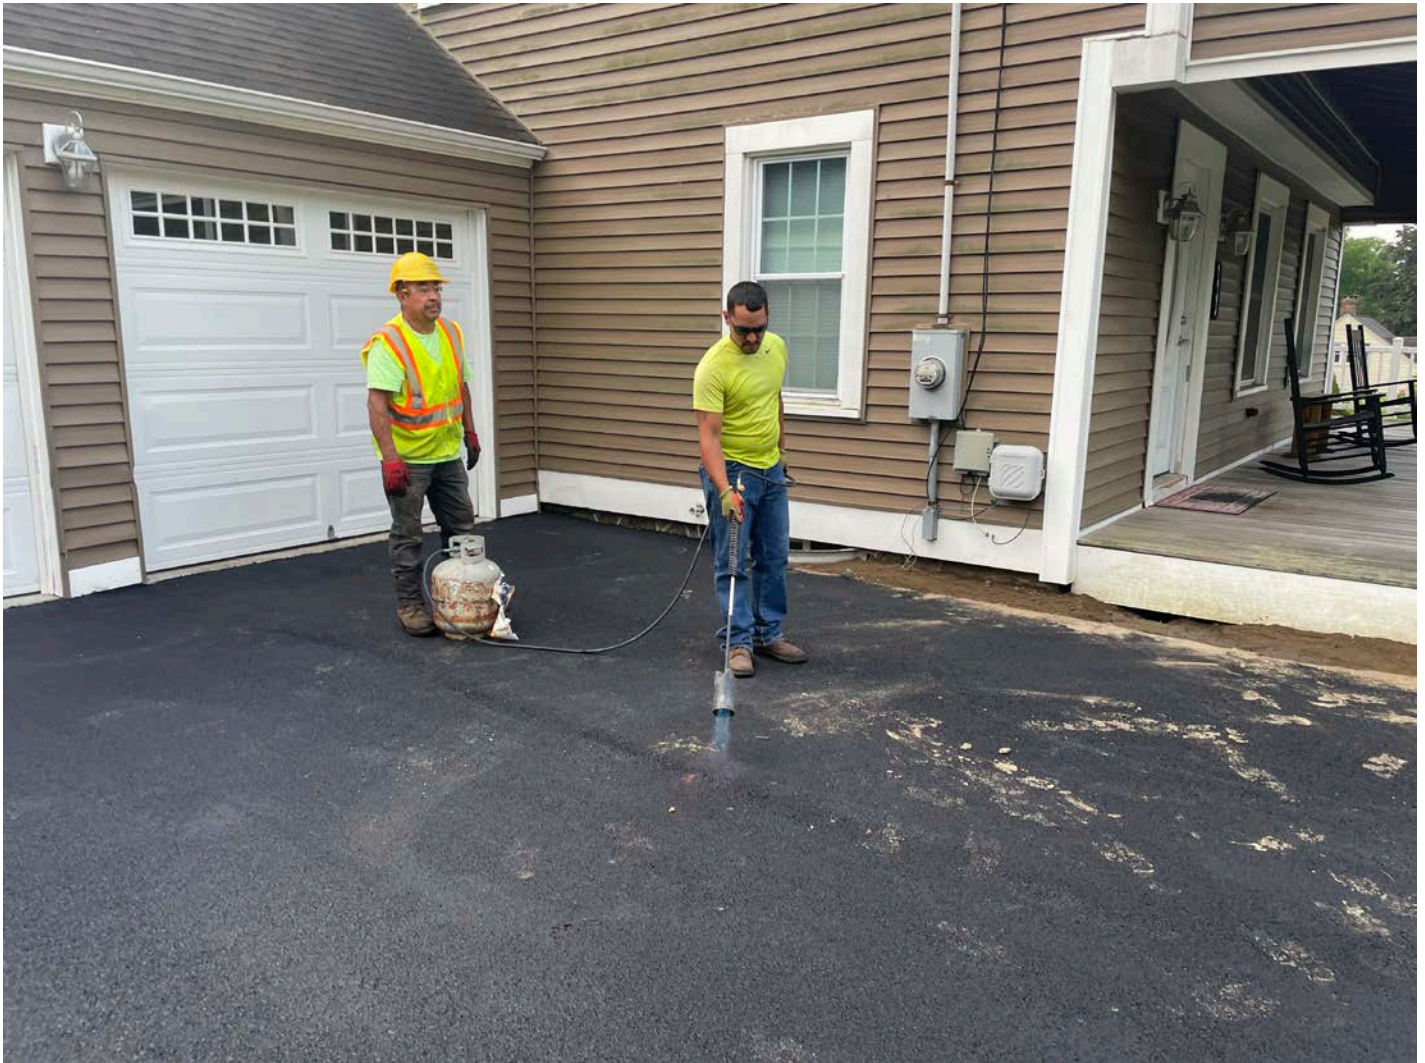
Picture 1: Ludlow using a torch to heat a high spot on the driveway located on the north side of the 245 Maple Avenue, Durham, residence. View to the southeast.

- Ludlow mobilized back to the driveway located on the north side of the 245 Maple Avenue residence. Ludlow is using a torch to heat up a high spot in the asphalt and used a rolling compactor to flatten the high spot.
- Ludlow repaired the asphalt curbing located on the south side of the 321 Main Street, Durham, building.

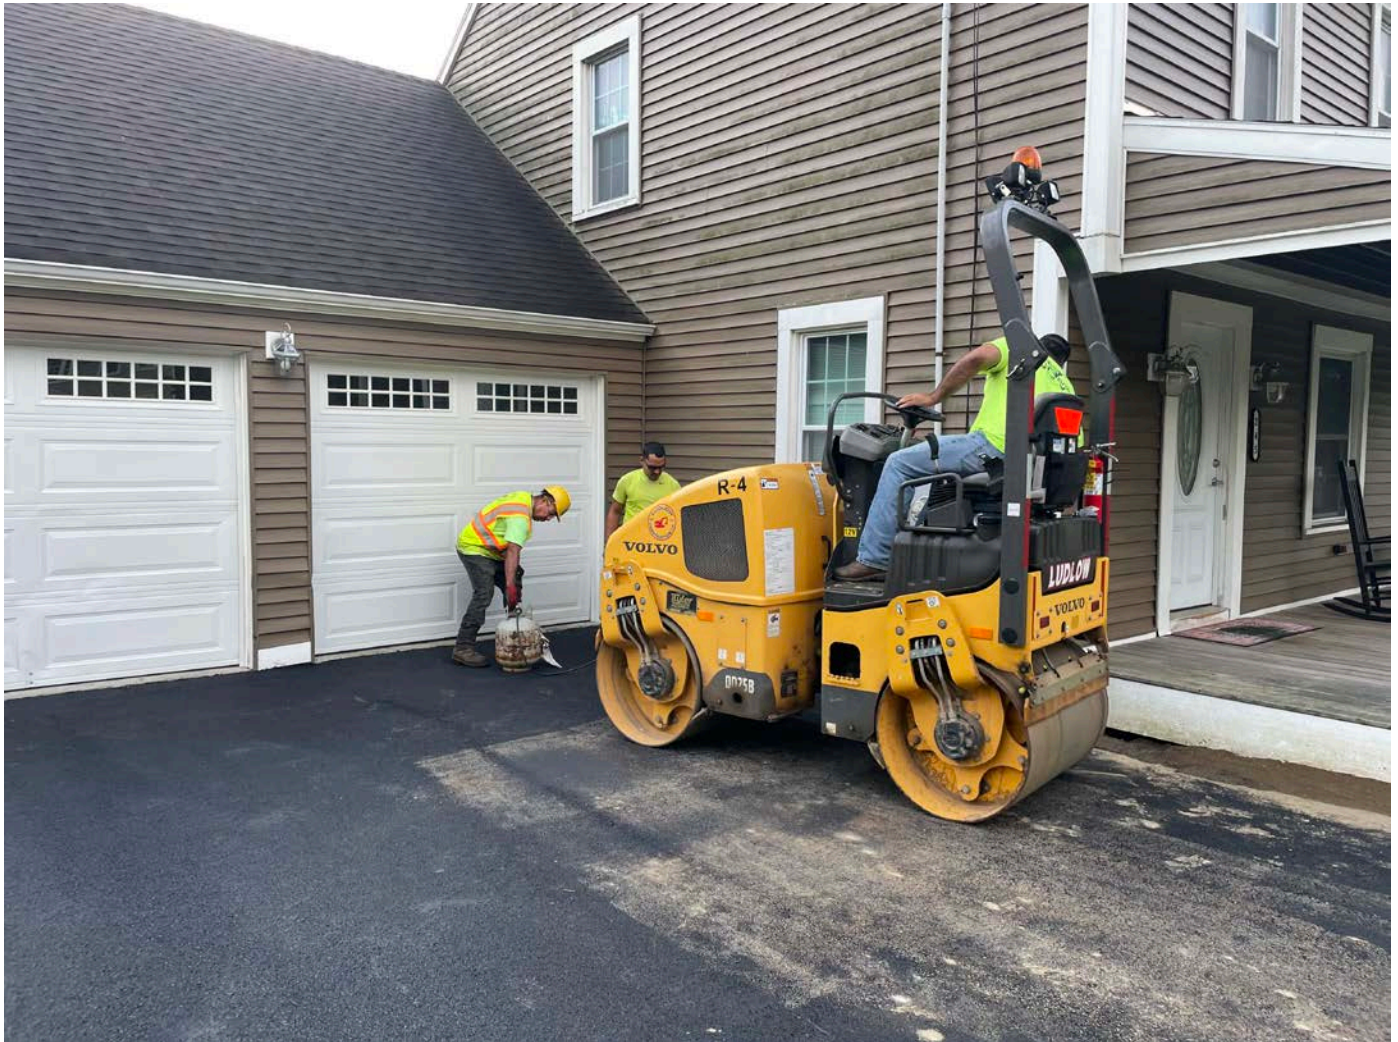
Picture 2: Ludlow rolling a high spot on the driveway located on the north side of the 245 Maple Avenue, Durham, residence after they heated the asphalt with a torch. View to the southeast.

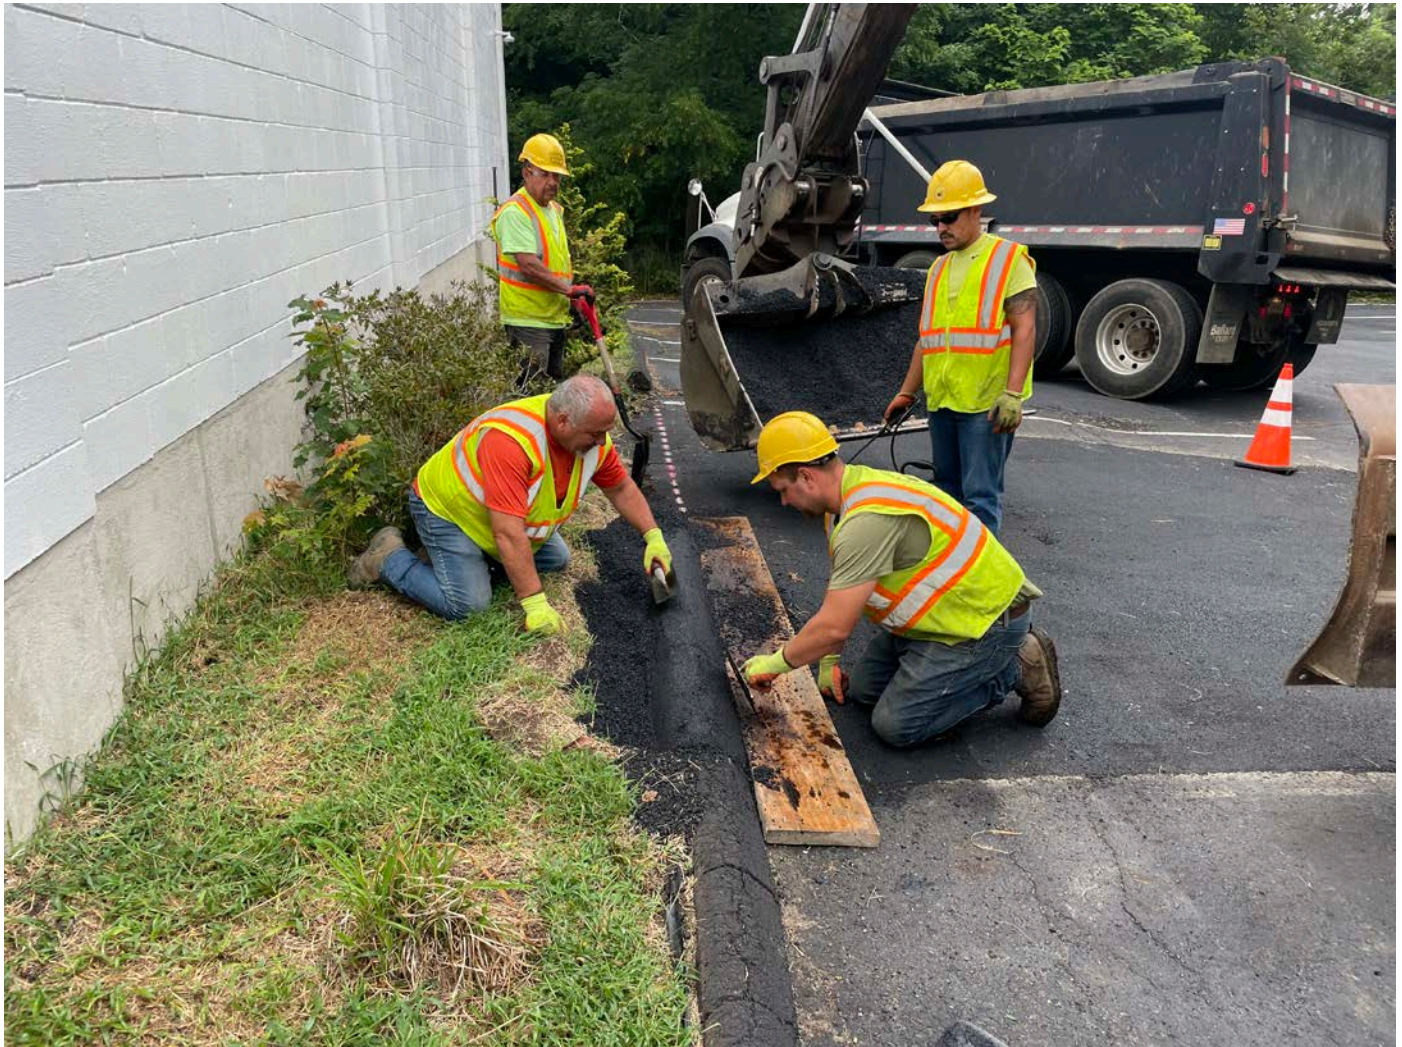
Picture 3: Ludlow repairing the asphalt curbing located on the south side of the 321 Main Street, Durham, building. View to the east.

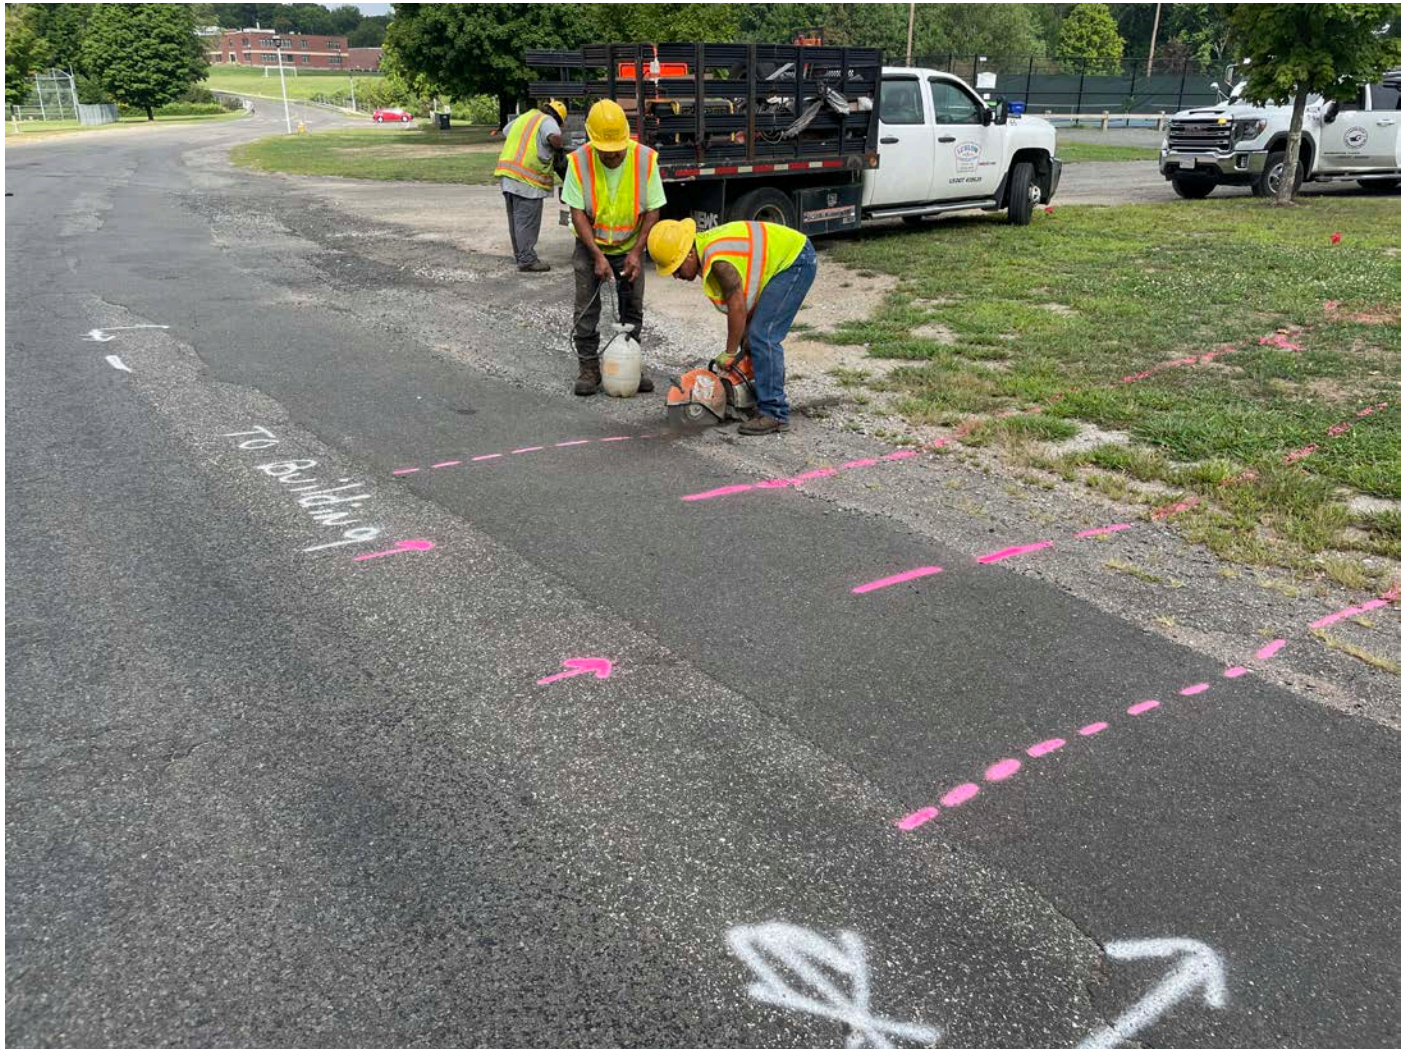
Picture 4: Ludlow saw-cutting pavement on Pickett Lane where they are preparing to install two 1.5" water service lines at Station ~516+50. View to the northwest.

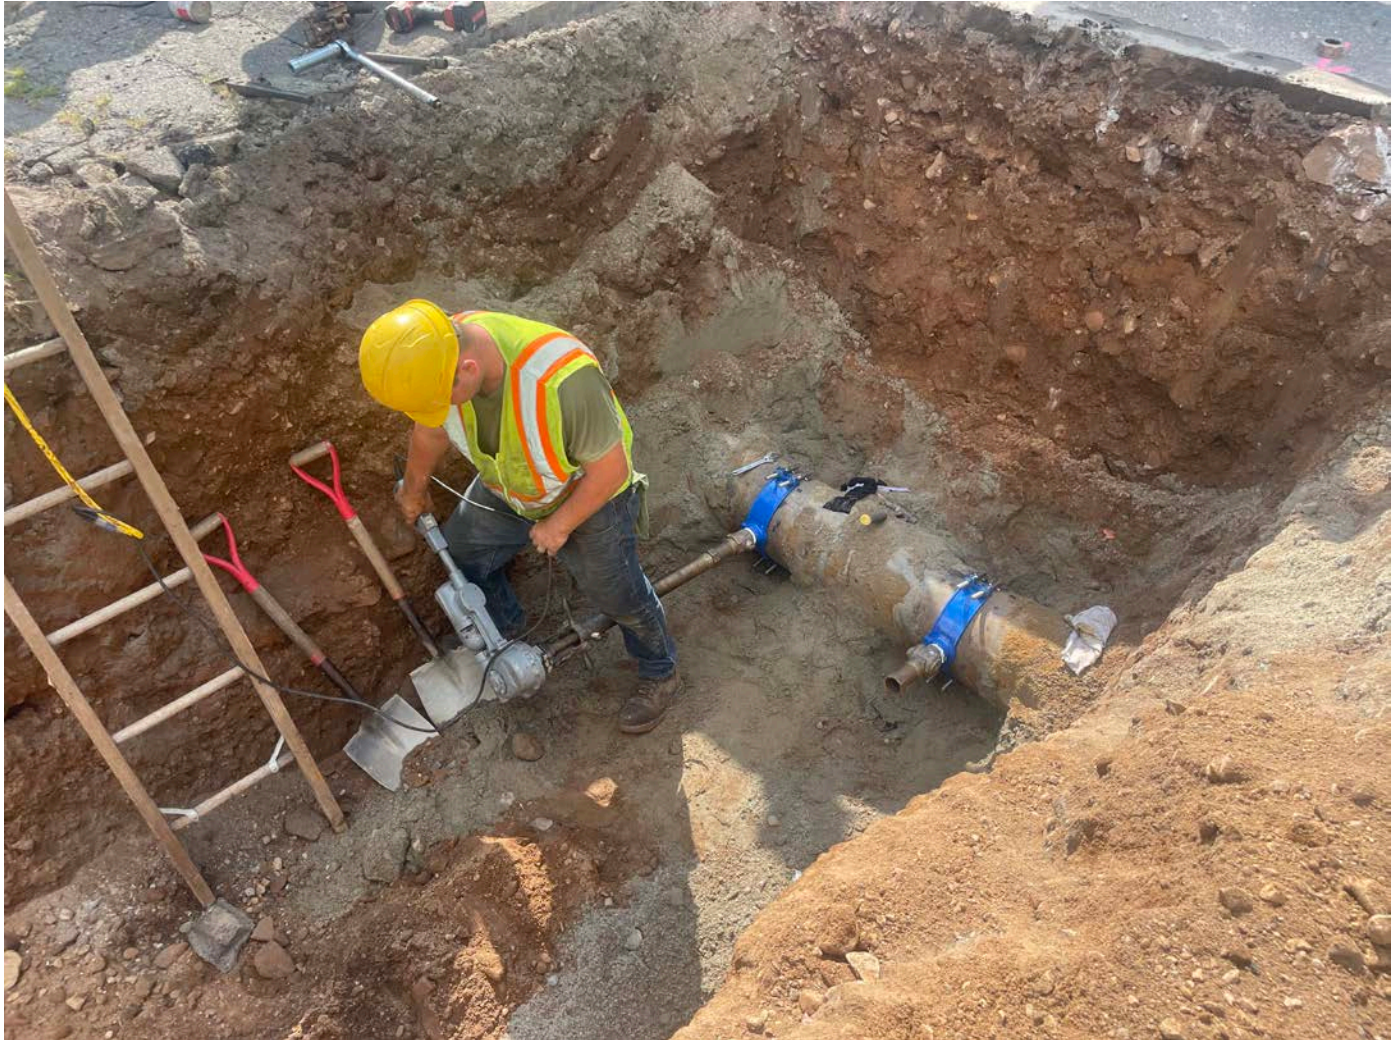
**Picture 5: Ludlow tapping the 12" DIP water line they previously installed on the north side of Pickett Lane at Station ~516+55 to install the second of two corporation stops. View to the southeast.**

1023: Ludlow has successfully executed the first of two taps on the 12" DIP waterline at Station ~516+55

1039: Ludlow has finished drilling the second tap on the 12" DIP waterline at Station ~516+55

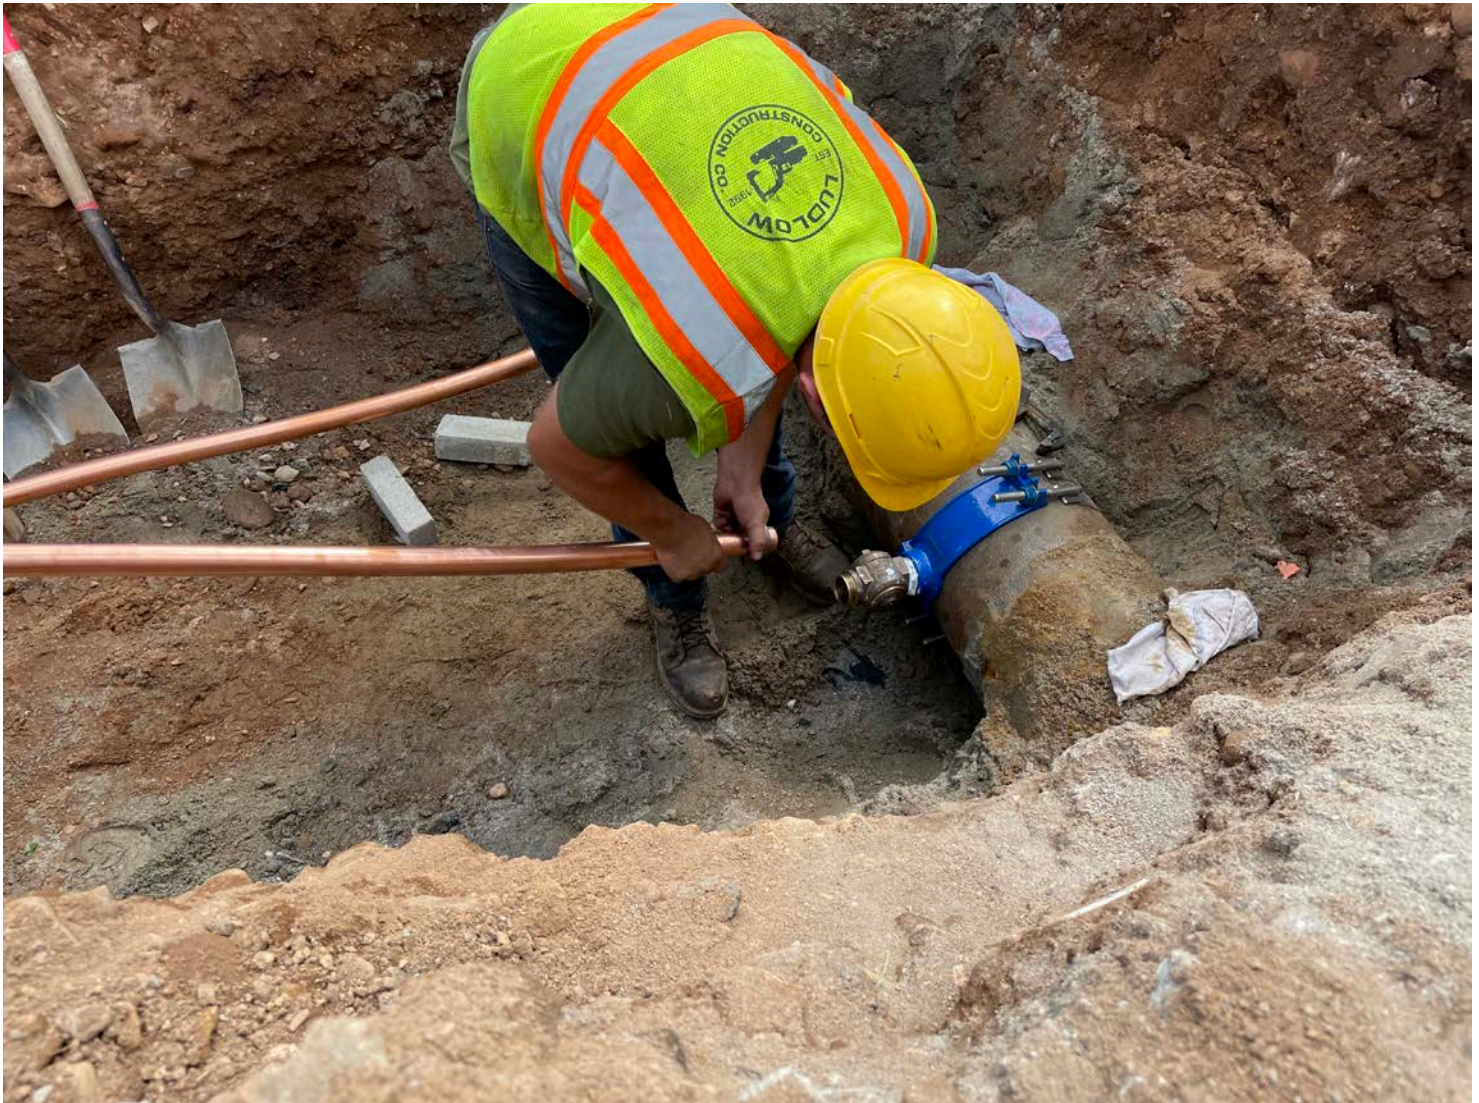
Picture 6: Ludlow connecting 1.5” copper water service line one of the two corporation stops they installed this morning on the 12” DIP water line they previously installed on the north side of Pickett Lane at Station ~516+55. View to the southeast.

1109: Ludlow begins to run 1.5" copper line between the corporation stops that Ludlow just installed on the 12" DIP waterline and the two meter pits located ~20' to the north of the water line.

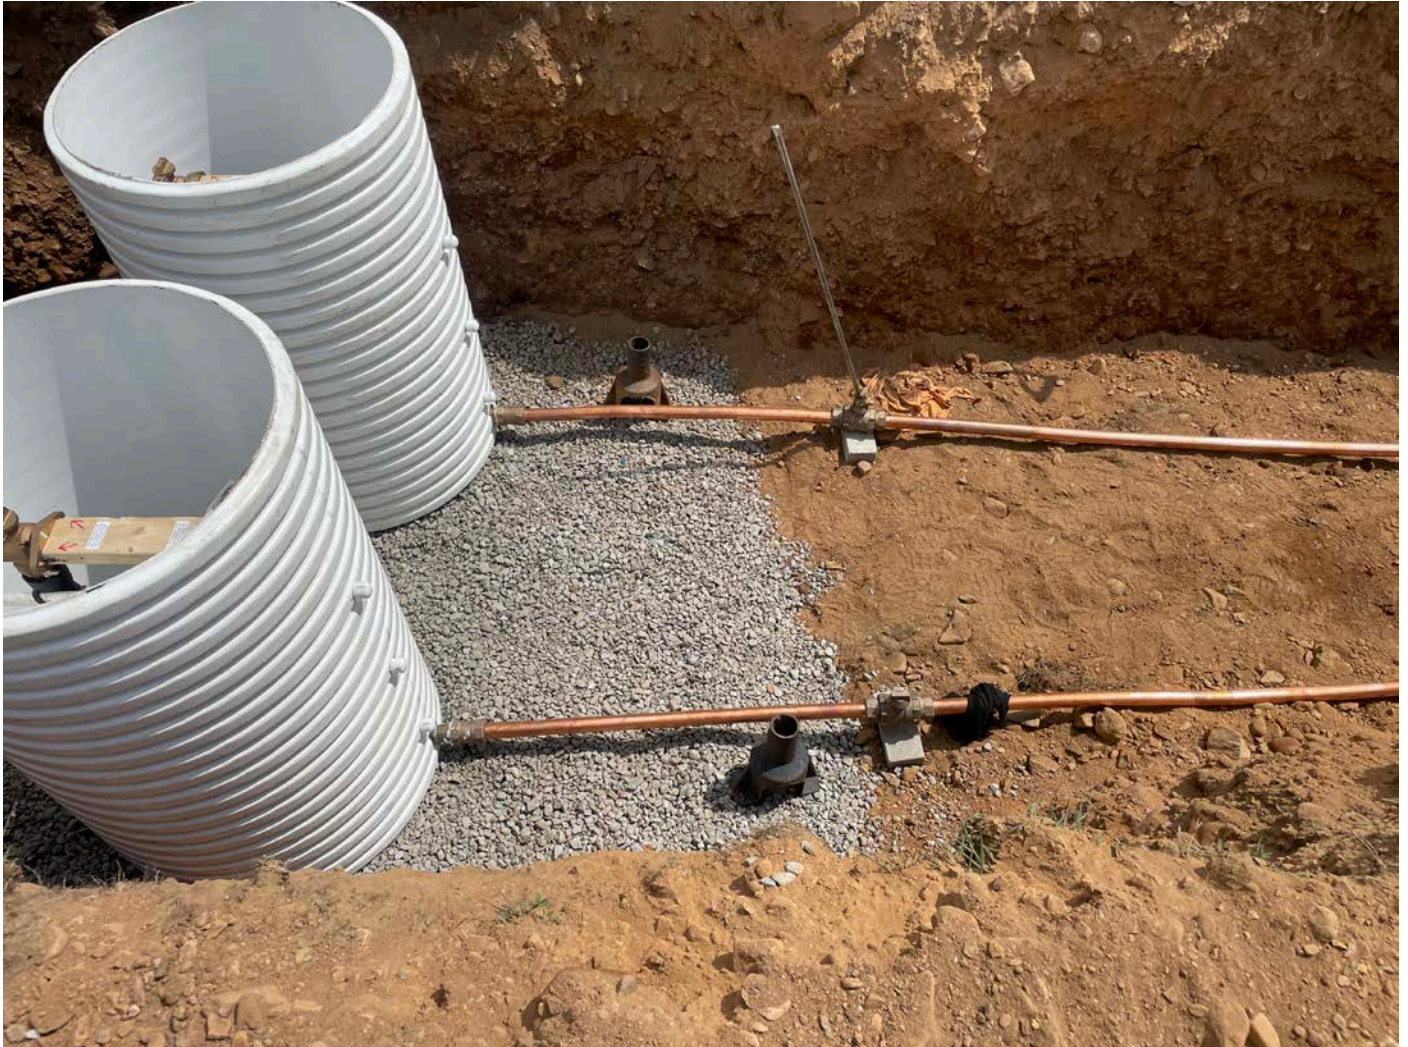
Picture 7: Two curb stops, meter pits and 1.5" copper water service lines that Ludlow has installed at Station ~516+55. View to the east.

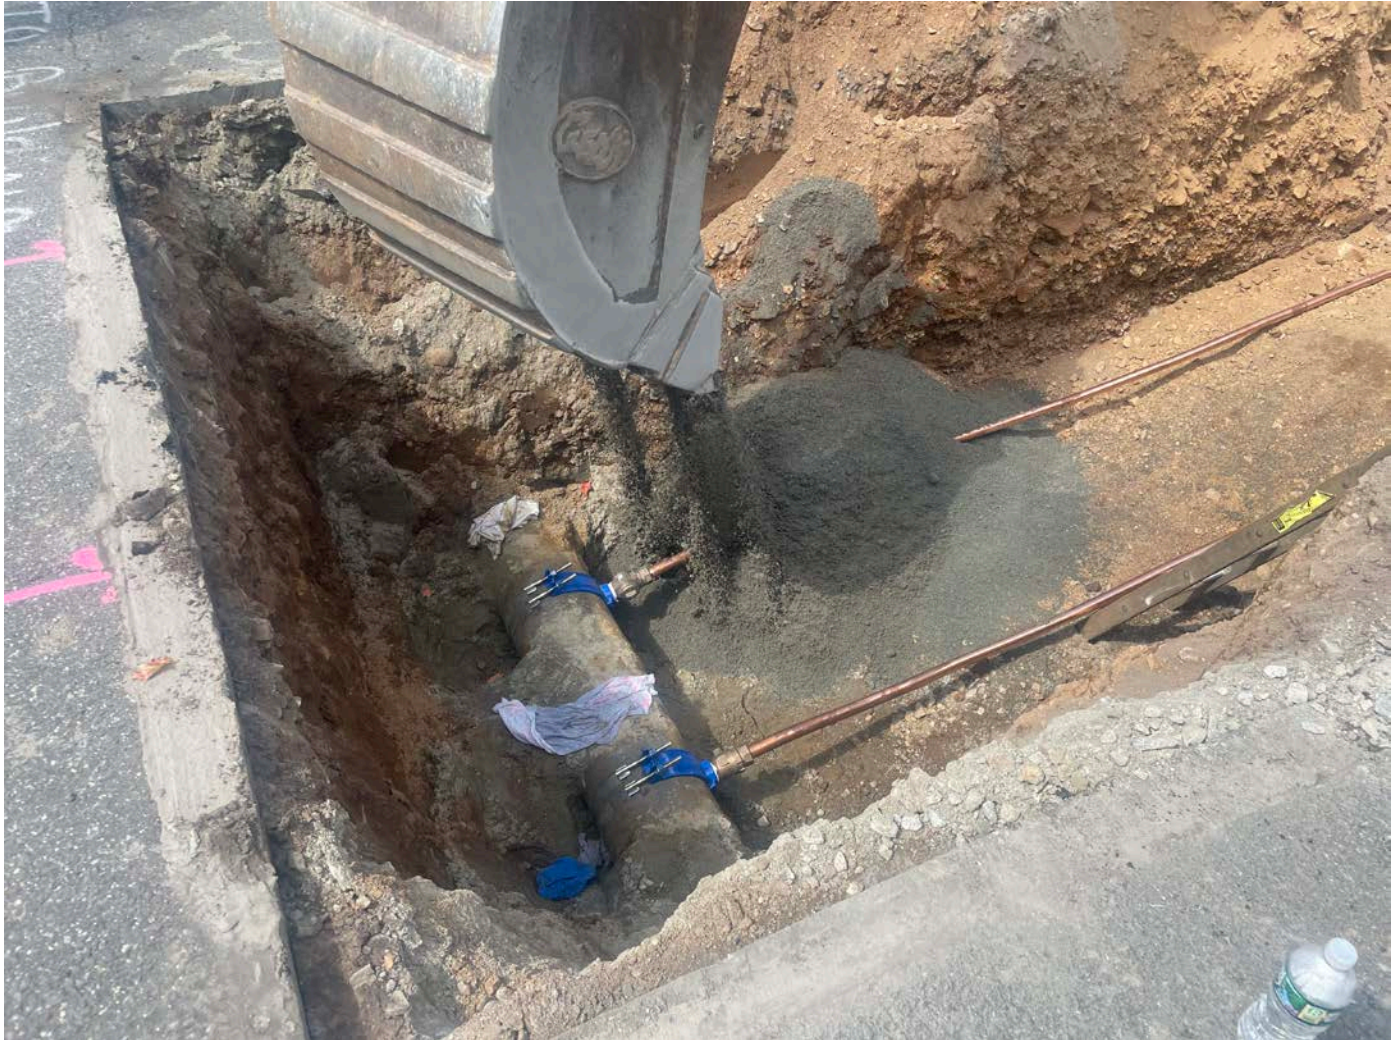
**Picture 8: Ludlow placing sand above and below the two 1.5" copper water service lines they connected to the 12" DIP water line located on the north side of Pickett Lane at Station ~516+55. View to the west.**

1229: Ludlow begins to place sand above and below the 1.5" copper water service lines they just installed between the 12" DIP water line on the north side of Pickett Lane and the two meter pits they just installed.

1238: Ludlow has placed 1' of sand over the two 1.5" copper water service lines they just installed between the 12" DIP water line on the north side of Pickett Lane and the two curb stops and meter pits they just installed.

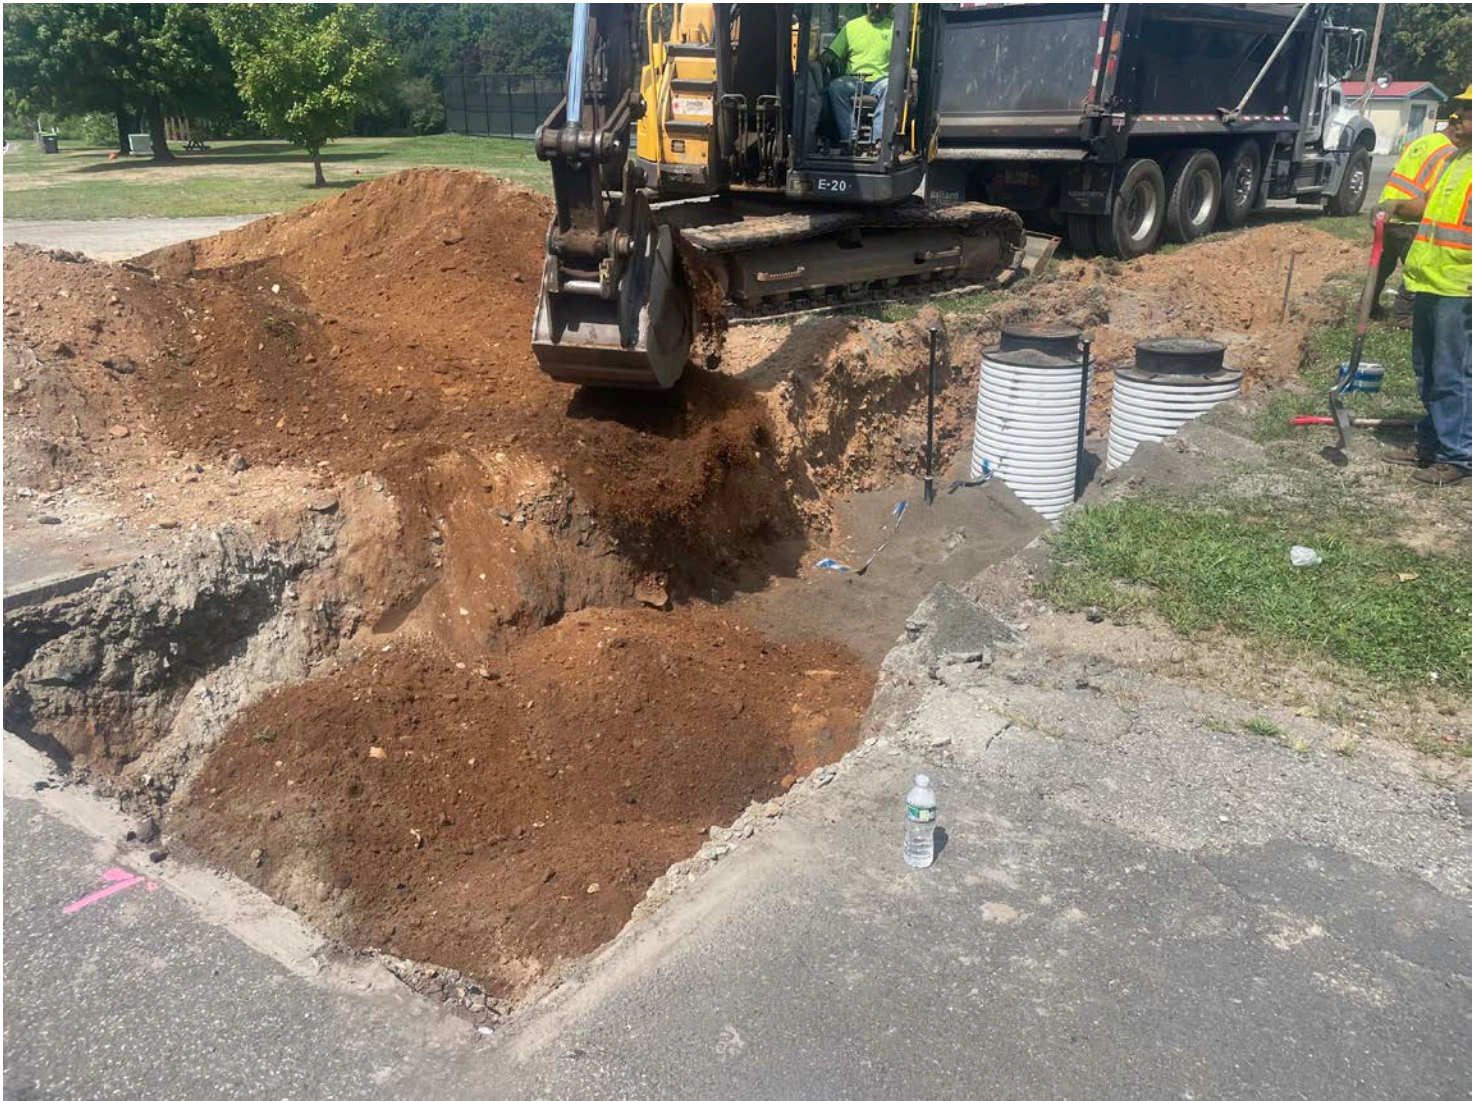
**Picture 9: Ludlow placing native fill over the sand they placed over the two 1.5" copper water service lines that they installed between the 12" DIP water line located on the north side of Pickett Lane and the two curb stops and meter pits the placed to the north of the water line. View to the northwest.**

1301: Ludlow continues to place fill into the trench where they installed two 1.5" copper water service lines at Station ~516+55. Ludlow has placed 1.25" processed gravel within the footprint of the trench excavation where it intersects Pickett Lane.

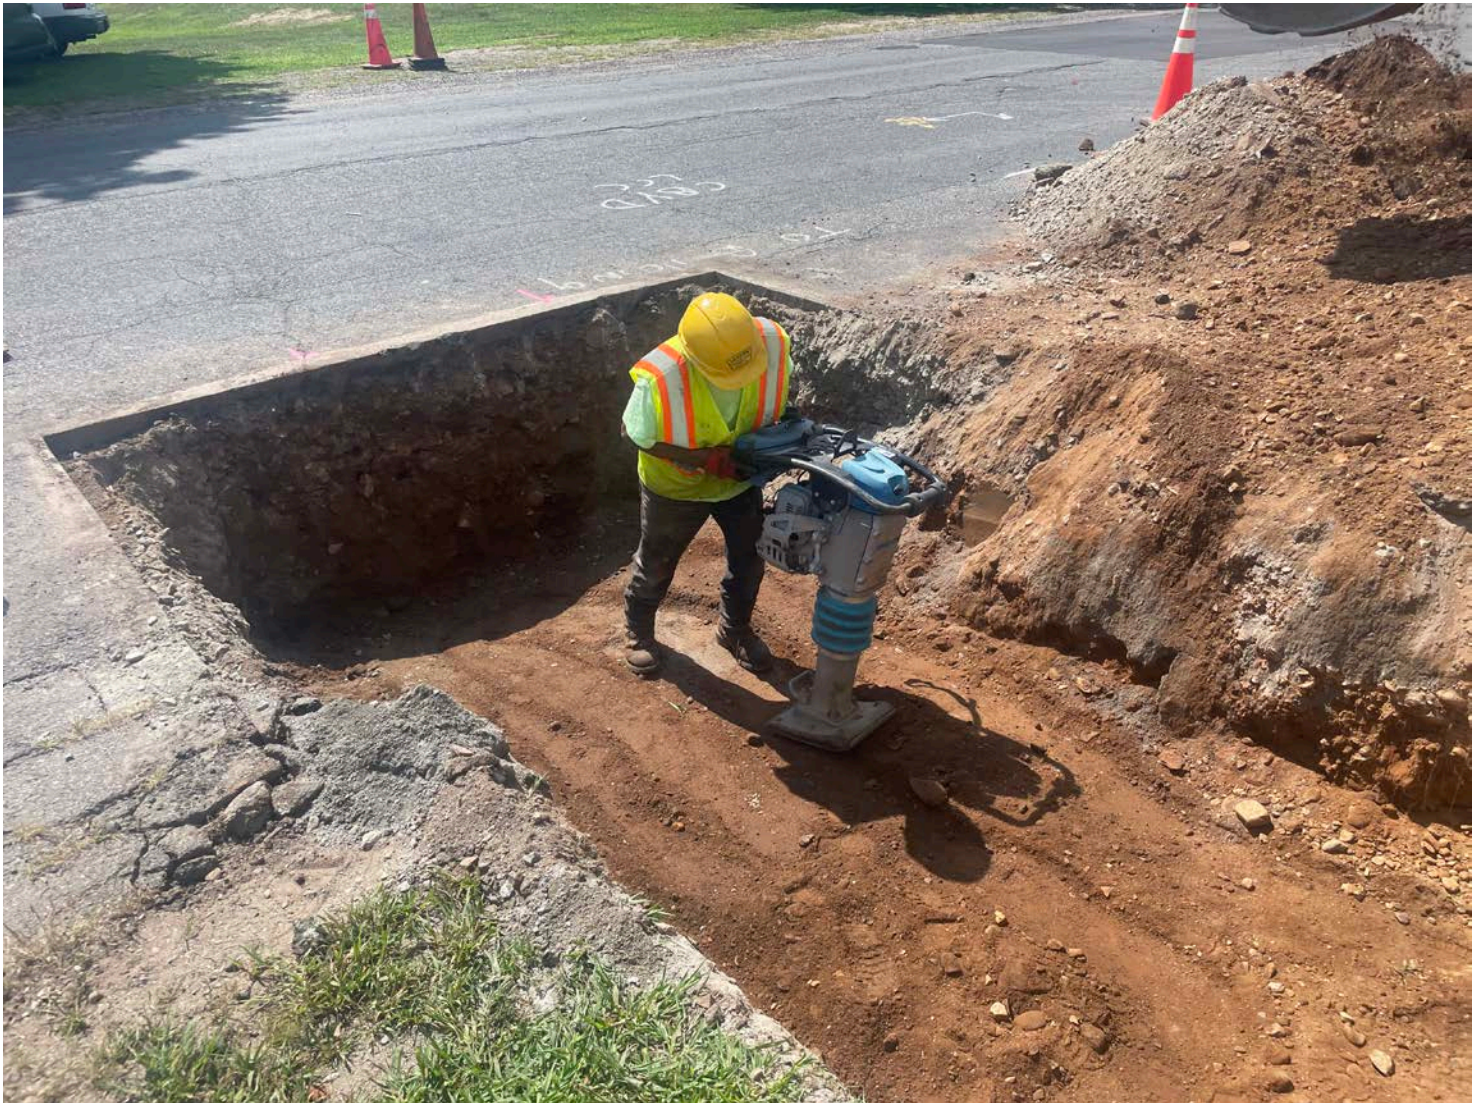
Picture 10: Ludlow using a jumping jack to compact the fill they placed over the two 1.5" copper water service lines they installed at Station ~516+55. View to the southwest.

1244: Ludlow is using a plate compactor to compact the fill they just backfilled into the trench where they installed two 1.5" copper water service lines at Station ~516+55.

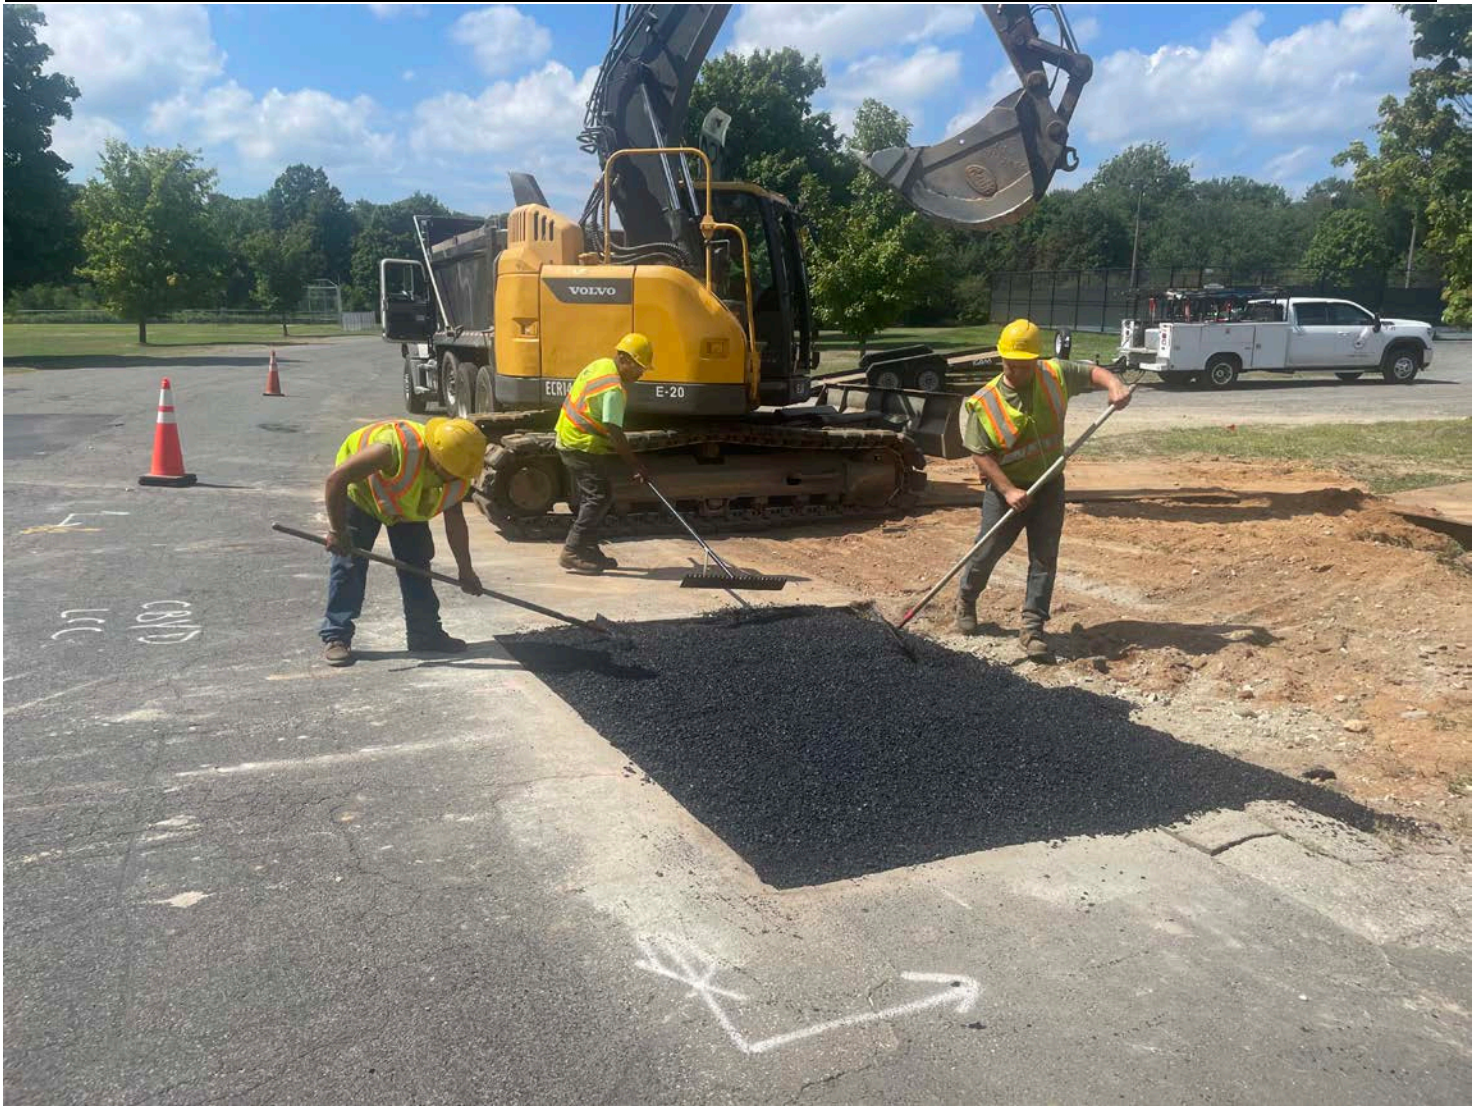
Picture 11: Ludlow placing the first of two lifts of temporary pavement at Station ~516+55 on Pickett Lane. View to the west.

1344: Ludlow begins to place the first of two lifts of asphalt on Pickett Lane at Station ~516+55.

1350: After compacting the first lift of asphalt with a rolling compactor and a jumping Jack, Ludlow is placing a second lift of asphalt within the footprint of the trench where it intersects Pickett Lane at Station ~516+55.
