## Daily Report

<b>Project:</b>	Durham Meadows Pipeline Installation	<b>Date:</b>	September 1, 2022
<b>Location:</b>	Pickett Lane and Main Street, Durham	<b>Day of Week:</b>	Thursday
<b>Project #:</b>	AECOM: 6061487	<b>Report No:</b>	502
<b>Contractor:</b>	Ludlow Construction	<b>Page:</b>	1 of 14

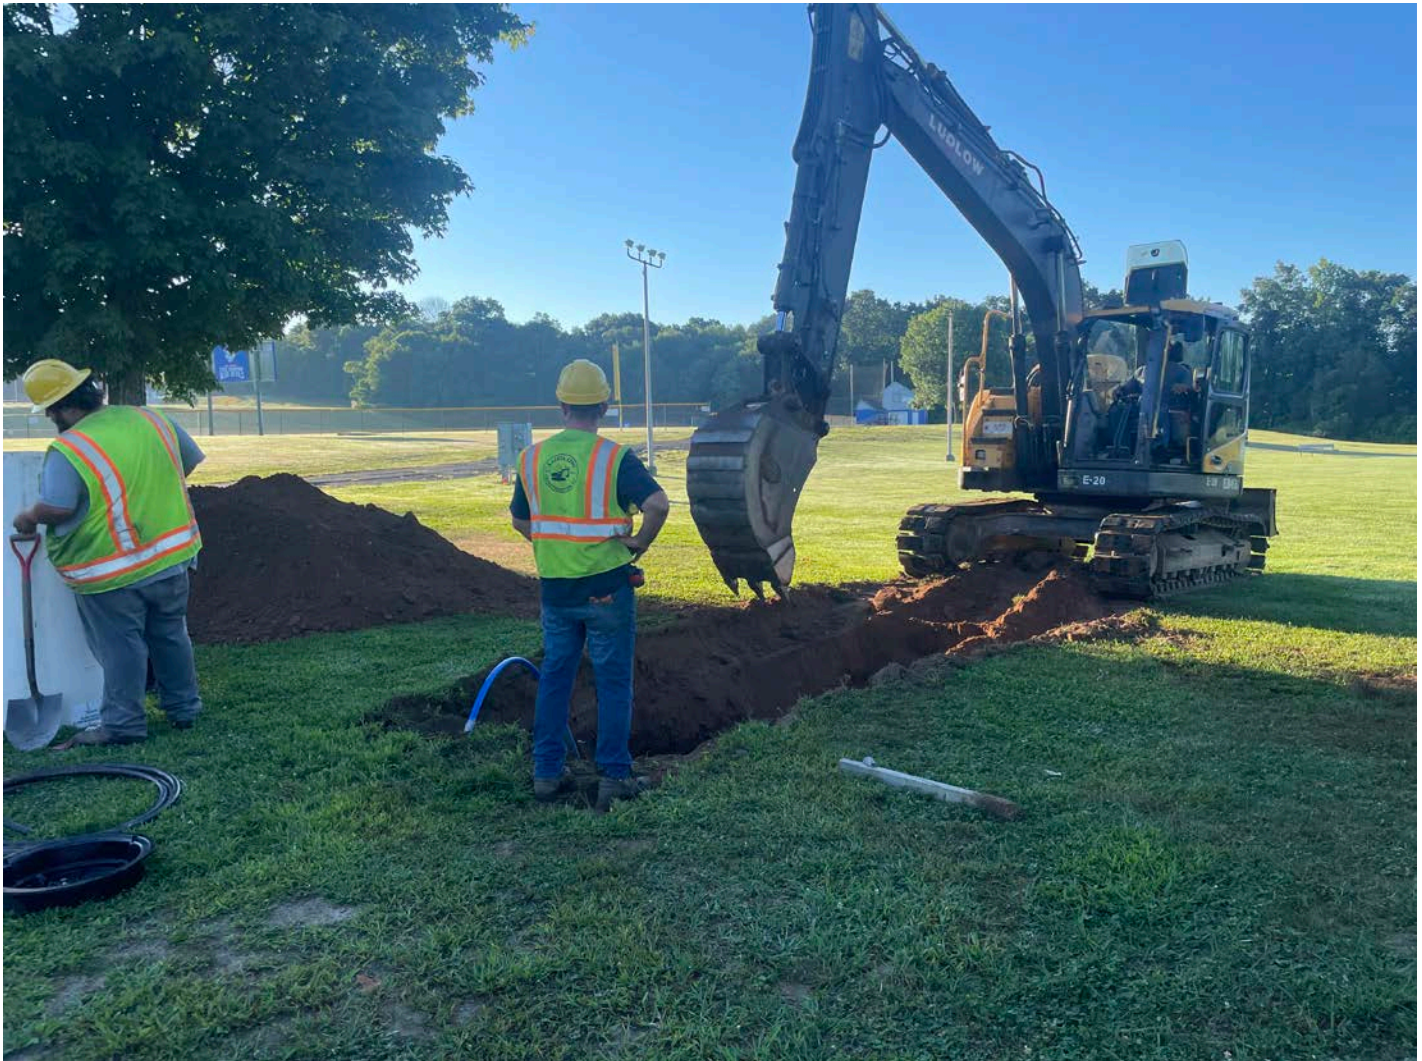
Picture 1: Ludlow excavating at Station 517+73 for the installation of a 1" copper water service line. View to the southeast.

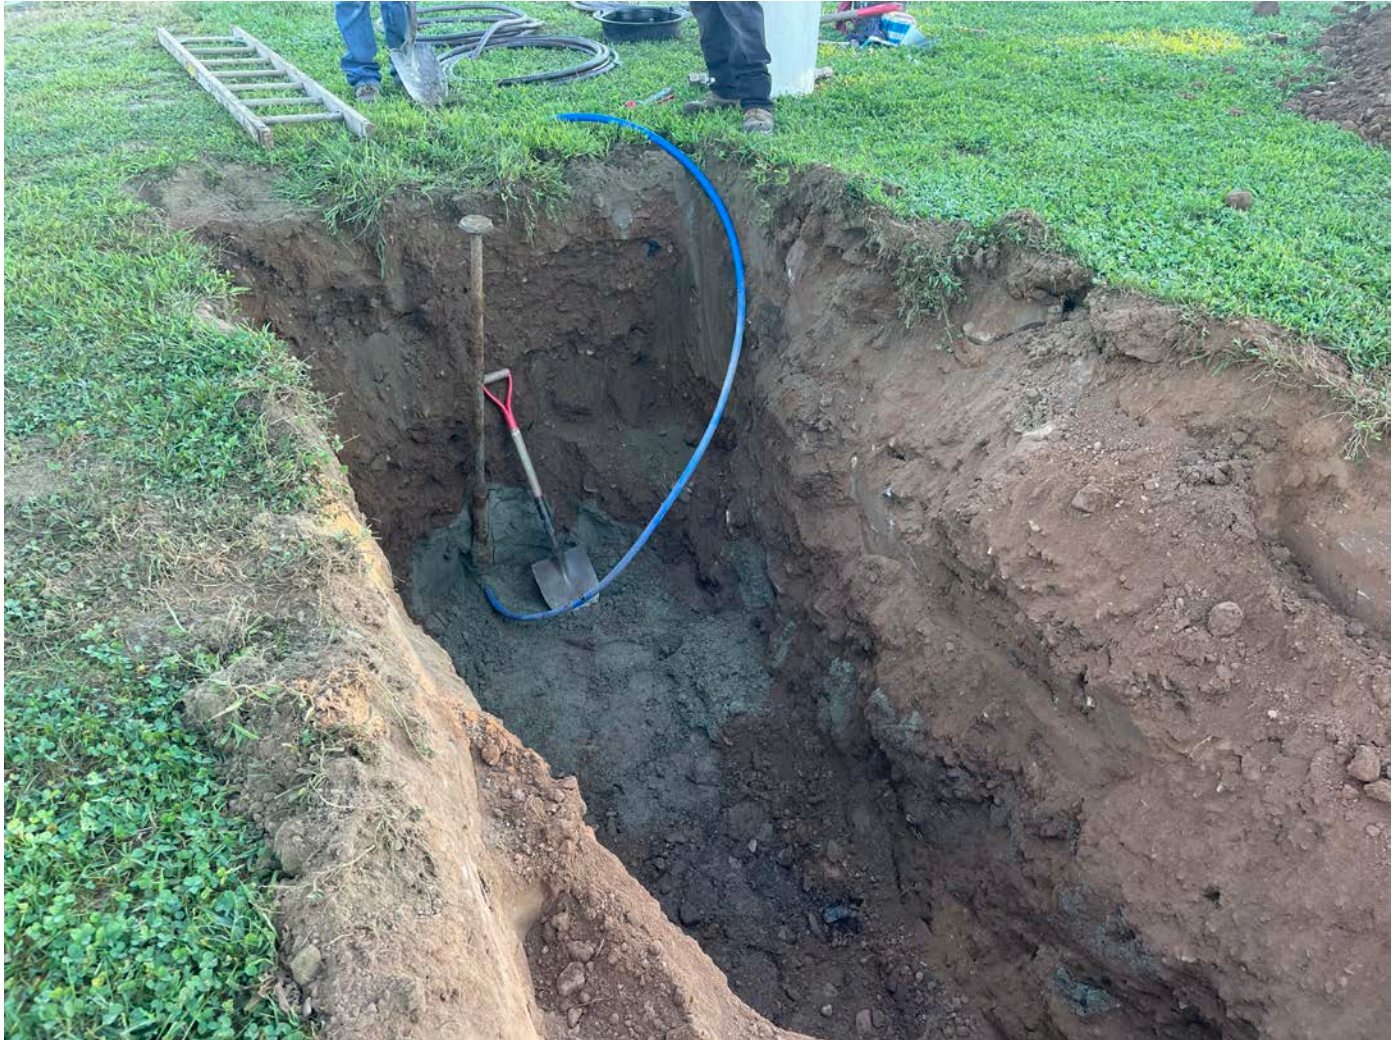
Picture 2: Curb stop located at Station 517+73 that Ludlow daylighted. View to the northeast.

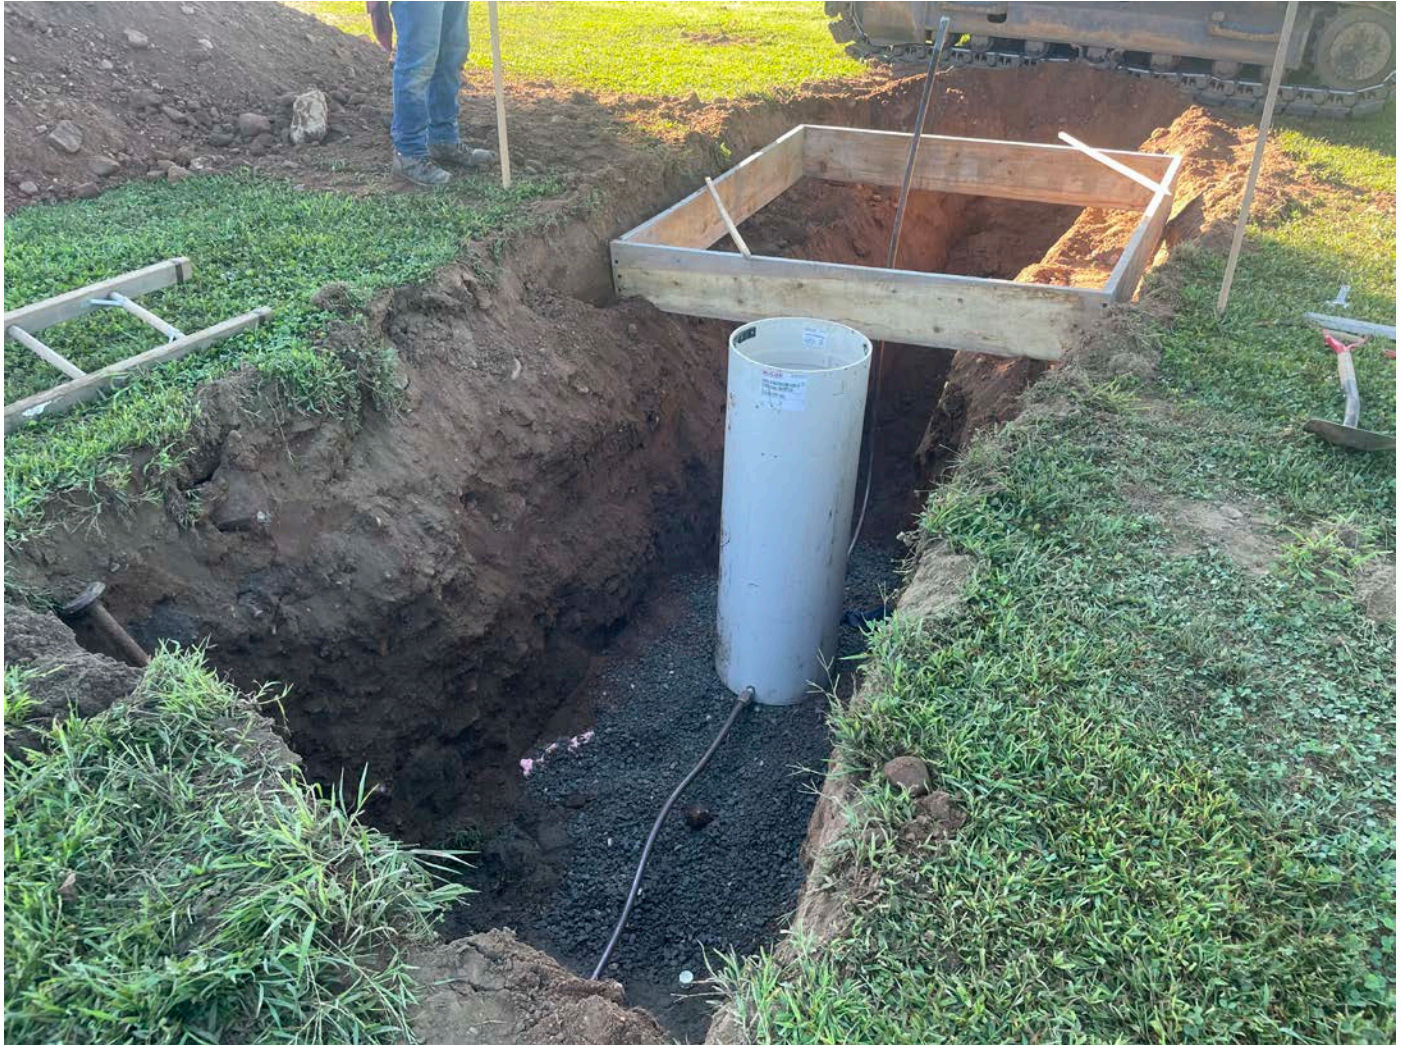
**Picture 3: Meter pit that Ludlow installed at Station 517+73, with a section of 1" copper water service line that was run between the curb stop and the meter pit. View to the southeast.**

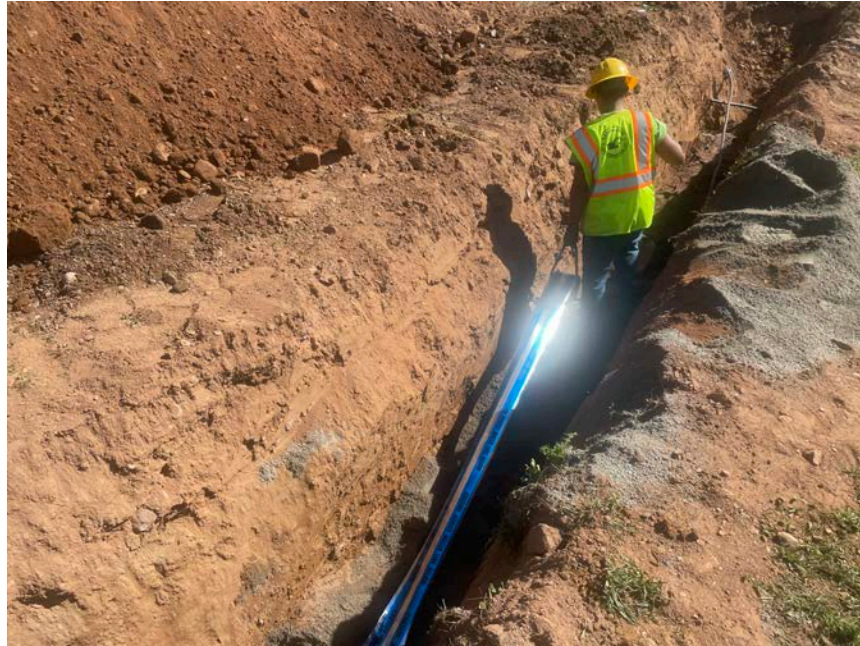
Picture 4: Ludlow placing caution tape over sand they just placed over the 1" copper water service line they are installing at Station 517+73.

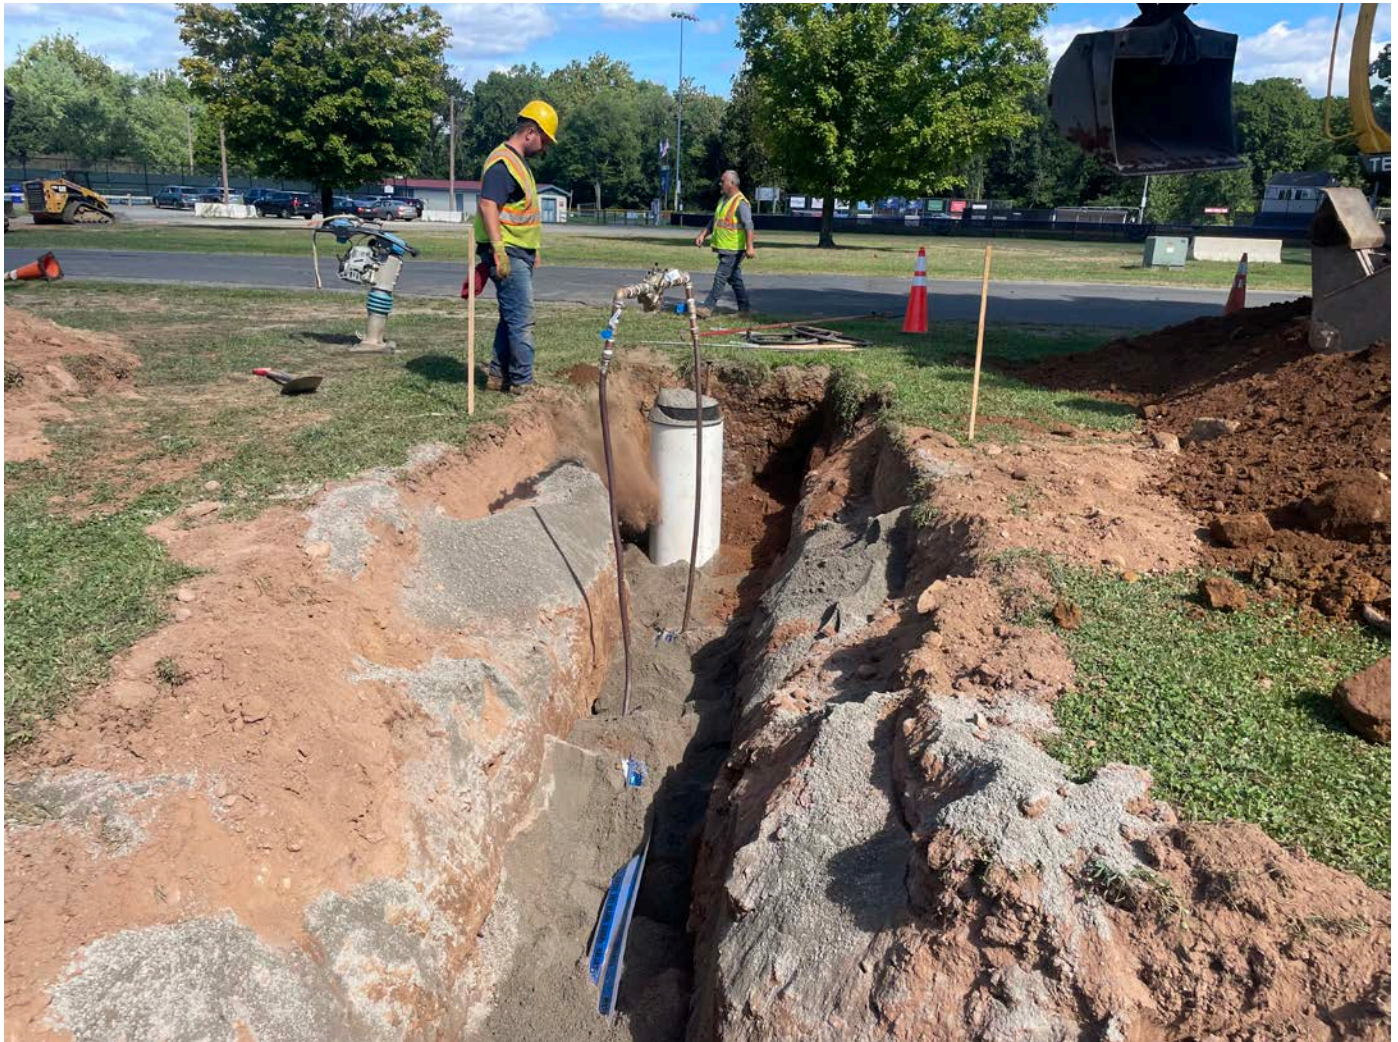
Picture 5: Backflow preventer and meter pit that Ludlow installed at Station 517+73. View to the north.

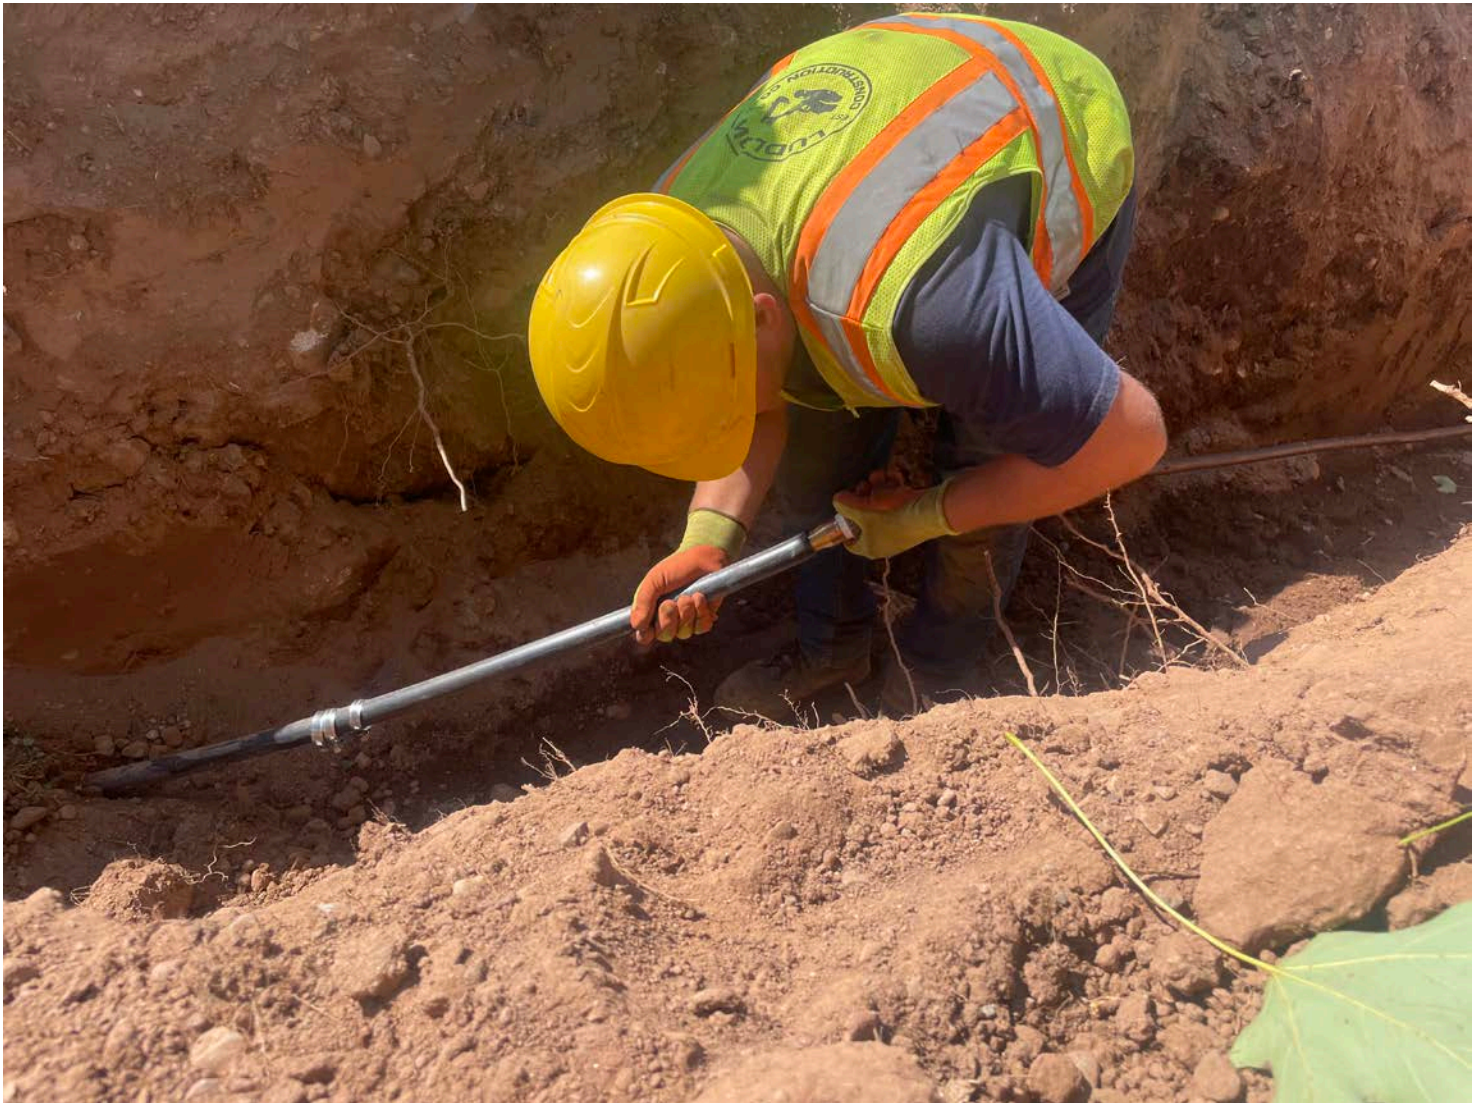
**Picture 6: Ludlow connecting the 1" copper water service line that they ran from Station 517+73 to the south and then to the east to the existing HDPE water line.**

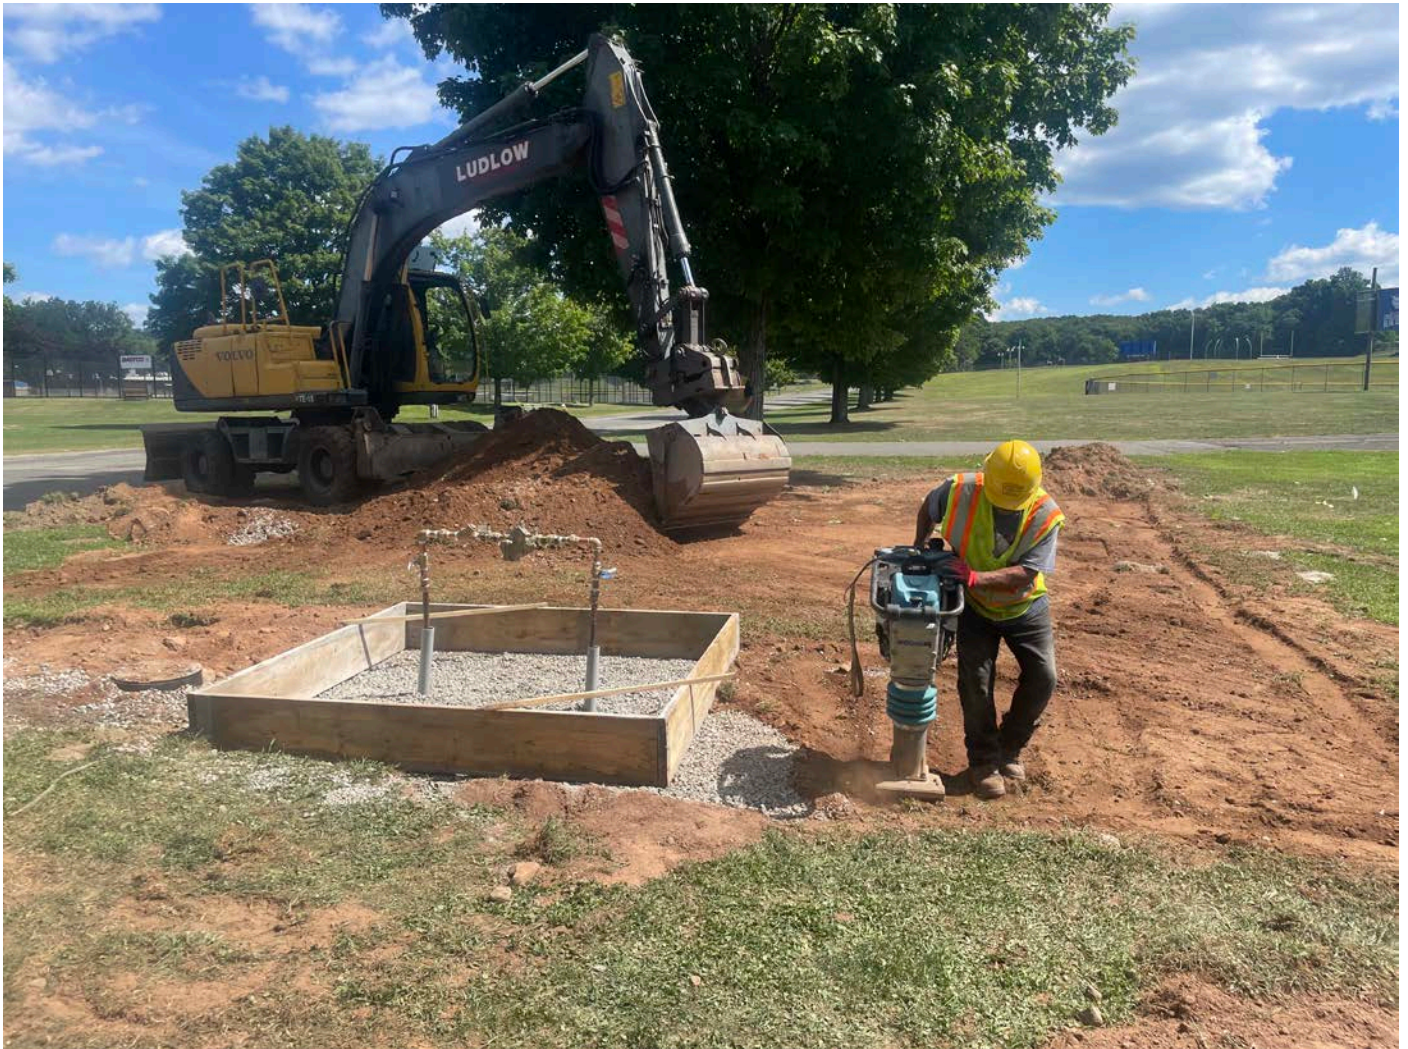
Picture 7: Ludlow compacting backfill on the north side of a concrete form they placed around the backflow preventer at Station 517+73. View to the east.

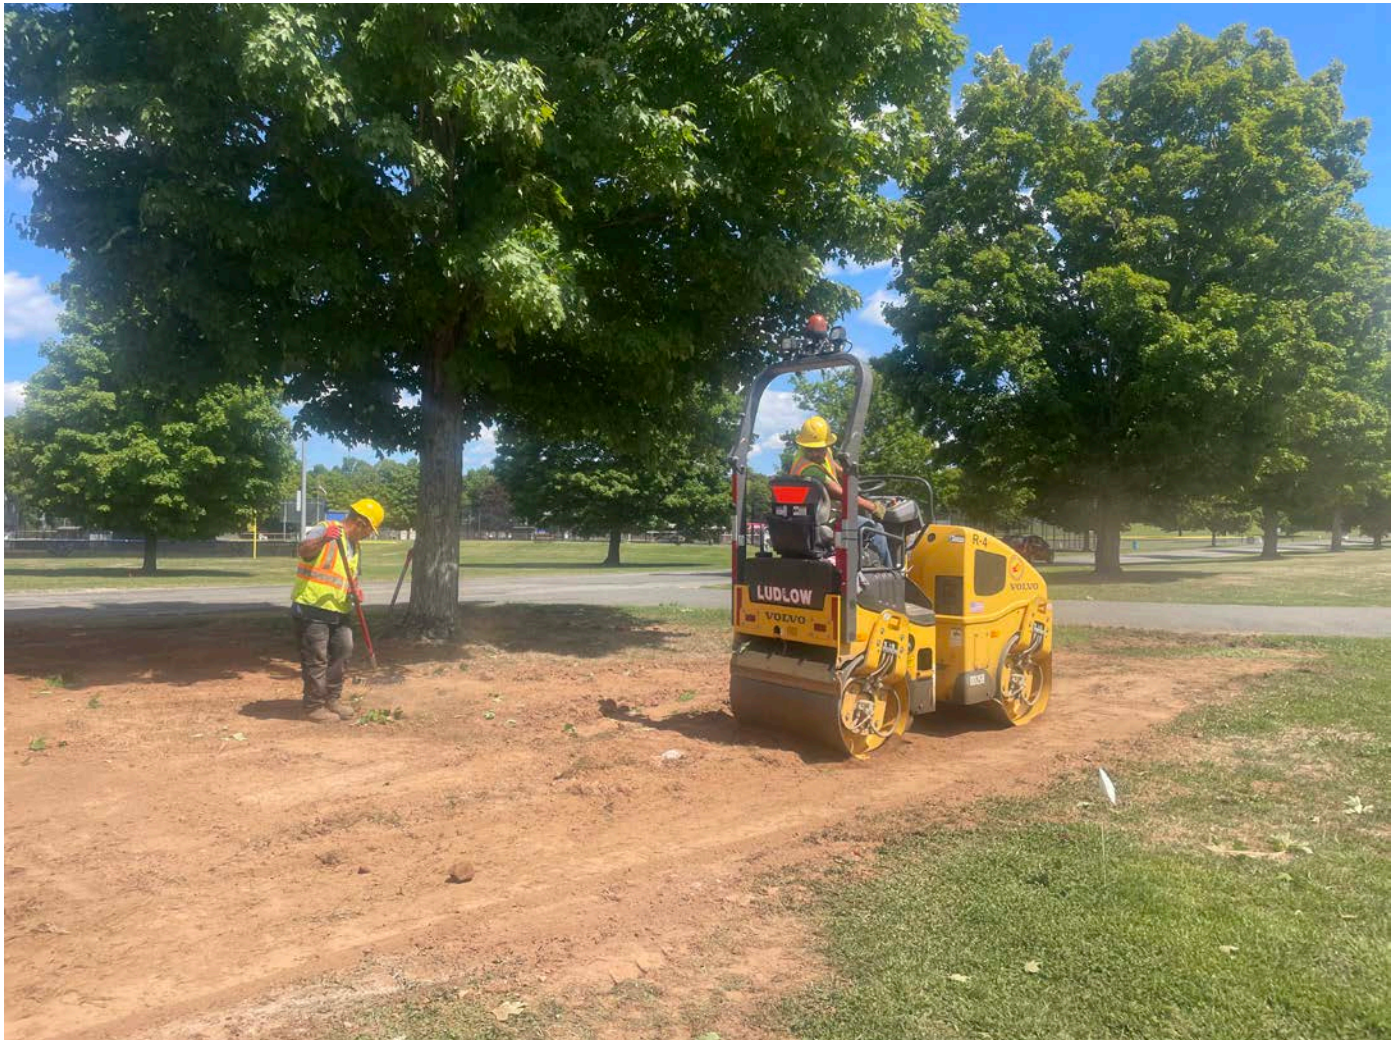
**Picture 8: Ludlow using a rolling compactor on the native fill they backfilled over the 1" copper water service line they installed starting at the curb stop located at Station 517+73. View to the northeast.**

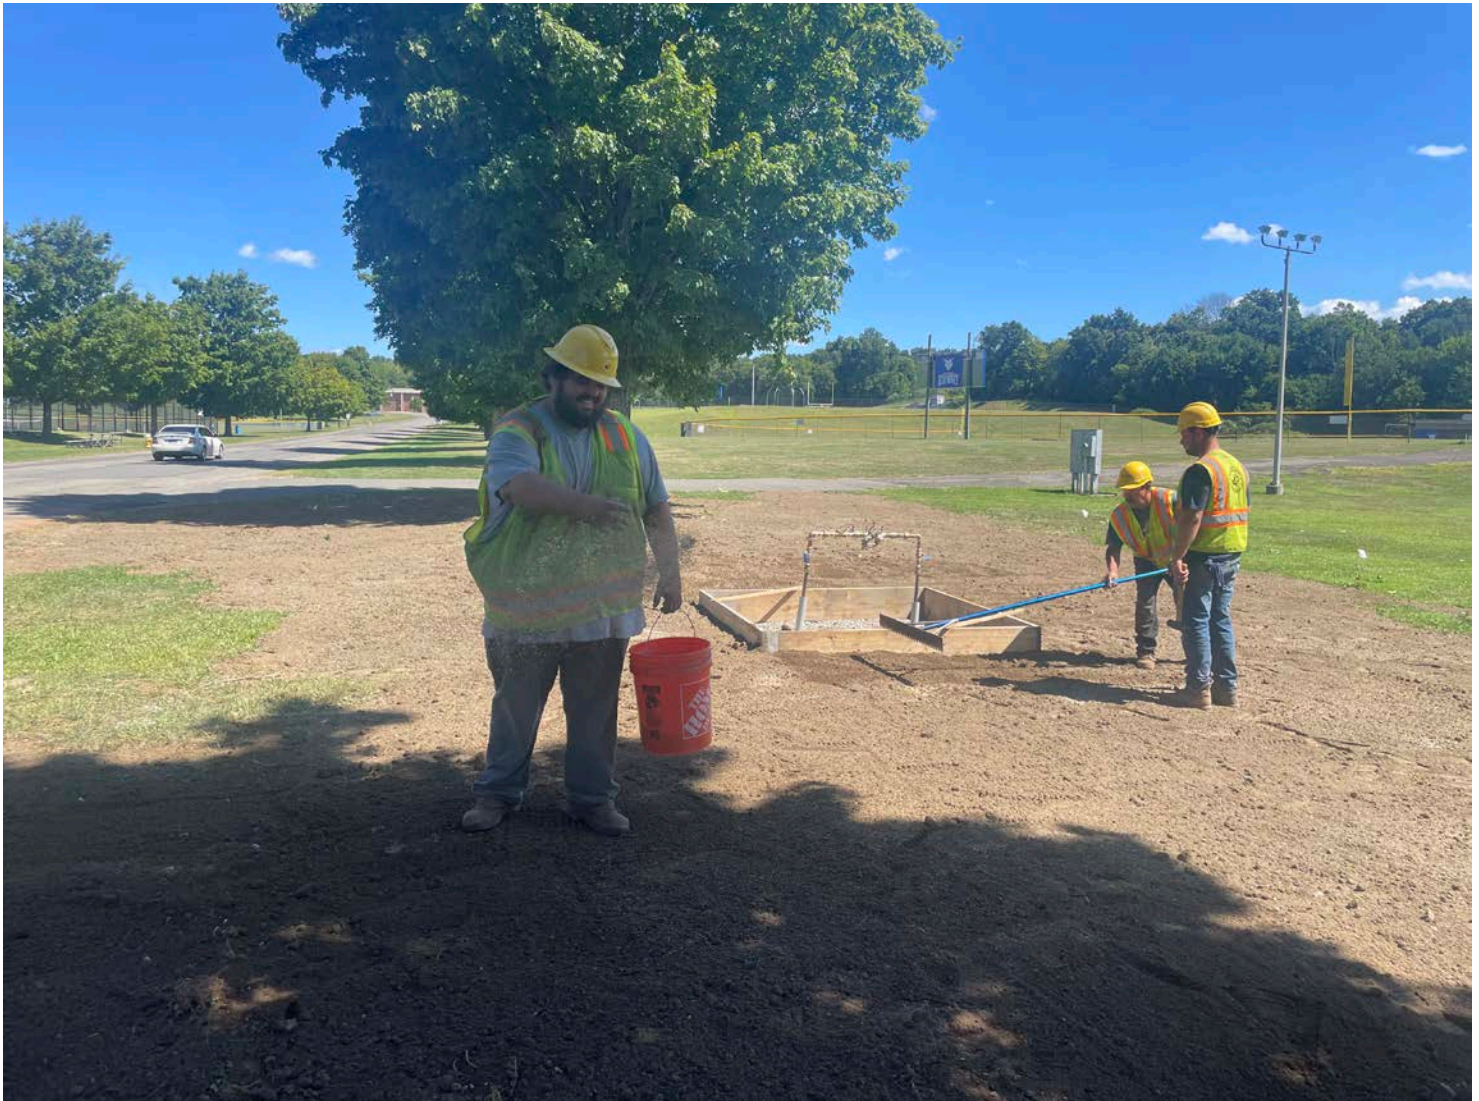
Picture 9: Ludlow grading loam and spreading grass seed on the areas that were disturbed when they installed a meter pit, backflow preventer, and copper water service line starting at the curb stop located at Station 517+73. View to the west.

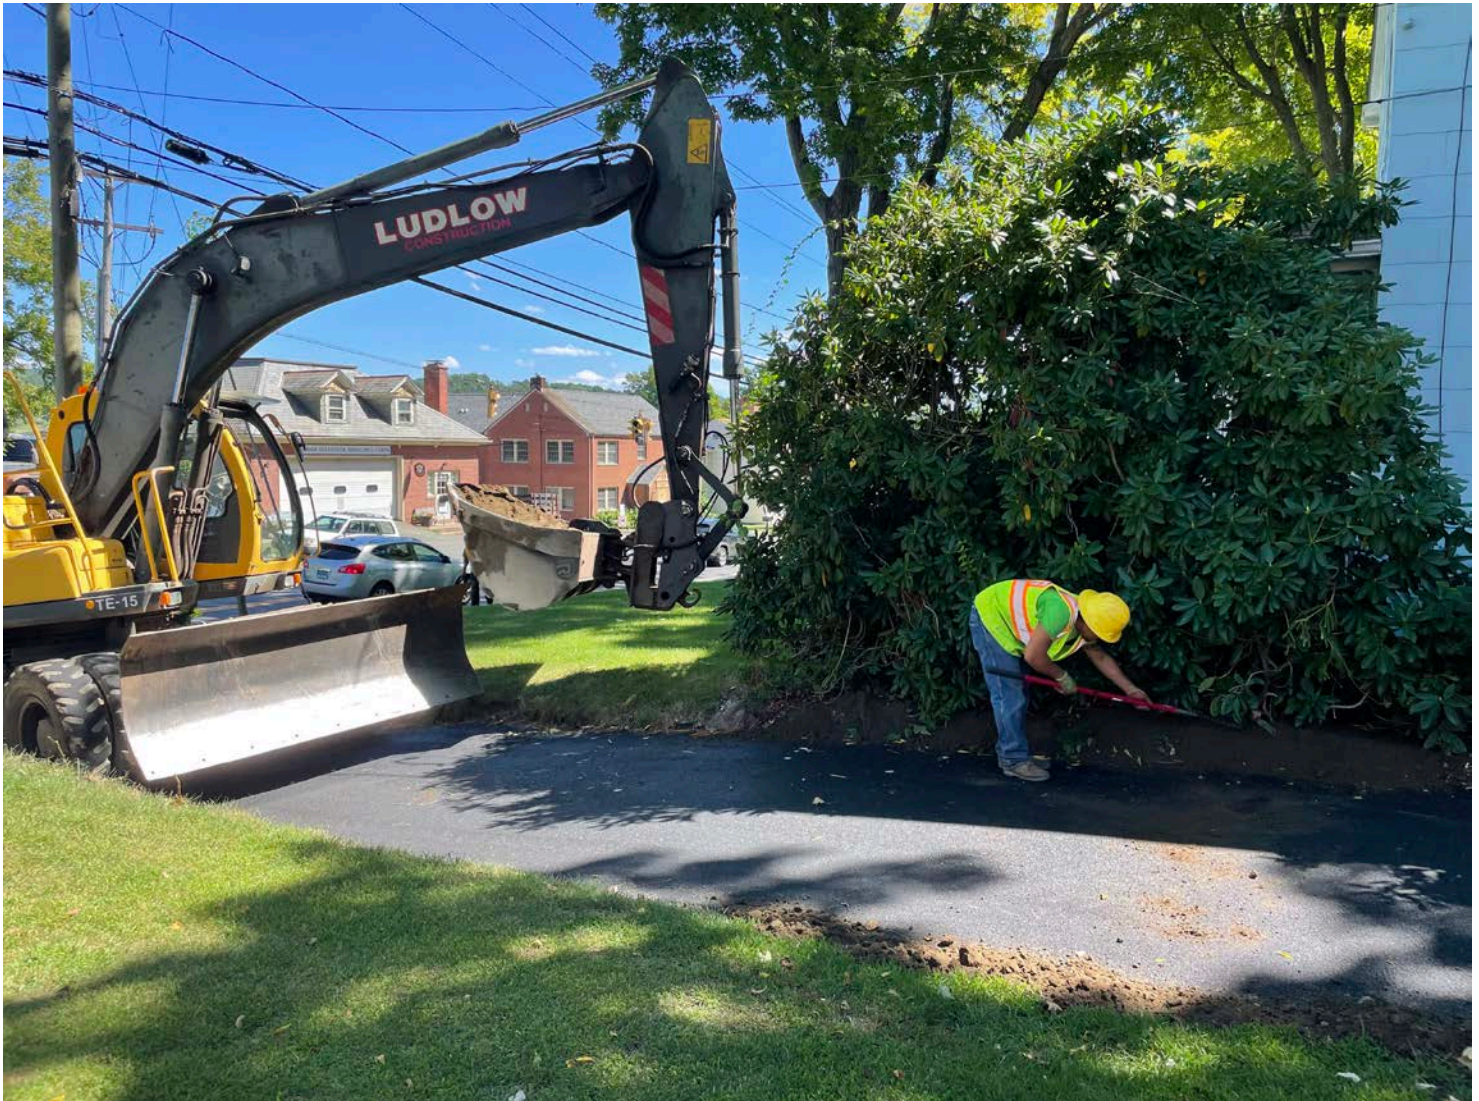
Picture 10: Ludlow placing loam and grass seed on both sides of the paved portion of the driveway located at the 208 Main Street, Durham, property. View to the southeast.

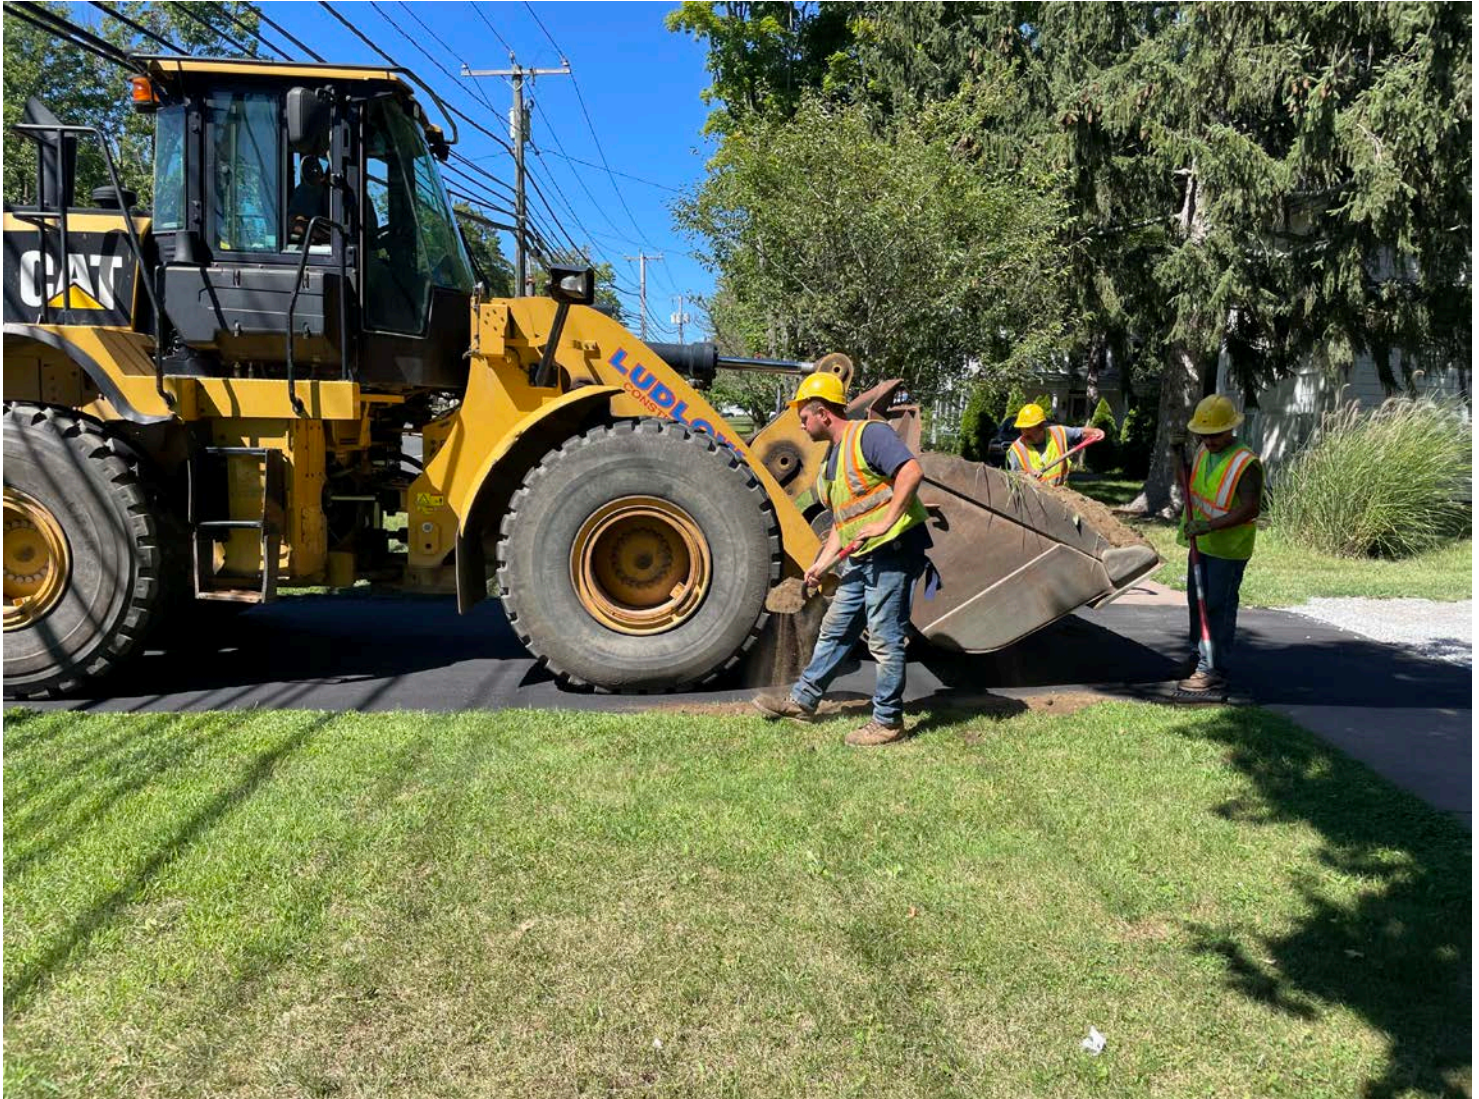
**Picture 11: Ludlow placing loam and grass seed on both sides of the paved portion of the driveway located at the 303/305R Main Street, Durham, property. View to the north.**
