## Daily Report

<b>Project:</b>	Durham Meadows Pipeline Installation	<b>Date:</b>	September 14, 2022
<b>Location:</b>	Main Street, Pickett Lane, Durham; S. Main Street, Middletown	<b>Day of Week:</b>	Wednesday
<b>Project #:</b>	AECOM: 6061487	<b>Report No:</b>	509
<b>Contractor:</b>	Ludlow Construction	<b>Page:</b>	1 of 13

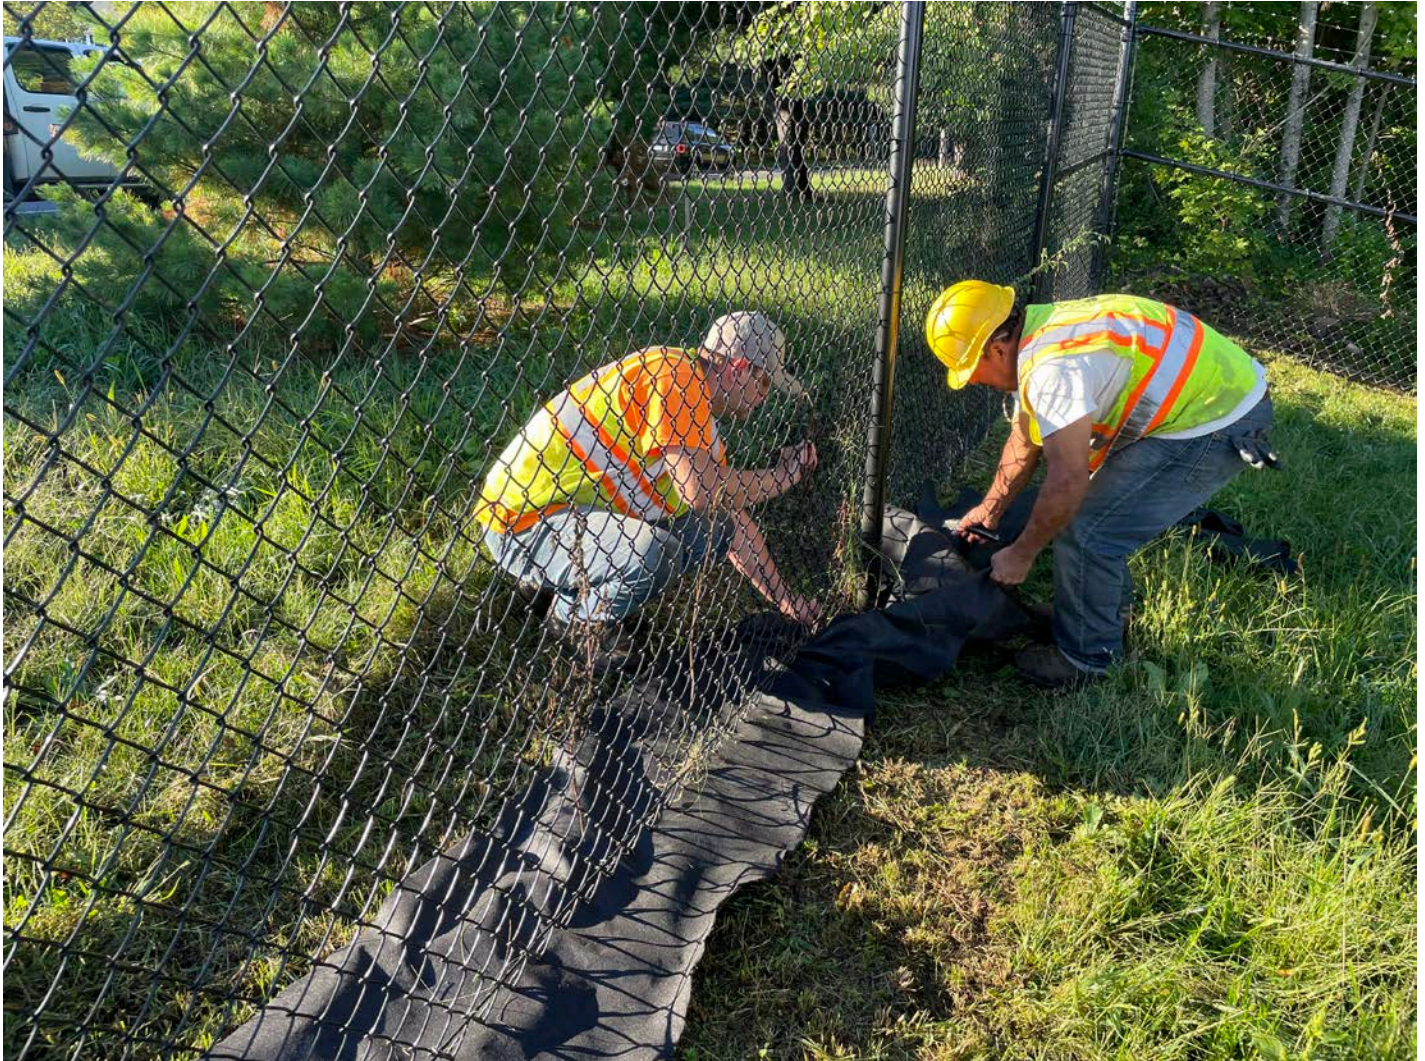
**Picture 1: Ludlow placing geofabric at the base of the fence that surrounds the Booster Station located on S. Main Street in Middletown. View to the south.**

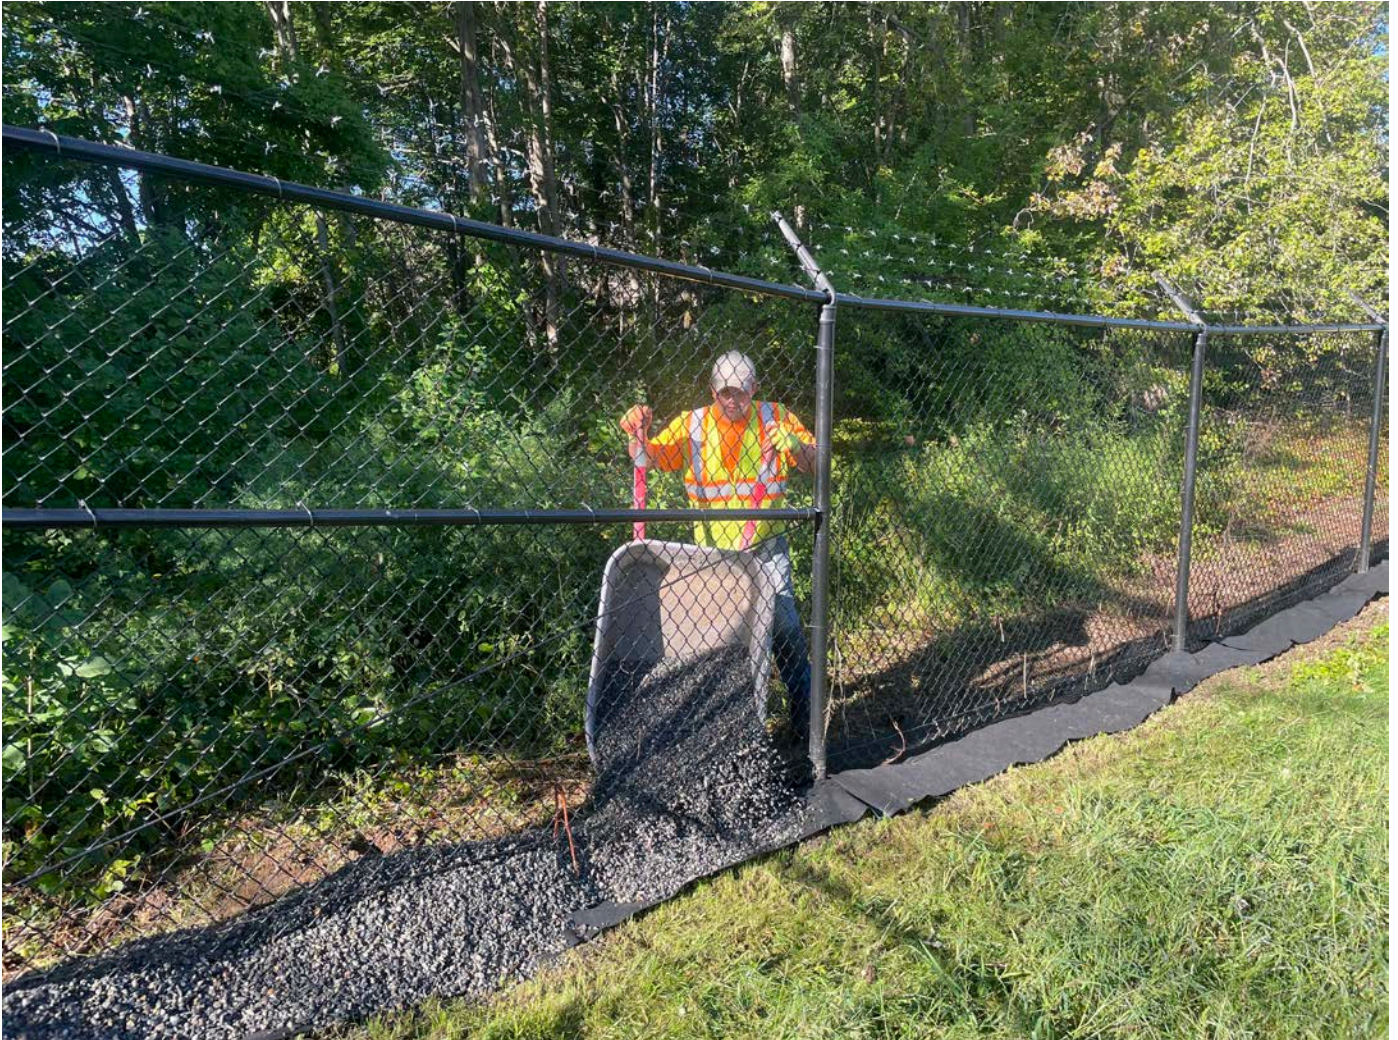
**Picture 2: Ludlow placing 3/4" stone on top of the geofabric they placed at the base of the fence that surrounds the Booster Station located on S. Main Street in Middletown. View to the southwest.**

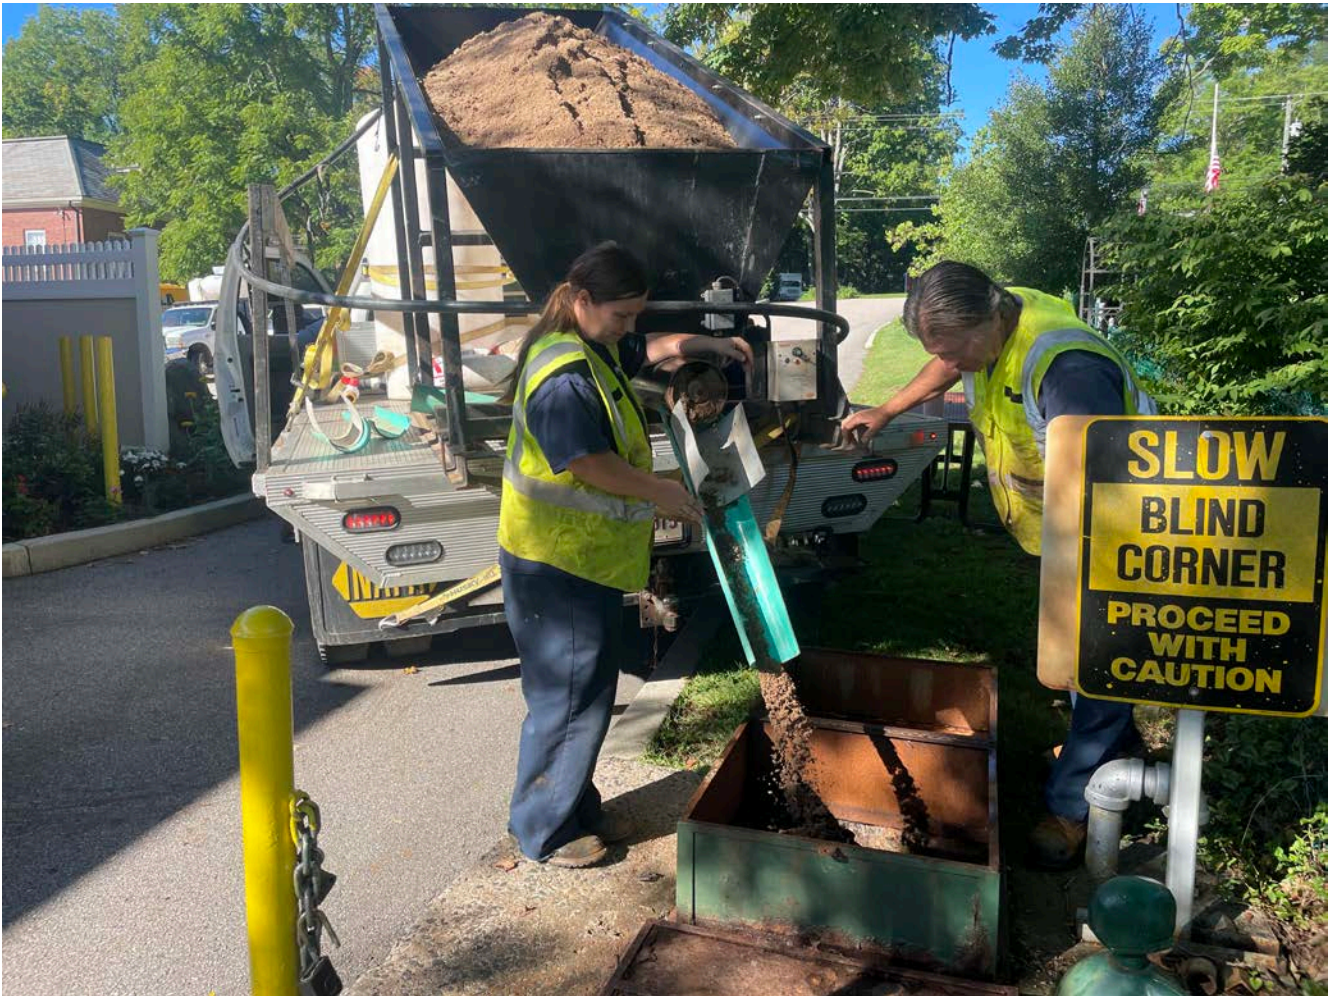
Picture 3: Grela placing sand into the well located to the north of the northwest corner of the Durham Manufacturing facility located on 201-203 Main Street in Durham as part of well decommissioning activities. View to the west.

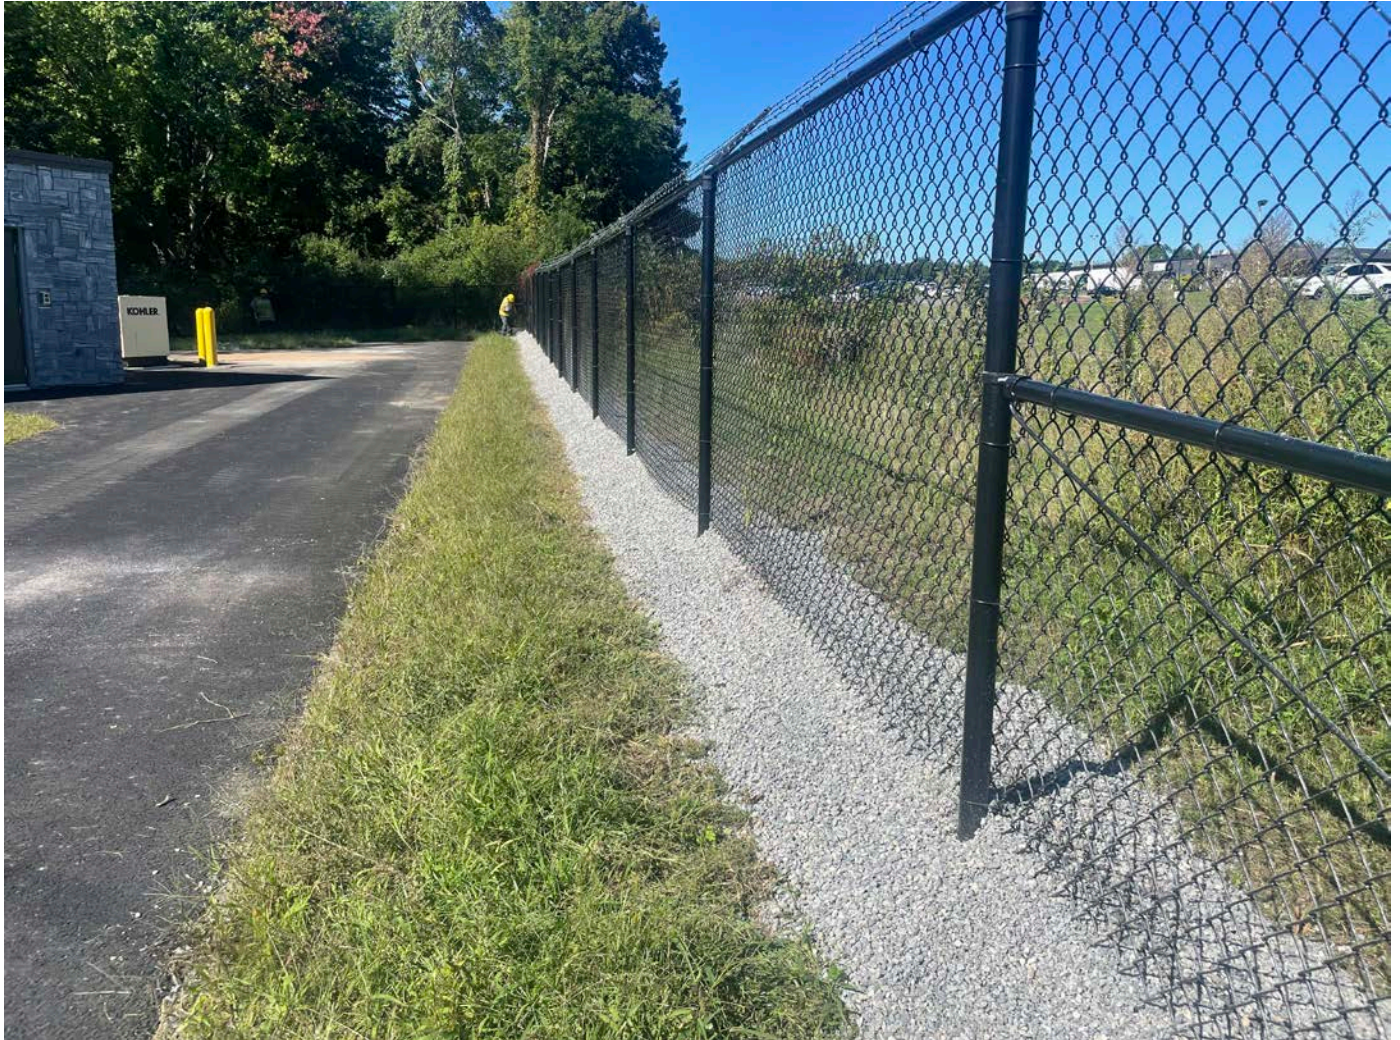
**Picture 4: View of the ¾" stone that Ludlow placed at the north side of the fence that surrounds the Booster Station located on S. Main Street, Middletown. View to the west.**

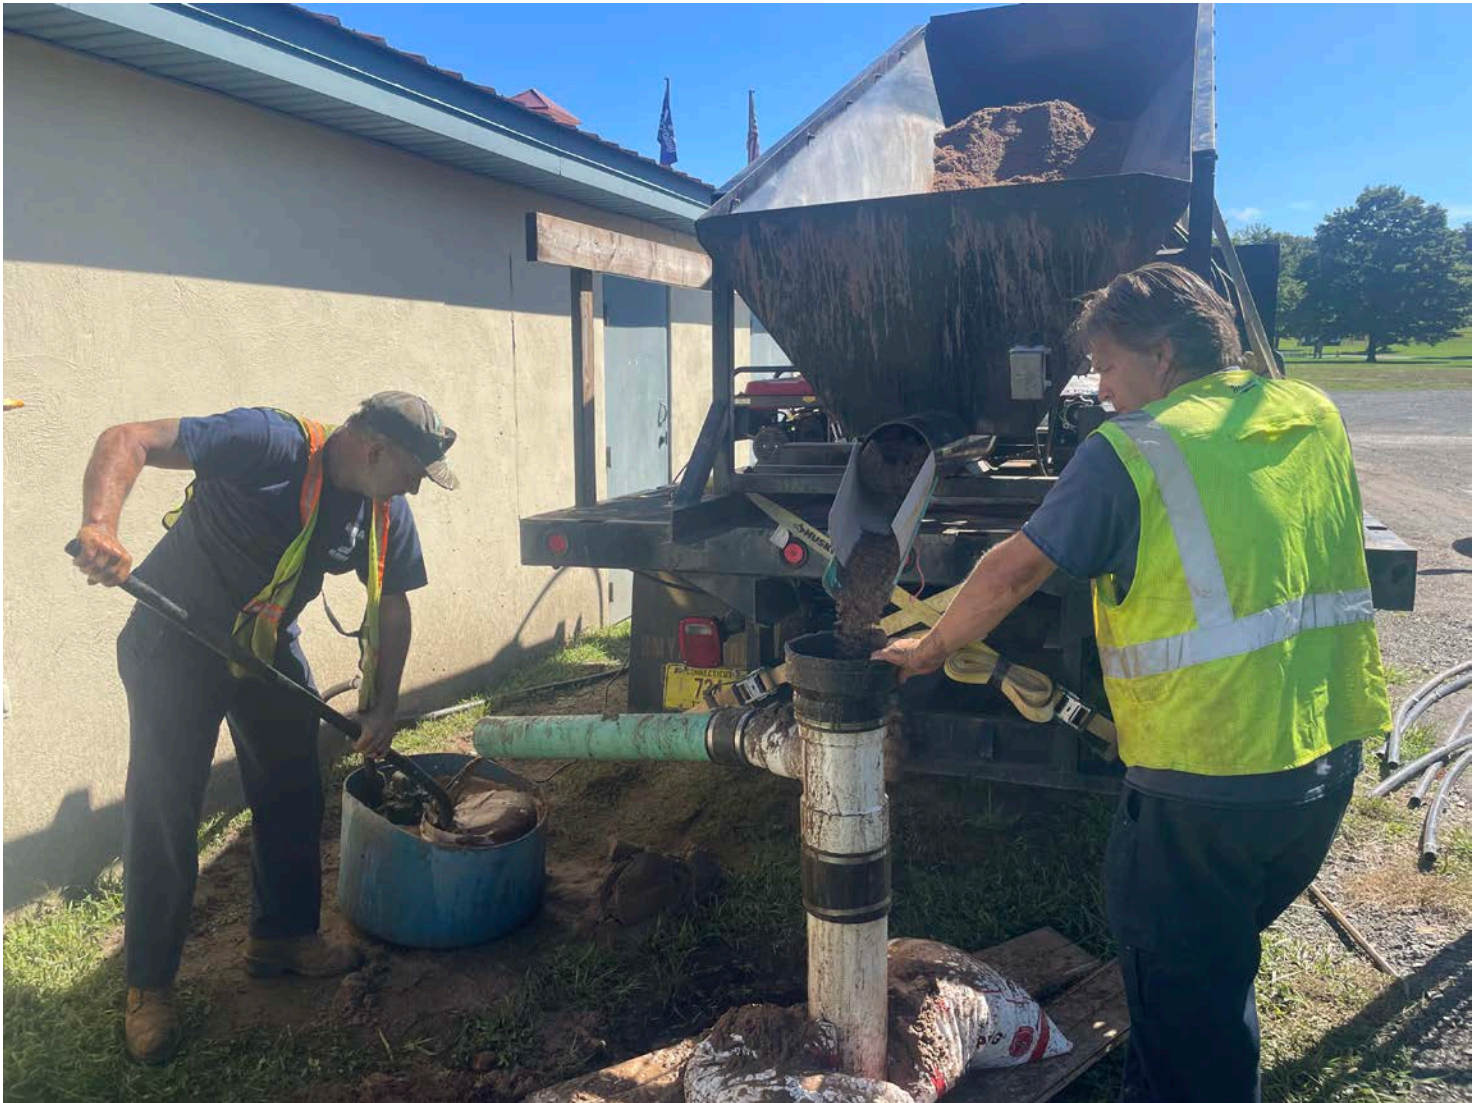
Picture 5: Grela placing sand into the well located to the south side of the recreation center next to the pickleball courts on the north side of Pickett Lane. View to the east.

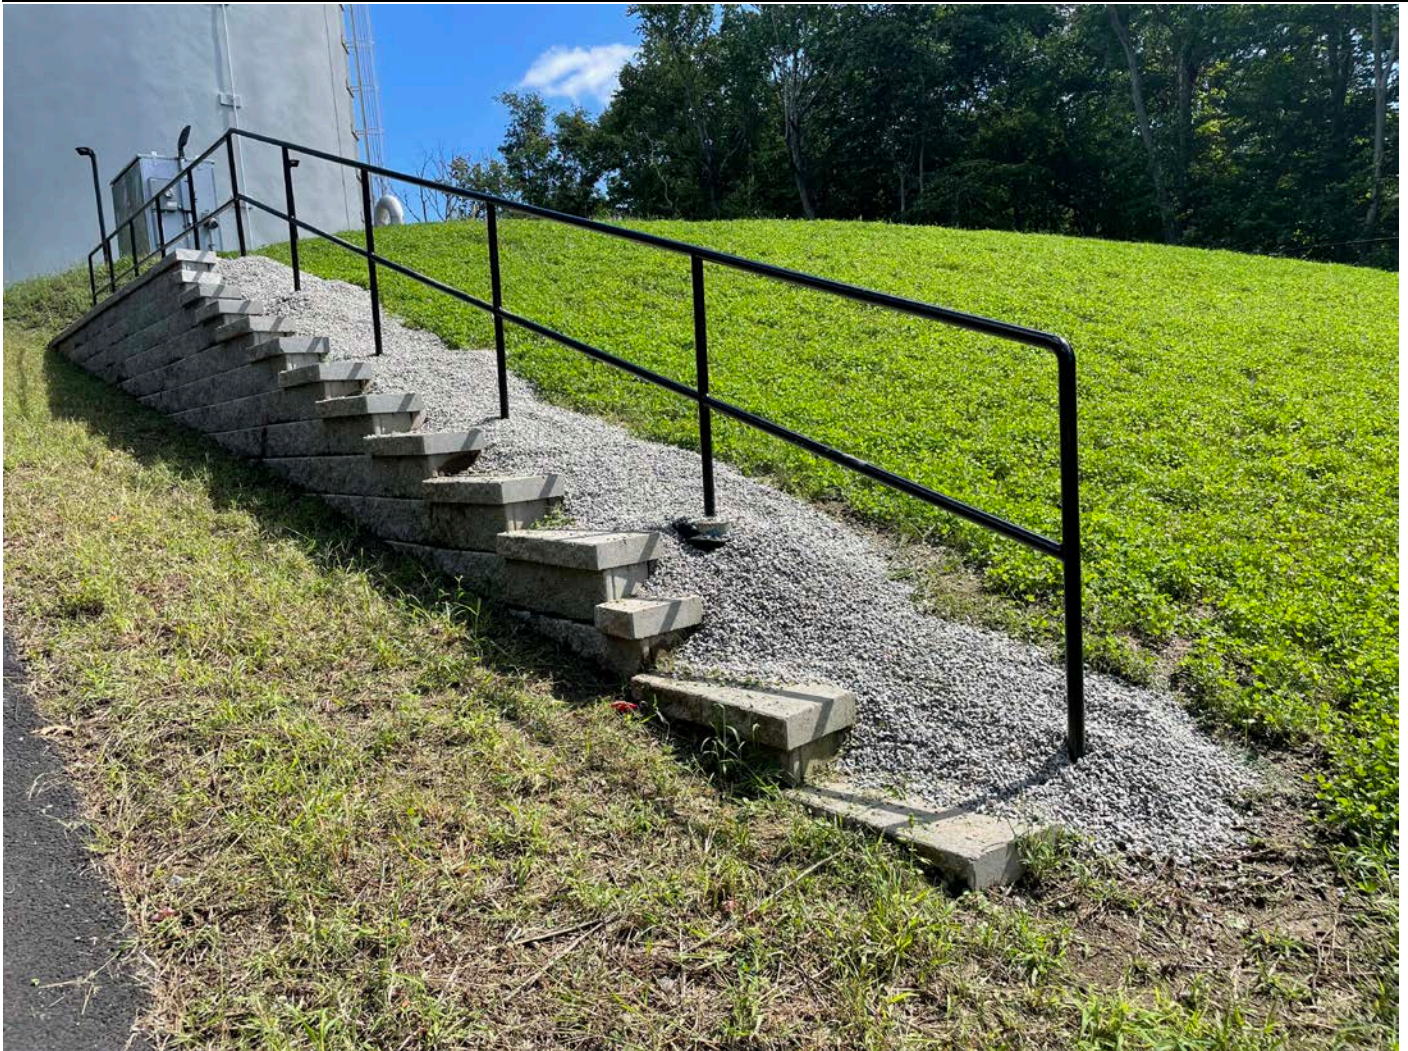
**Picture 6: View of the ¾” stone that Ludlow placed at the base of the railing that was installed on the south side of the retaining wall located on the Shared Access Road in Middletown. View to the southeast.**

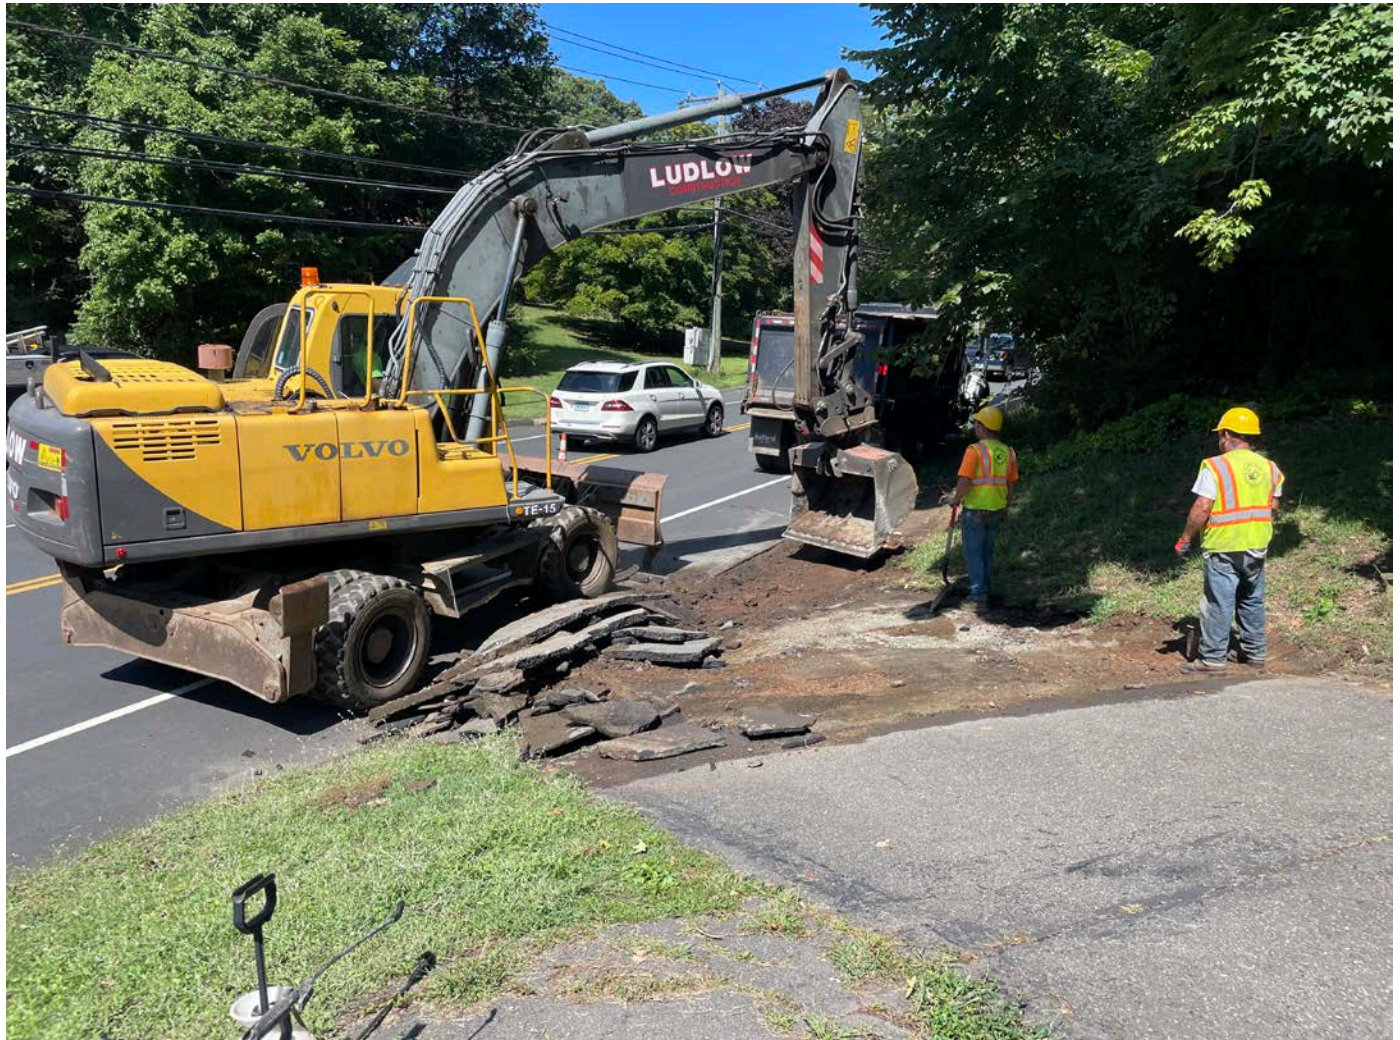
Picture 7: Ludlow stripping asphalt from the driveway apron of the 475 Main Street, Durham, property as they prepare to repave. View to the northwest.

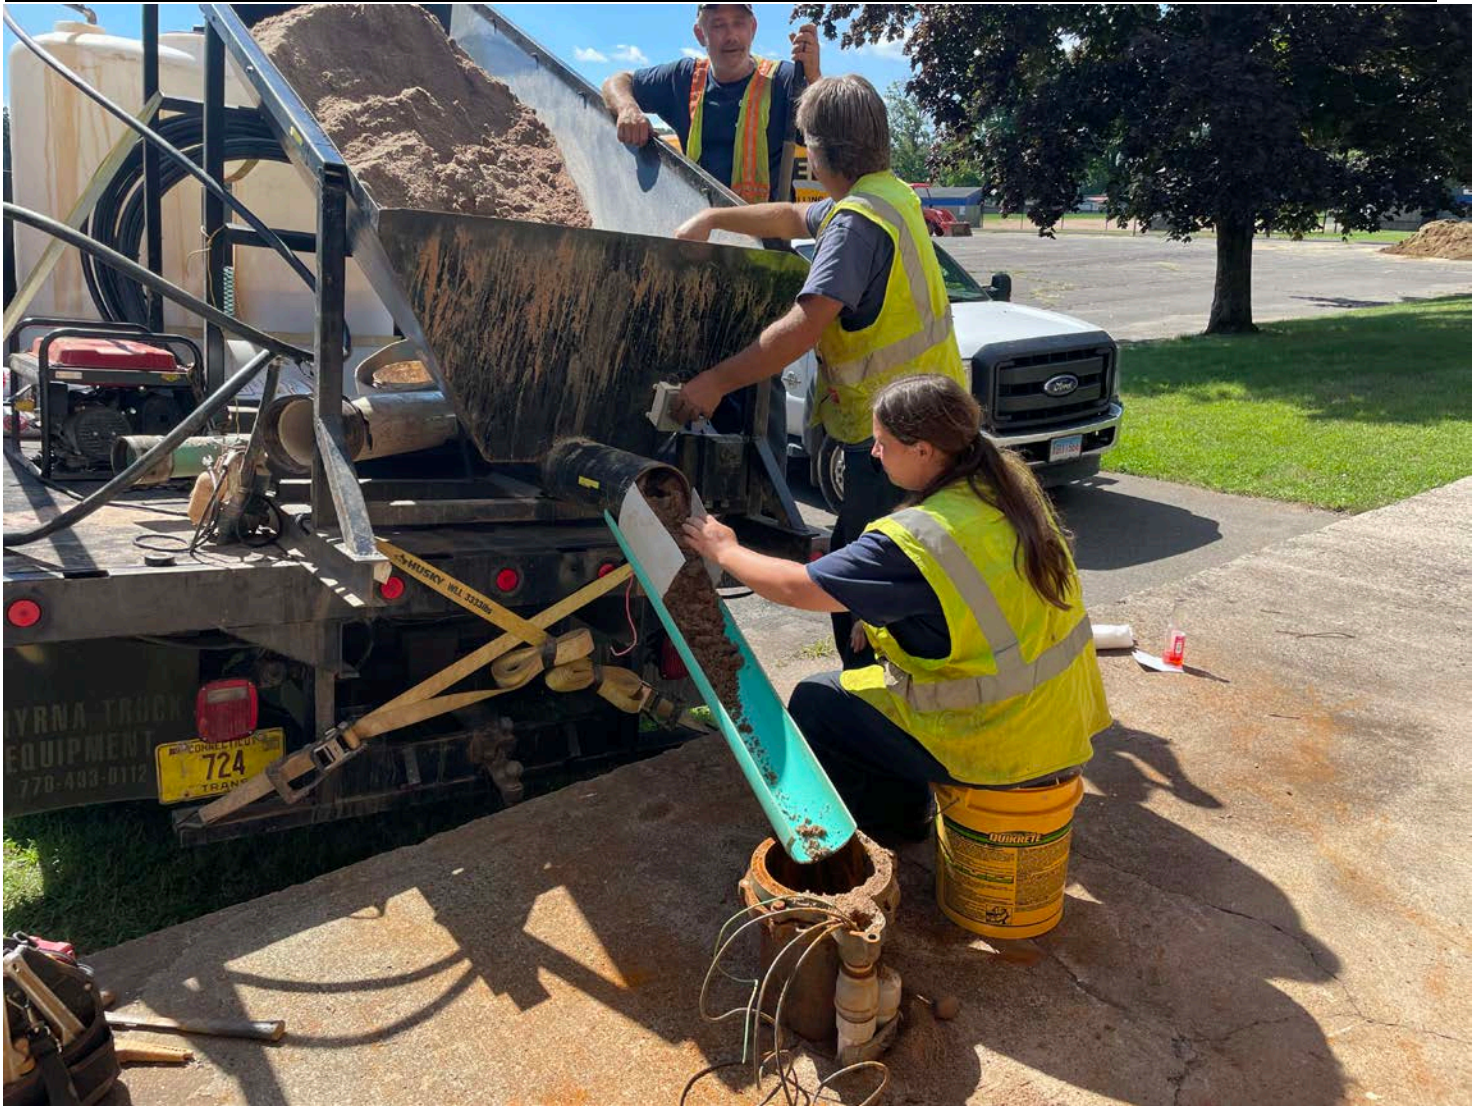
Picture 8: Grela placing sand into the well located on the south side of the Korn School located on Pickett Lane as part of well decommissioning activities. View to the southwest.

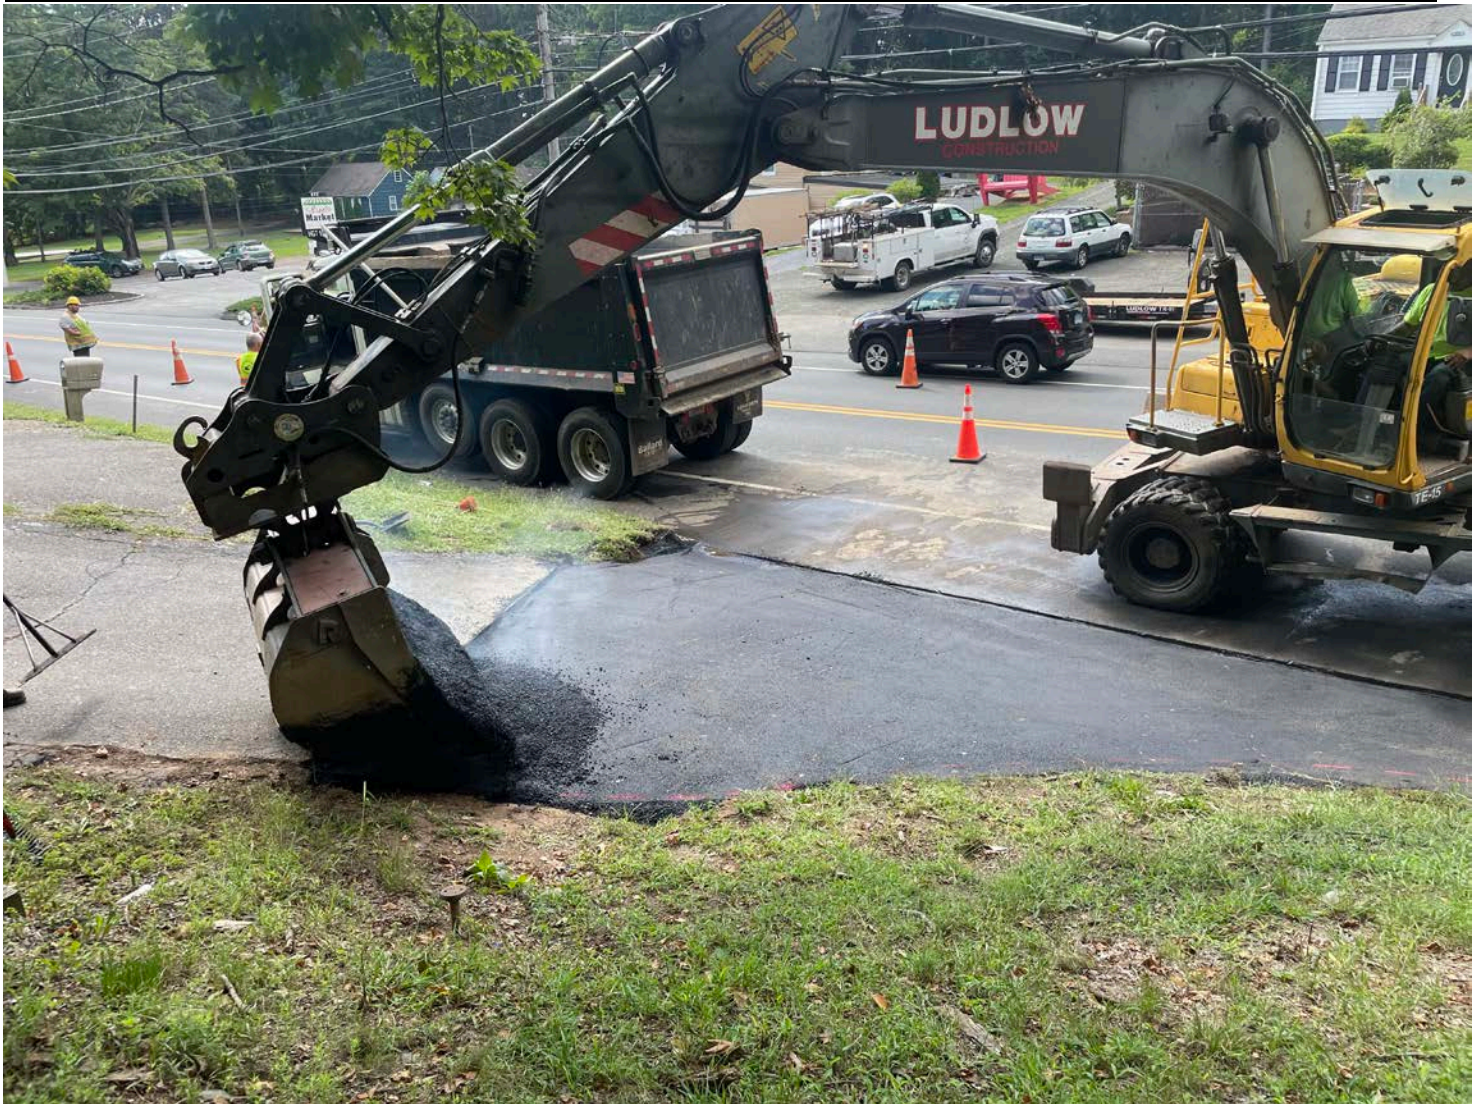
Picture 9: Ludlow placing a second lift of asphalt onto the footprint of the driveway apron at the 475 Main Street, Durham, property. View to the southwest.

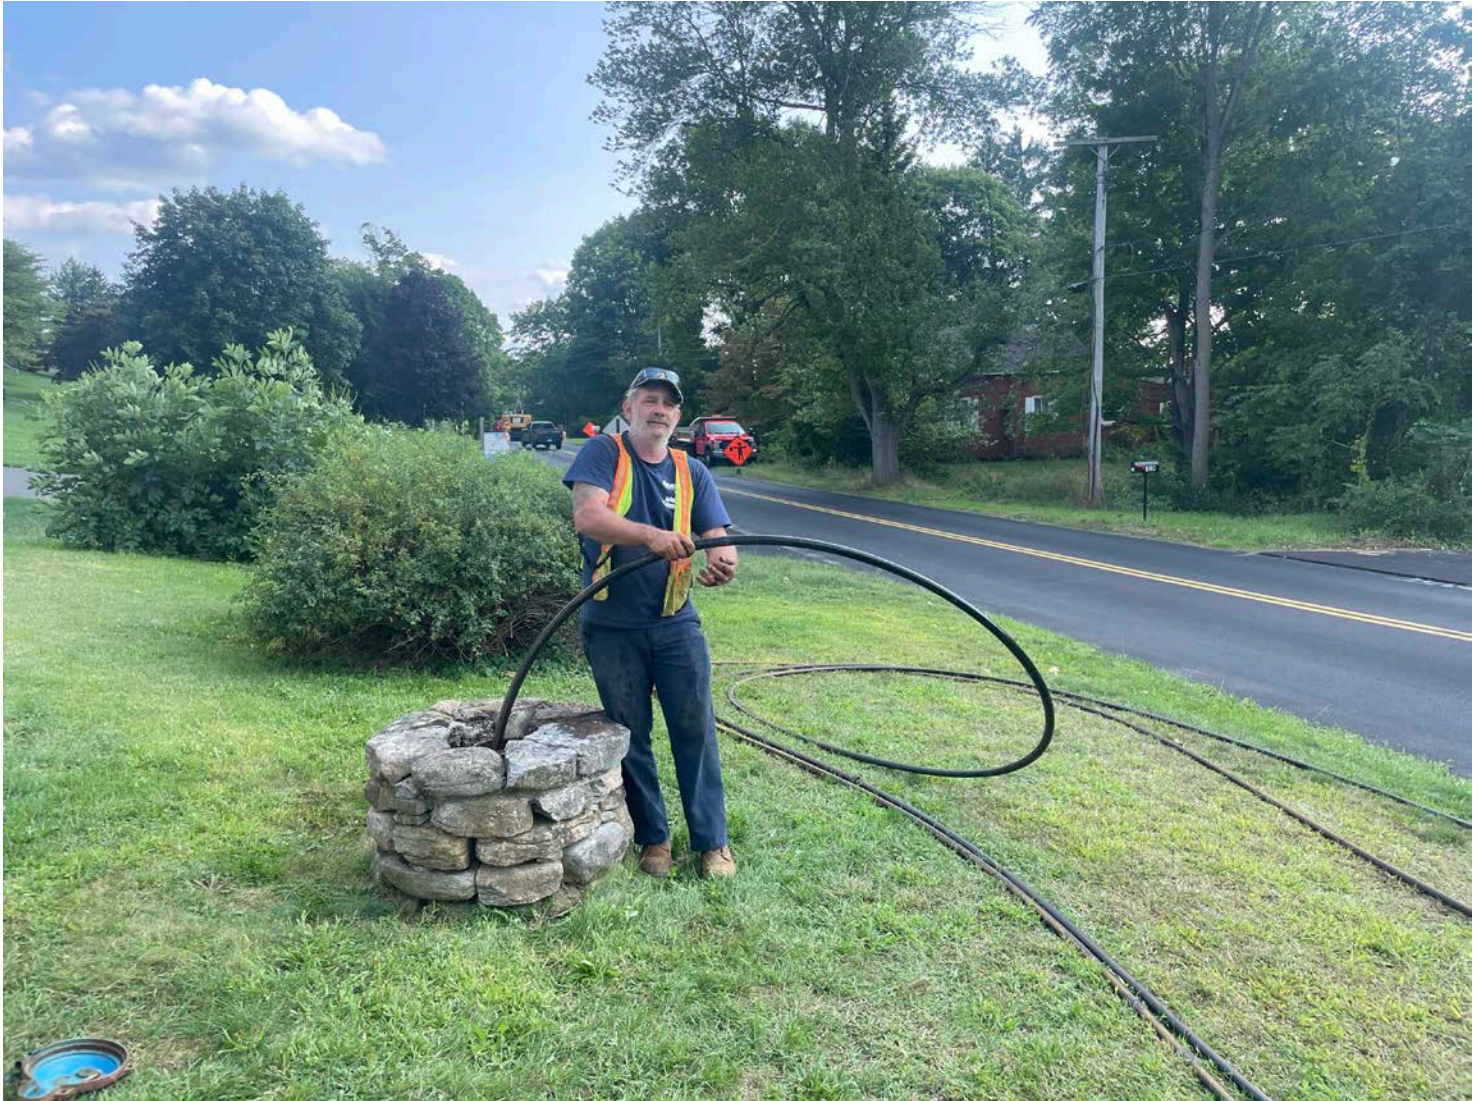
**Picture 10: Grela pulling the pump from the well located on the west side of the 133 Maple Avenue, Durham, residence. View to the south.**
