Daily Report

Project:	Durham Meadows Pipeline Installation	Date:	October 6, 2022
Location:	Pickett Lane, Durham	Day of Week:	Thursday
Project #:	AECOM: 6061487	Report No:	524
Contractor:	Ludlow Construction	Page:	1 of 18

Daily Activities – installation of catch basin and manhole, Pickett Lane, Durham

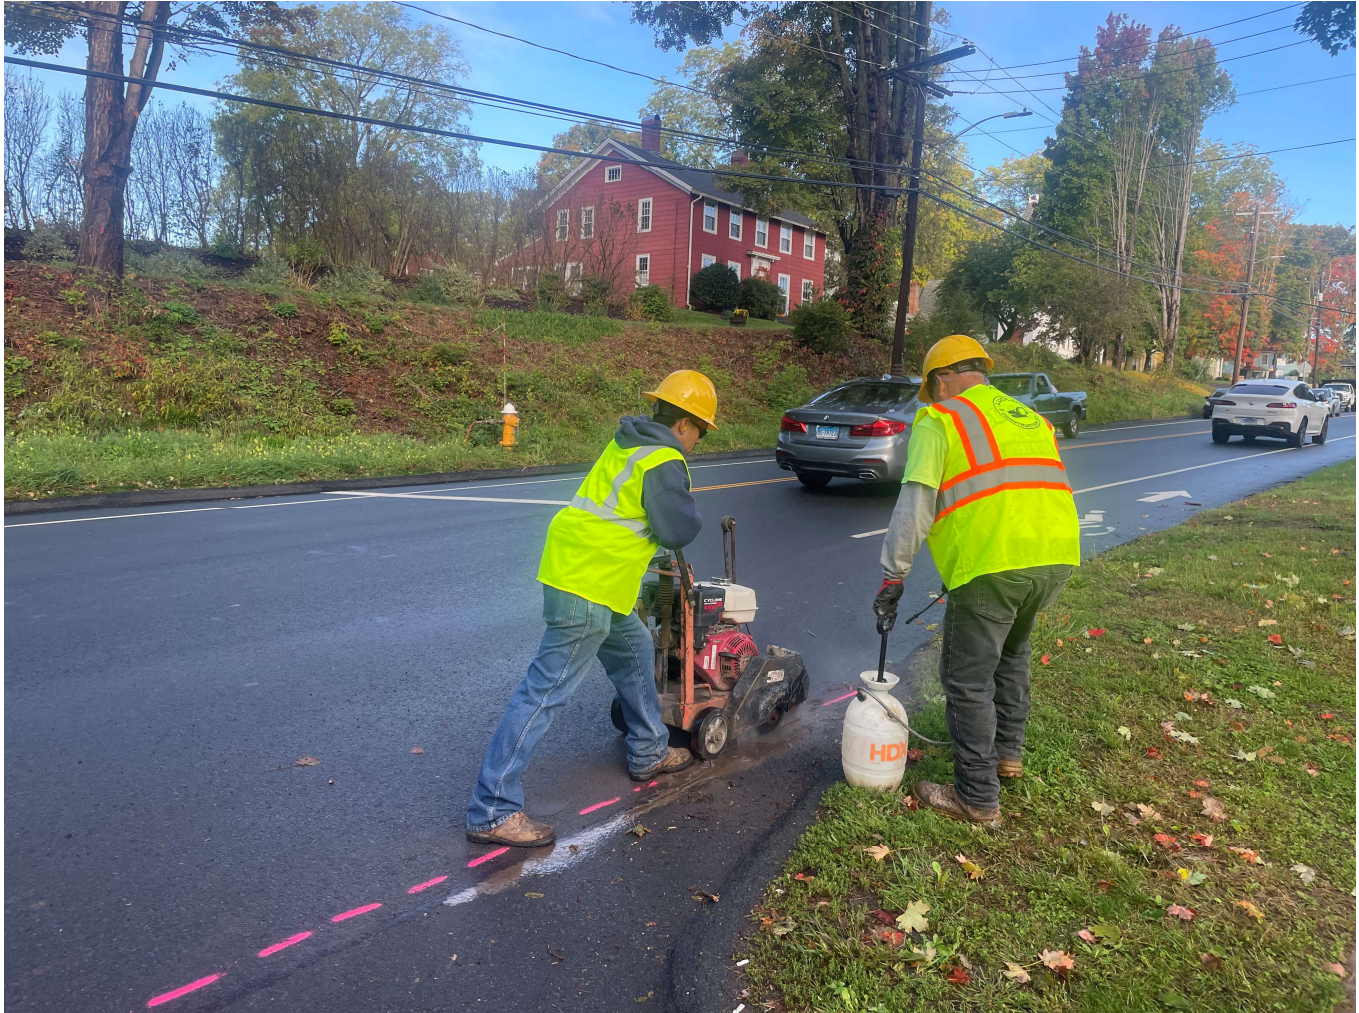
Picture 1: Ludlow saw cutting the pavement where Pickett Lane intersects with Main Street in Durham in preparation of upcoming road repair/repaving activities on Pickett Lane. View to the northwest.

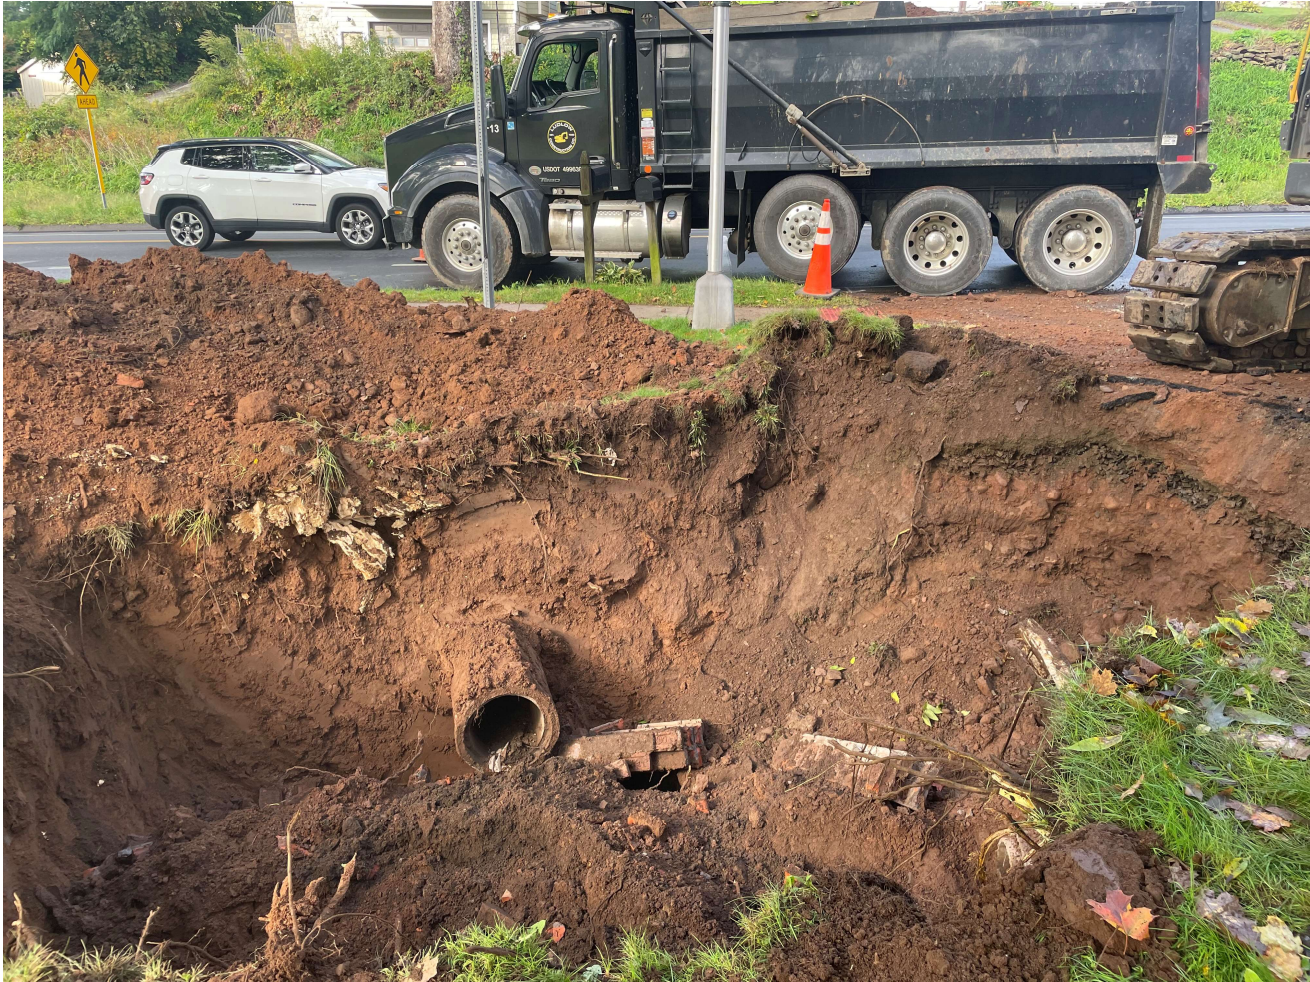
Picture 2: Excavation that Ludlow has begun on the northwest corner of the 177R Main Street property where they will be installing a manhole. View to the northwest.

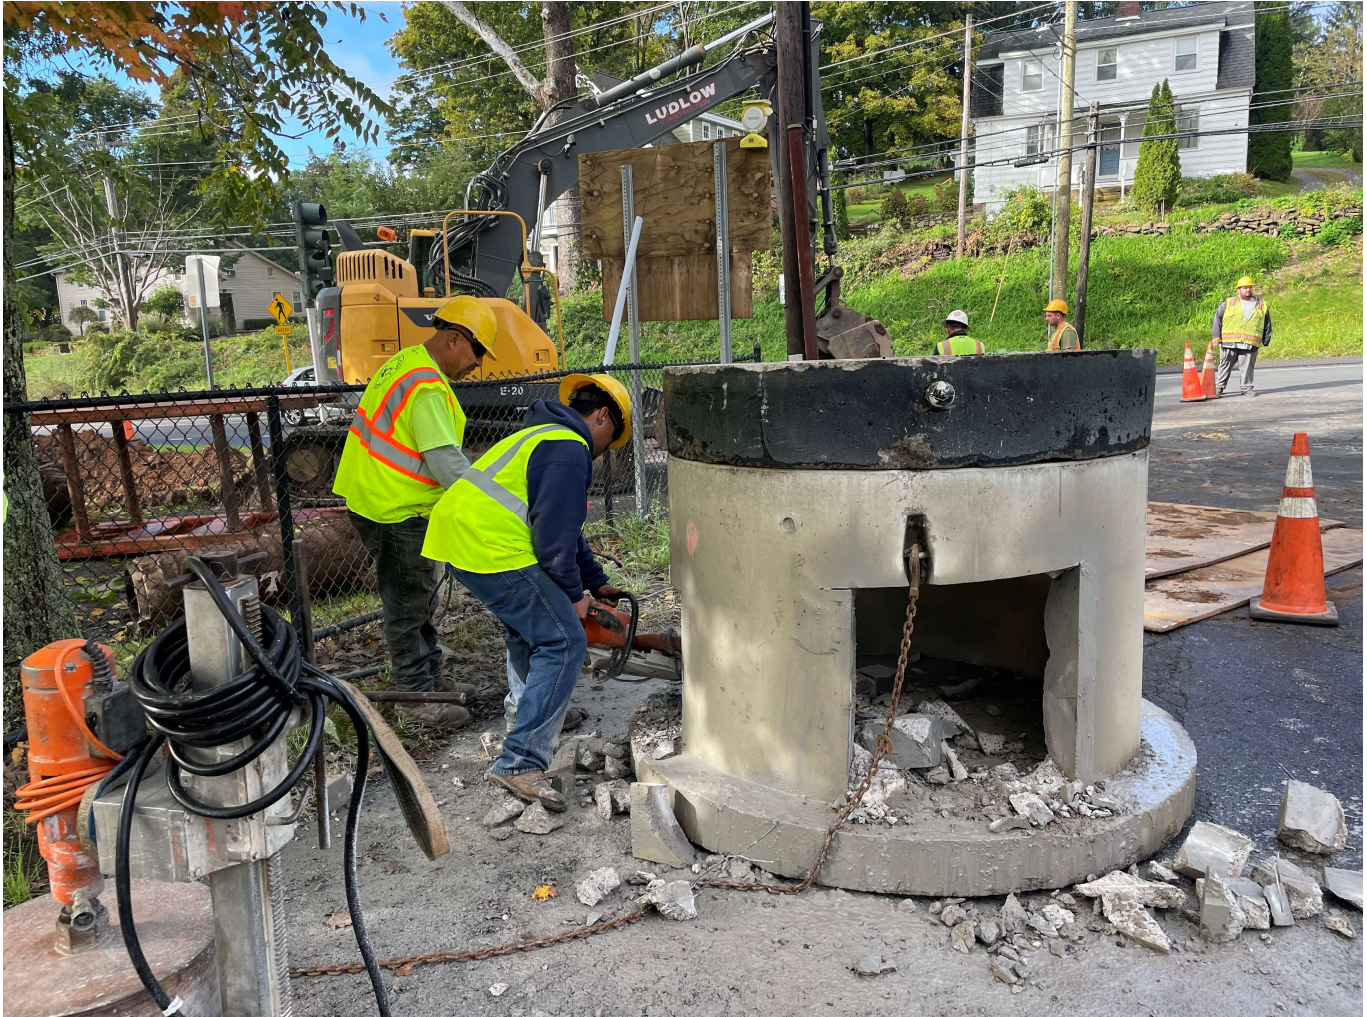
Picture 3: Ludlow using a cutoff saw to enlarge the openings in the side of the catch basin they plan to install on the northwest corner of the 177R Main Street property.

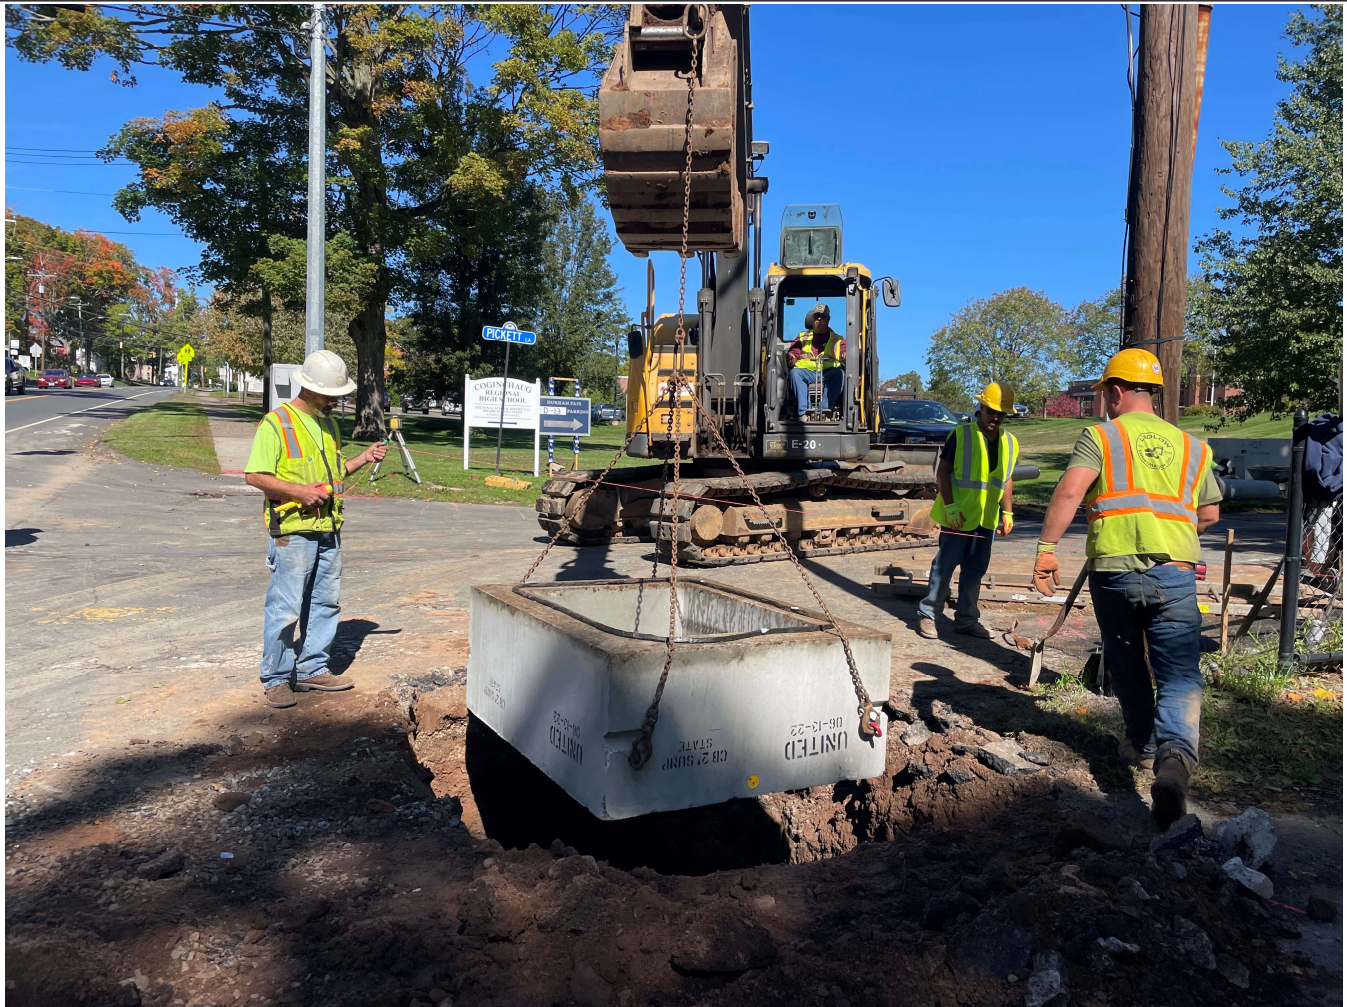
Picture 4: Ludlow setting the base of a catch basin into the excavation they made on the southeast corner of the intersection of Pickett Lane and Main Street, Durham. View to the north.

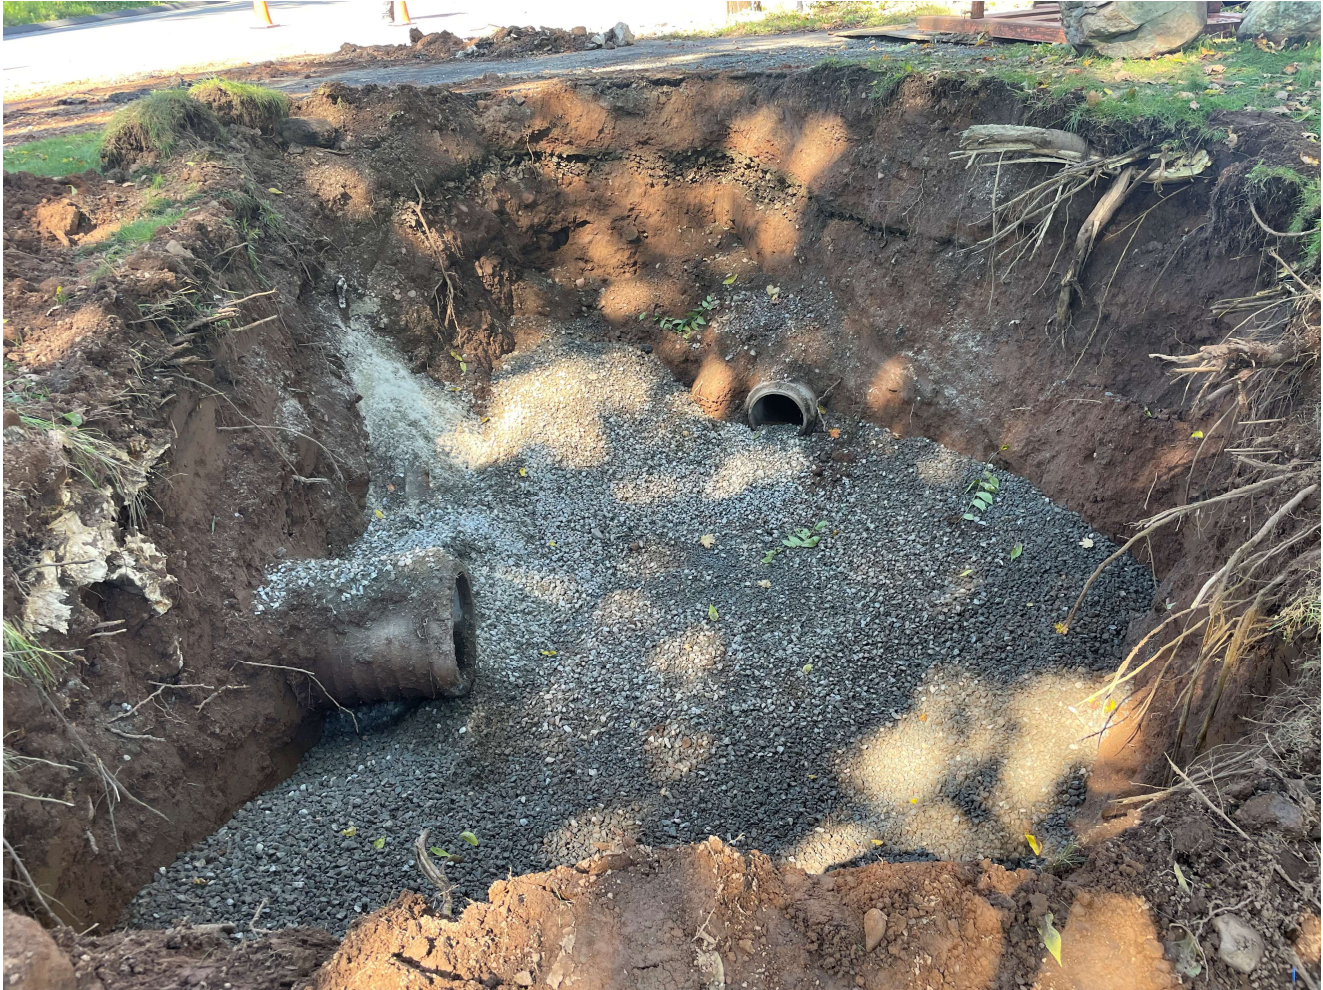
Picture 5: The excavation that Ludlow made on the northwest corner of the 177R Main Street property where they have daylighted two existing sections of 15" RCP. Ludlow has also placed ¾" stone on the bottom of the excavation. View to the northwest.

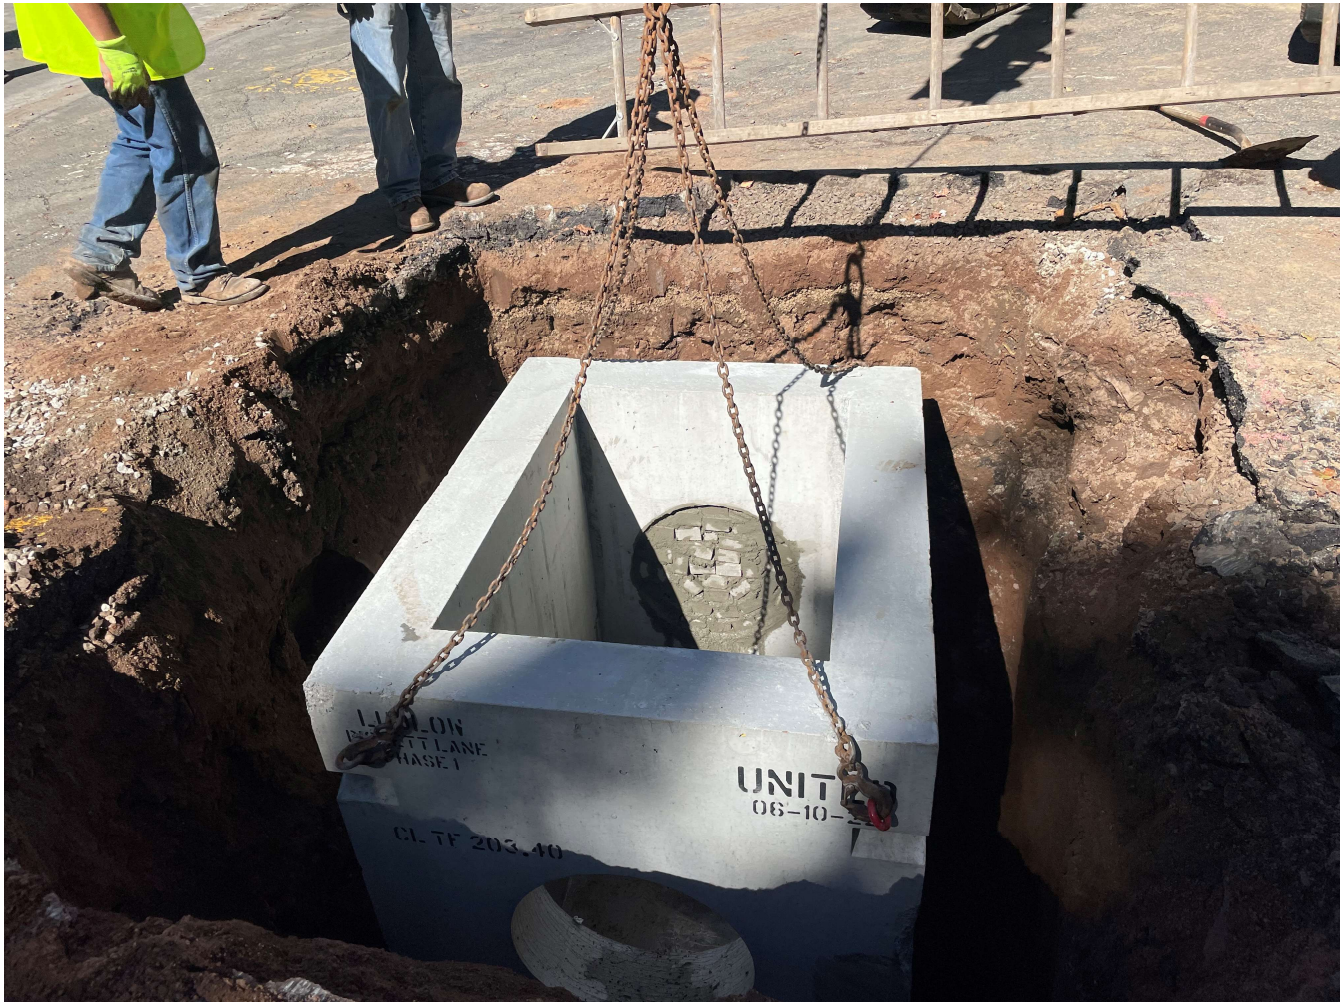
Picture 6: Ludlow setting the base of a catch basin at the southeast corner of the intersection of Pickett Lane and Main Street in Durham. View to the north.

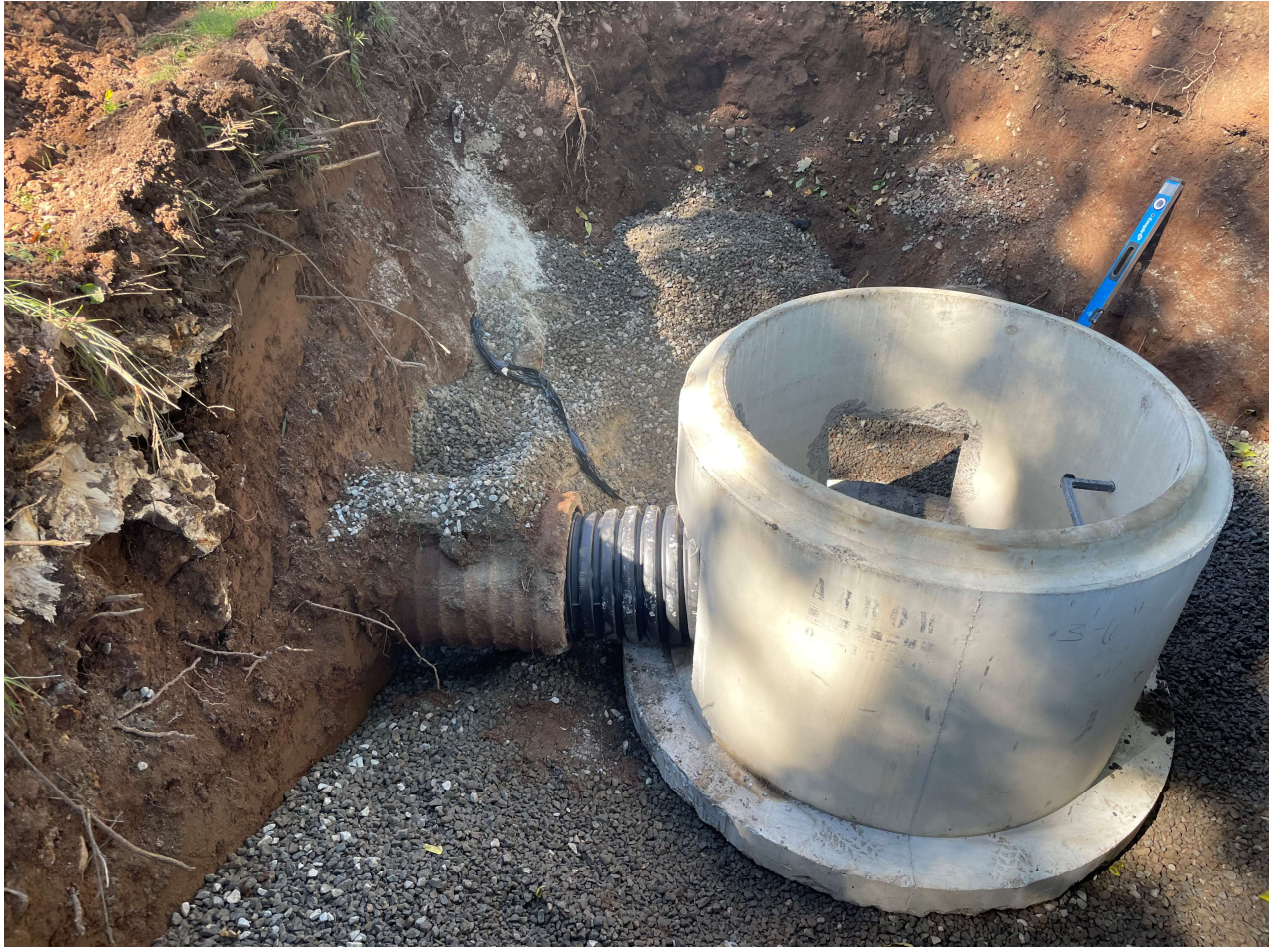
Picture 7: The base of the manhole that Ludlow placed into the excavation they made at the northeast corner of the 177R Main Street property. Ludlow has begun to connect the manhole to a section of existing 15" RCP located on the southwest side of the manhole with 15" black corrugated CPEP. View to the northwest.

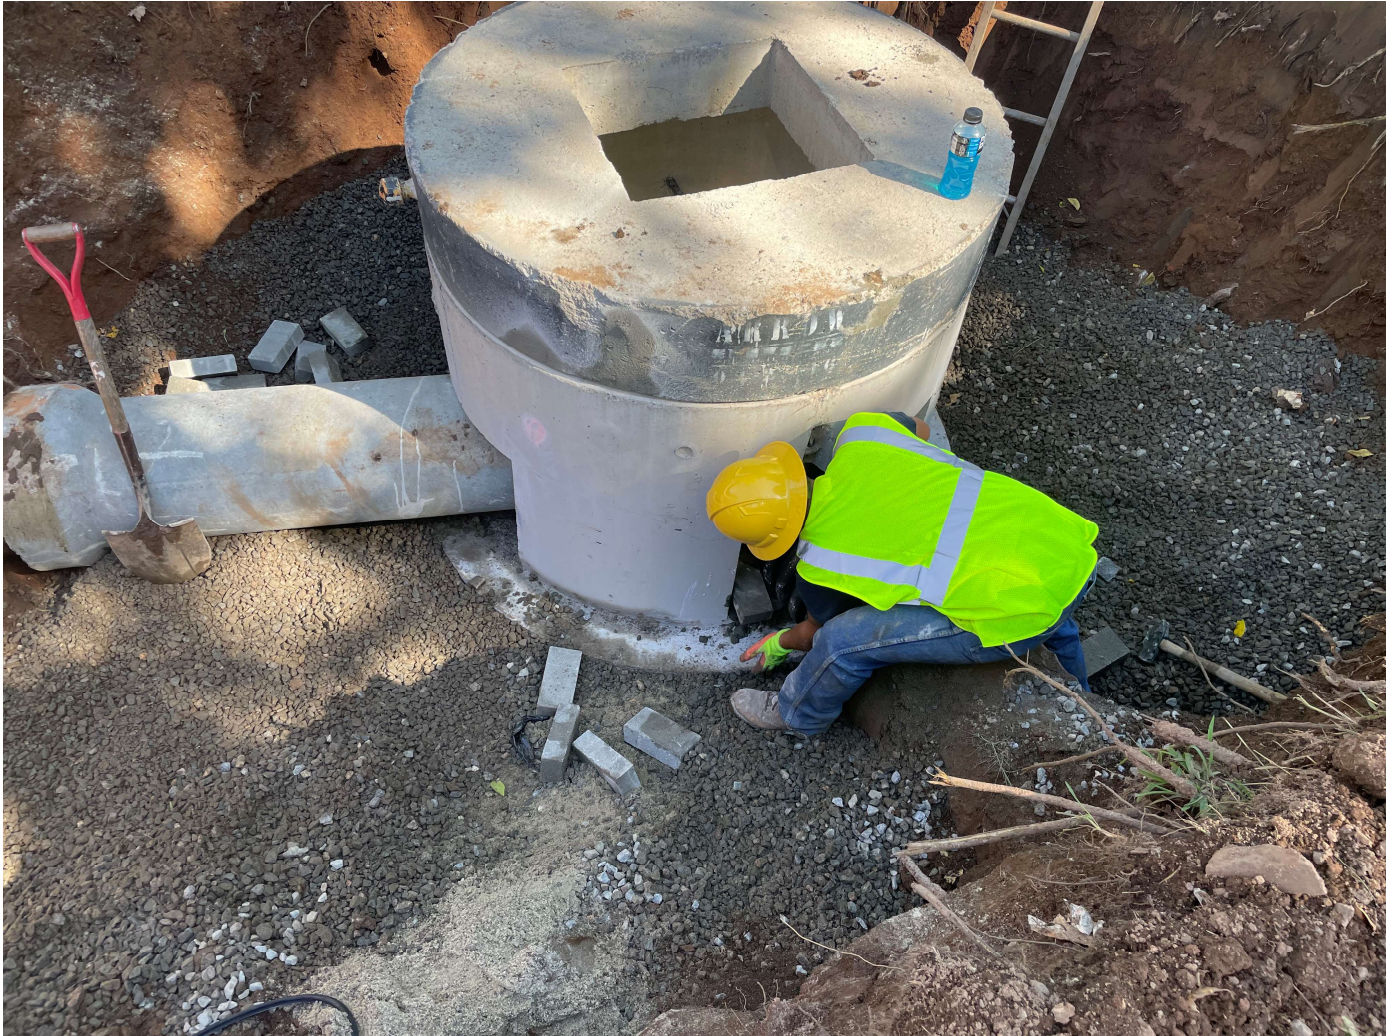
Picture 8: Ludlow placing brick and cement around the section 15" black corrugated CPEP they just installed on the southwest side of the manhole they just placed at the northwest corner of the 177R Main Street property. View to the southeast.

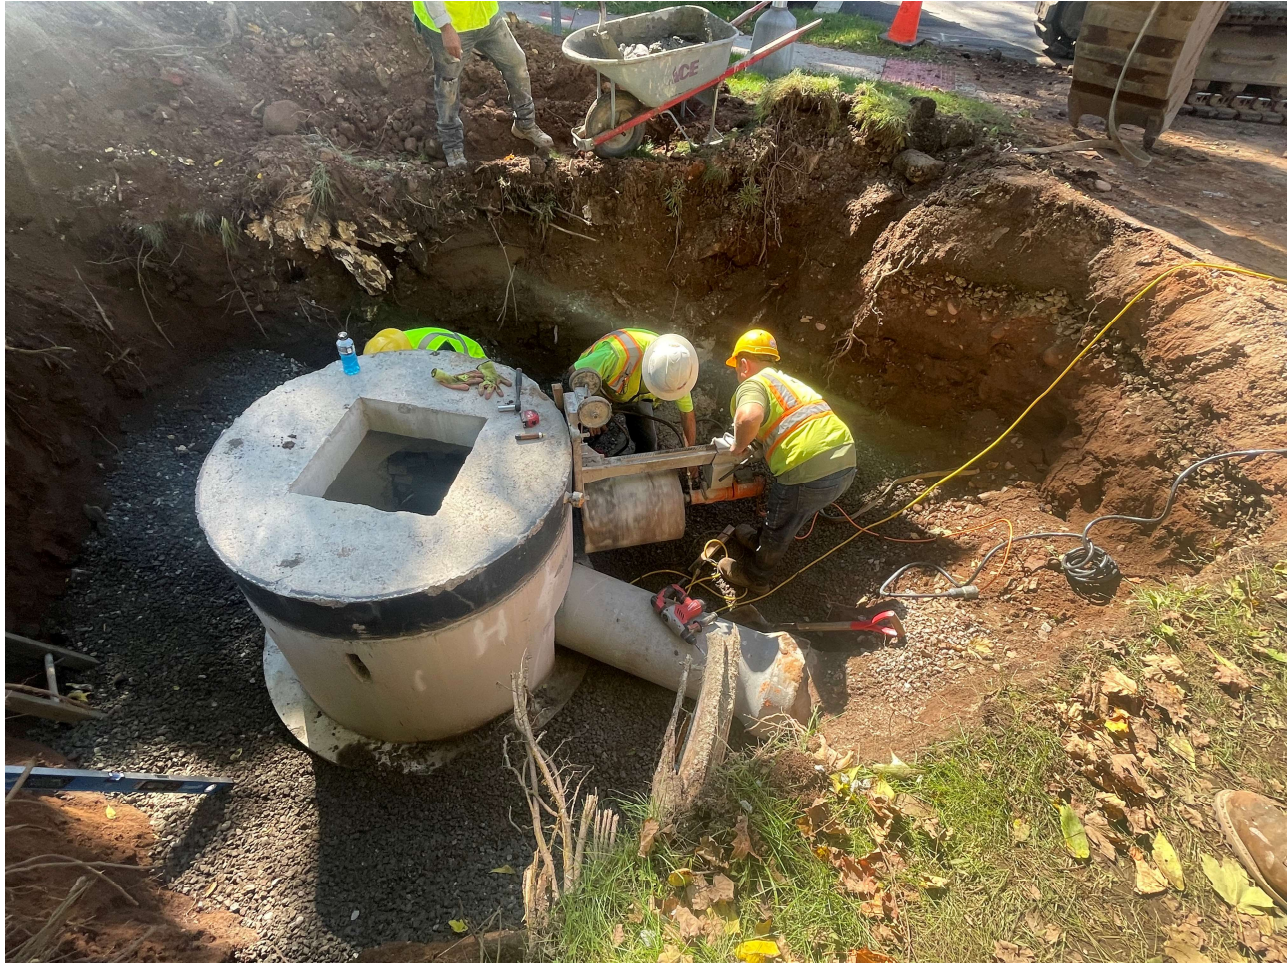
Picture 9: Ludlow coring a hole into the north side of the manhole they just installed on the northwest corner of the 177R Main Street, Durham, property. View to the northwest.

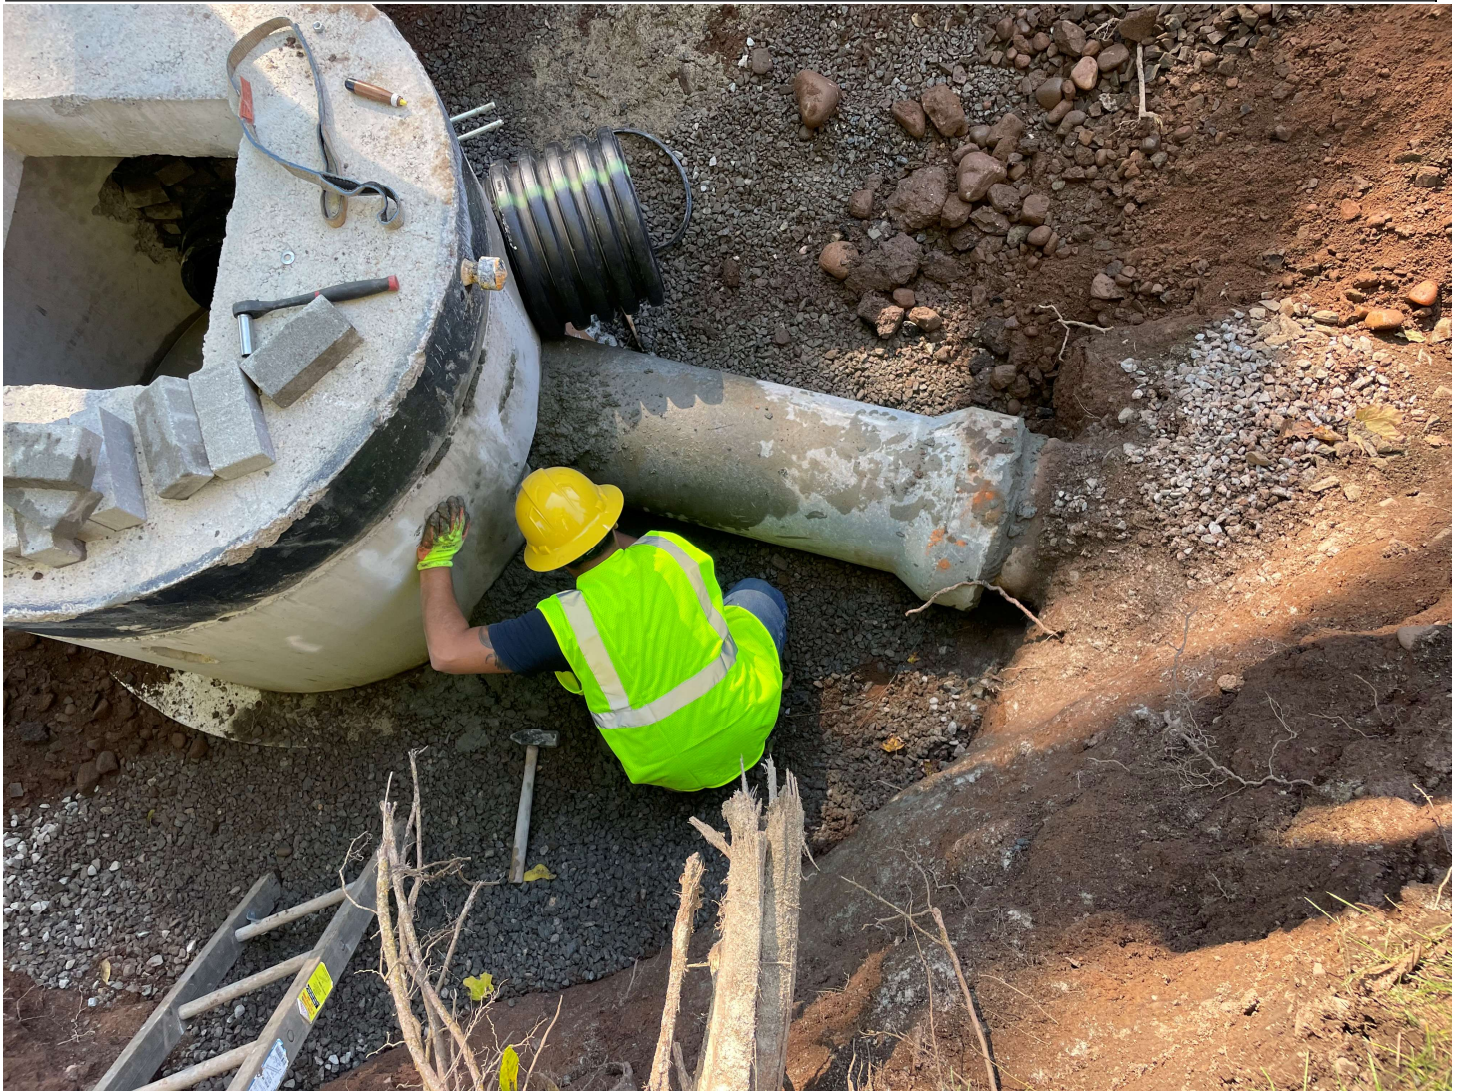
Picture 10: Ludlow placing brick and cement on the north side of the manhole they installed on the northwest corner of the 177R Main Street, Durham, property to secure a new section of 15" RCP that connects to existing 15" RCP coming into the excavation from the northeast. View to the northwest.

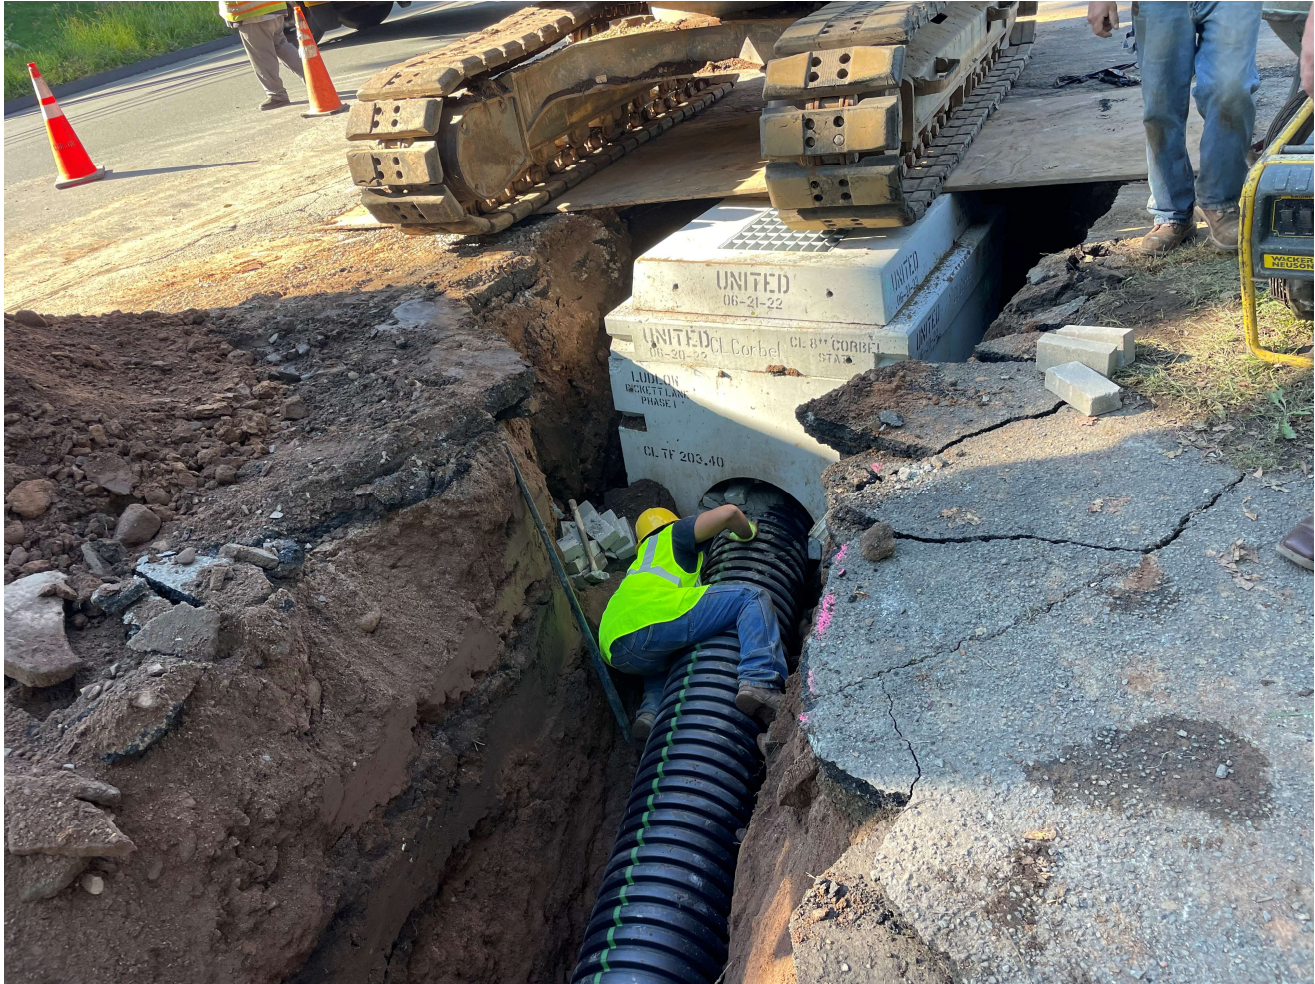
Picture 11: Ludlow placing brick and cement around 15" CPEP that they ran from the manhole they installed on the 177R Main Street property to the catch basin they installed on the southeast corner of the intersection of Pickett Lane and Main Street. View to the north.

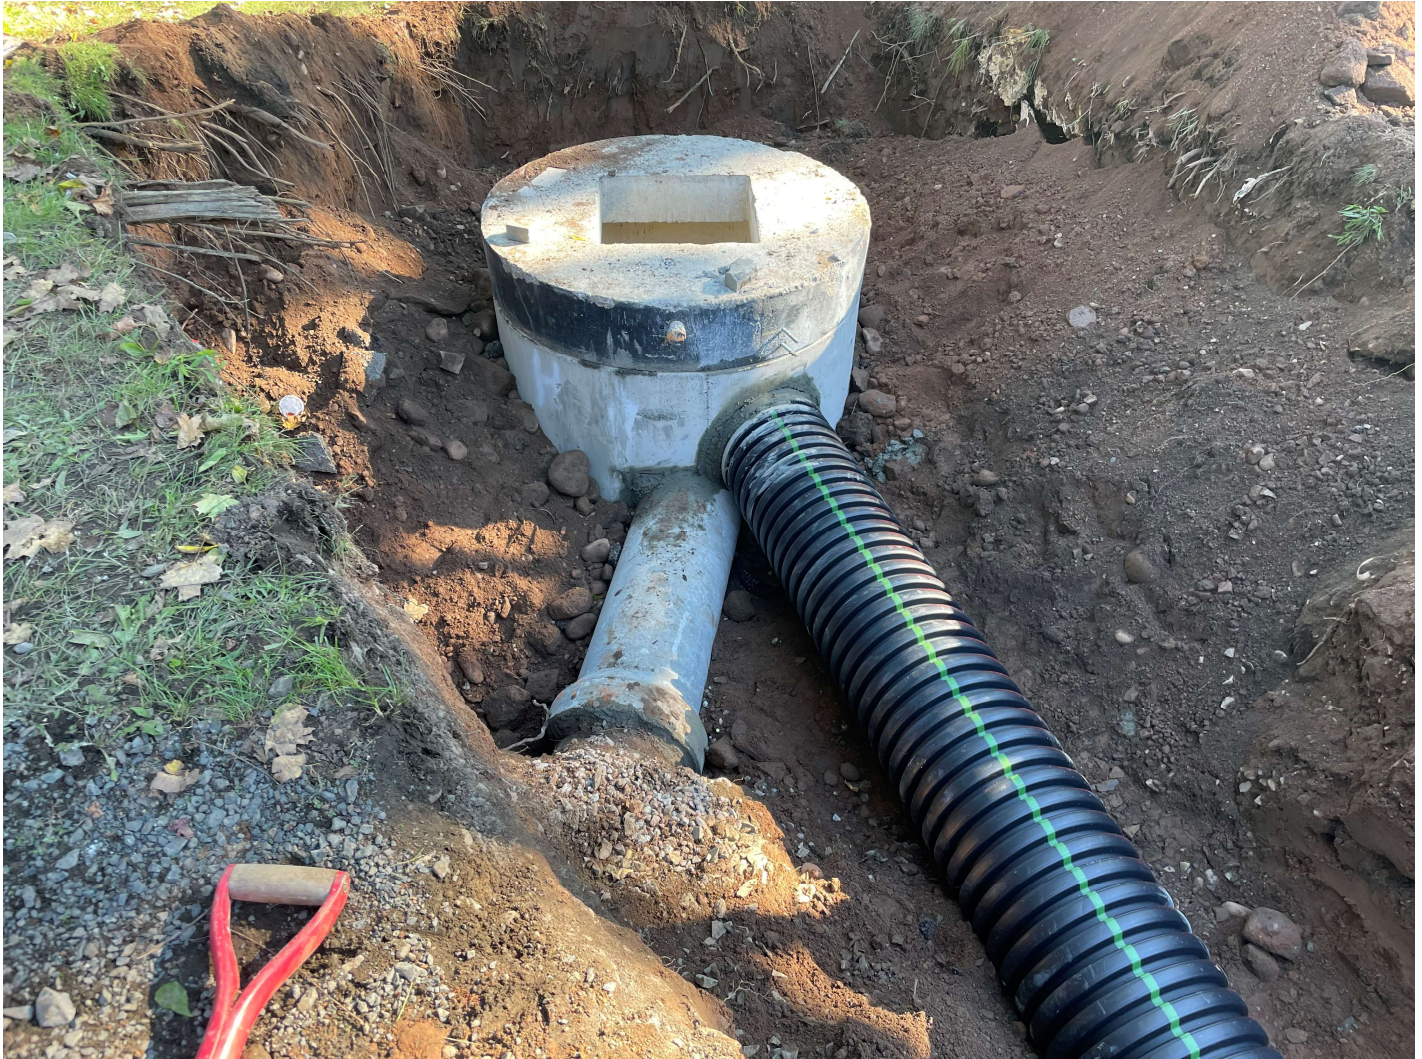
Picture 12: View of the 15" RCP and CPEP that Ludlow secured with brick and cement on the north side of the manhole they installed on the 177R Main Street property. View to the south.

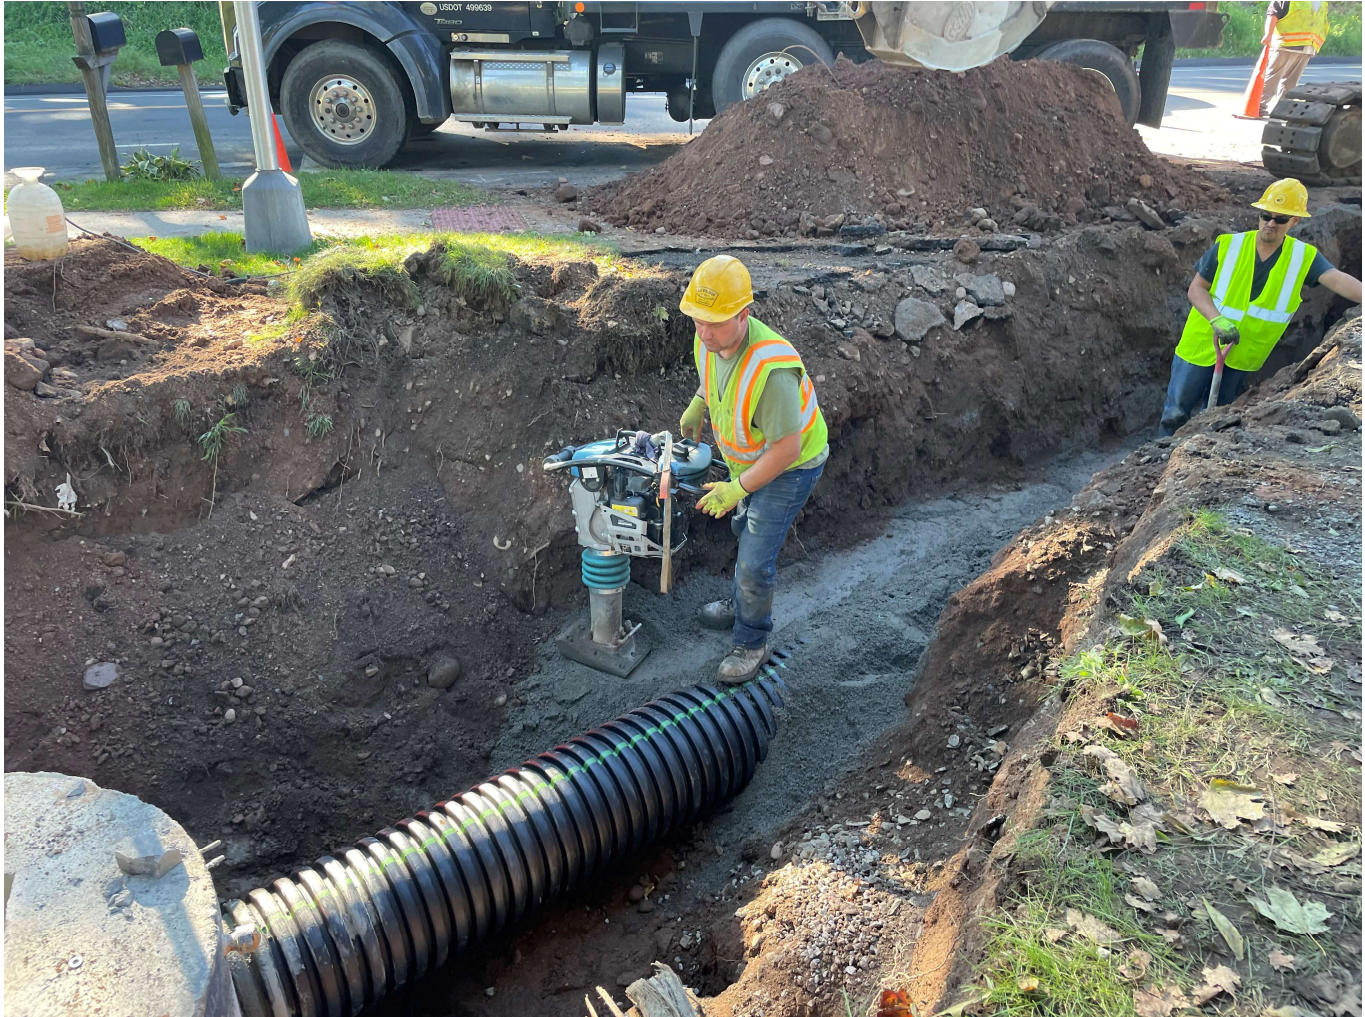
Picture 13: Ludlow using a jumping jack to compact the sand they are placing around the 15" CPEP they installed between the manhole on the 177R Main Street property and the catch basin they installed on the southeast corner of Pickett Lane and Main Street, Durham. View to the northwest.

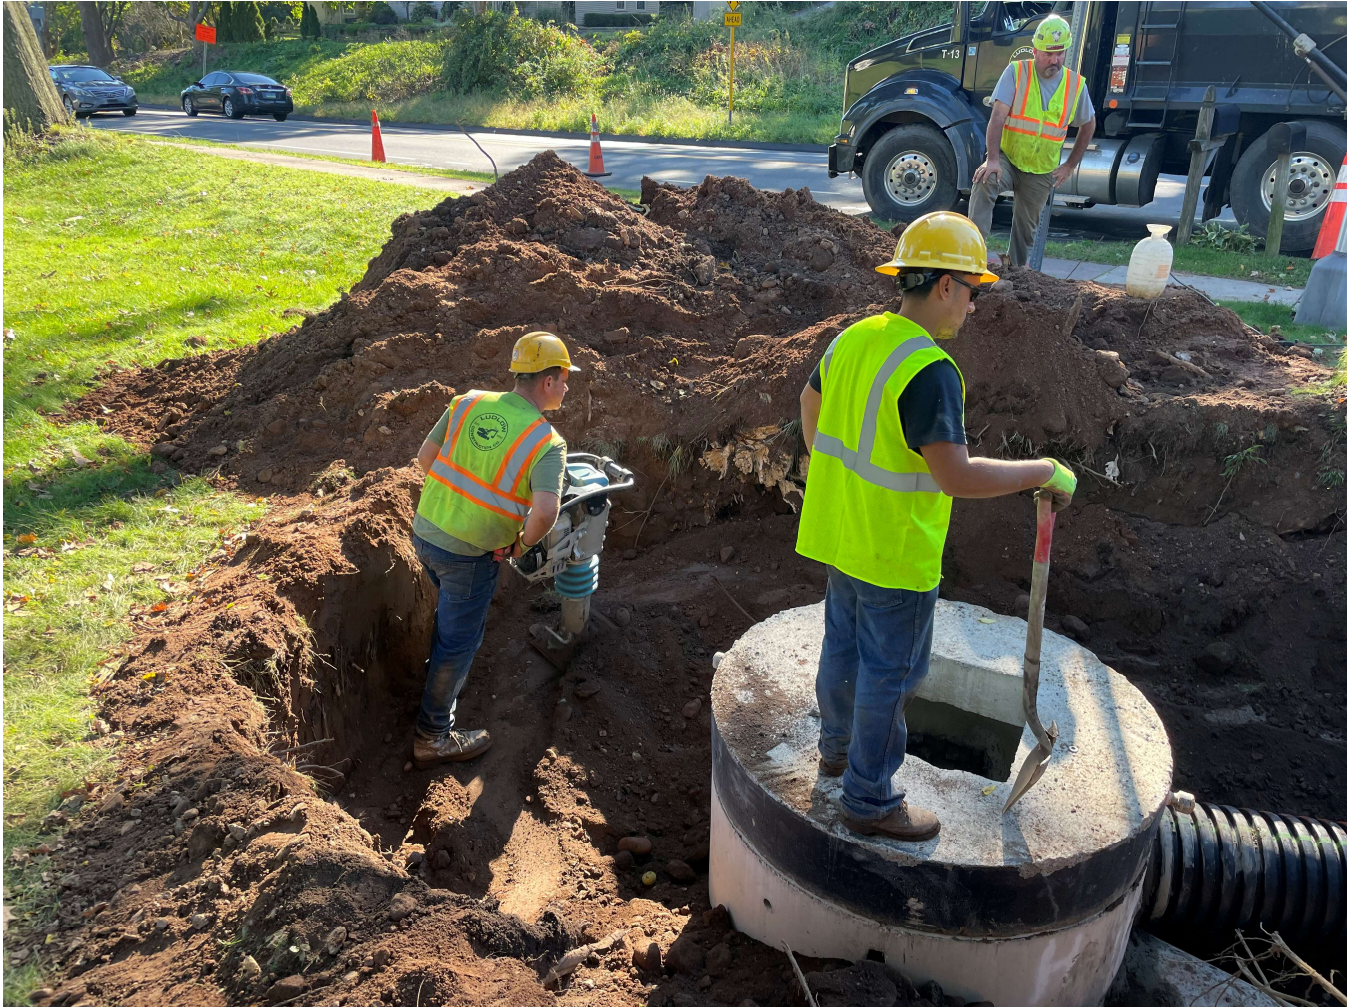
Picture 14: Ludlow compacting backfill they placed around the manhole they installed today on the northwest corner of the 177R Main Street, Durham, property. View to the west.

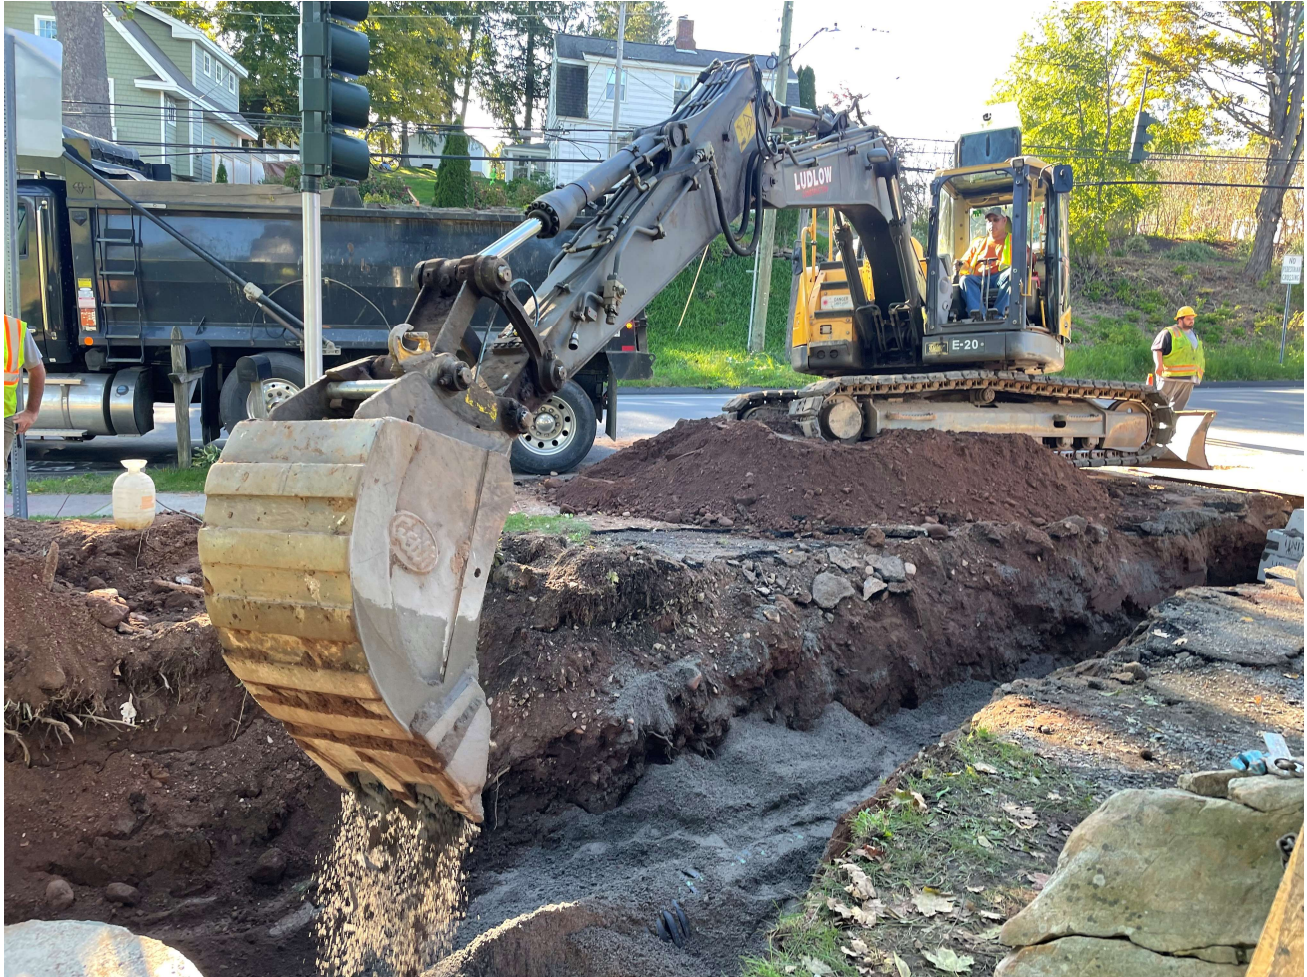
Picture 15: Ludlow placing sand over the 15" CPEP they installed between the manhole on the 177R Main Street property and the catch basin they installed on the southeast corner of Pickett Lane and Main Street, Durham. View to the northwest.
