#### **Daily Report**

Project: October 27, 2022 **Durham Meadows Pipeline Installation** Date: Day of Week: Thursday Location: Maiden Lane and Maple Avenue, Durham

**Report No:** 538 Project #: AECOM: 6061487 Page: 1 of 8

**Contractor: Ludlow Construction**

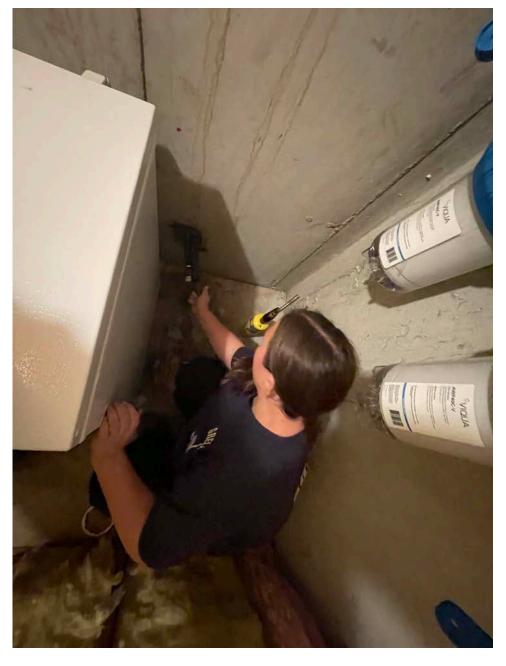
Picture 1: Grela installing a plug into the HDPE well line that enters the north side of the 228 Maple Avenue, Durham, residence. View to the north.

0928: Grela is placing a plastic plug into the HDPE well line that enters the north foundation of the 228R Maple Avenue residence as part of well decommissioning activities.

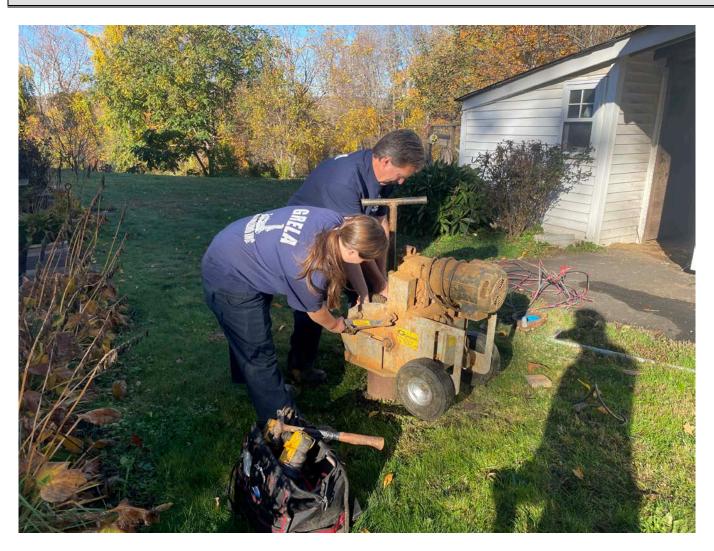
Picture 2: Grela setting up a pump puller on the well located on the northeast corner of the 228 Maple Avenue residence. View to the northwest.

0944: Grela is pulling the pump from the well located on the northeast corner of the 228R Maple Avenue residence.

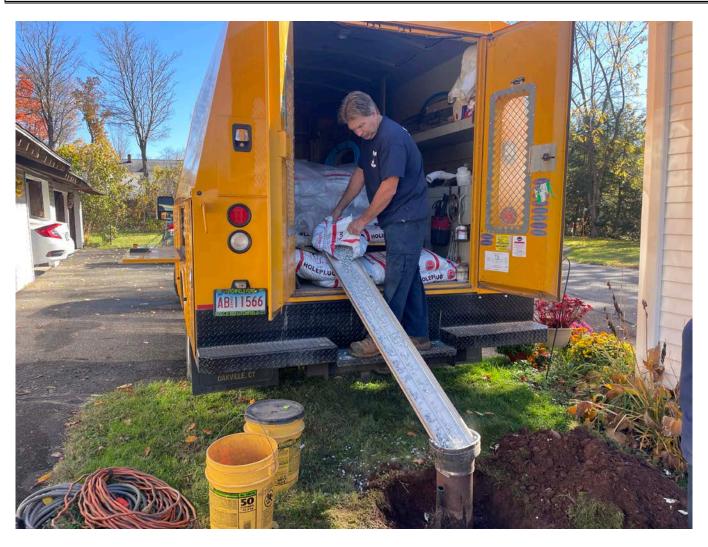
Picture 3: Grela placing bentonite chips into the well located on the northeast corner of the 228 Maple Avenue, Durham, residence. View to the east.

1037: Grela has begun placing coated bentonite chips into the well located at the 228R Maple Avenue property as part of well decommissioning activities. Grela is only using bentonite chips to decommission this well.

1109: Grela has finished decommissioning the well located at the 228R Maple Avenue property. Grela has also cut the well's steel riser below grade and has backfilled over the riser after they placed a cap on it.

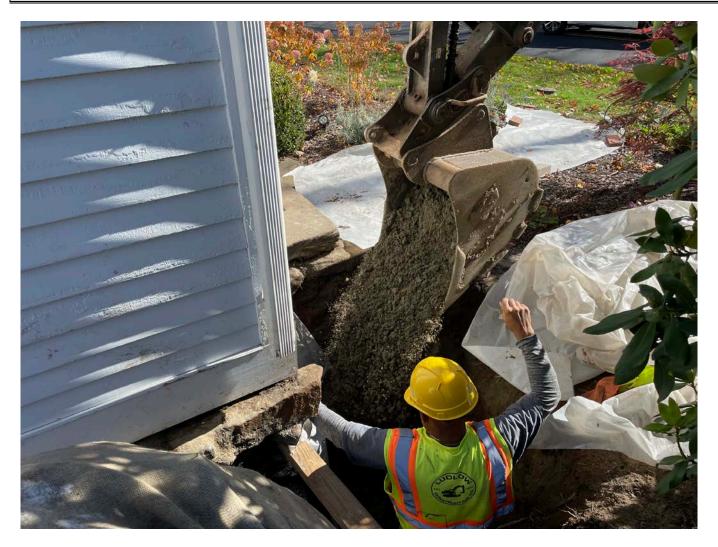
Picture 4: Ludlow placing 1.25" processed gravel around the southwest corner of the 24 Maiden Lane, Durham, residence. View to the south.

1210: Ludlow is backfilling around the southwest corner of the 24 Maiden Lane residence foundation with 1.25" processed gravel.

1238: Ludlow continues to backfill around the southwest corner of the 24 Maiden Lane residence foundation with 1.25" processed gravel.

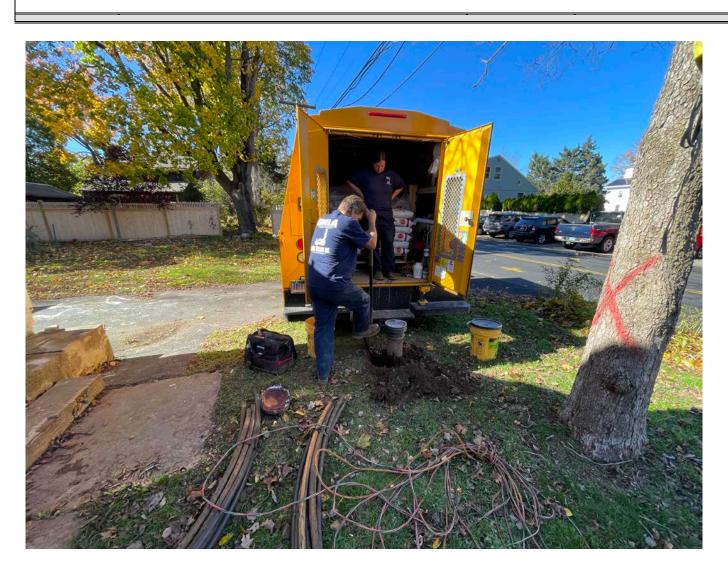
Picture 5: Grela hand excavating around the steel riser of the well located on the north side of the 11 Maiden Lane, Durham, residence in order to cut it below grade. View to the northwest.

1358: Grela has finished decommissioning the well located on the 11 Maiden Lane property. The well riser has been cut below grade and has been capped. Grela backfilled the hole left behind after the cut the well riser below grade.

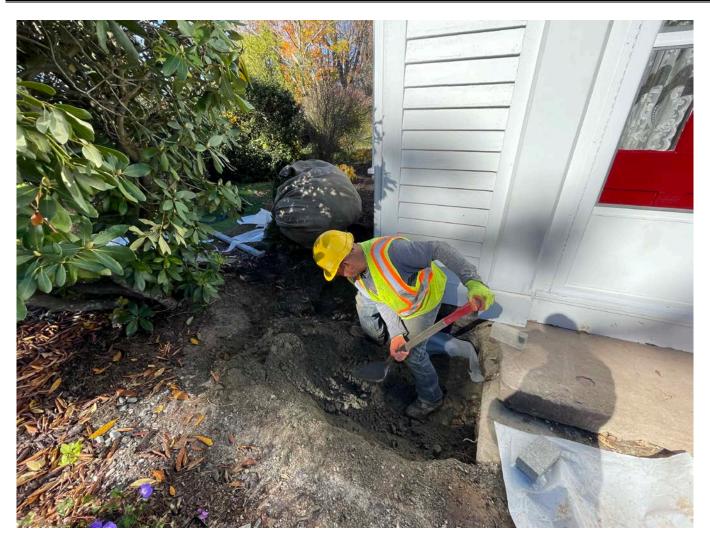
Picture 6: Ludlow placing 1.25" processed gravel around the southwest corner of the 24 Maiden Lane, Durham, residence. View to the northwest.

1417: Ludlow continues to place 1.25" processed gravel on the southwest corner of the foundation of the 24 Maiden Lane residence.
