Daily Report

Project:	Durham Meadows Pipeline Installation	Date:	November 23, 2022
Location:	Pickett Lane and Main Street, Durham	Day of Week:	Wednesday
Project #:	AECOM: 6061487	Report No:	553
Contractor:	Ludlow Construction	Page:	1 of 15

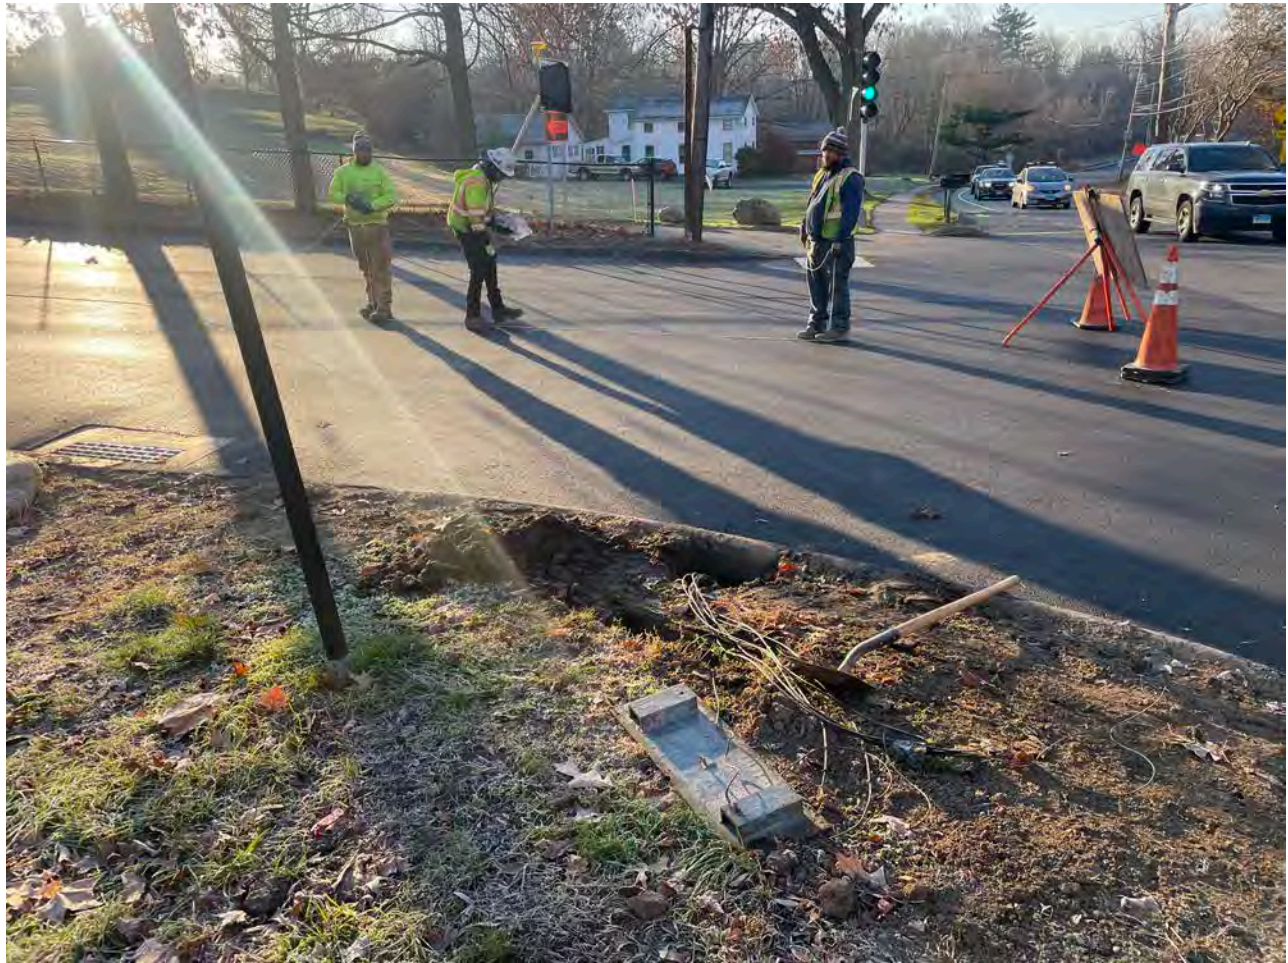
Picture 1: K.T.M laying out the locations of traffic loops on Pickett Lane between Stations 10+00 and ~10+50. View to the south.

0806: K.T.M. is currently laying out traffic loop placement on Pickett Lane.

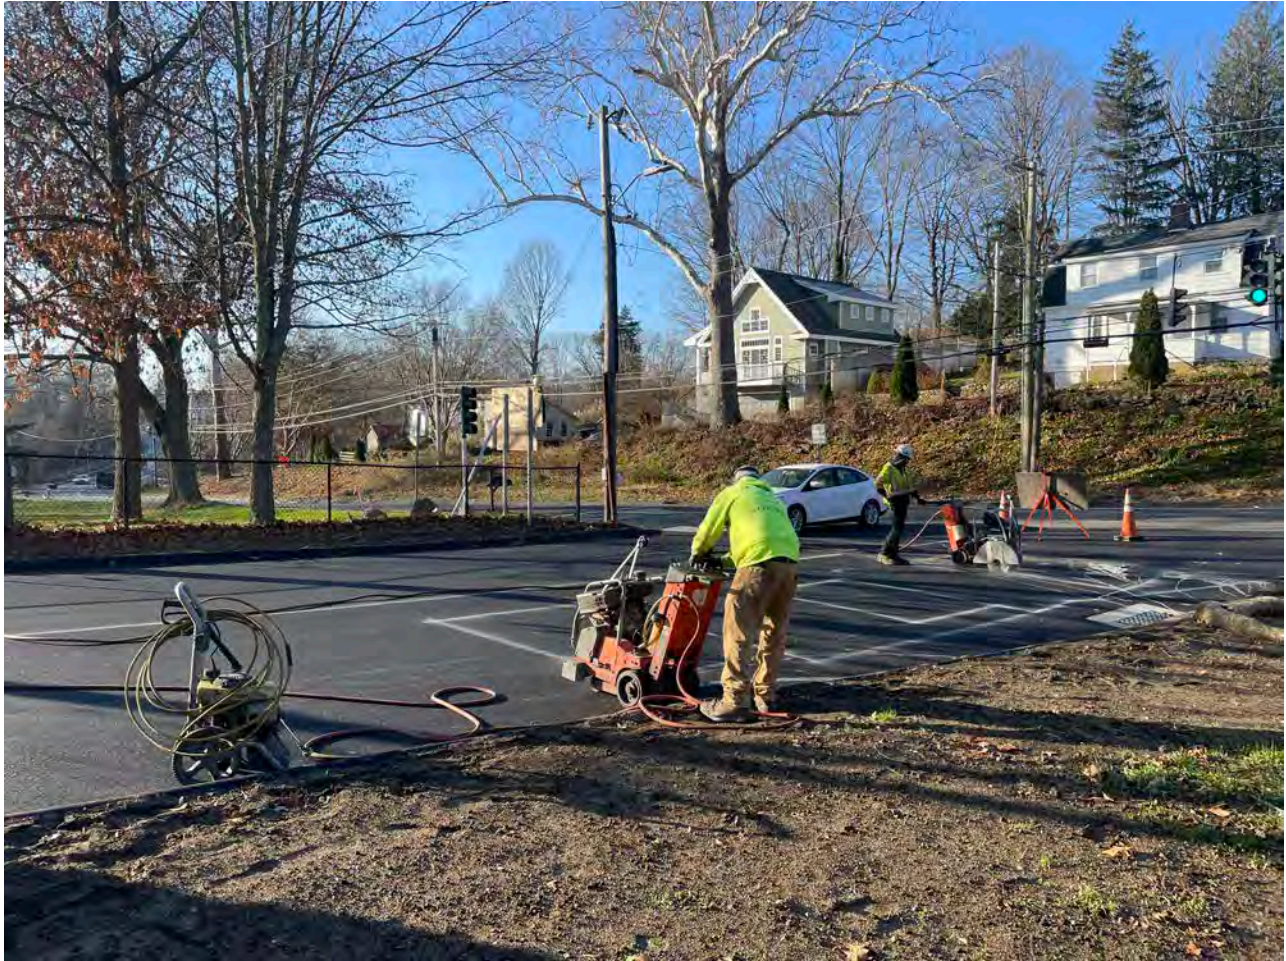
Picture 2: K.T.M saw-cutting pavement on the westbound lane of Pickett Lane for the installation of traffic loops between Stations 10+00 and ~10+50. View to the southwest.

0851: K.T.M. has begun saw-cutting pavement on Pickett Lane as part of installing traffic loops between Stations 10+00 and ~10+50.

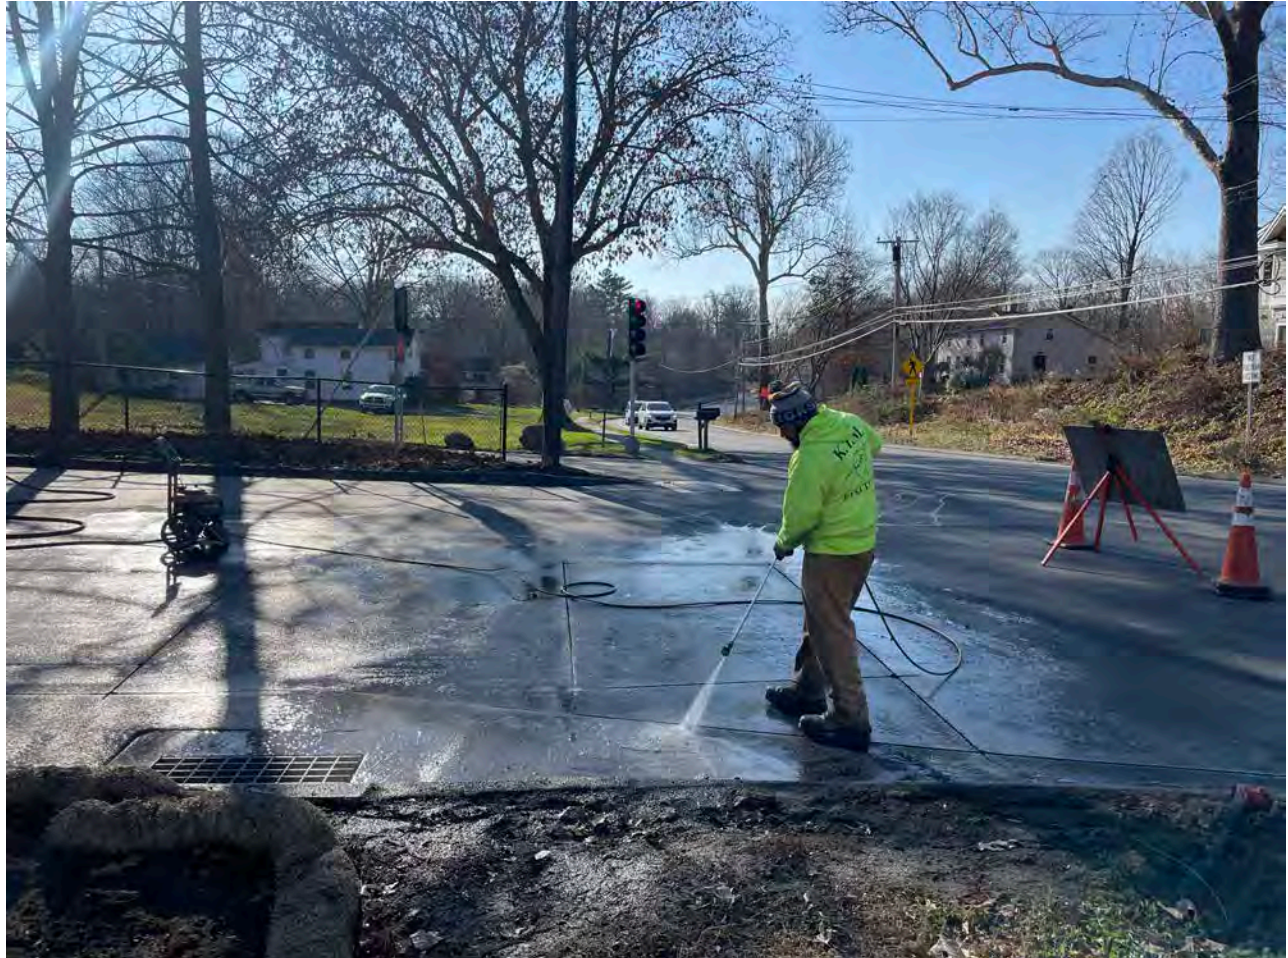
Picture 3: K.T.M using pressurized water to clean out the cuts they made in the pavement on Pickett Lane for the installation of traffic loops between Stations 10+00 and ~10+50. View to the south.

0956: K.T.M. is using pressurized water and air to clean out the cuts they made in the pavement of the westbound lane of Pickett Lane for the placement of traffic loop wire.

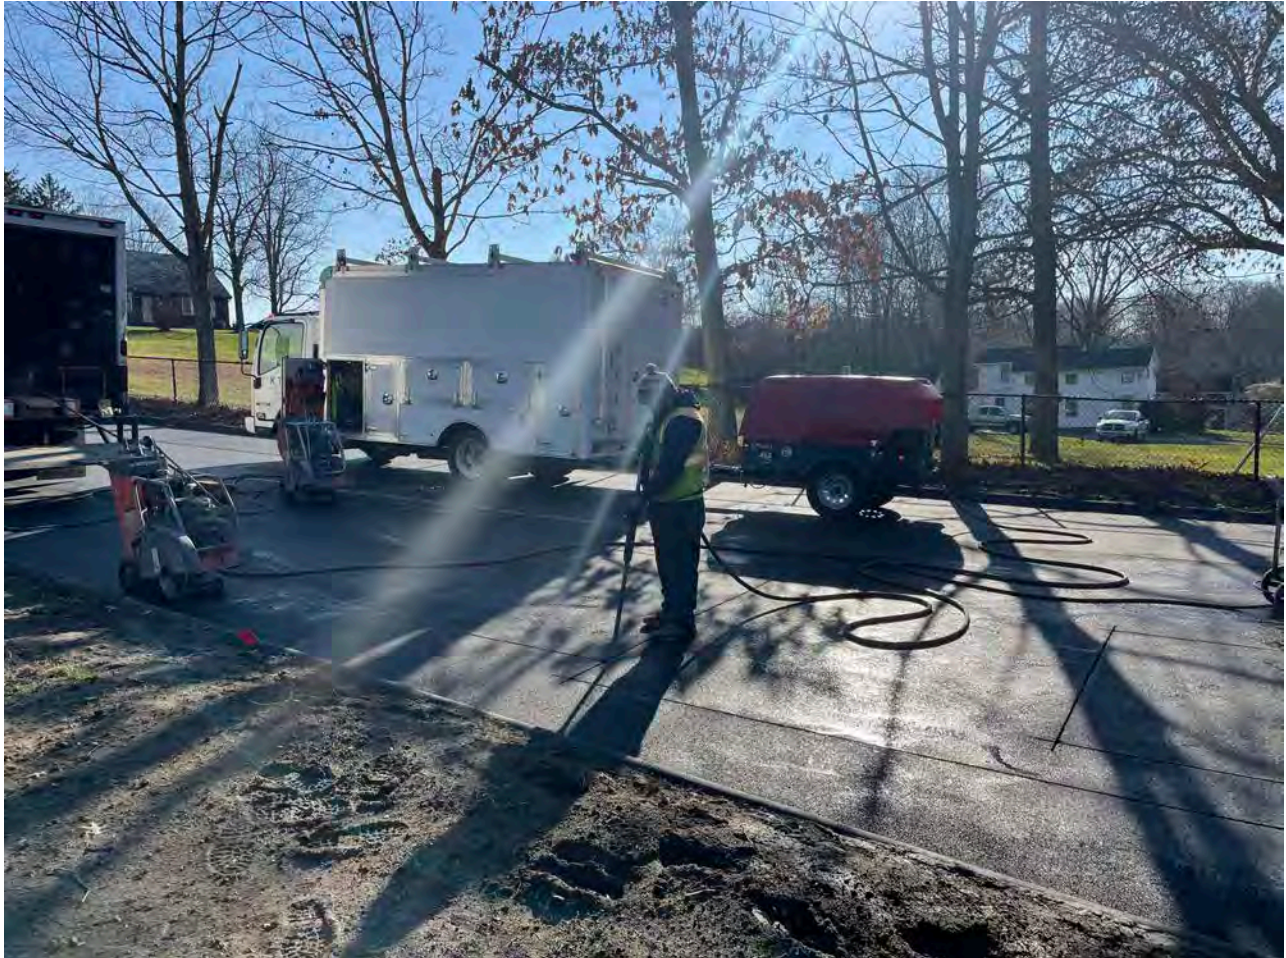
Picture 4: K.T.M using pressurized air to clean out the cuts they made in the pavement on Pickett Lane for the installation of traffic loops between Stations 10+00 and ~10+50. View to the southeast.

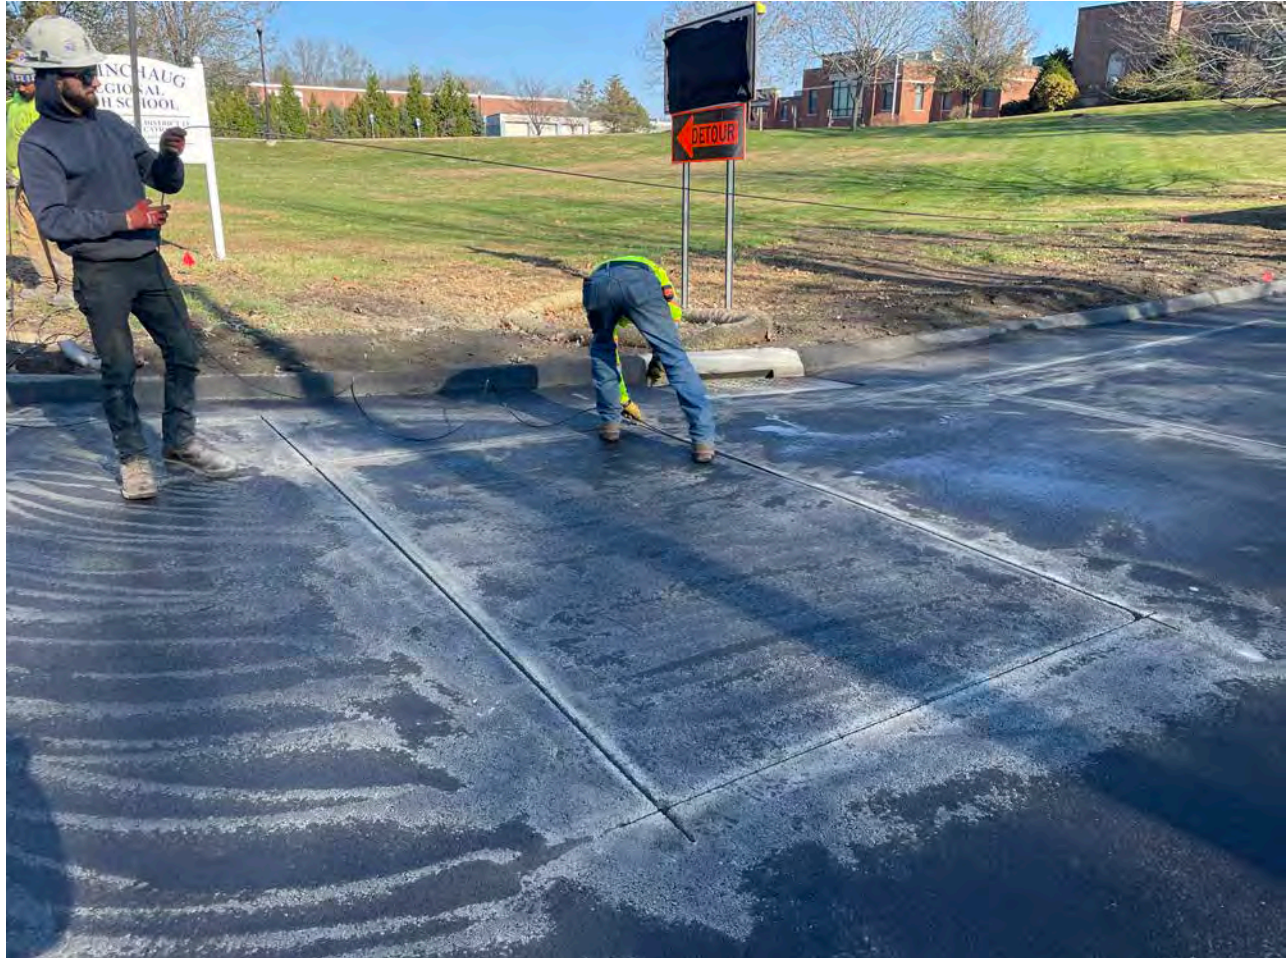
Picture 5: K.T.M installing loop wire in the cuts they made in the pavement on Pickett Lane for the installation of traffic loops between Stations 10+00 and ~10+50. View to the northeast.

1046: K.T.M. is inserting loop wire into the saw cuts they made in the pavement of the westbound lane of Pickett Lane between Stations 10+10 and ~10+50.

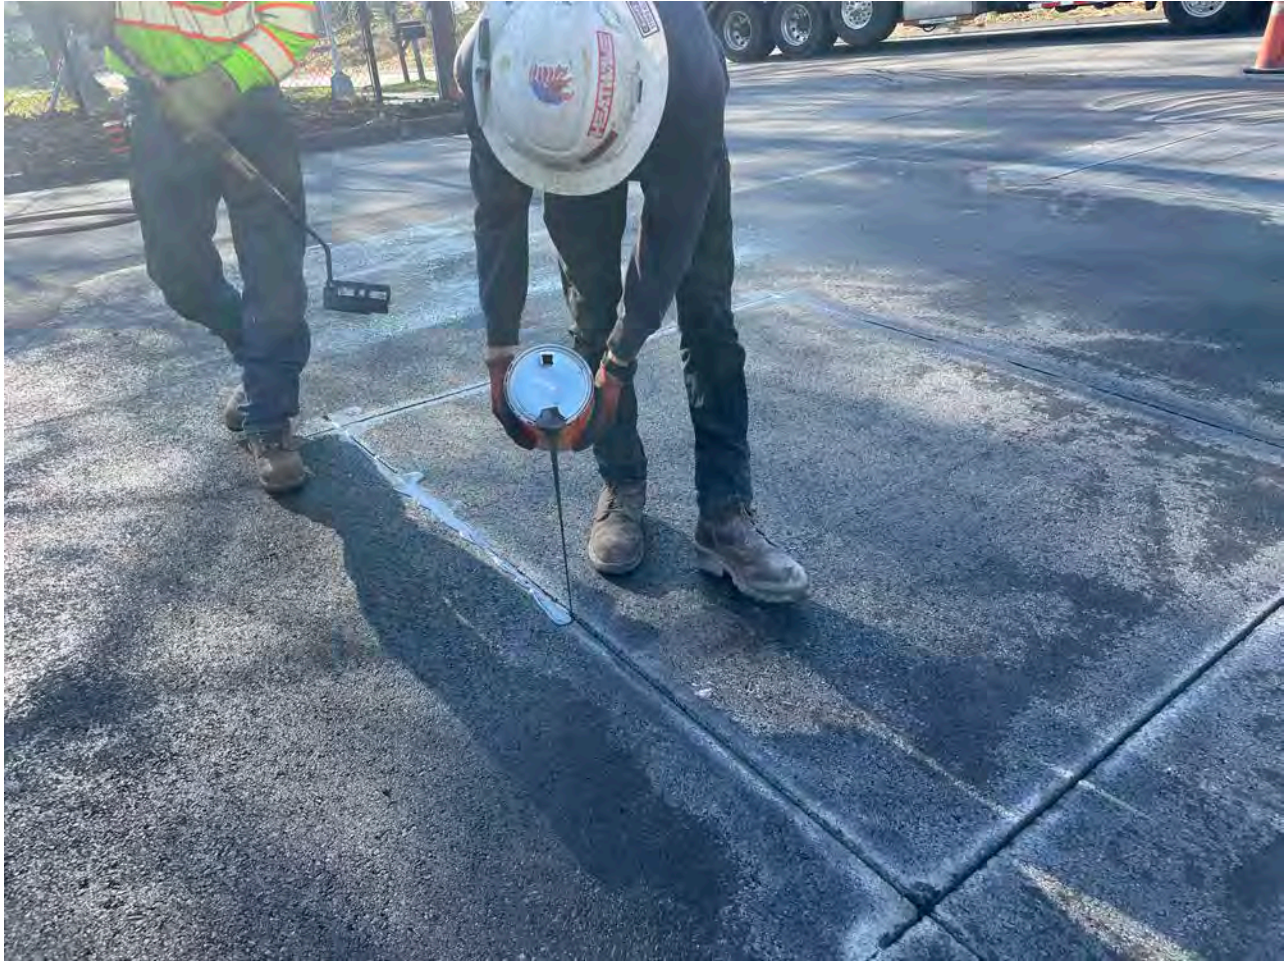
Picture 6: K.T.M placing sealant over the loop wire they placed in the cuts they made in the pavement on Pickett Lane for the installation of traffic loops between Stations 10+00 and ~10+50. View to the southwest.

1100: K.T.M. is in the process of placing sealer over the looping wire they placed into the saw cuts they made in the pavement of the westbound lane of Pickett Lane between Stations 10+10 and ~10+50.

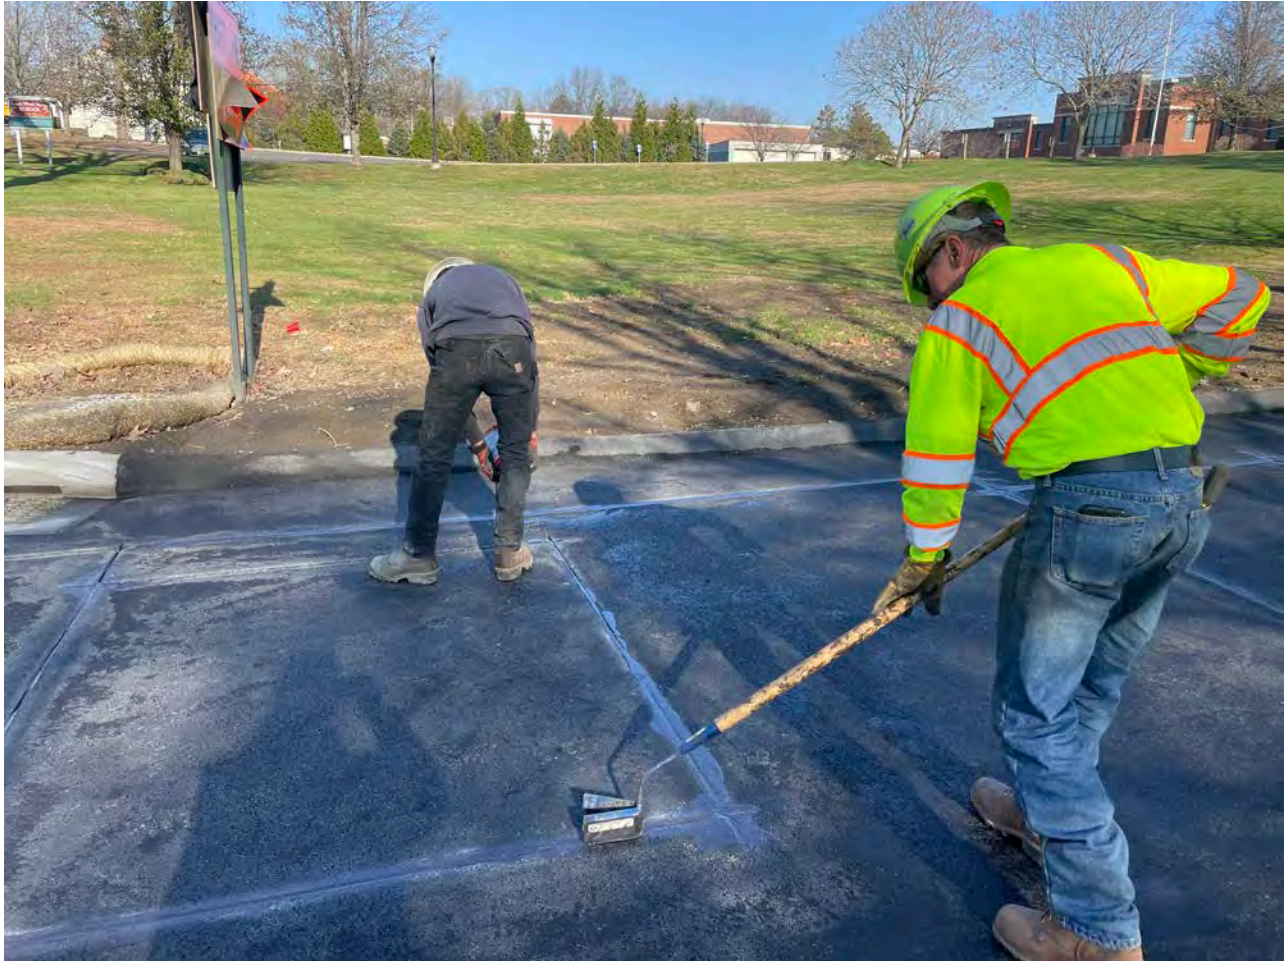
Picture 7: K.T.M leveling the sealant over the loop wire they placed in the cuts they made in the pavement on Pickett Lane for the installation of traffic loops between Stations 10+00 and ~10+50. View to the north.

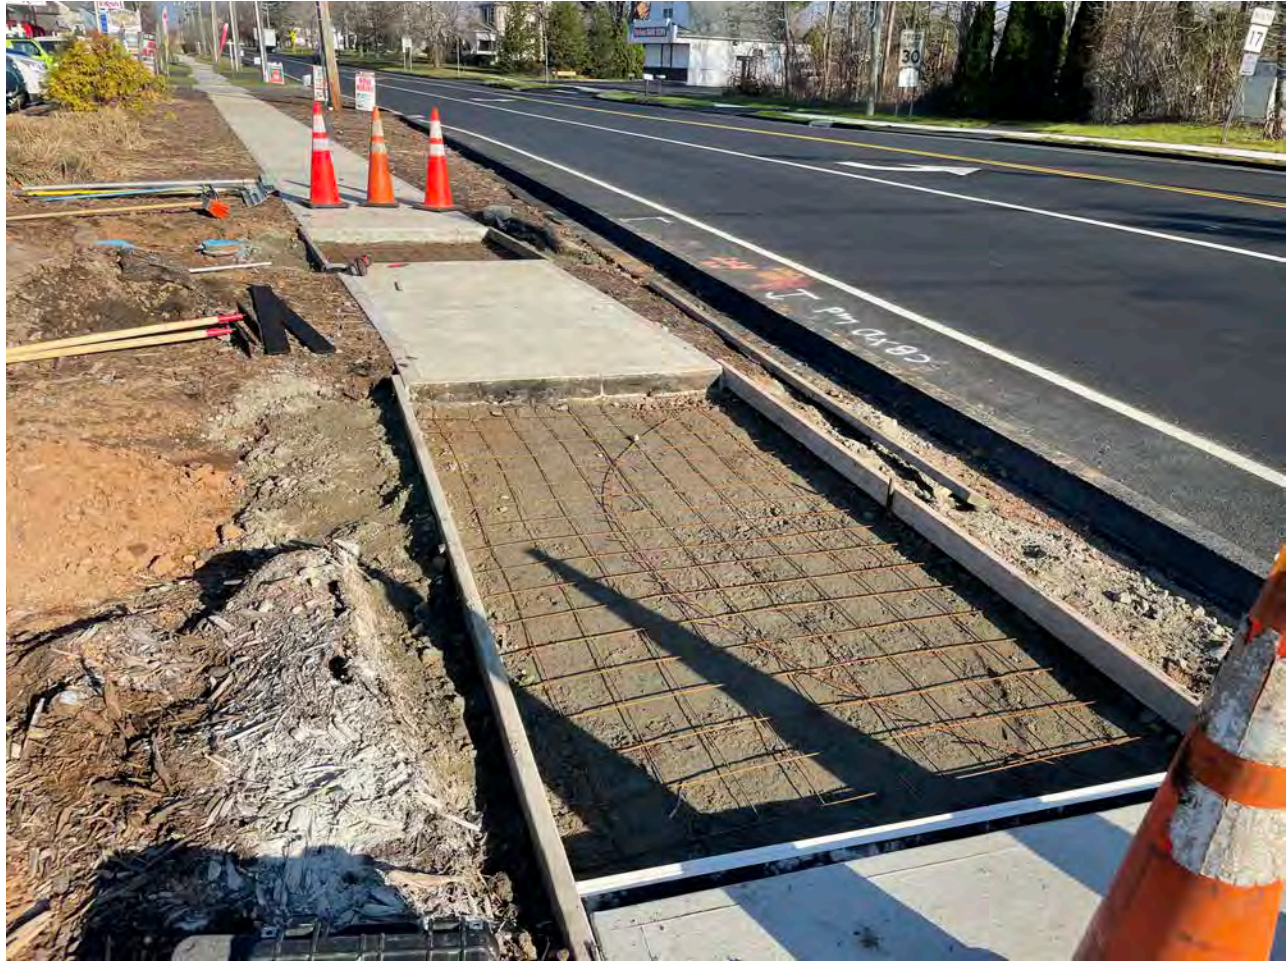
Picture 8: Section of sidewalk that Ludlow has framed up to receive a pour of 4000 PSI concrete as part of repair activities on the east side of the 6 Main Street, Durham, property. View to the northeast.

0909: Ludlow is working on constructing forms to repair several panels of the concrete sidewalk located on the east side of the 6 Main Street, Durham, building.

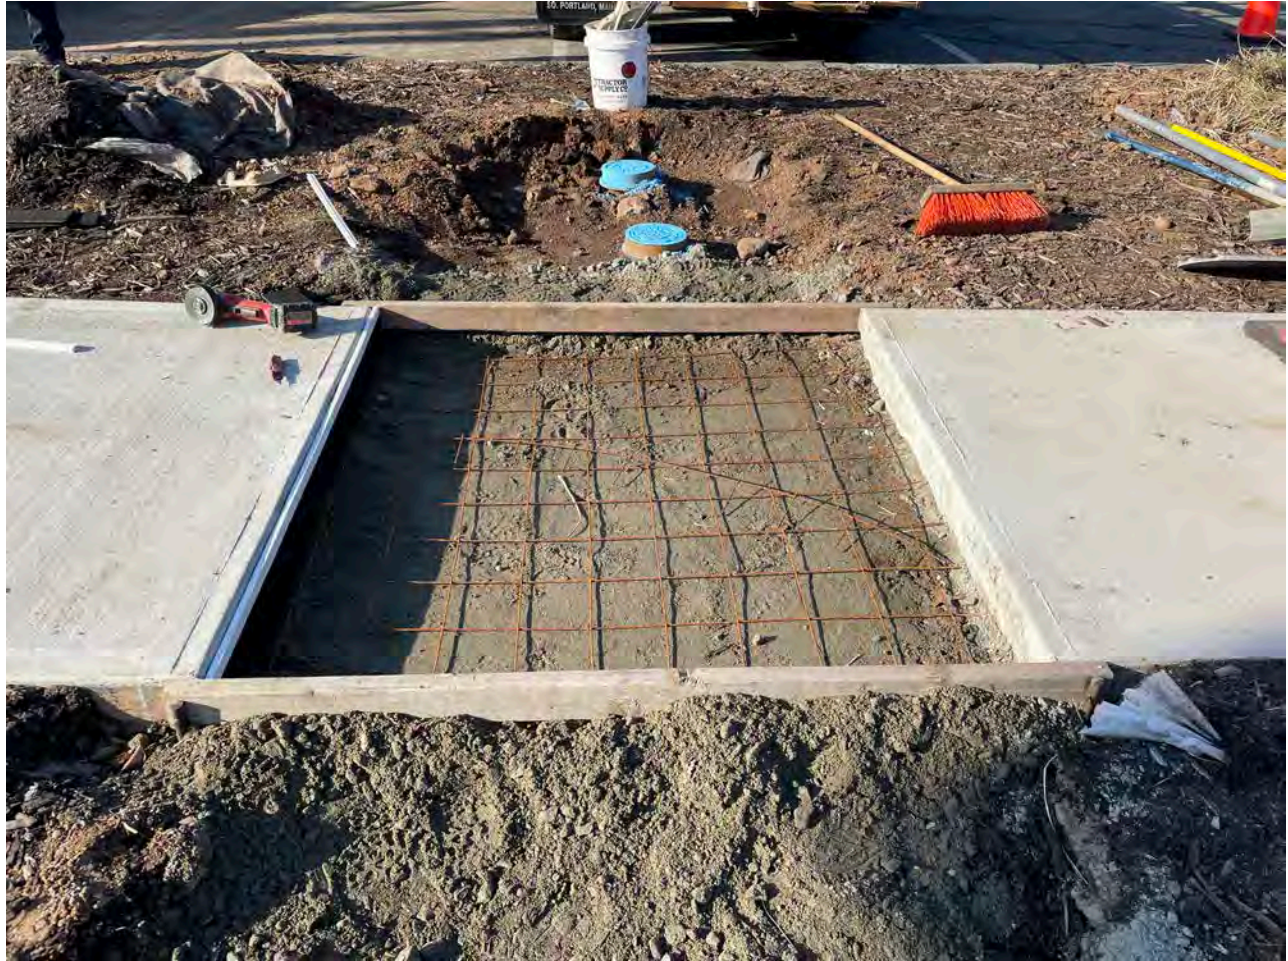
Picture 9: Section of sidewalk that Ludlow has framed and has placed a sheet of steel 4" x4" screen before filling with 4000 PSI concrete on the east side of the 6 Main Street, Durham, property. View to the west.

0922: Ludlow has placed steel 4" x 4" screen into the concrete forms they constructed on the east side of the 6 Main Street, Durham, building for a pour of 4000 PSI concrete.

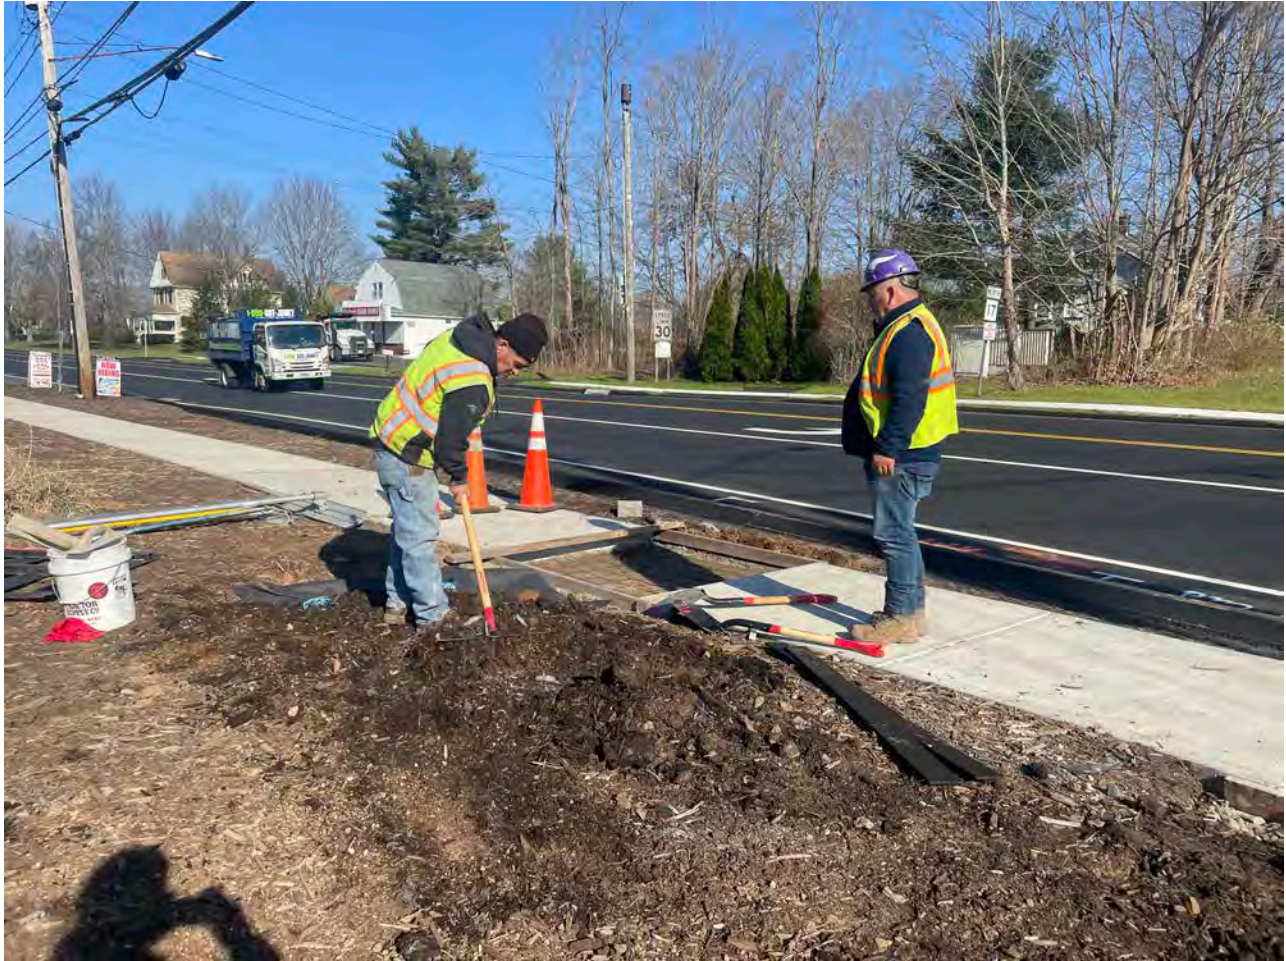
Picture 10: Ludlow restoring the mulch bed located on the west side of the sidewalk they are repairing on the east side of the 6 Main Street, Durham, property. View to the northeast.

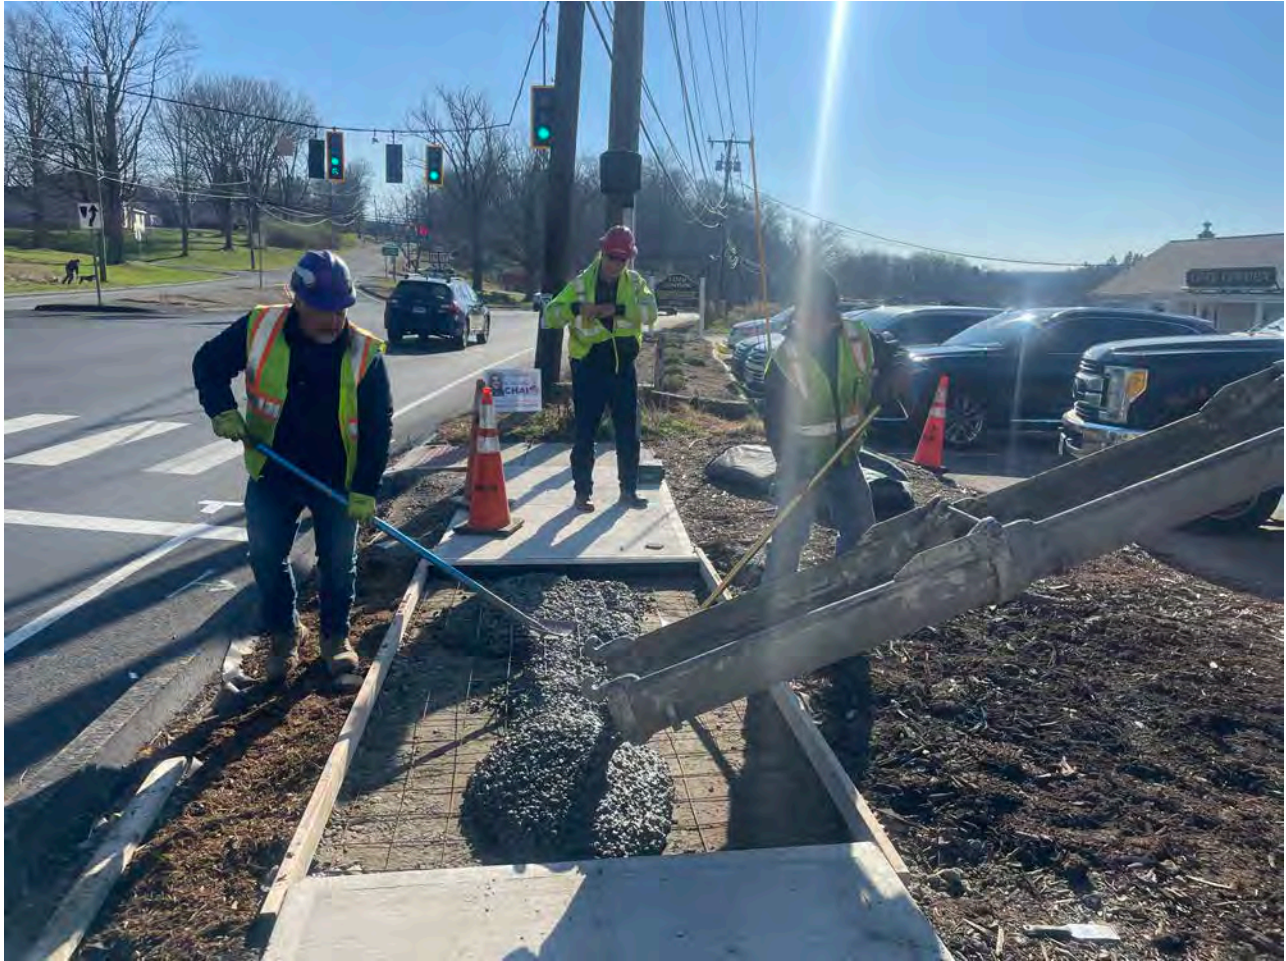
Picture 11: Ludlow assisting in the placement of the concrete being placed by Farmington Ready Mix in one of two forms they built to repair the sidewalk located on the east side of the 6 Main Street, Durham, property. View to the south.

1219: Farmington Ready Mix begins to place concrete into one of the two forms they built to repair three sidewalk panels on the east side of the 6 Main Street, Durham, building.

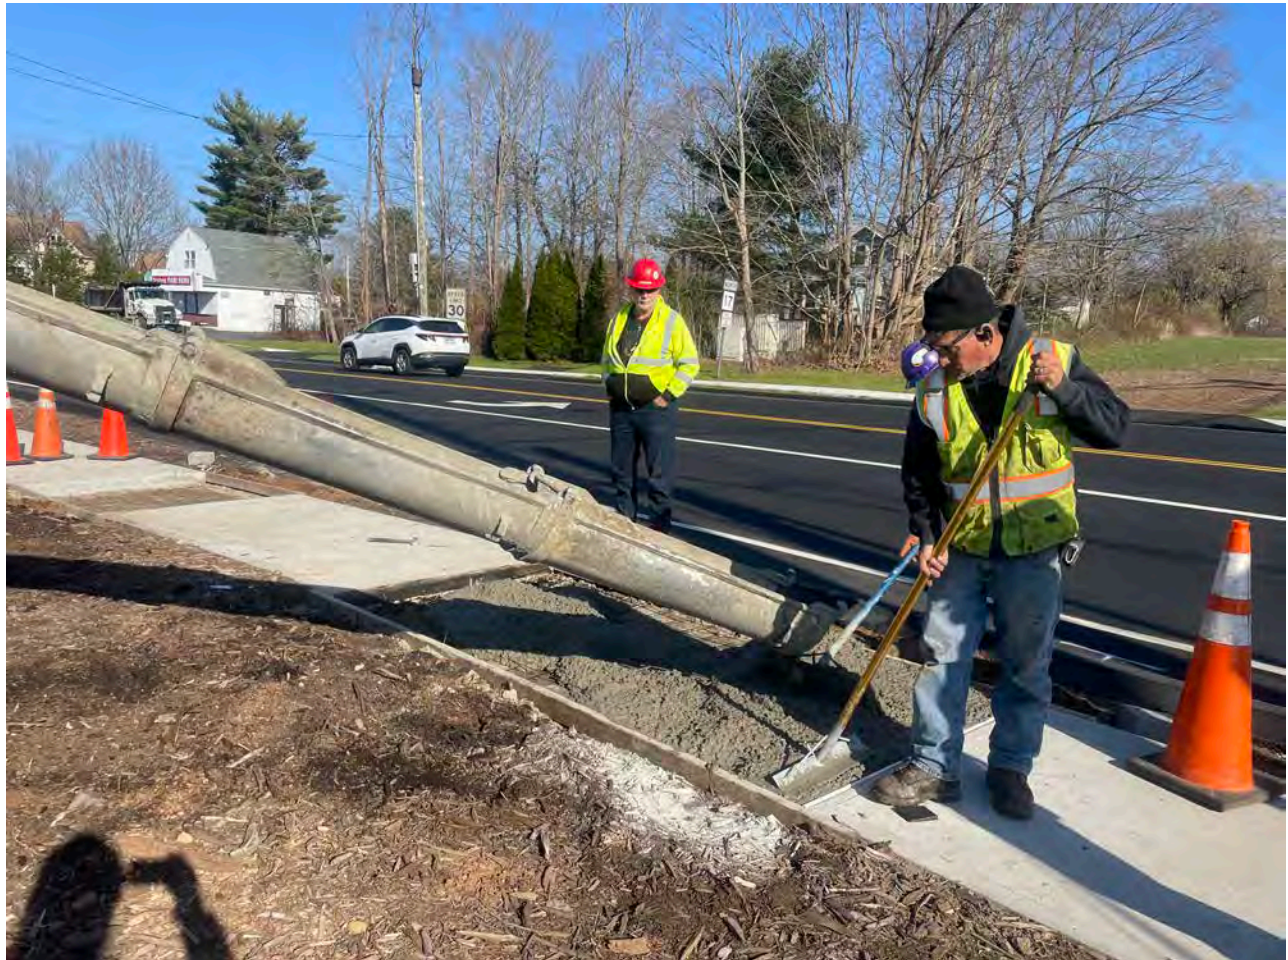
Picture 12: Ludlow assisting in the placement of the concrete being placed by Farmington Ready Mix in one of two forms they built to repair the sidewalk located on the east side of the 6 Main Street, Durham, property. View to the northeast.

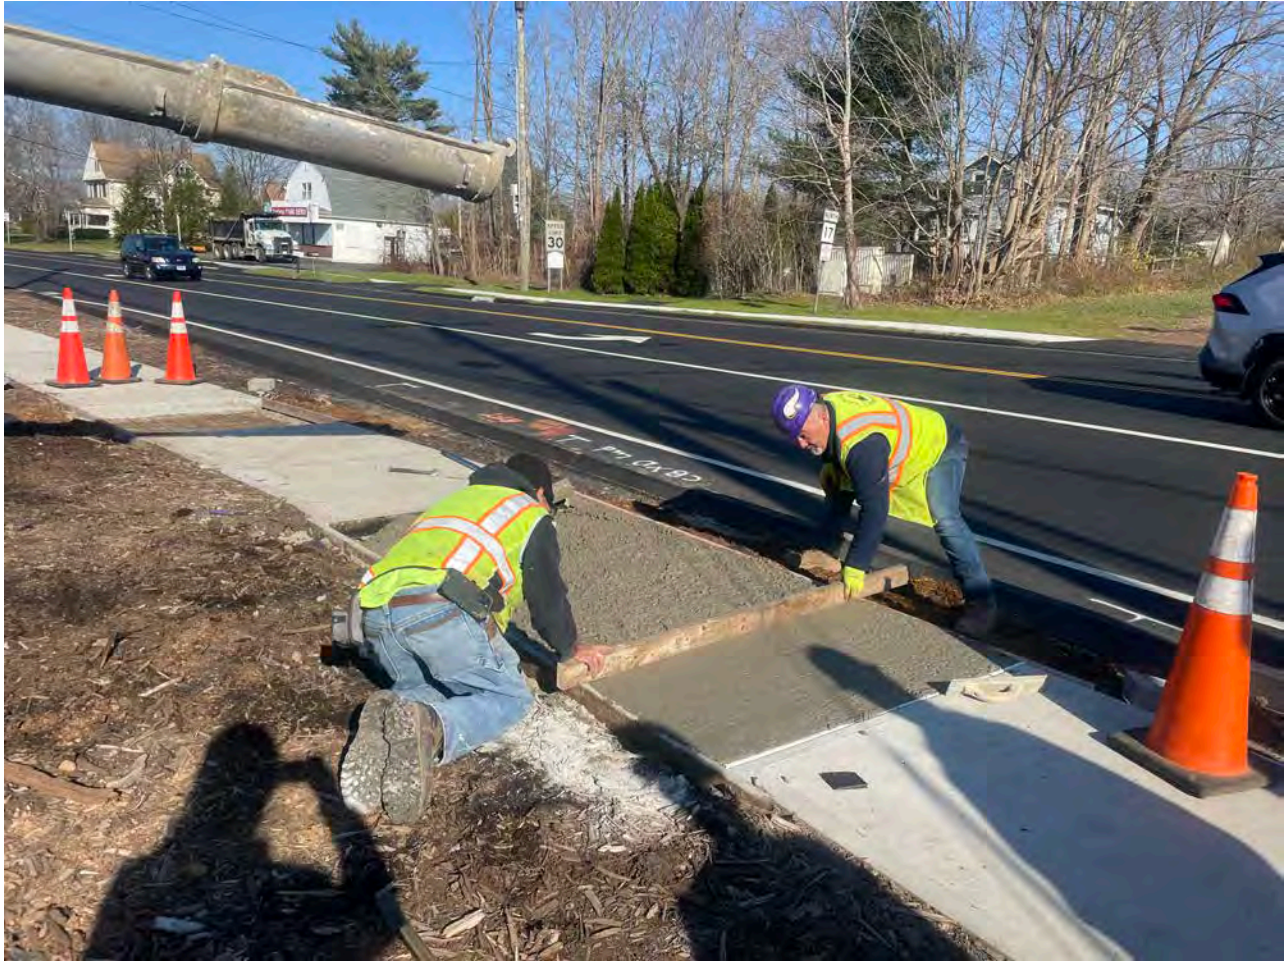
Picture 13: Ludlow leveling concrete being placed by Farmington Ready Mix in one of two forms they built to repair the sidewalk located on the east side of the 6 Main Street, Durham, property. View to the northeast.

1231: Ludlow is working on leveling the concrete that Farmington Ready Mix just placed as part of sidewalk repair activities on the east side of the 6 Main Street building.
