# NO FURTHER ACTION DECISION UNDER CERCLA

# STUDY AREA 43C HISTORIC GAS STATION SITES

FORT DEVENS, MASSACHUSETTS

**JANUARY 1995**

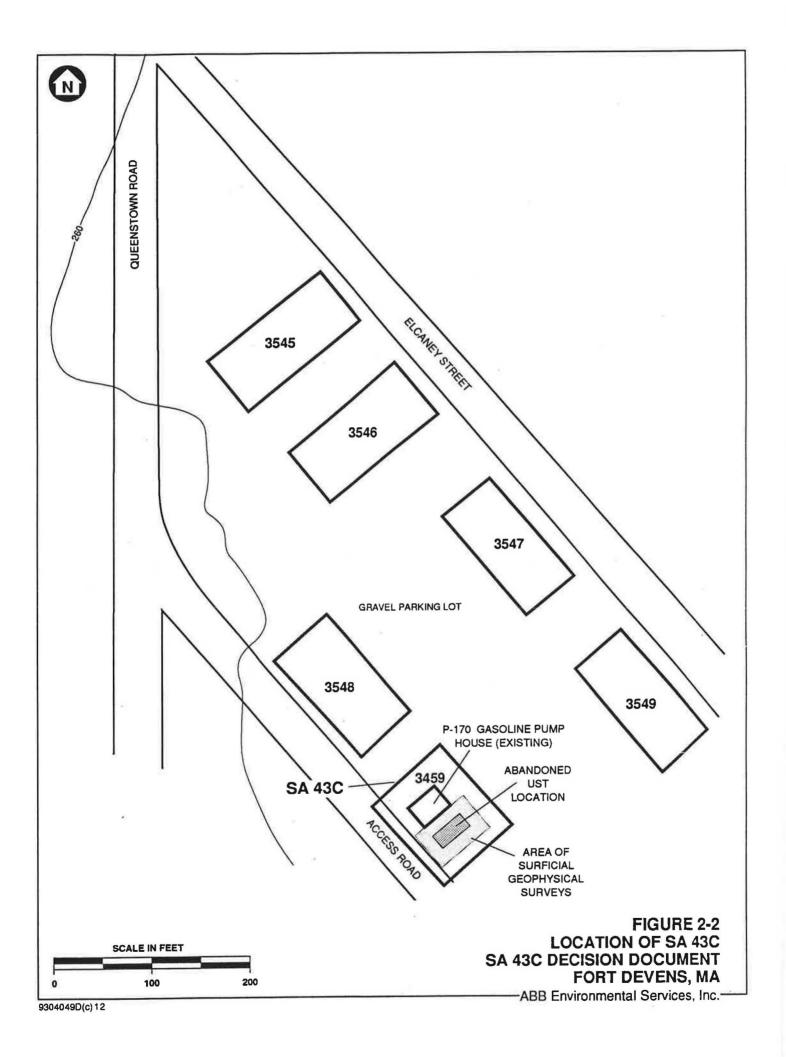
SA 43C, one of the 19 Historic Gas Station Sites, is included in the Group 2 SAs located on the Main Post. This SA is located off Queenstown Road (Figure 2-2). The structures of the historic gas station at SA 43C consisted of a pump island and a small gasoline pumphouse. Based on historic records, the gas station was a Type A station with one 5,000 gallon underground storage tank (UST) located between the gasoline pumphouse and the pump island. The station was used during World War II as a vehicle motor pool to support military operations. The motor pool operations were discontinued during the late 1940s or early 1950s. No records were available on the decommissioning of this motor pool and therefore, there was no evidence that the UST had been removed. The pumphouse (Building 3459) was still present at this SA prior to the SI field investigation. The pumphouse appeared to be constructed of corrugated steel and some piping was present in the building. The building was secured by a locked metal door. The area around the pumphouse is a gravel parking lot (see Figure 2-2).

The SI field investigation program for SA 43C consisted of a surficial geophysical program which included a metal detector and ground penetrating radar (GPR) survey. The geophysical investigation conducted at SA 43C indicated that one abandoned UST was present on the southern side of the existing pumphouse (see Figure 2-2). The metal detector was used first to locate the UST and then the GPR survey identified the ends and the sides of the UST. The geophysical measurements collected in the field are presented in Appendix L of the SI Report (ABB-ES, 1993).

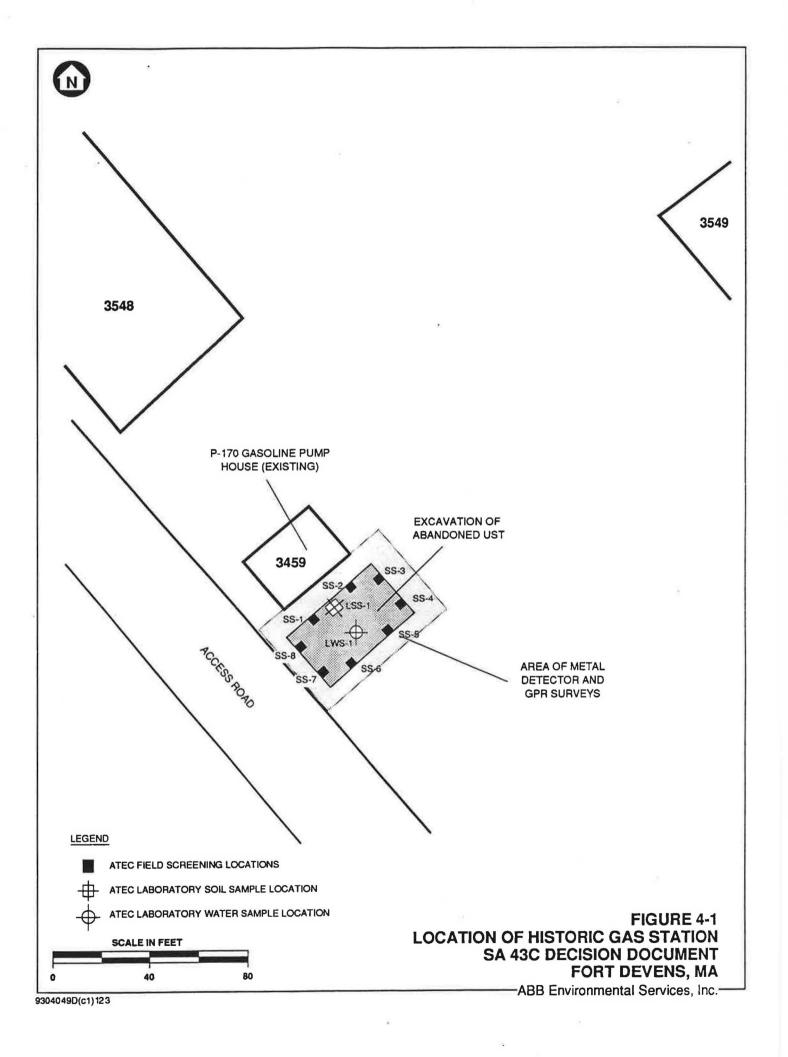
The 5,000-gallon UST at SA 43C was removed by ATEC Environmental Consultants (ATEC) on August 27, 1992. The tank was observed to be severely corroded, without holes or perforations. Associated piping was also corroded (ATEC, 1992). Tank contents at the time of removal consisted of about 1,288 gallons of diesel fuel and sludge. The fuel was removed by Hitchcock Gas Engine Company. The scrap tank was disposed of at John C. Tombarello and Sons on September 1, 1992 (ATEC, 1992). Groundwater was observed in the UST excavation at a depth of approximately 10 feet below ground surface (bgs). Soil and groundwater samples were collected from the excavation to determine whether the contents of the UST had adversely impacted soil or groundwater quality at SA 43C. The results of the analyses are presented in the following paragraphs.

At the time of the tank removal, ATEC performed field screening on eight soil samples (SS-1 through SS-8) collected from the excavation walls at depths of 5 feet to 6 feet bgs (see Figure 4-1). The headspace of the soil samples was screened with a photoionization detector (PID) for total volatile organic compounds (VOCs) and a Non-Dispersive Infrared (NDIR) Analyzer was used to screen for total petroleum hydrocarbons (TPHC). The PID results ranged from nondetect to 0.2 part per million (ppm), and TPHC levels were 20.5 to 287 ppm (ATEC, 1992) (Table 4-1). ATEC also collected one soil sample from the excavation for confirmatory laboratory analysis. The soil sample was analyzed for TPHC. This sample was analyzed by a non-USAEC certified laboratory and the data do not reside in the Installation Restoration Data Management Information System (IRDMIS). TPHC results were below the detection limit of the method (see Table 4-1). ABB-ES collected one composite soil sample from the bottom of the excavation. This sample was analyzed for TPHC using U.S. Environmental Protection Agency (USEPA) Method 418.1 at ABB-ES' Wakefield, Massachusetts laboratory. TPHC was detected at 78.2 ppm (see Table 4-1). Based on ATEC's sampling results, ATEC backfilled the excavation and no further site investigation was conducted (ATEC, 1992).

Fuel-related soil contamination was not observed or detected in the soil or groundwater after the UST was removed from SA 43C. Based on these results it appears that the contents of the former UST did not adversely impact the soil or groundwater quality at SA 43C. Based on the results of the field investigation and sampling conducted by ABB-ES and by ATEC during the tank removal at SA 43C, no further action is recommended for this historic gas station site.
