# GREAT CHEBEAGUE ISLAND MAINE NAVIGATION IMPROVEMENT PROJECT

## APPENDIX K BENTHIC COMMUNITY ANALYSIS

**June, 2018**

Planning Division
Environmental Resources Section
U.S. Army Corps of Engineers
New England District
Concord, Massachusetts

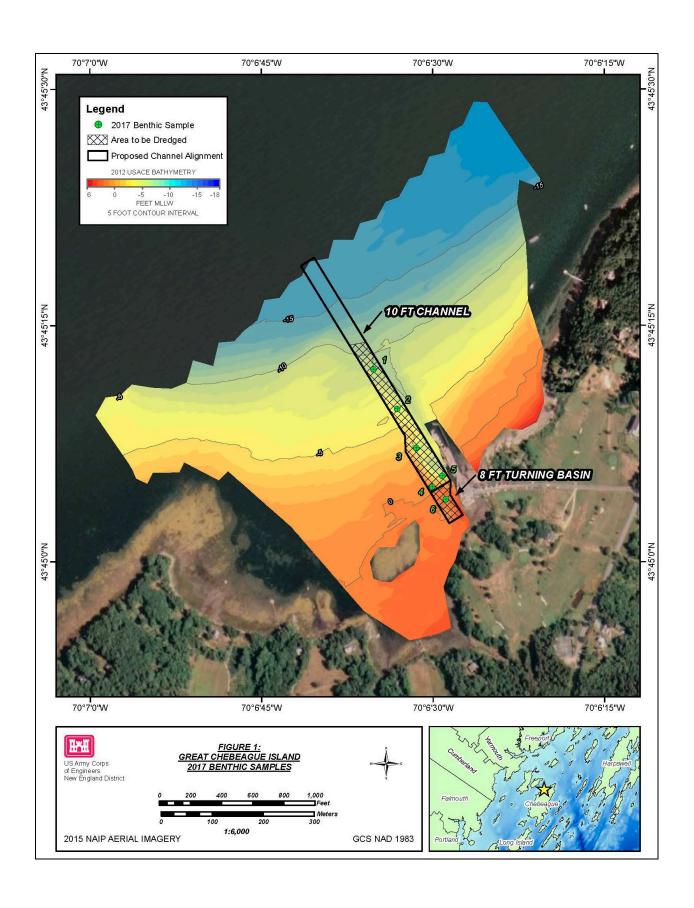
Six sample locations were established within the project area to collect samples for benthic community analysis. All stations were located within proposed improvement areas (Figure 1). At all stations, a 0.04 m<sup>2</sup> sized VanVeen grab sampler was used to collect benthic samples for community analysis. Visual descriptions of the sediments were noted for each sample location. No samples were obtained from Station #5 as the entire bottom at Station #5 was covered in a dense layer of leaf litter and macroalgal wrack.
