Muddy River Flood Damage Reduction Project
Phase 2 Construction Activities Next 90 Days
August 2023

General: The Muddy River Flood Damage Reduction Phase 2 Construction Project is located in the footprint generally between Leverett Pond to Boylston Street in Boston and Brookline. The major project components involve dredging 1 to 8' of sediment for flow conveyance in the Back Bay Fens and the Riverway sections of the Muddy River. It also includes excavation of the sandbar and island at Leverett Pond. Work also includes the removal of *phragmites* from the wetland and riparian areas which affect flow conveyance. After removal of river sediments and *phragmites*, preservation and restoration of the historic park shoreline in construction areas will consist of planting emergent wetland plants and restoring riparian vegetation in upland areas by planting trees and shrubs. This Notice is intended to identify the general construction activities that will be performed in the next 90 days. A figure that shows a typical flood control channel and the proposed improvements is at the end of this report.

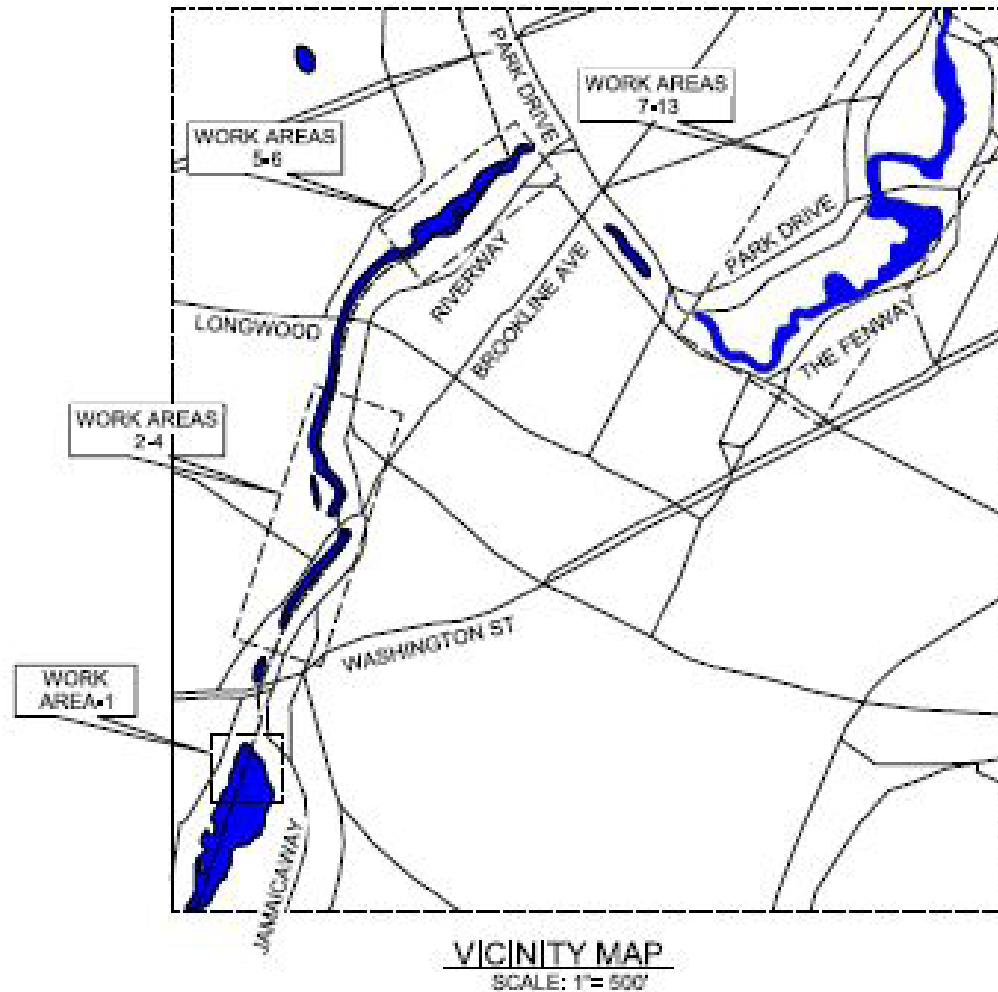
EXTENTS OF PROJECT WORK AREA FOR PHASE 2 CONSTRUCTION

- Dredging of the Muddy River is divided into 12 work areas as shown in the Vicinity Map, with 6 work areas upstream of the Riverway and 6 work areas downstream of Ave. Louis Pasteur.

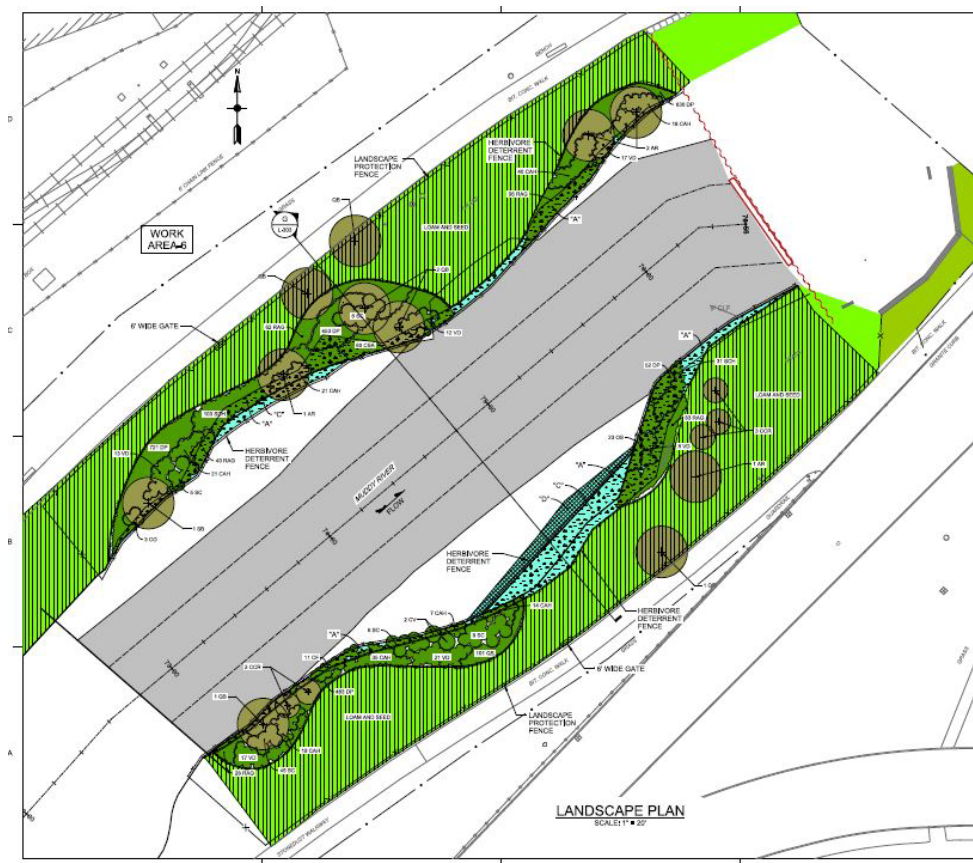
REPRESENTATIVE FIGURE OF FLOOD CONTROL CHANNEL AND PROPOSED IMPROVEMENTS

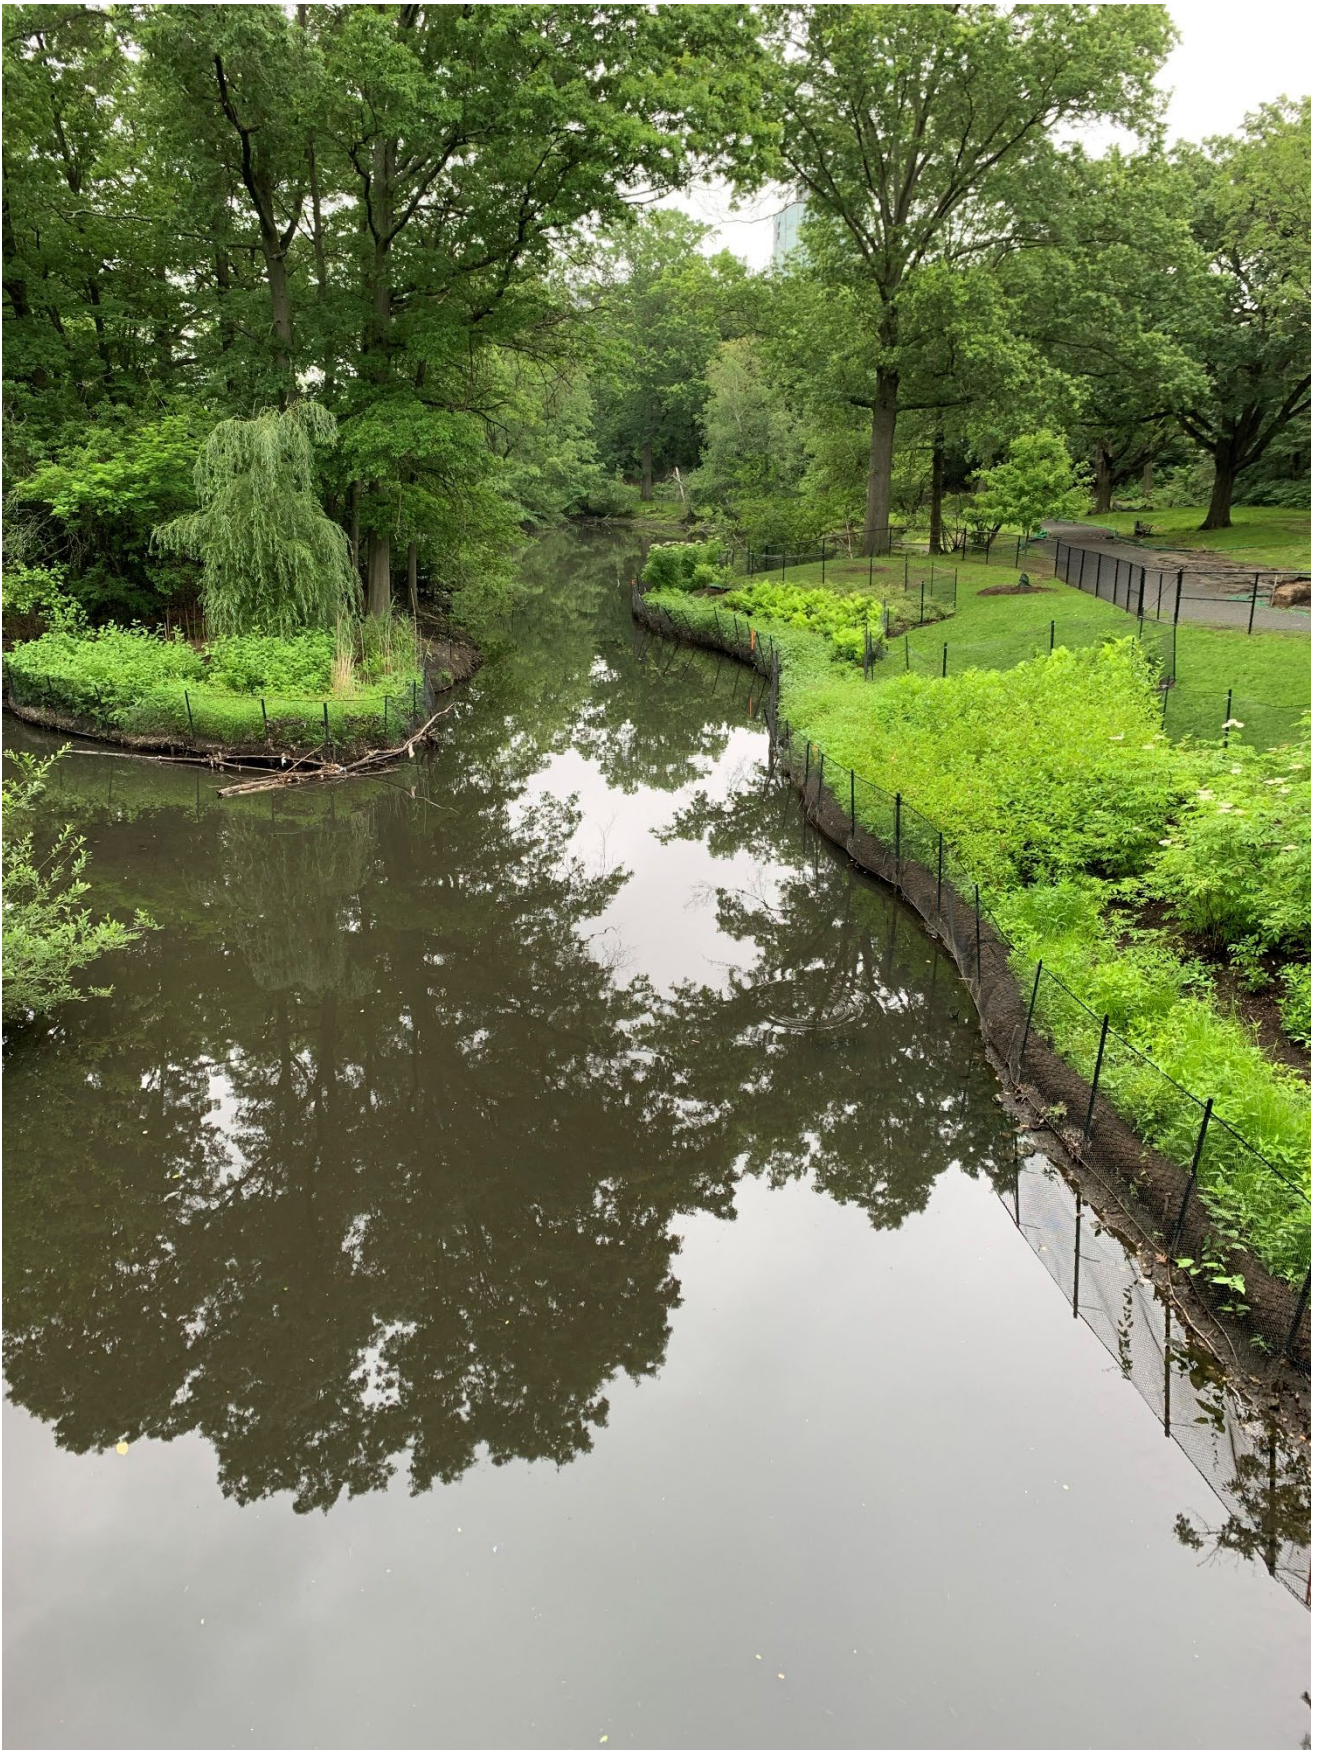
Work Area #5 – section of river by Short Street Bridge to Back Bay Yard – looking downstream, a review of the planted area on the bank and the new island.

- **Work Area #5** – section of river by Short Street Bridge to Back Bay Yard – near the intersection of Park Drive and Riverway – the contractor completed dredging this section April 2022. Surveying was done in May 2022 to confirm new flood risk management cross sections. Trees and shrubs were planted between early- to mid-June 2022. Maintenance of the planting in Work Area #5 will continue to October 2024 during the two-year plant guarantee period.

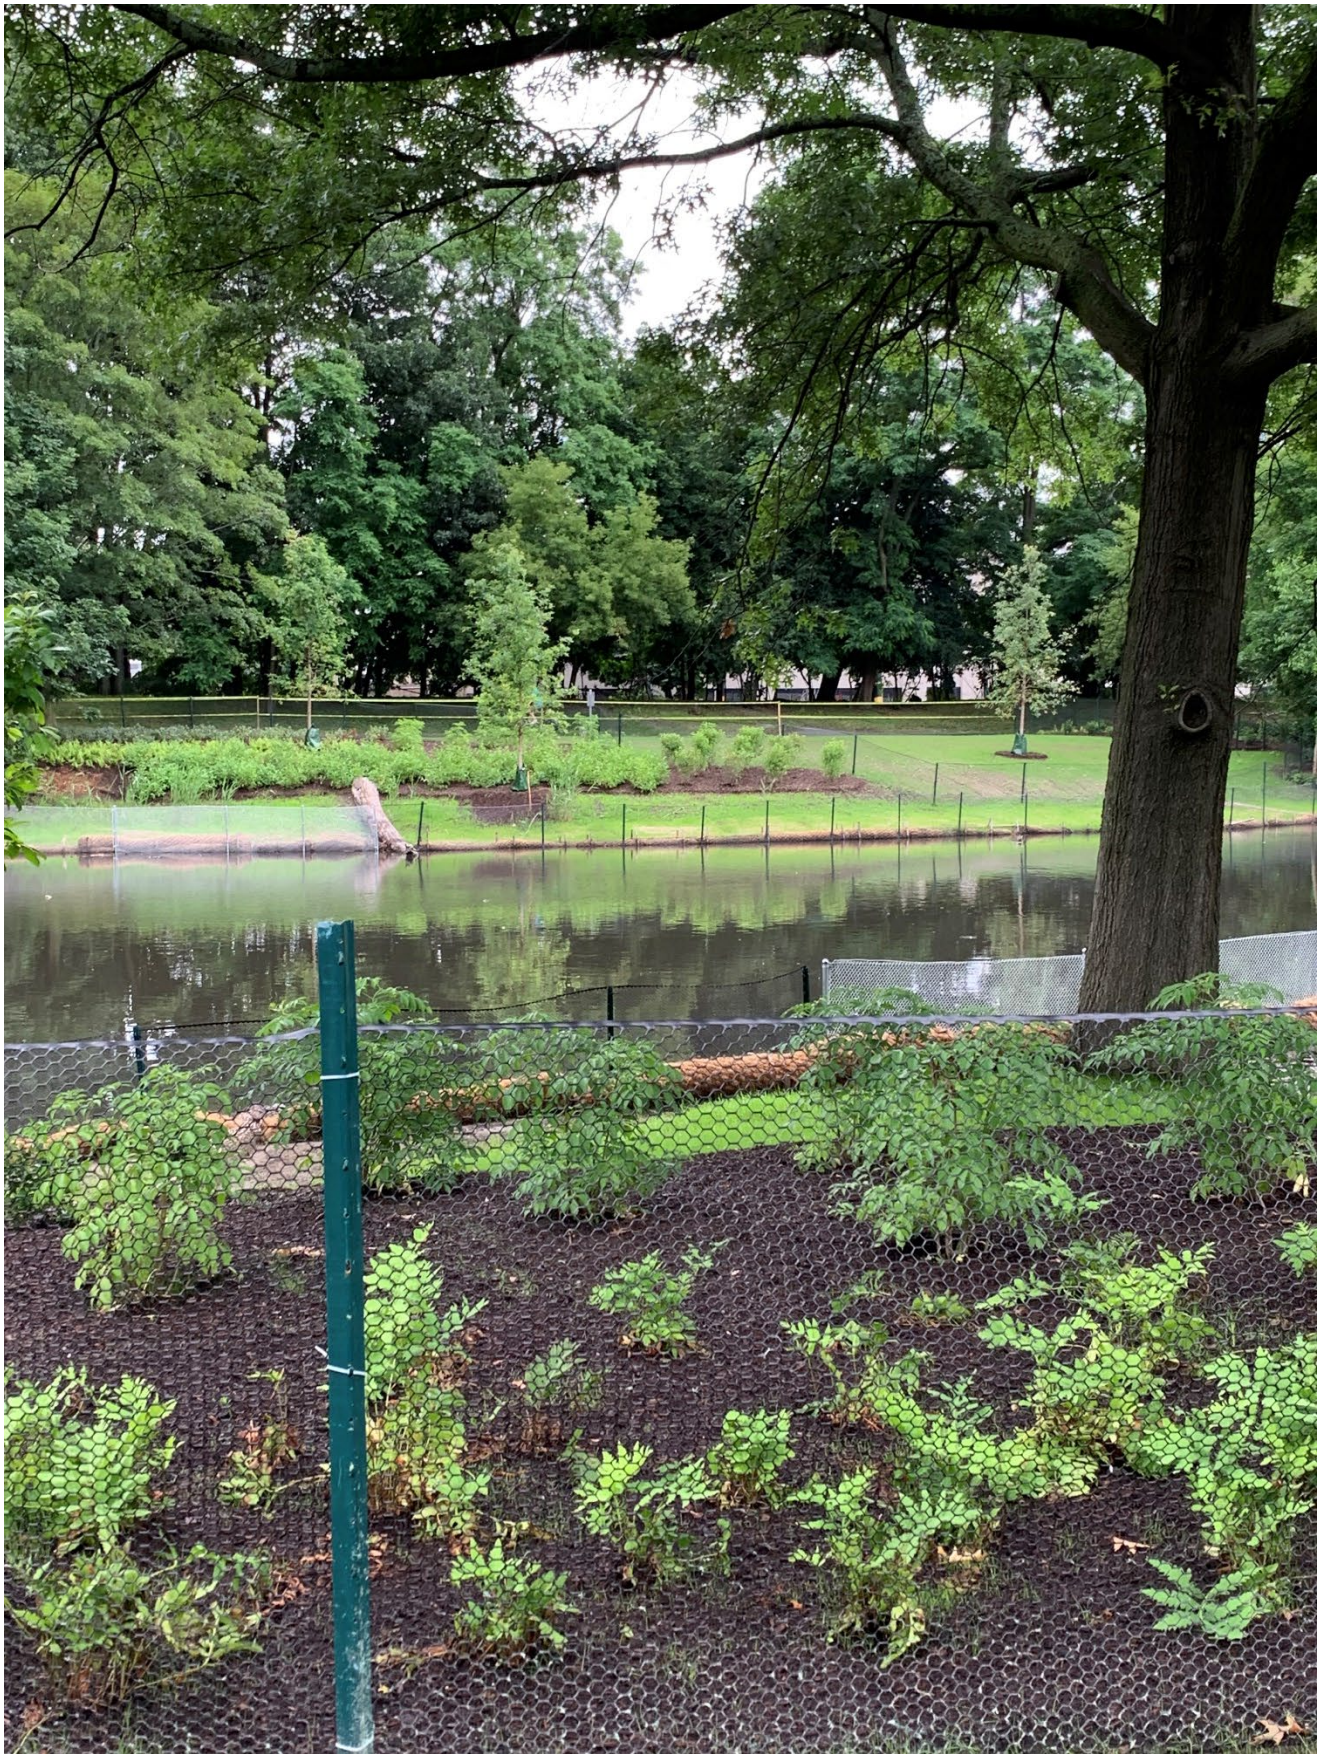
Work Area #6 – section of river by Back Bay Yard – both banks restored, planted, hydroseeded.

- **Work Area #6** – section of river by Back Bay Yard – near the intersection of Park Drive and Riverway – Dredging upstream of the MWRA easement for the existing sewer lines was completed in June 2022. In January 2023, the removal of the phragmites along the banks that were encroaching into the river within the MWRA easement was completed. Since that time, the contractor mobilized in mid-February to begin cutting the temporary Flow Restriction Control Structure (FRCS) ahead of the restoration and planting within this work area. The FRCS was installed under Phase 1 to mimic the effect of the former twin 72" culverts underneath The Riverway until the downstream areas of dredging were completed. The FRCS was cut to the final elevation and the last of the sediment was dredged in the vicinity in early April 2023. Site restoration and plantings were installed late-May into early June. Stonedust path restoration and paving of the pedestrian path was completed late June. Posts for the Landscape Protection Fence will be installed early next week and the chainlink fabric will be installed following all post installation. Maintenance of the planting in Work Area #6 will continue to October 2025 during the two-year plant guarantee period.

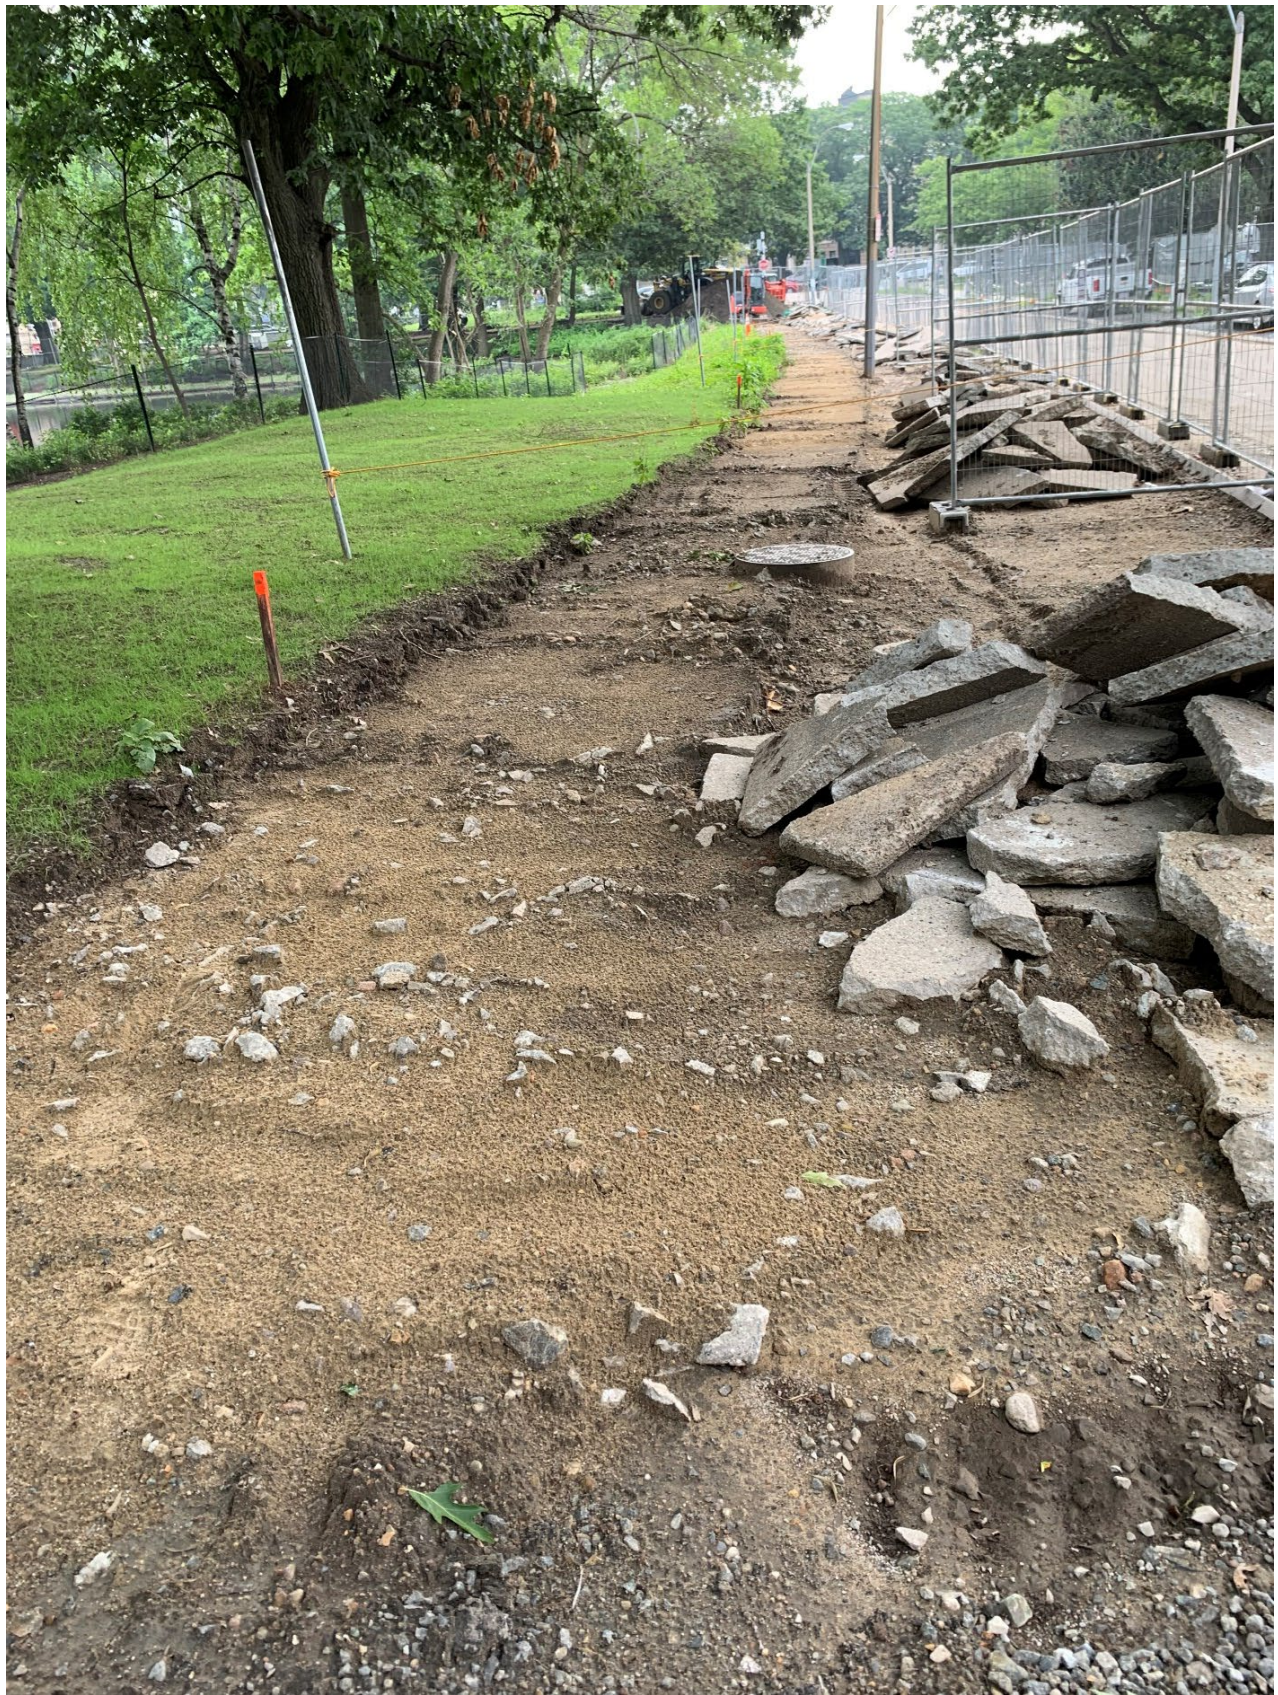
Work Areas #11 – Agassiz Road Bridge and the Duck House – existing sidewalk removed and area being prepared for new sidewalk replacement as part of the Agassiz Road restoration.

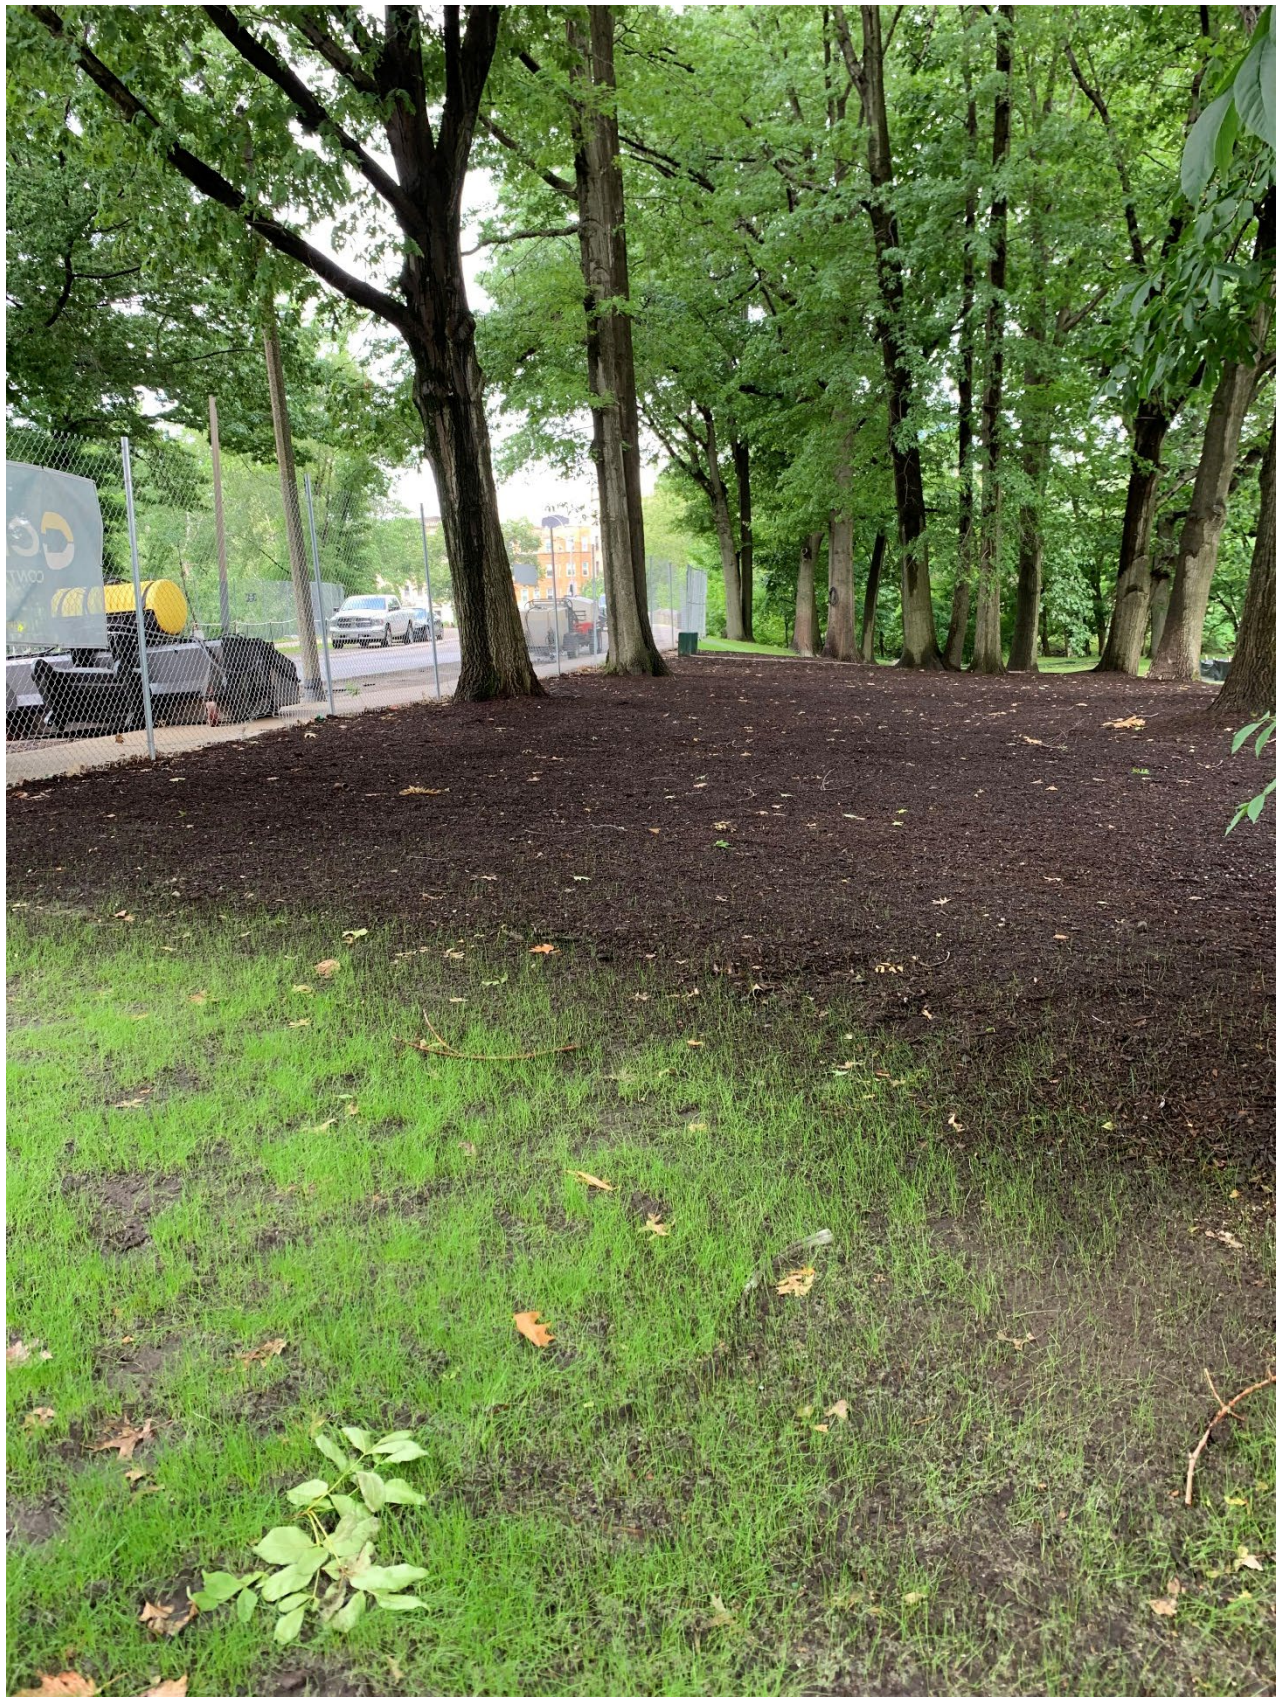
Work Areas #11 – Agassiz Road Bridge and the Duck House – area restored by the Duck House.

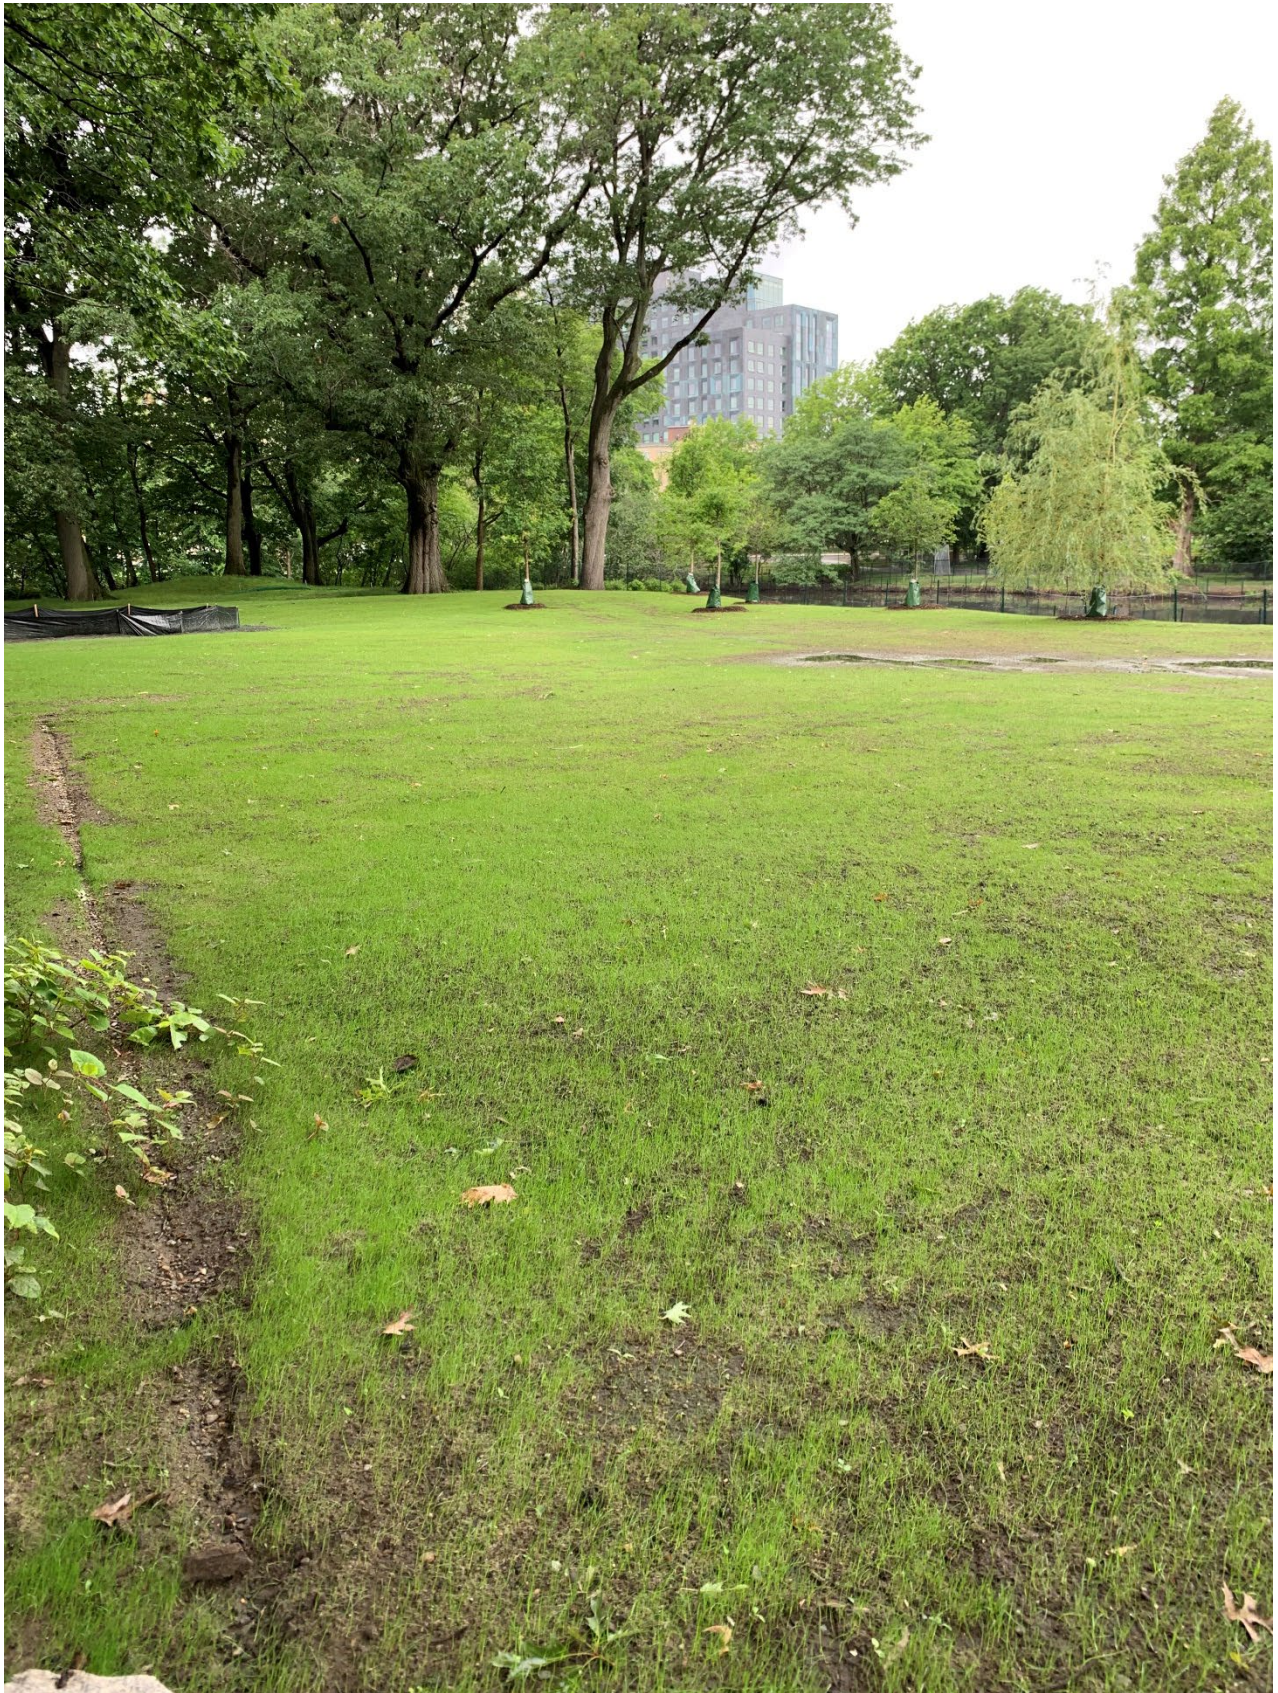
Work Areas #11 – section of the river downstream of Agassiz Road Bridge at the Duck House – Area of the Central Processing Bins where sediment was processed – area restored, planted, and hydroseeded (late June 2023).

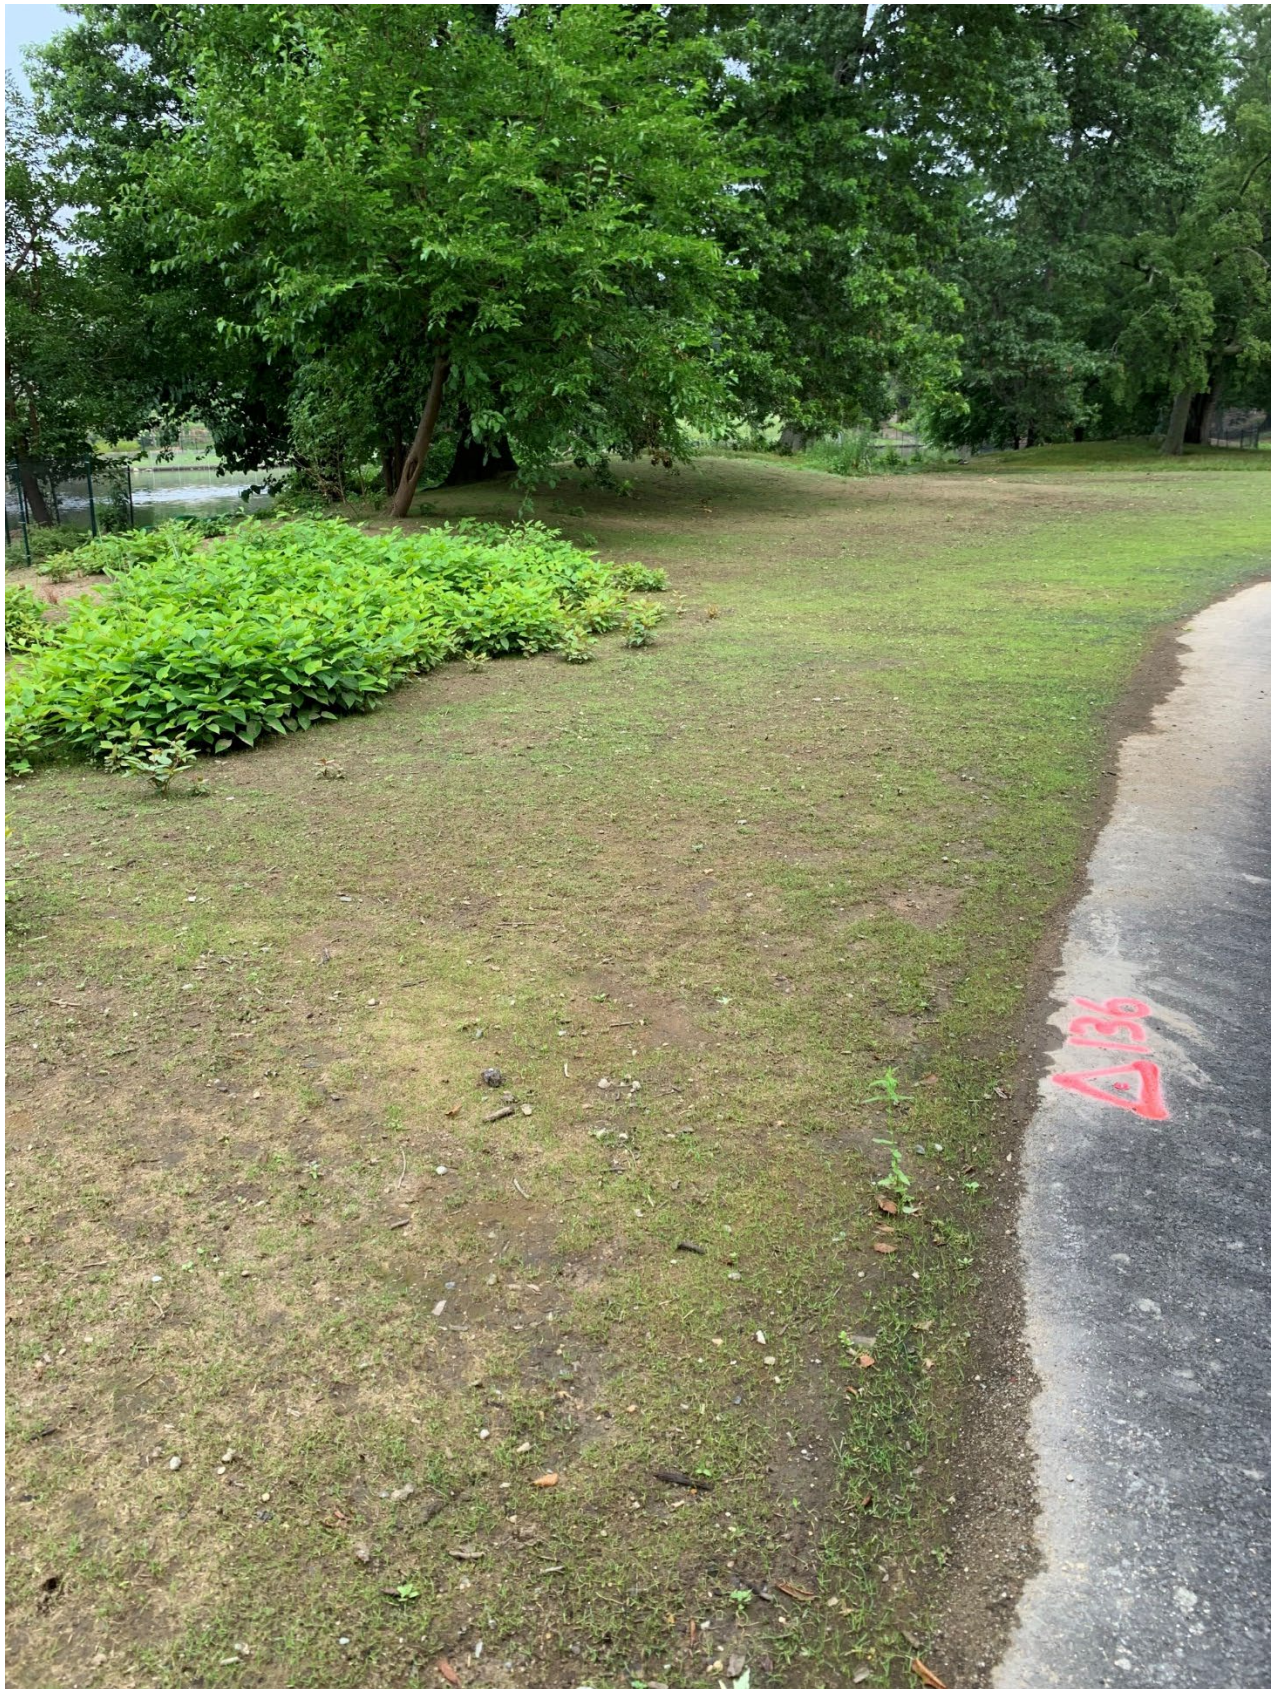
Work Area #12 – section of the river near Boylston Street Bridge – new paved pedestrian path; loam and seed; shrubs and trees planted in early June 2023. Lawn area will be reseeded as necessary during the two-year guarantee period.

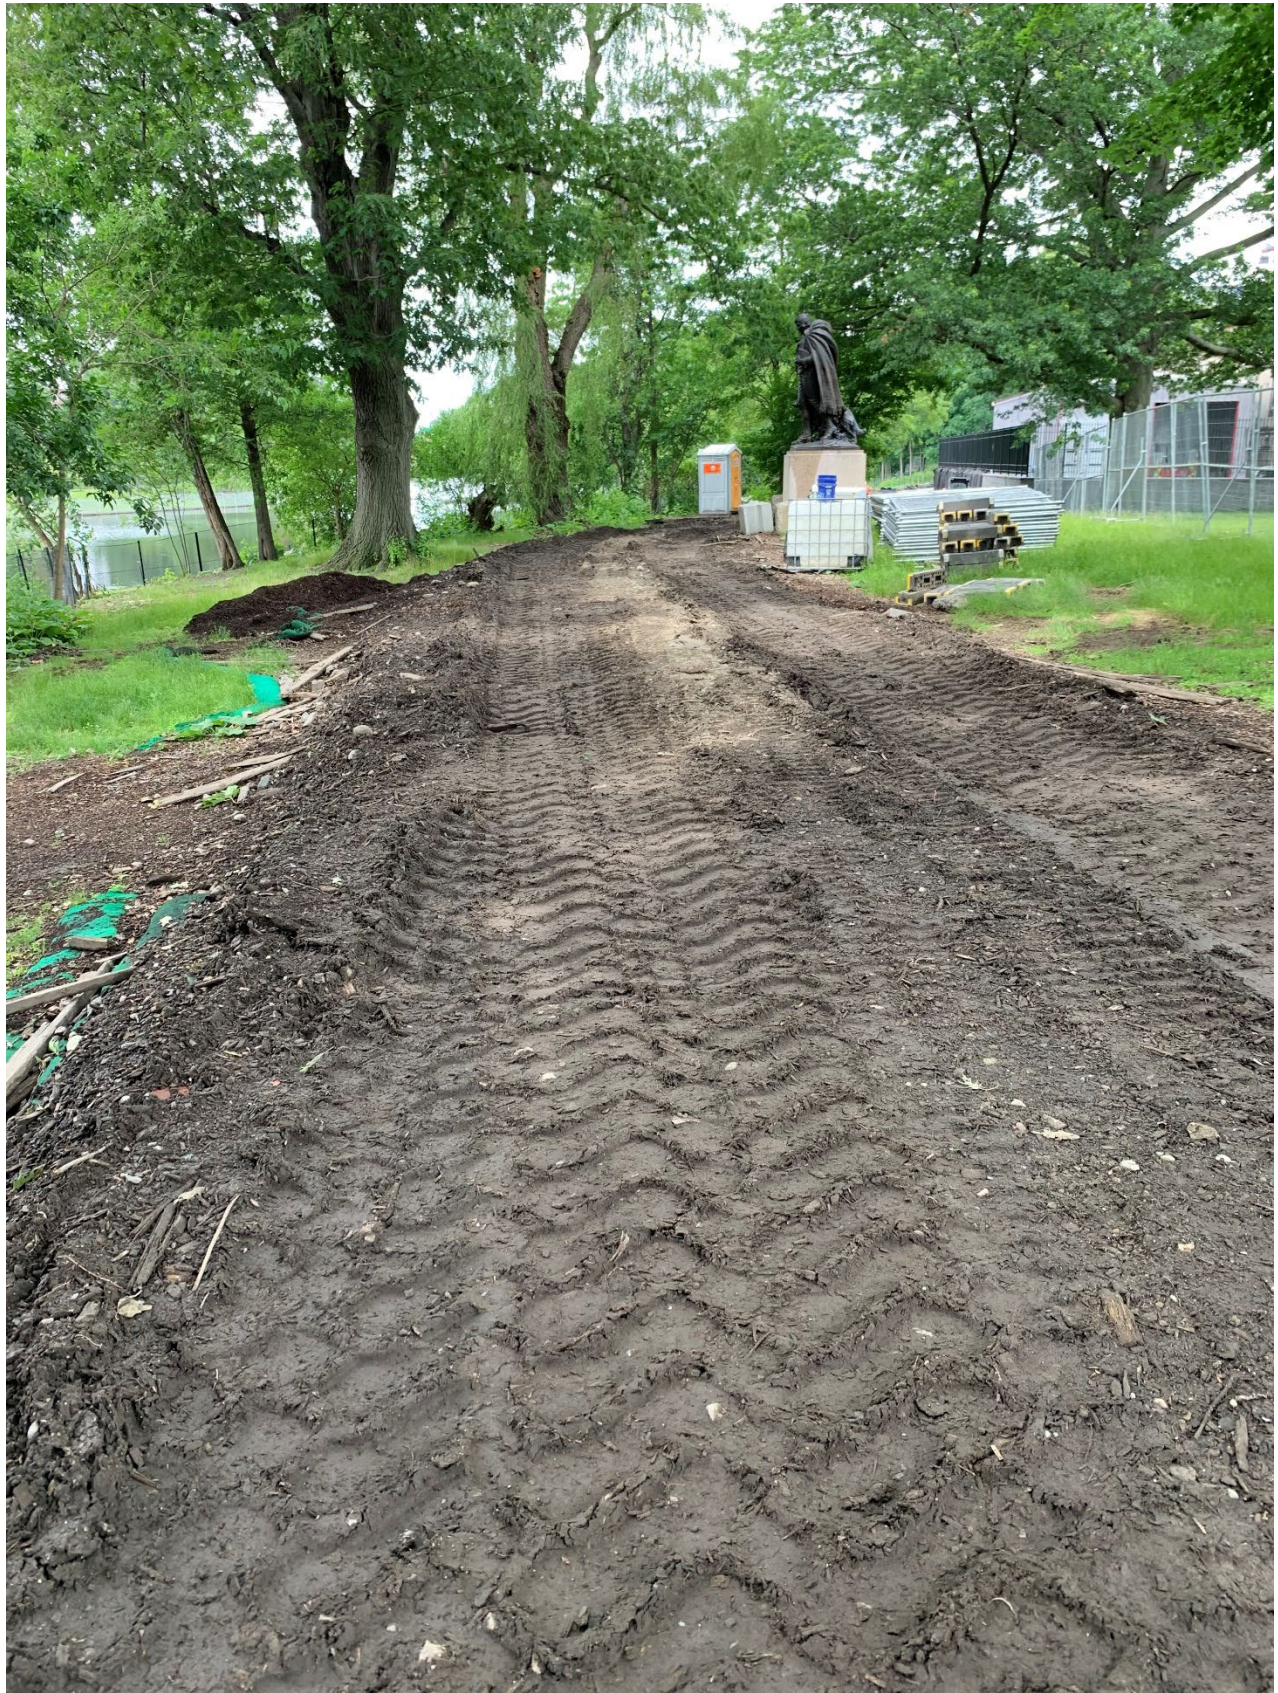
Work Area #13 – Boston Fire Department Building in the vicinity of The Fenway and Agassiz Road – tree root protection and timber mats removed ahead of excavation, grading, and installation of new stonedust path.

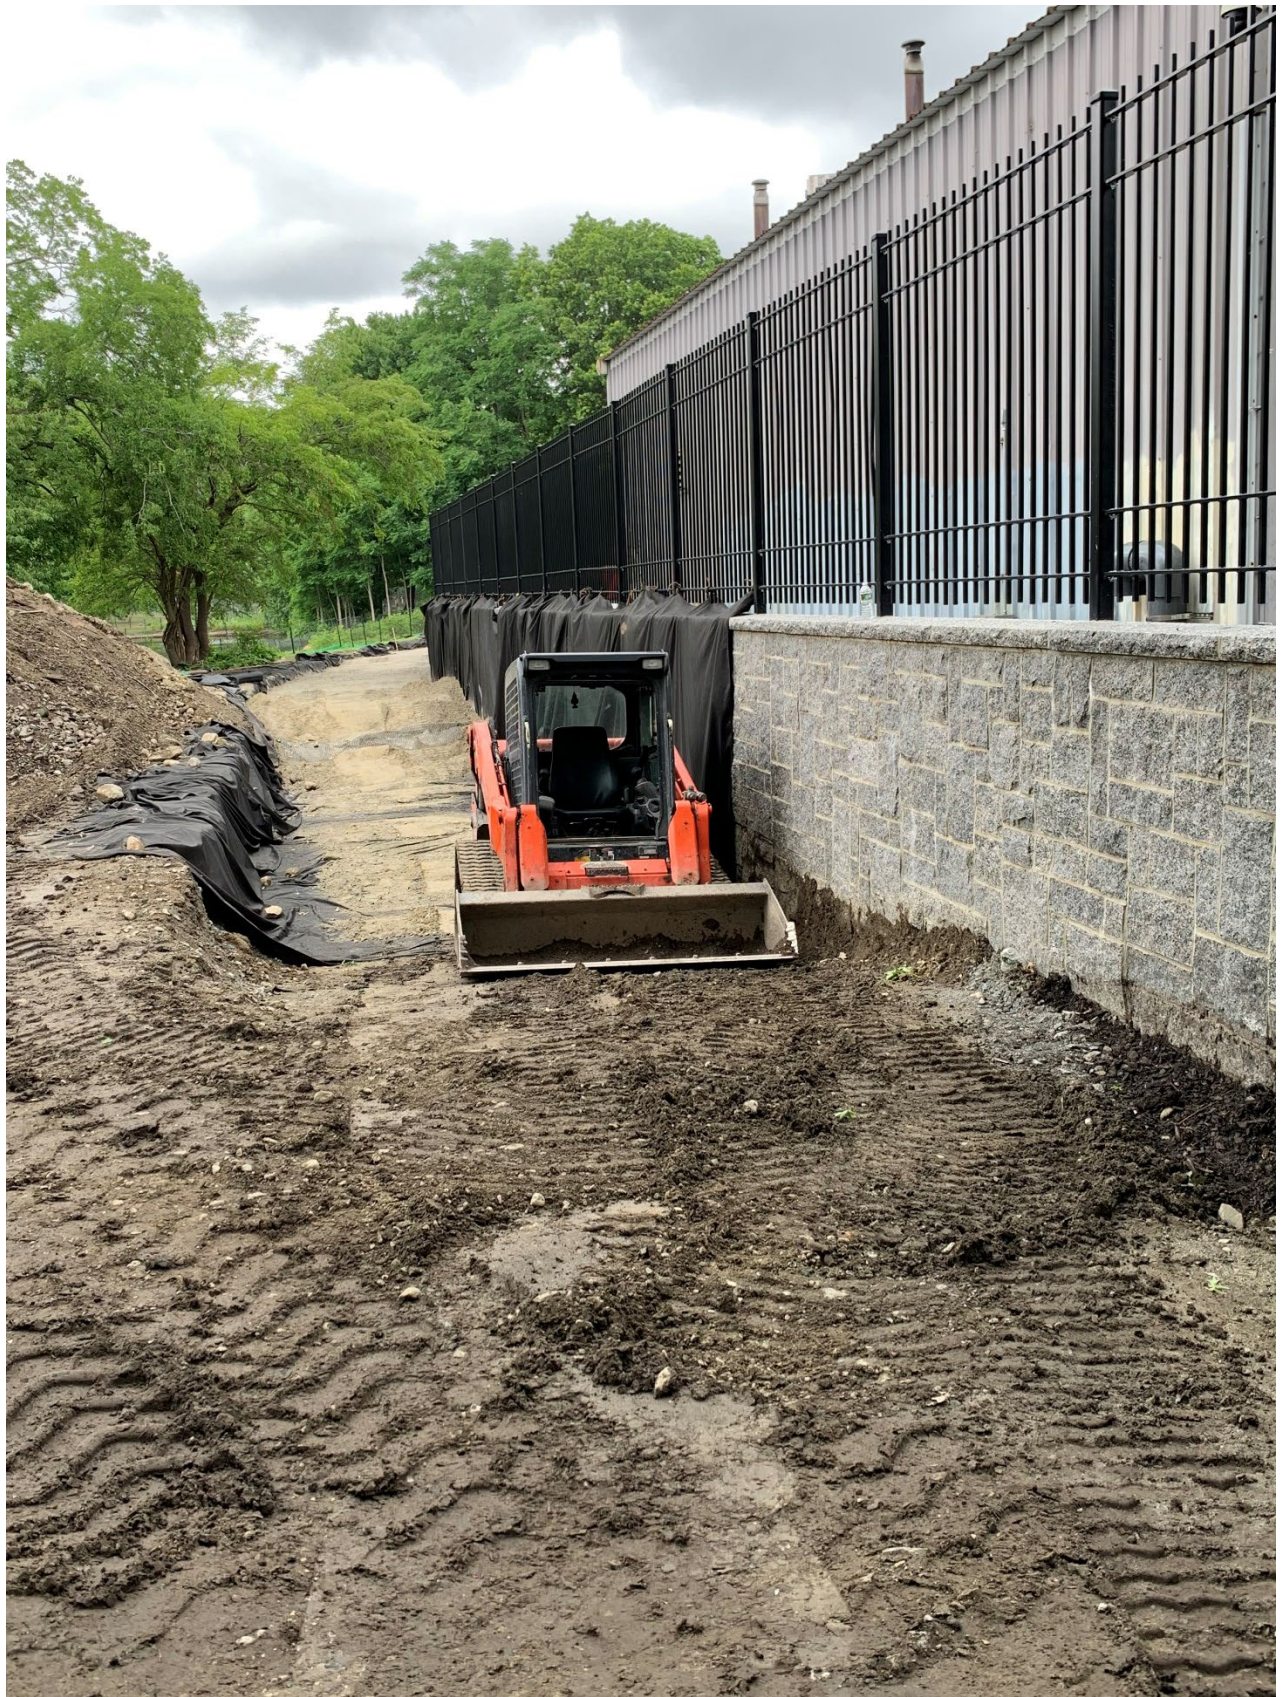
Work Area #13 – Boston Fire Department Building in the vicinity of The Fenway and Agassiz Road – excavation of subgrade and full depth restoration of the stonedust path.
